Inspection Photos

Location Name: GUNNISON ENERGY LLC Spadafora 1190 /20-21 H1

Location ID: 417369

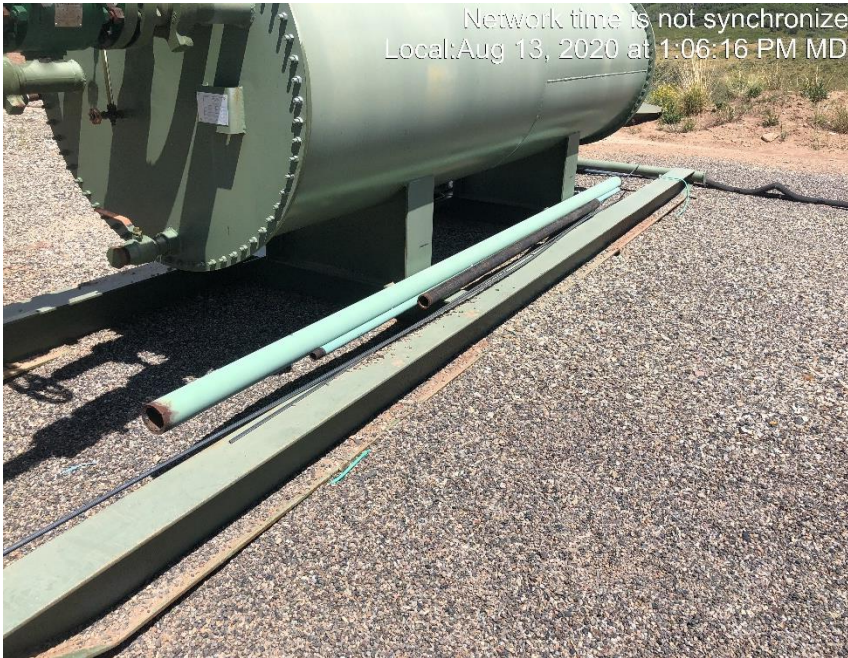
Photo #1717 Multiple places with unused equipment.

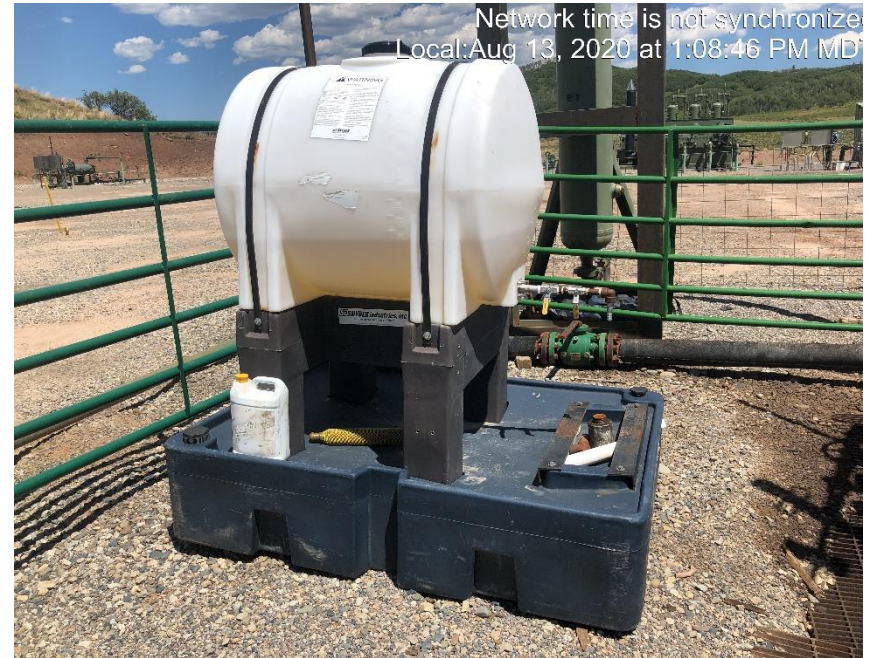
Photo #1718 Multiple places with unused equipment.

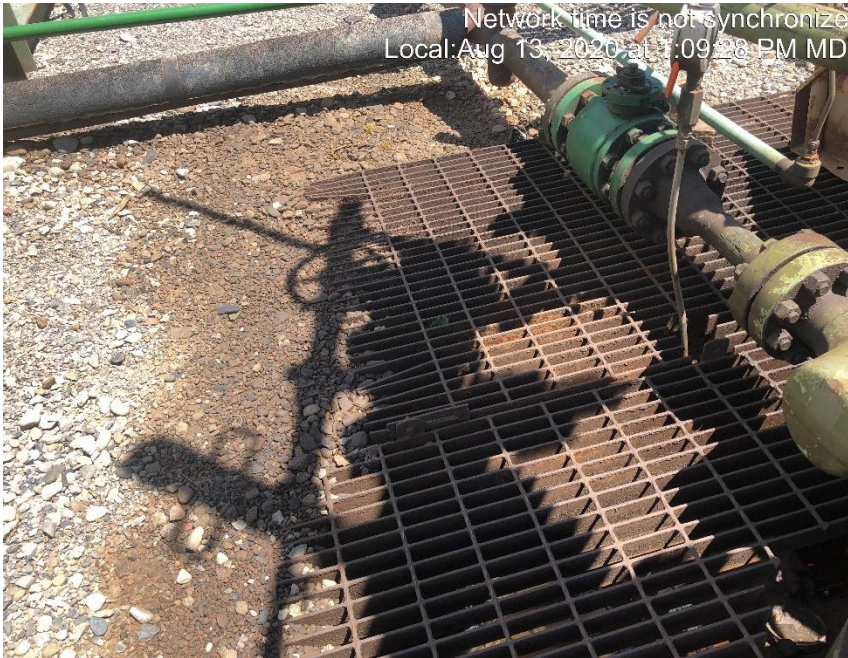
Photo #1719 stained soil.

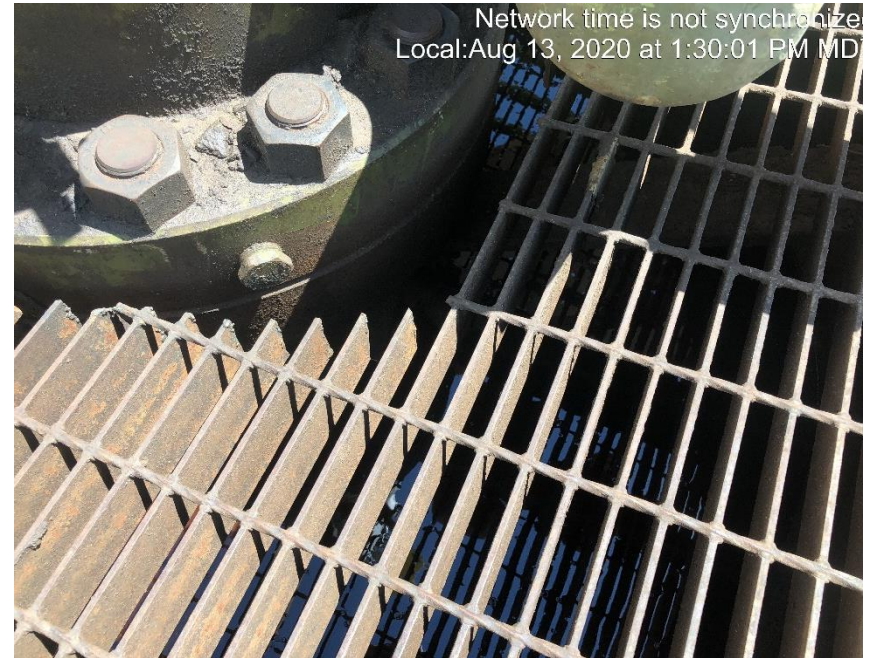
Photo #1721 oily fluid in cellar ring.
