Inspection Photos

API: 063-06043

Operator: CITATION OIL & GAS CORP

Inspection Date: 8/11/2020

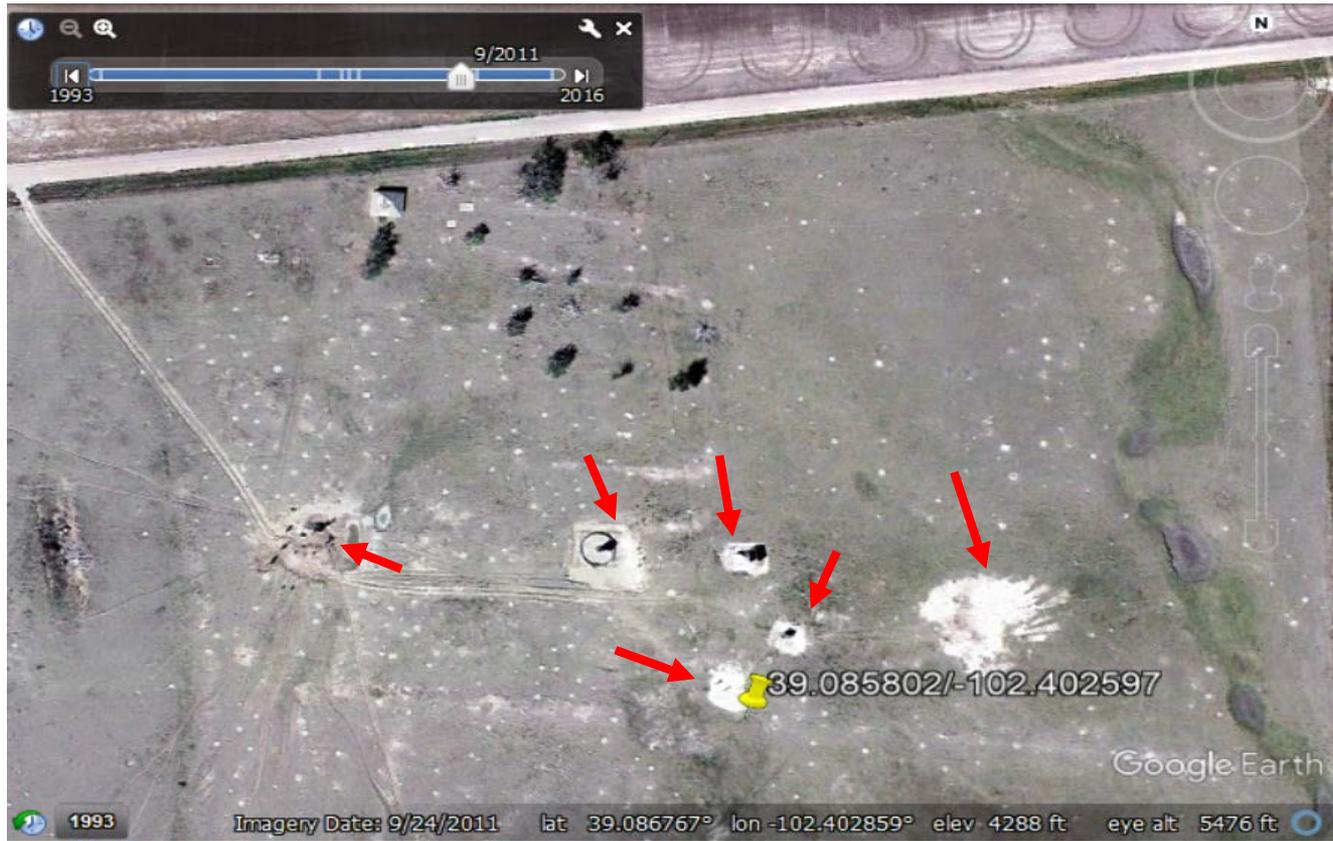
Photo 1. This is a 2011 aerial image of the location. There are multiple areas of disturbance shown by red arrow.

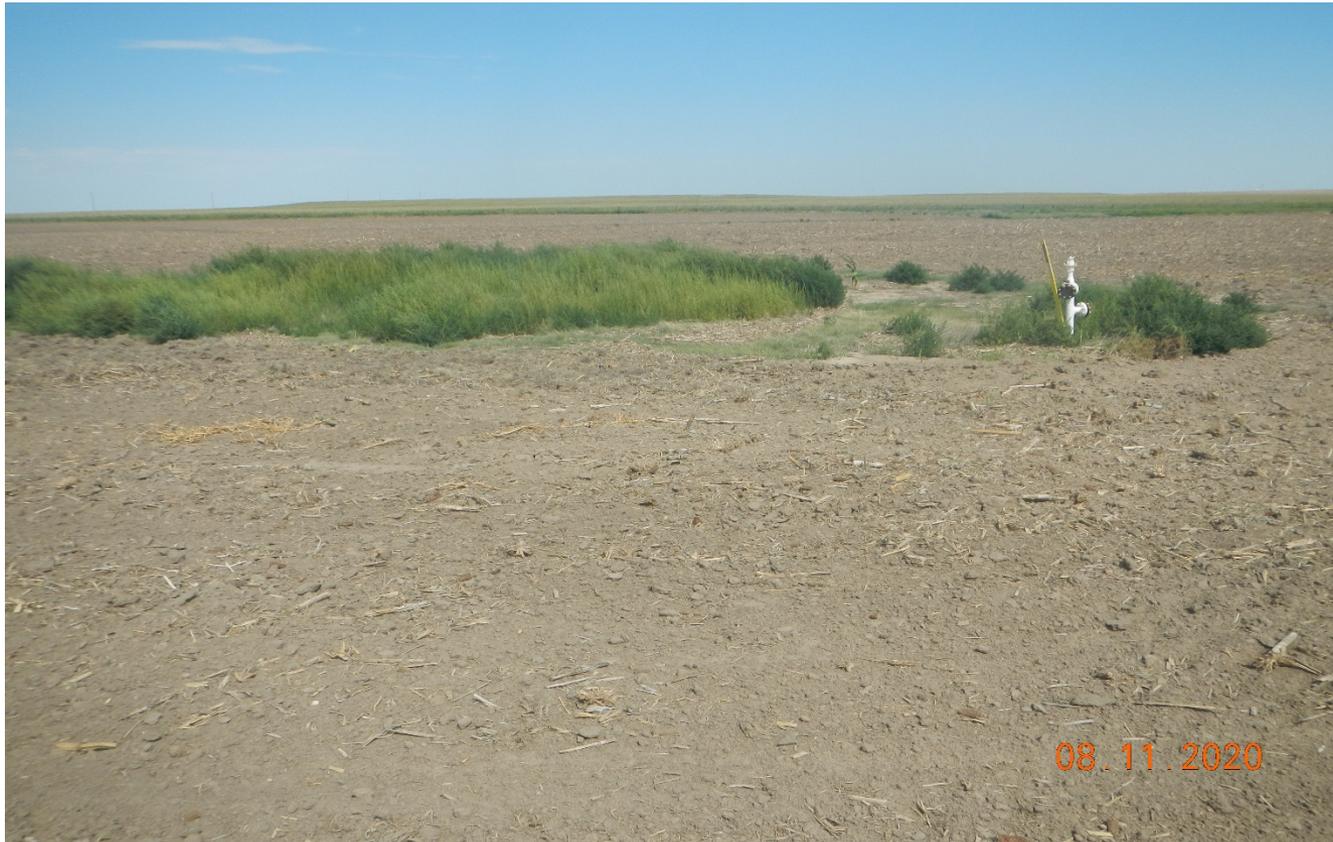
Photo 2. Facing east toward the location. This area of the location is being farmed around due to the prescience of a pipe riser that remains.

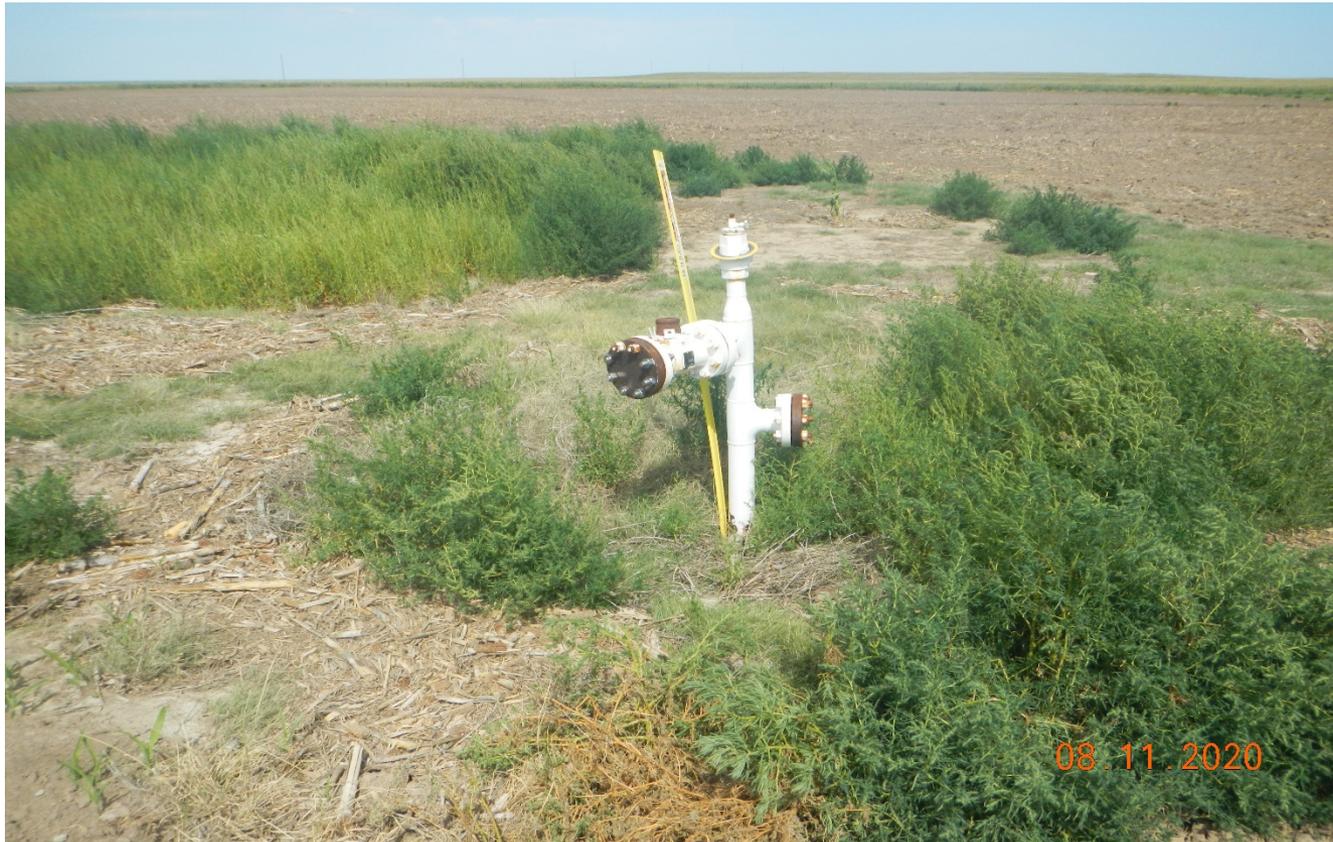
Photo 3. Pipe riser at the location has not been removed since previous inspection. Corrective action was not performed.

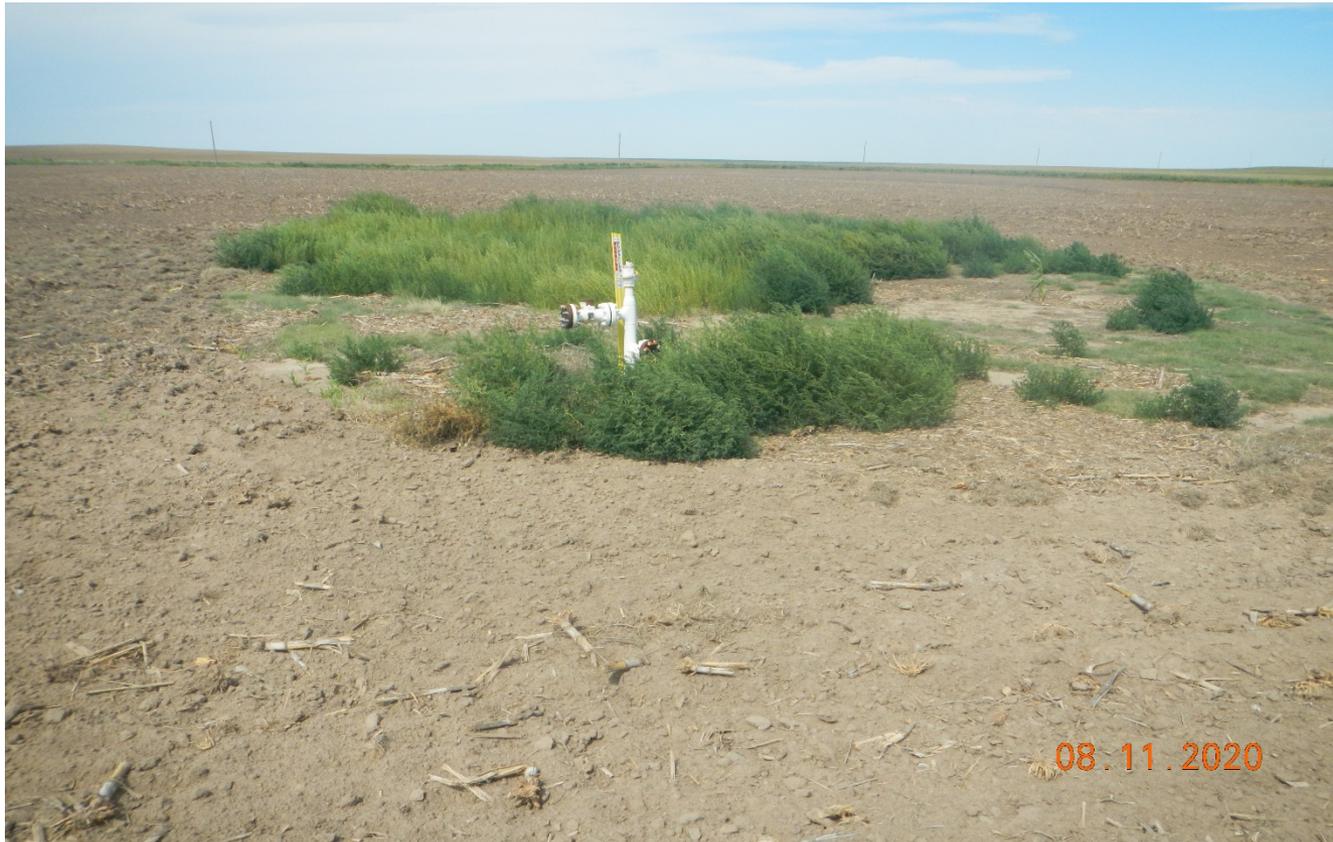
Photo 4. Facing northeast toward the location. The pipe riser is interfering with farming operations.
