Inspection Photos

Loc#322404

Operator: Maralex

Inspection Photos: Maralex Baldy Creek Loc#322404

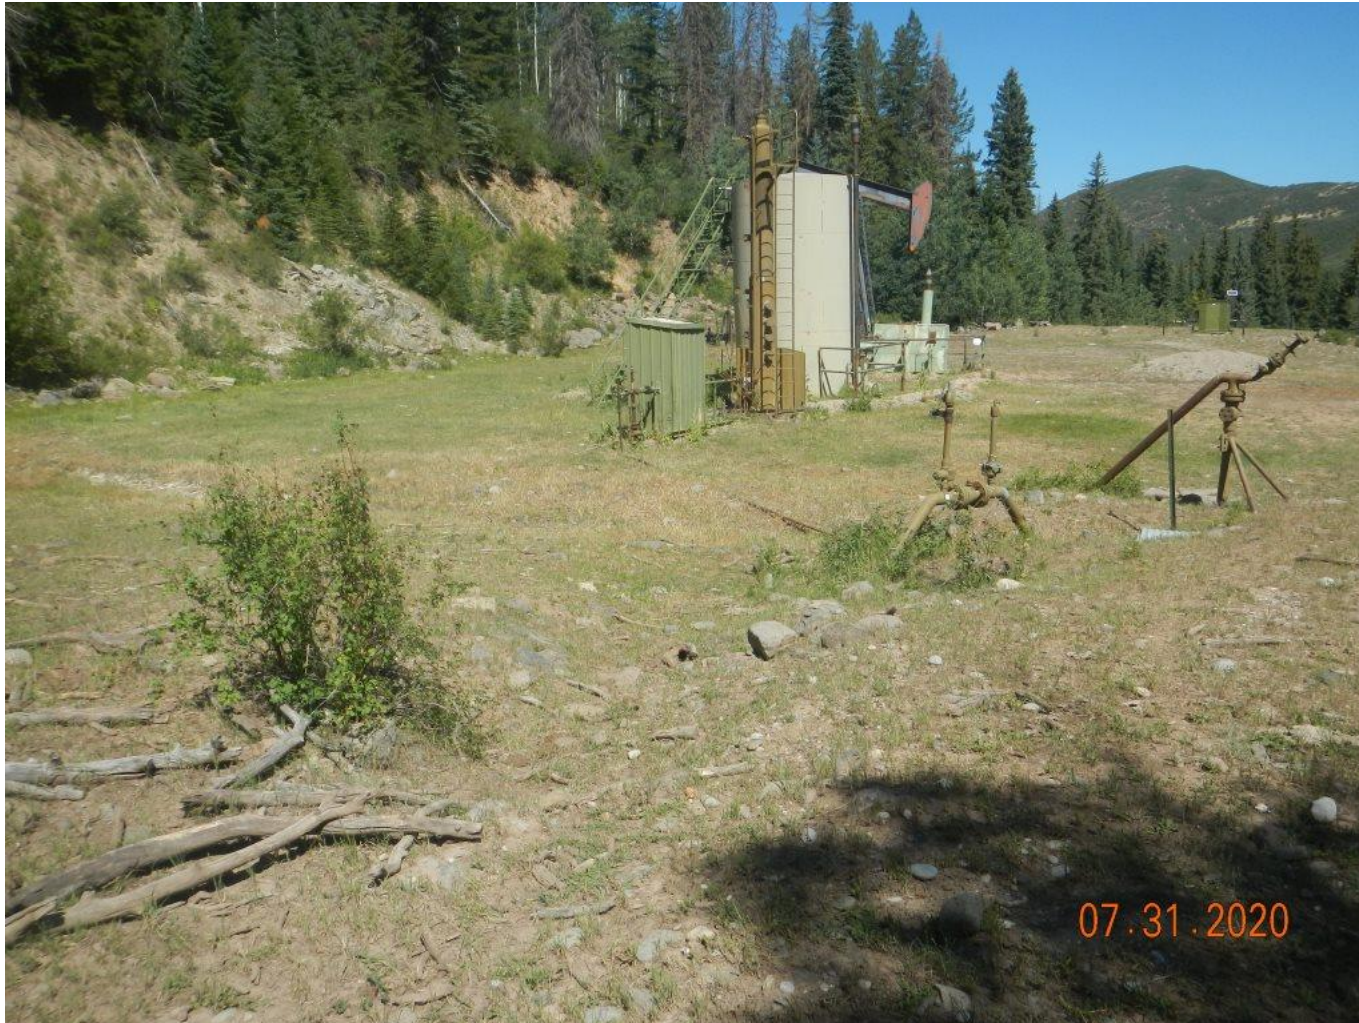
Photo#1:
Overview of Location to Northwest.

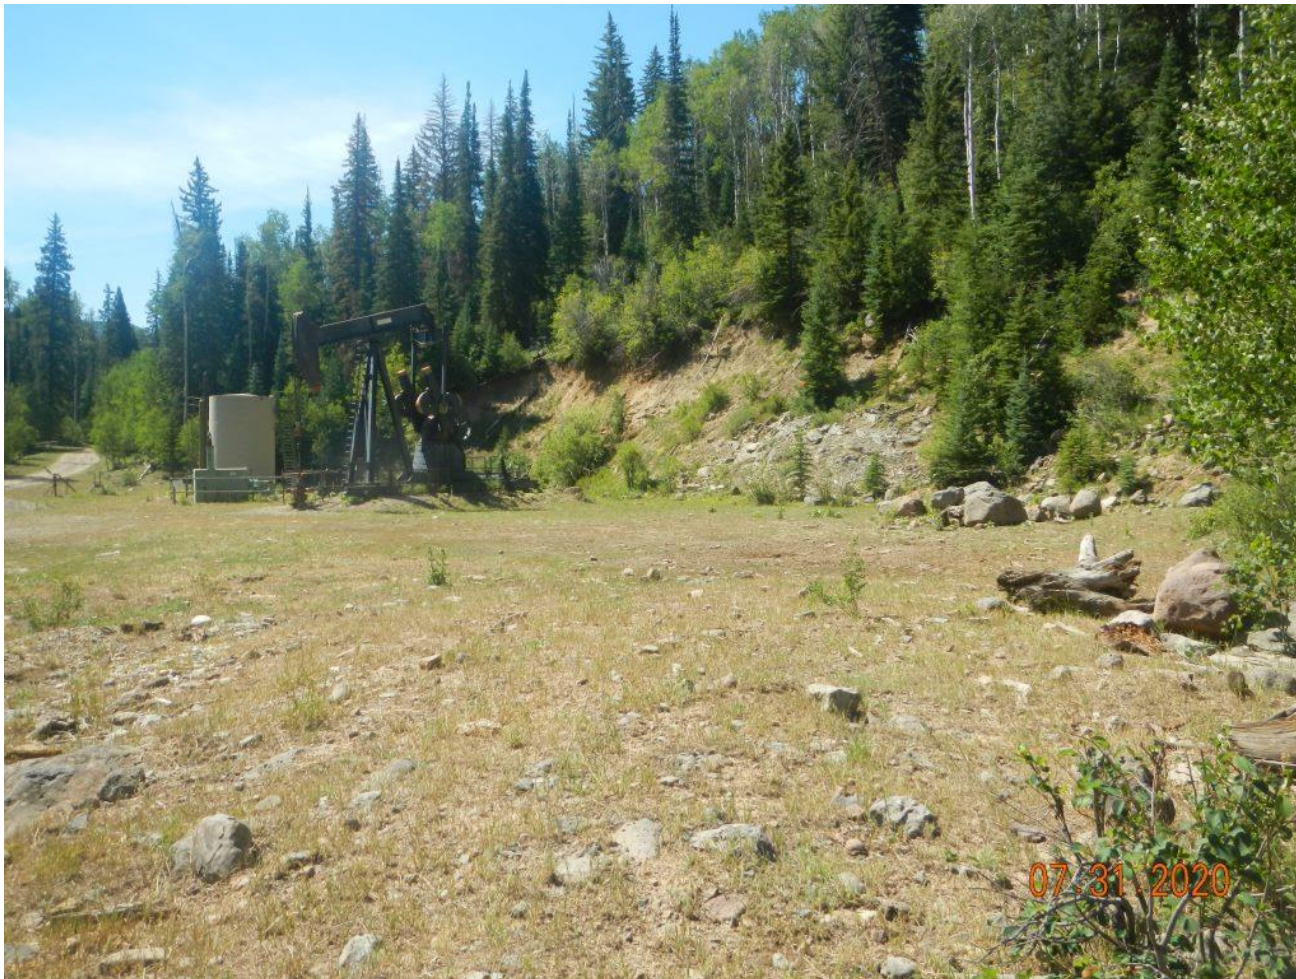
Photo#2:
Overview of Location to Southwest

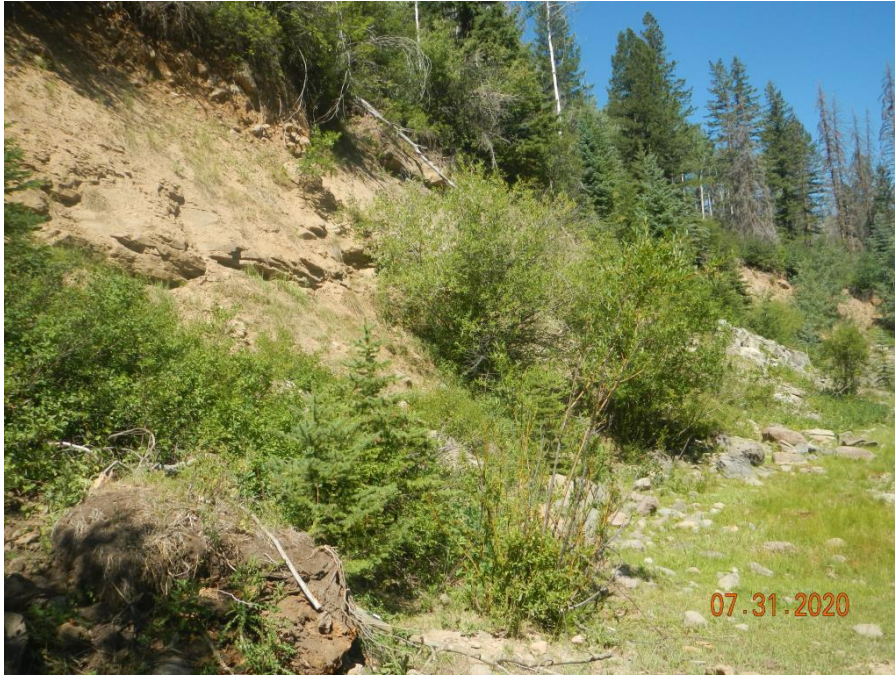
Photo#3:
View North along base of cut slope.

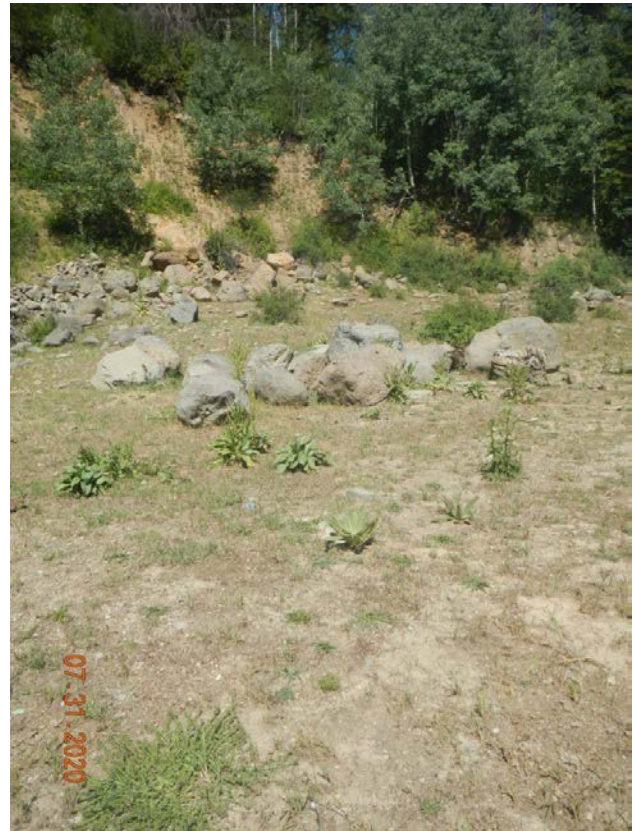
Photo#4:
North end of Cut slope. Noxious weed,
Houndstongue in foreground.

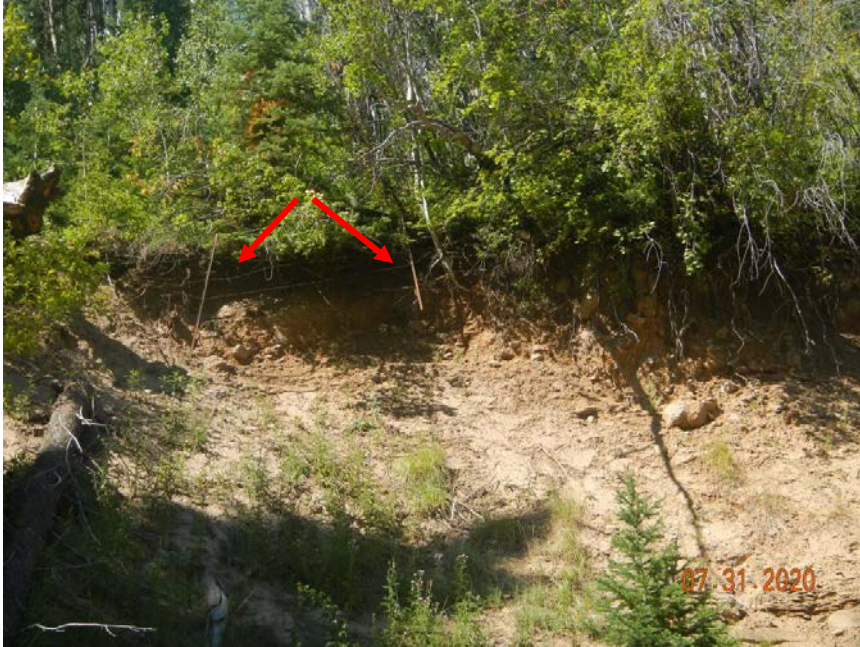
Photo#5:
Erosion and undermining of root systems at top of Cut.
Note undermined old fencing, indicated by arrows.

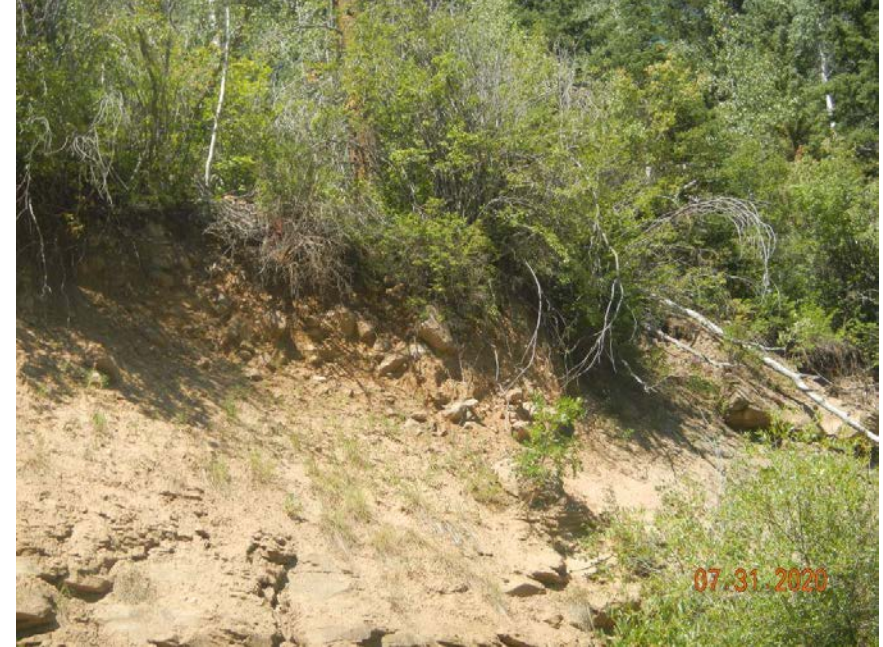
Photo#6:
Erosion and undermining of root systems at top of Cut.

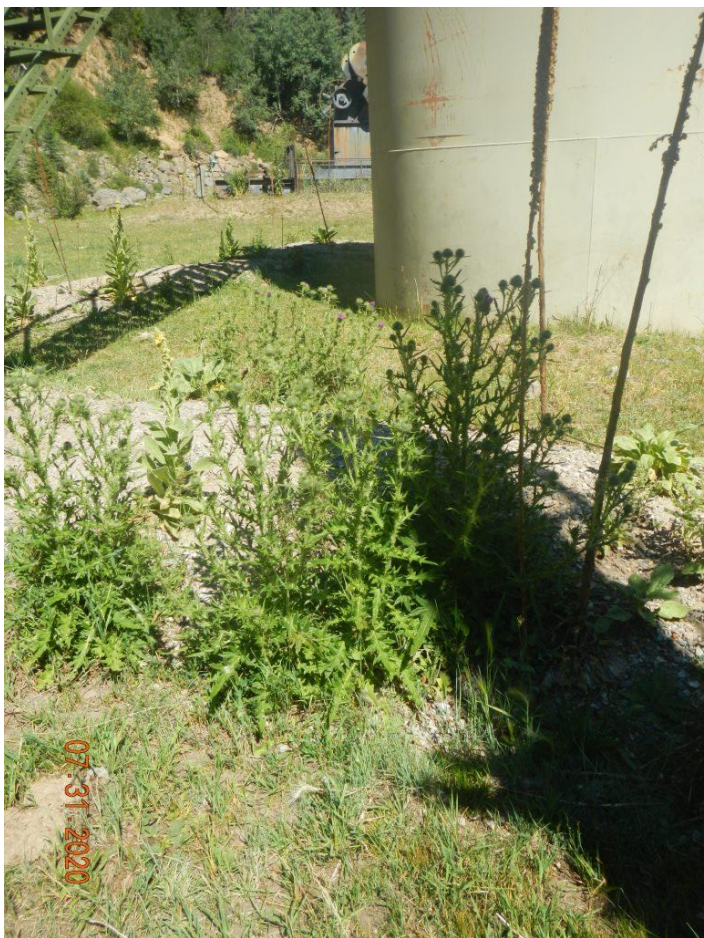
Photo#7:
Noxious weeds established on site.

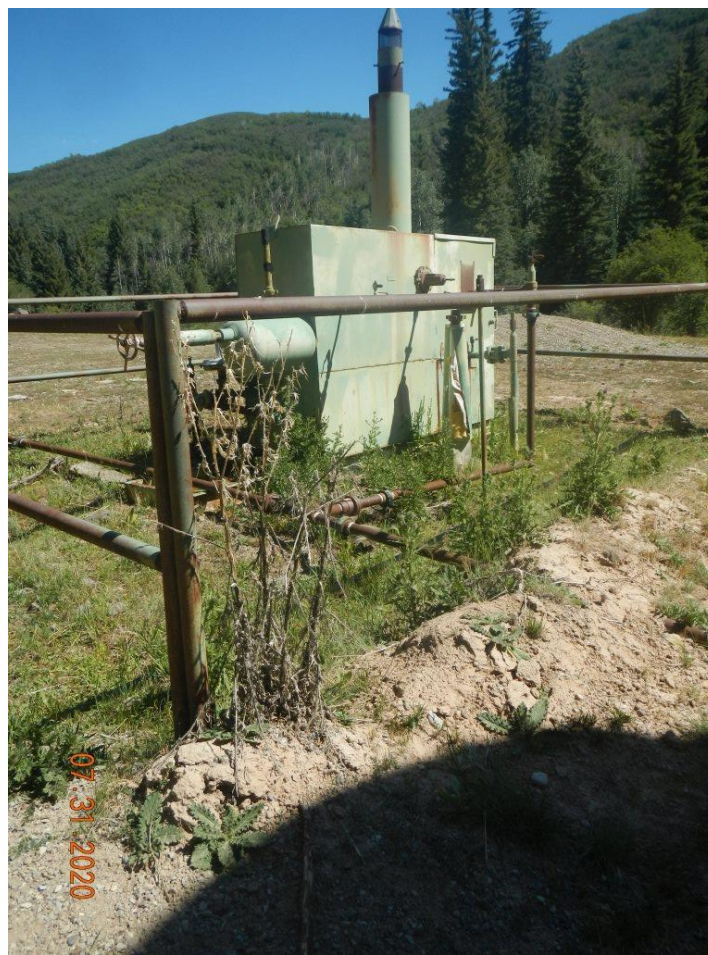
Photo#8:
Noxious weeds established on site.

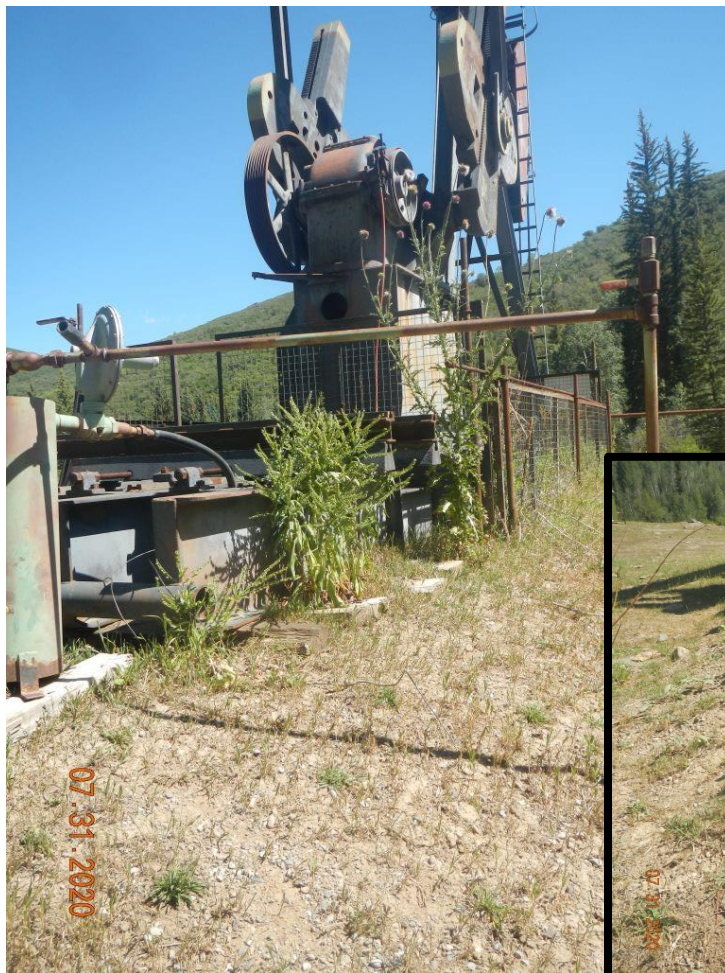
Photo#9:
Noxious weeds established on site

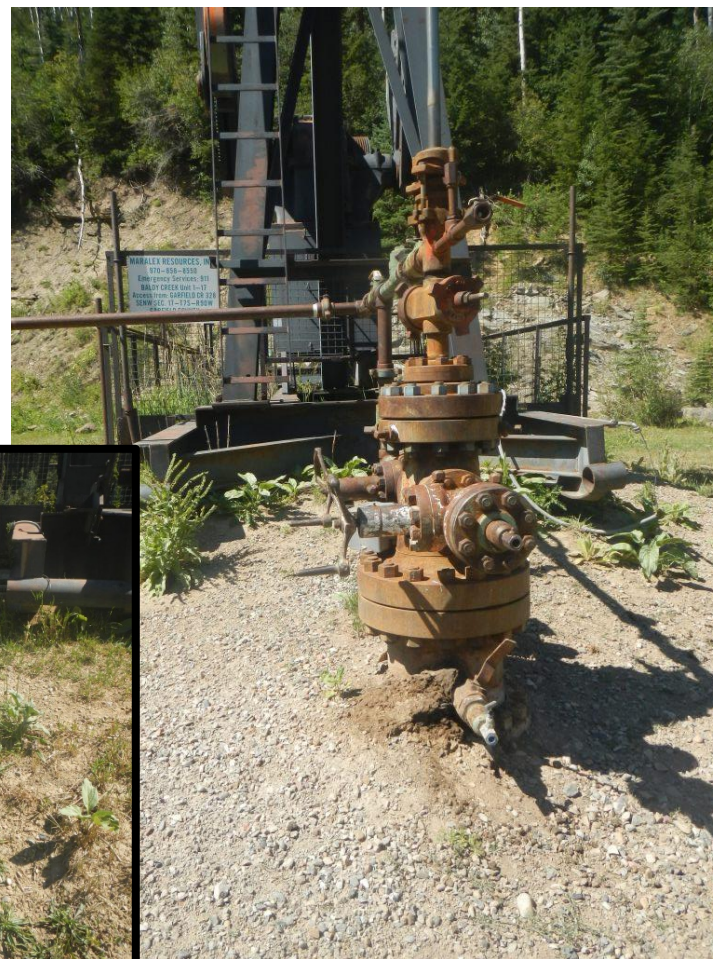
Photo#10:
Noxious weeds established on site.

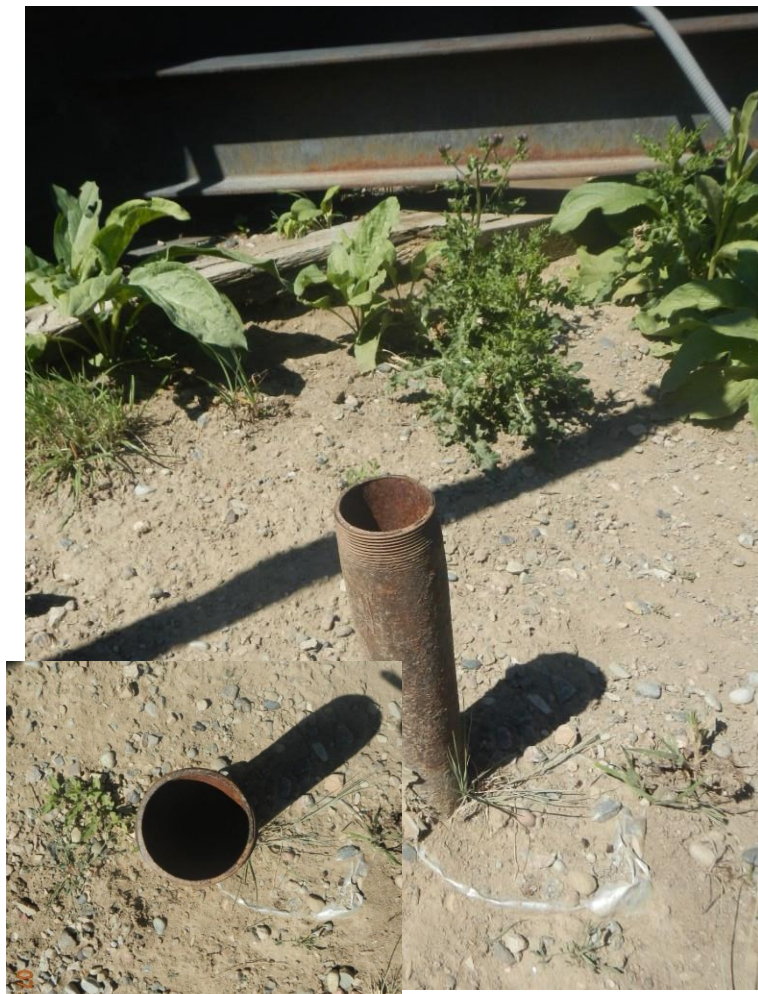
Photo#11:
Open riser at front of Pump Jack.

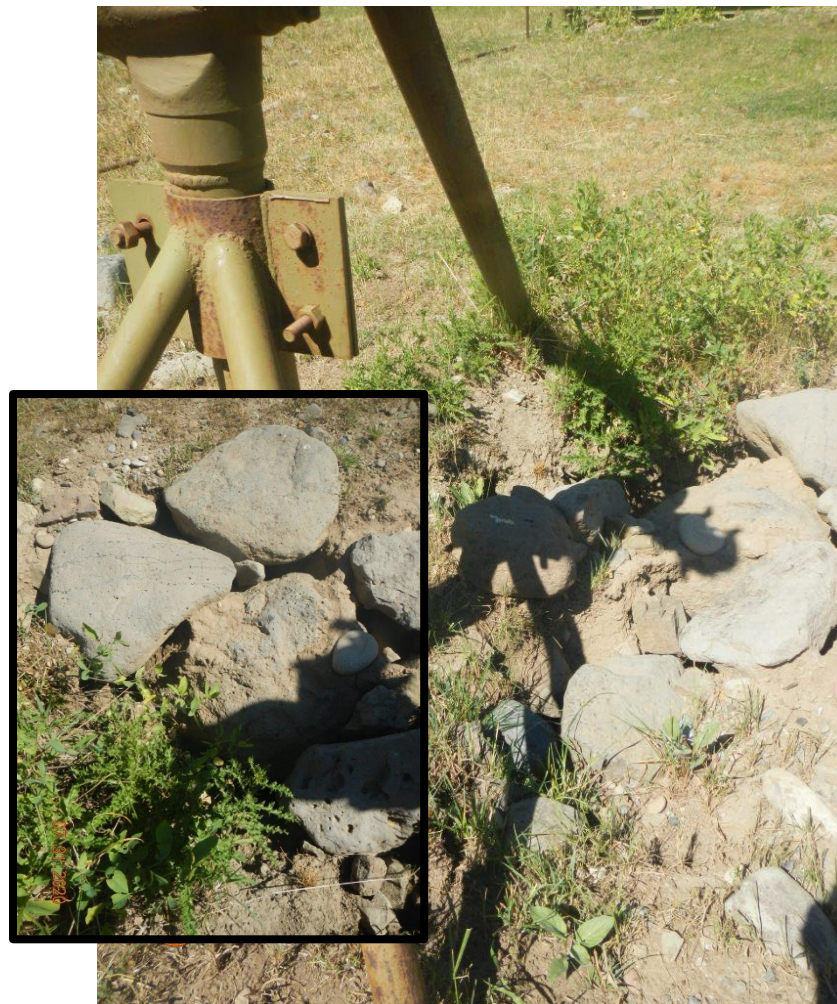
Photo#12:
Subsidence/wormhole under rocked drain area.
