Inspection Photos

Loc#322436

Operator: Maralex

Inspection Photos: Maralex Baldy Creek Federal Loc#322436

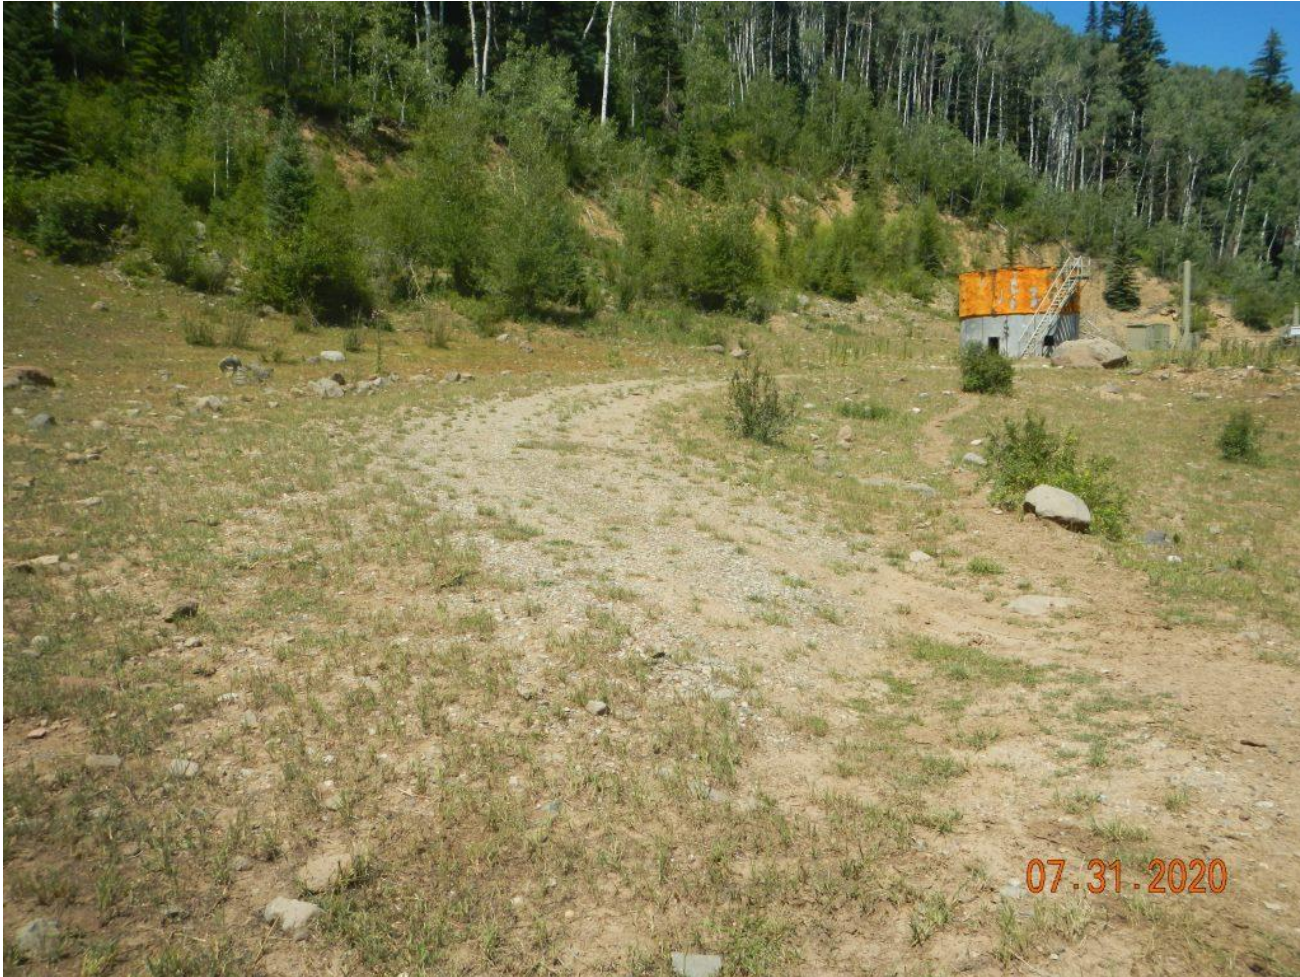
Photo#1:
Overview of Location from entry to Northwest.

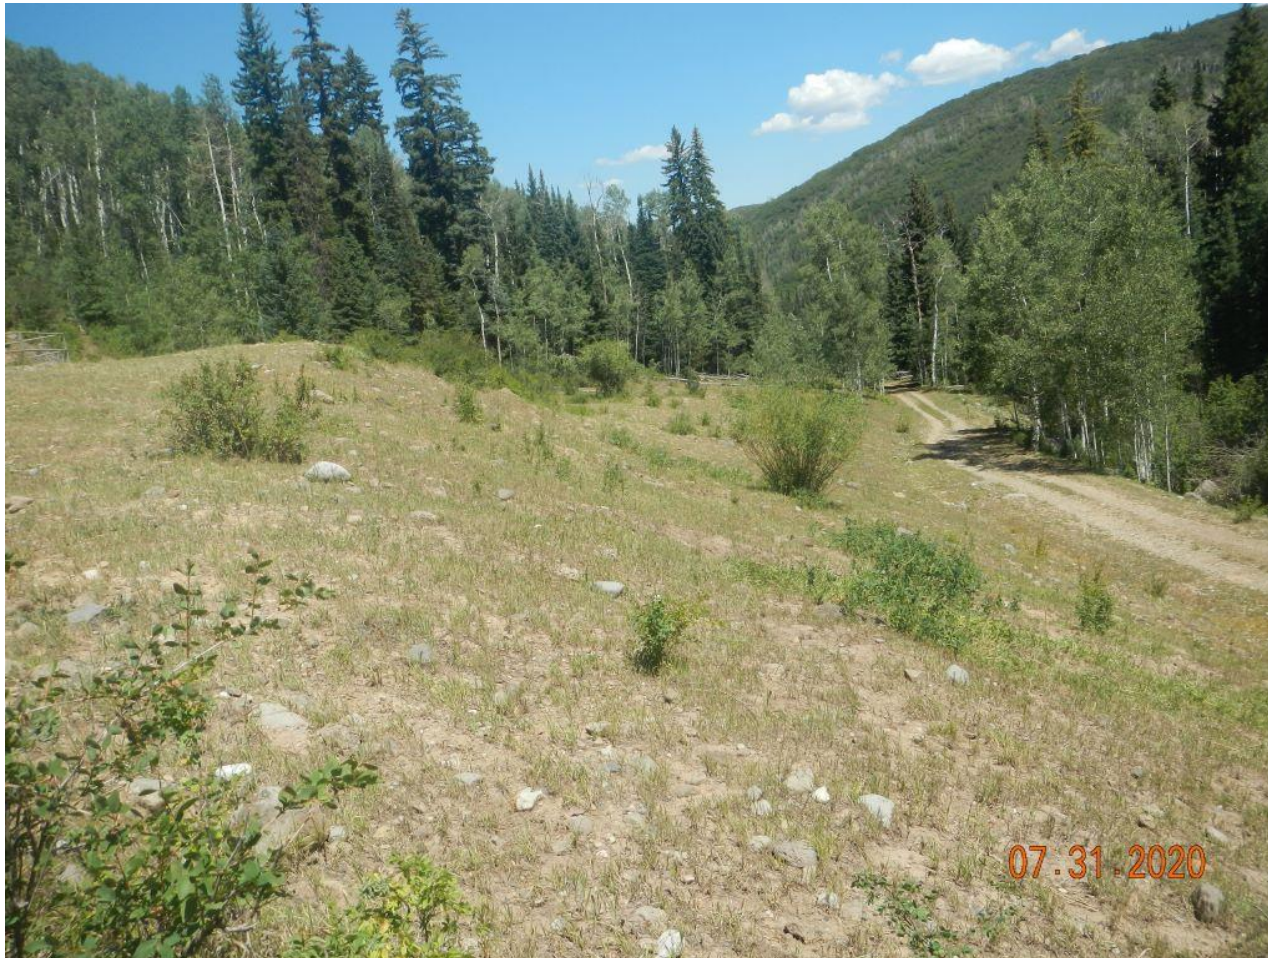
Photo#2:
View over East fill slope to North.

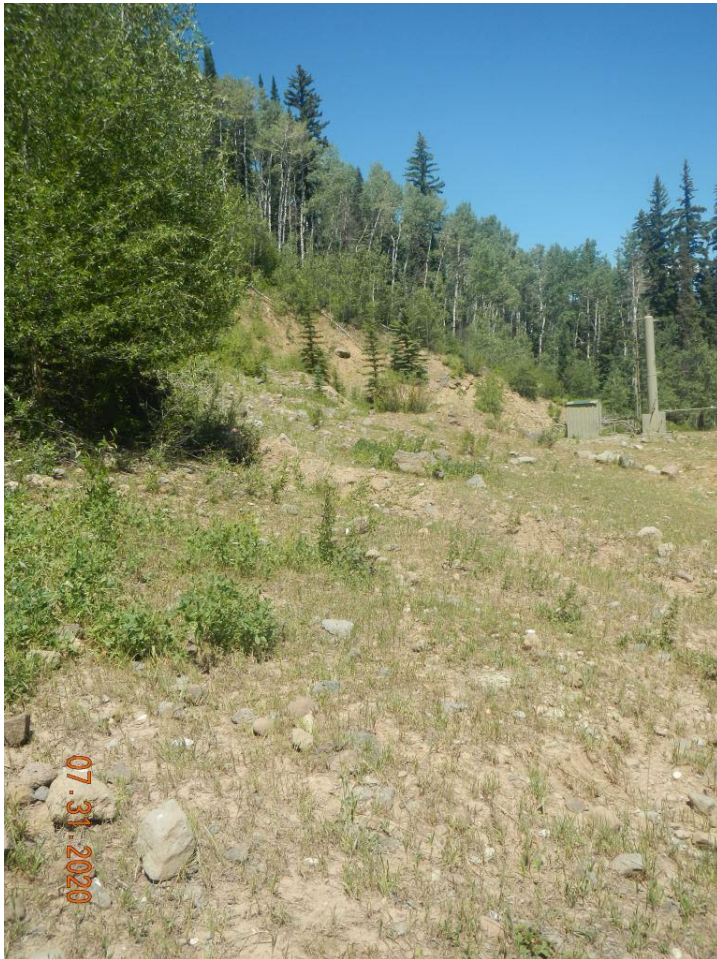
Photo#3:
View Northwest along cut slope.

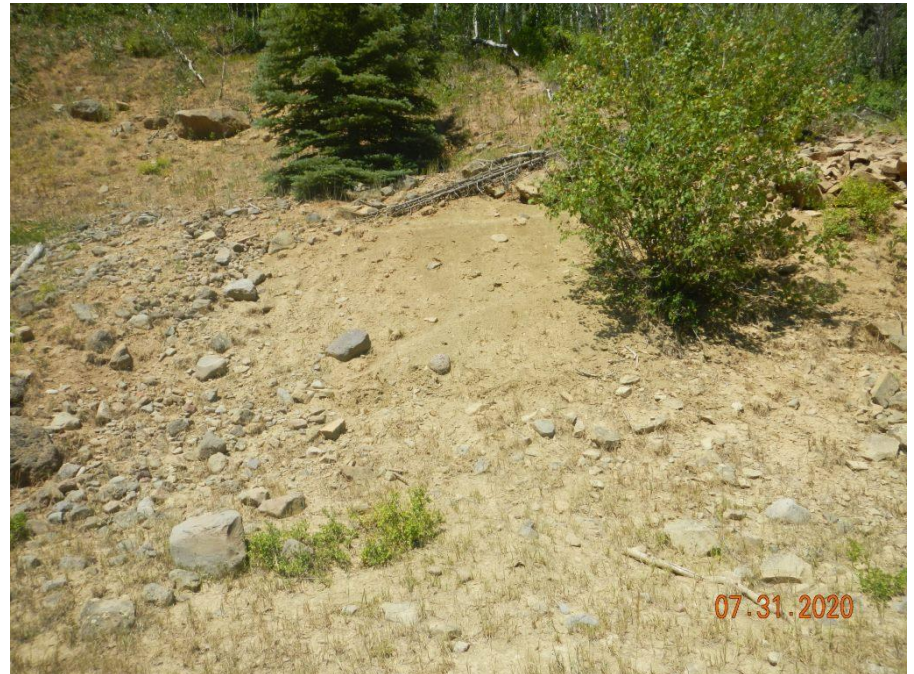
Photo#4:
North end of cut slope.

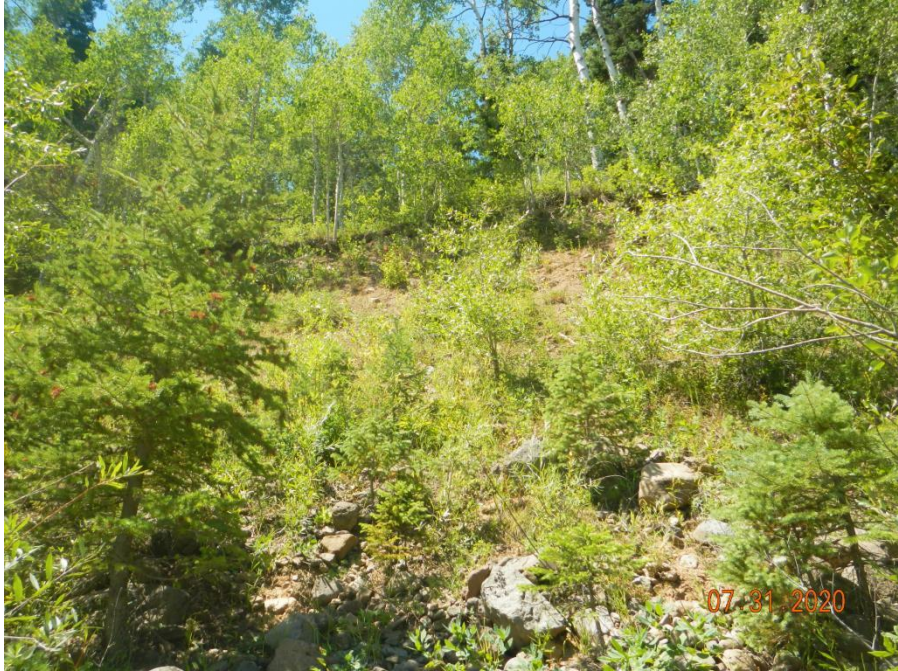
Photo#5:
Erosion and undermining of root systems at top of cut.

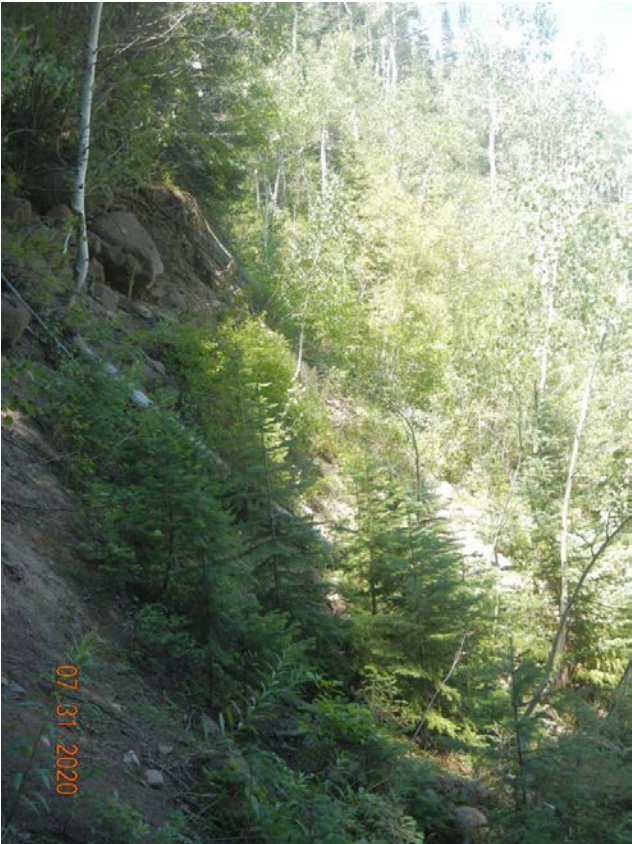
Photo#6:
Erosion and undermining of root systems at top of cut.

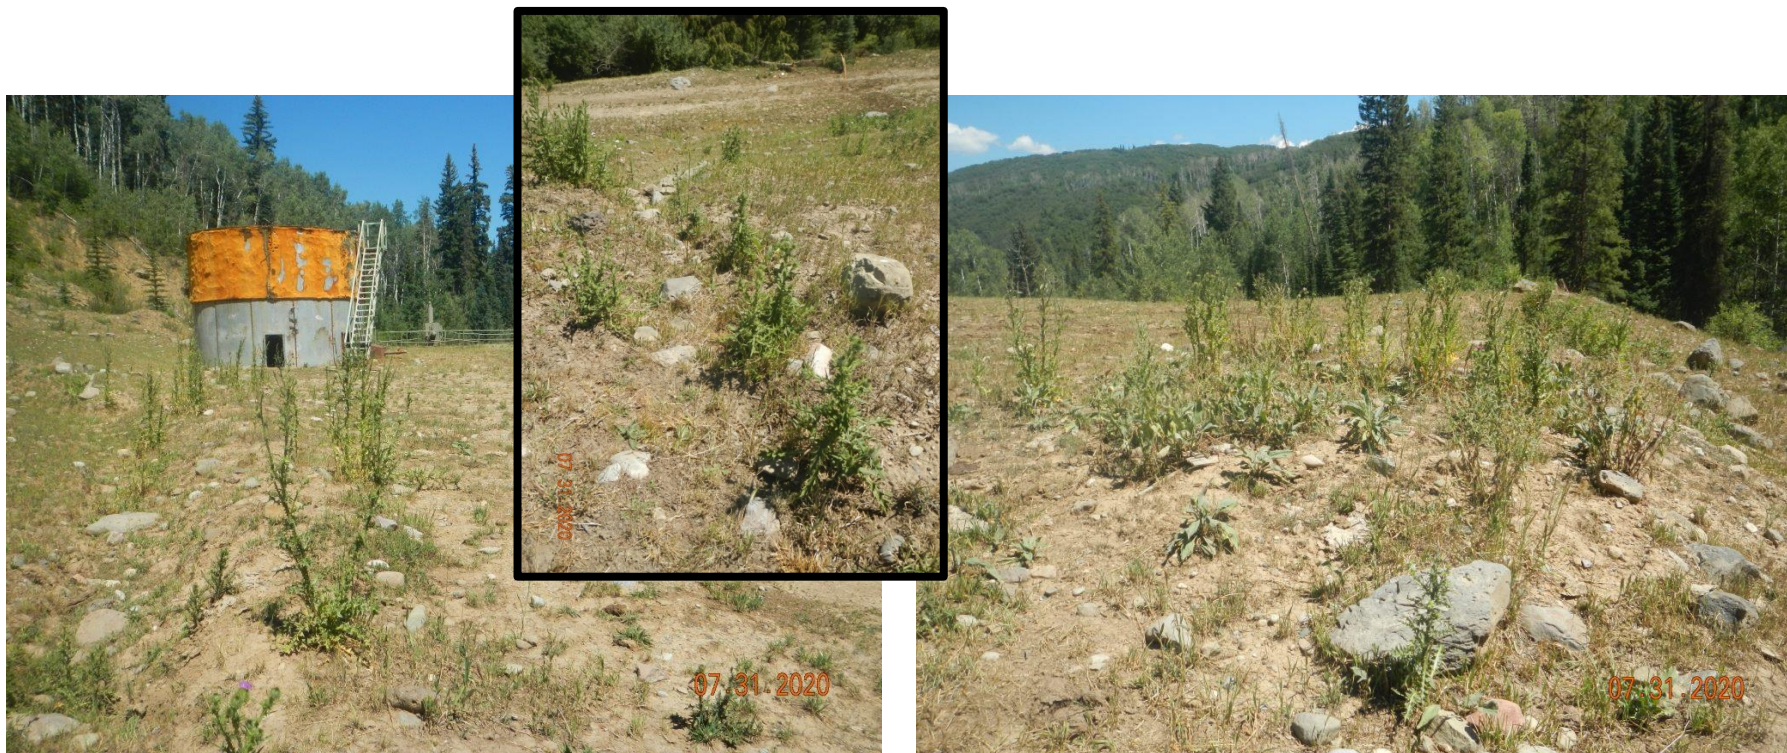
Photo#7:
Noxious weeds established on site.

Photo#8:
Noxious weeds established on site.

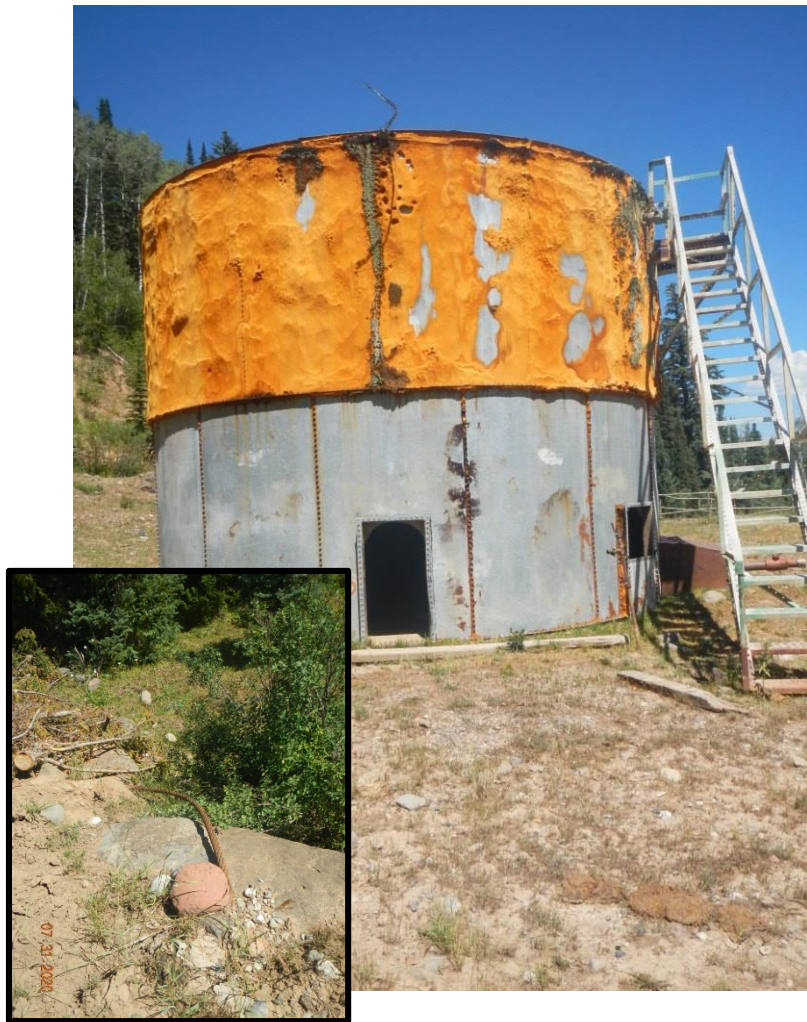
Photo#9:
Unused equipment and Debris.

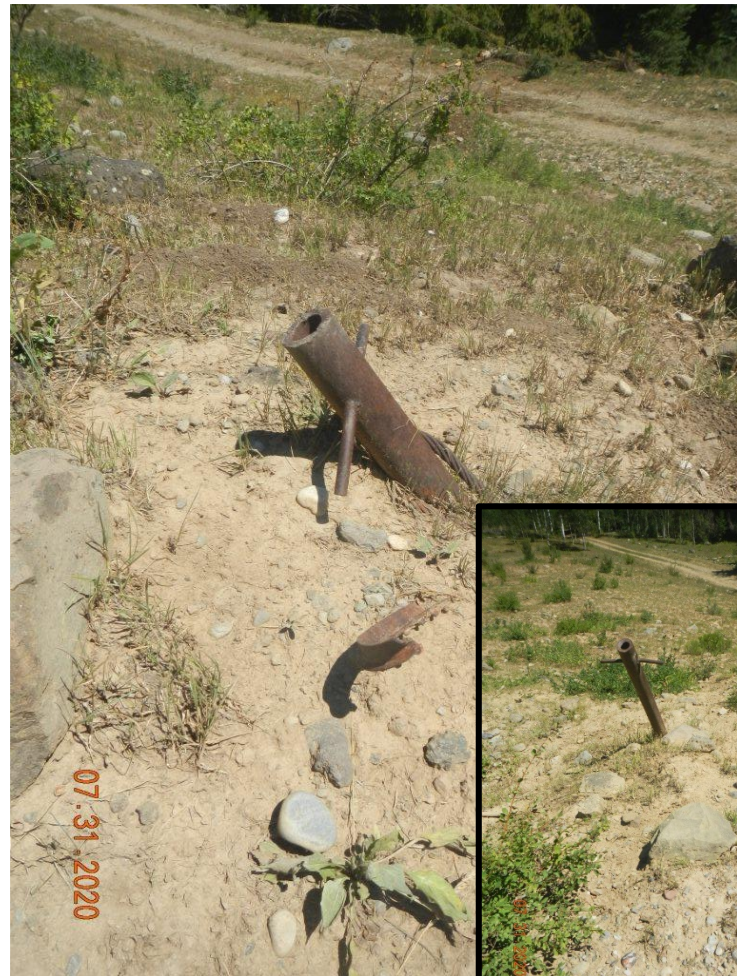
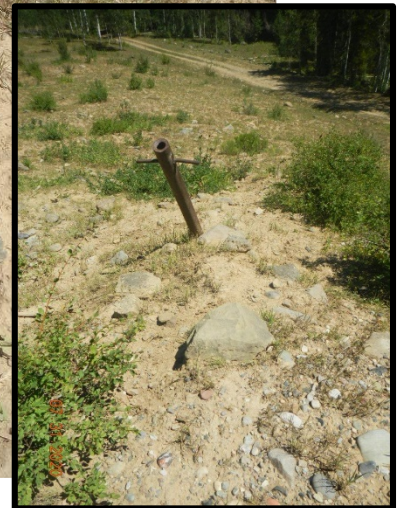
Photo#10:
Anchors not Marked.
