Inspection Photos

API: 061-06899

Operator: MCCOY PETROLEUM CORPORATION

Inspection Date: 8/11/2020

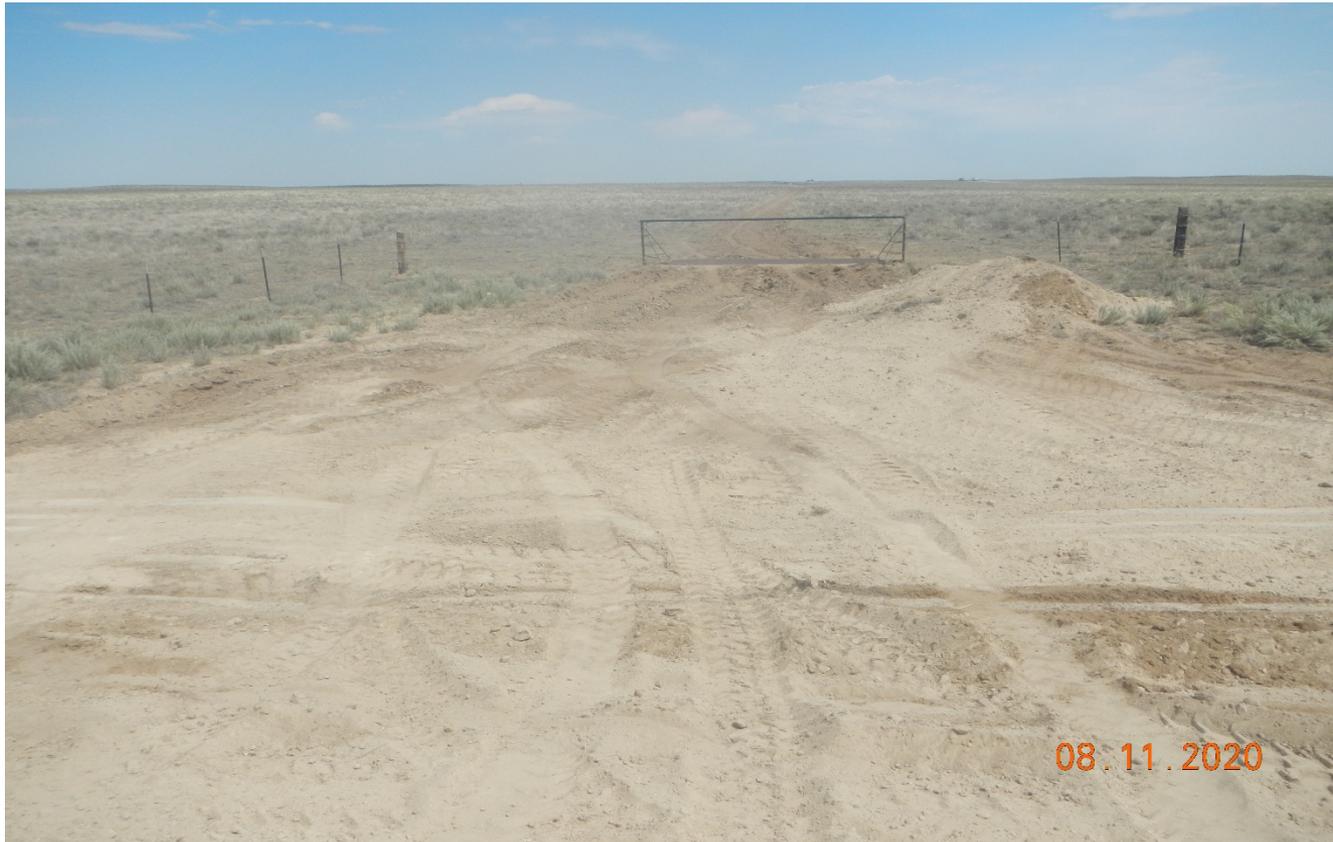
Photo 1. Facing north toward the beginning of the access road. The access from the county road has been regraded and soils decompacted.

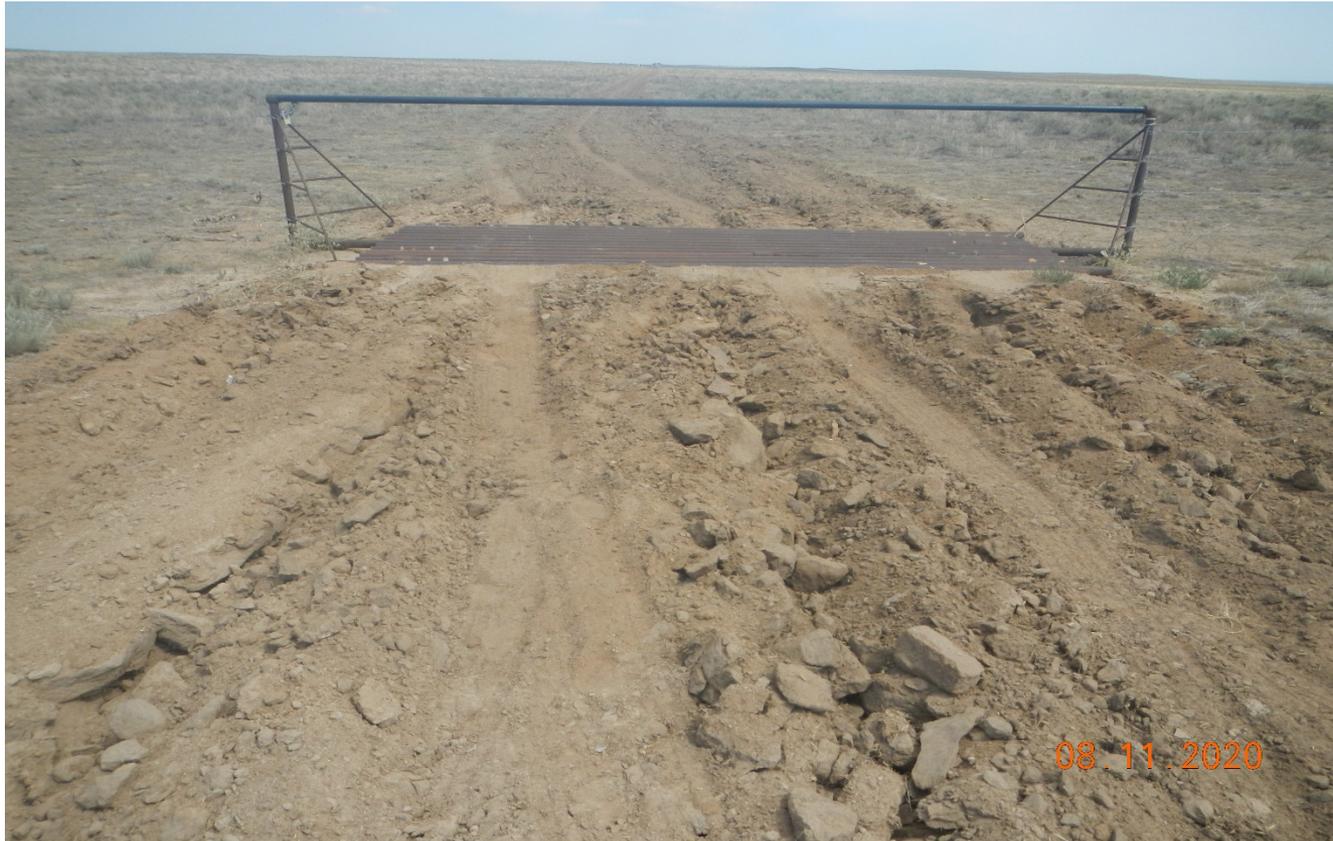
Photo 2. The soils were ripped along the access road. The cattle guard will need to be removed.

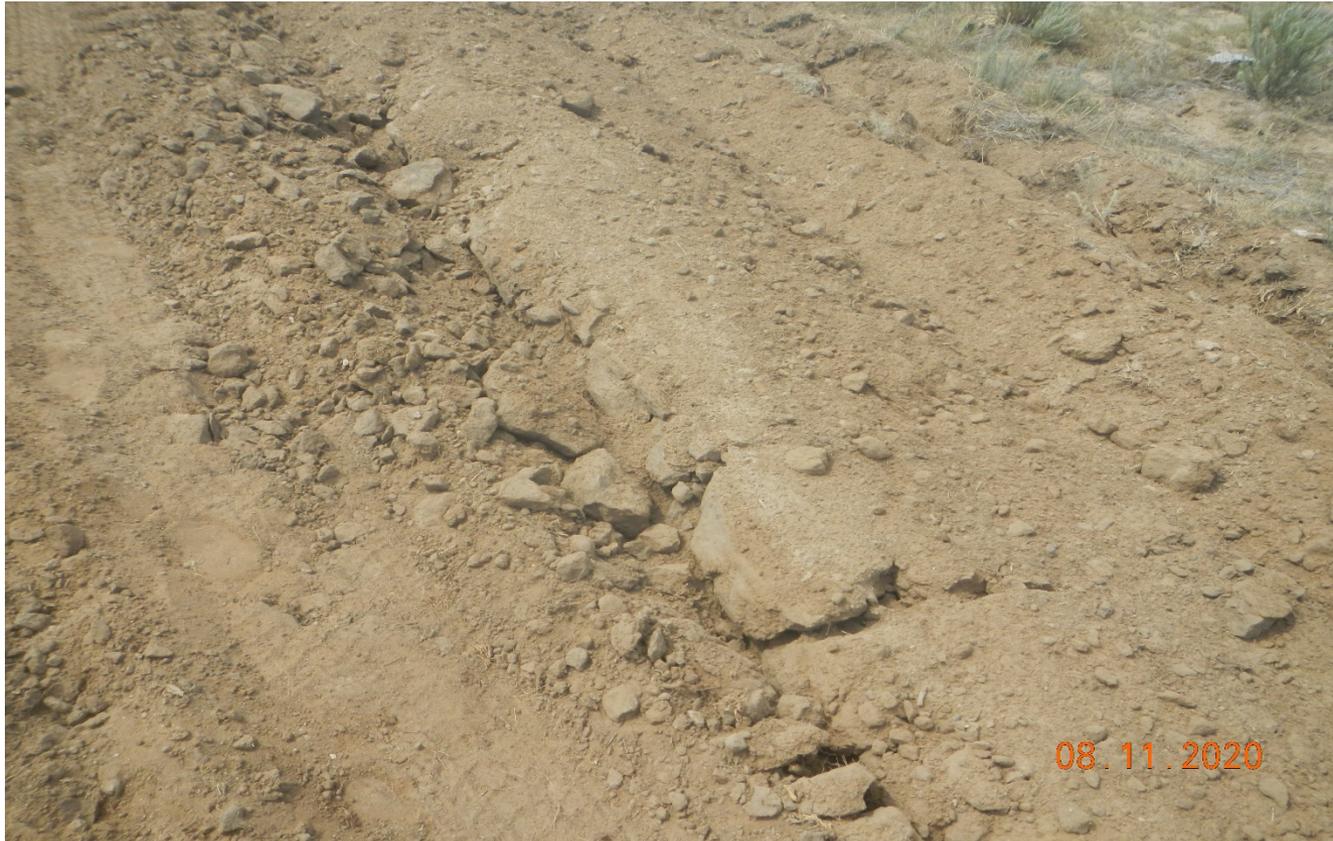
Photo 3. The soils were ripped but will need to be adequately tilled to establish a seed bed.

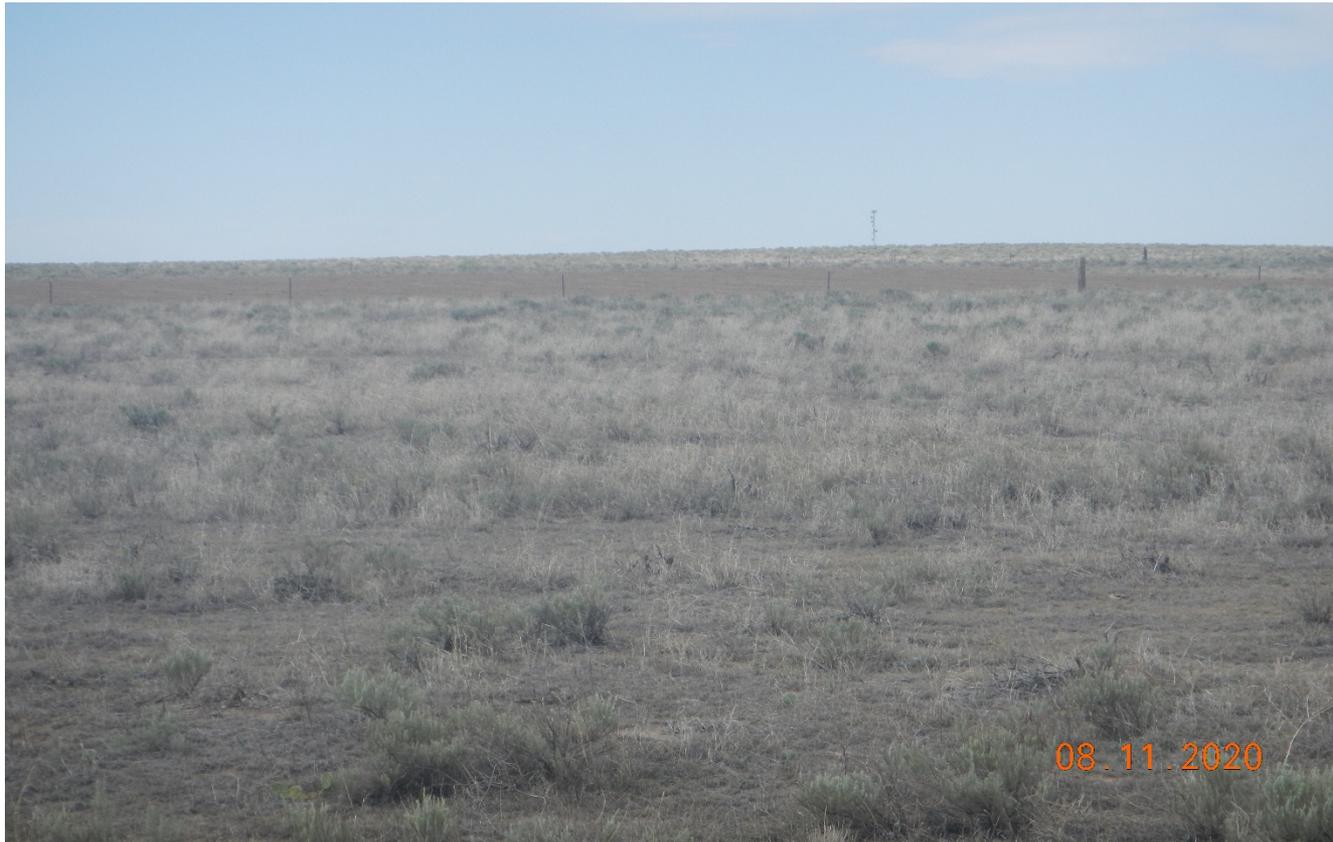
Photo 4. Facing west toward the location from a distance. The location has been recontoured and pits are backfilled.
