Inspection Photos

API: 121-10880

Operator: MERIT ENERGY COMPANY

Inspection Date: 8/12/2020

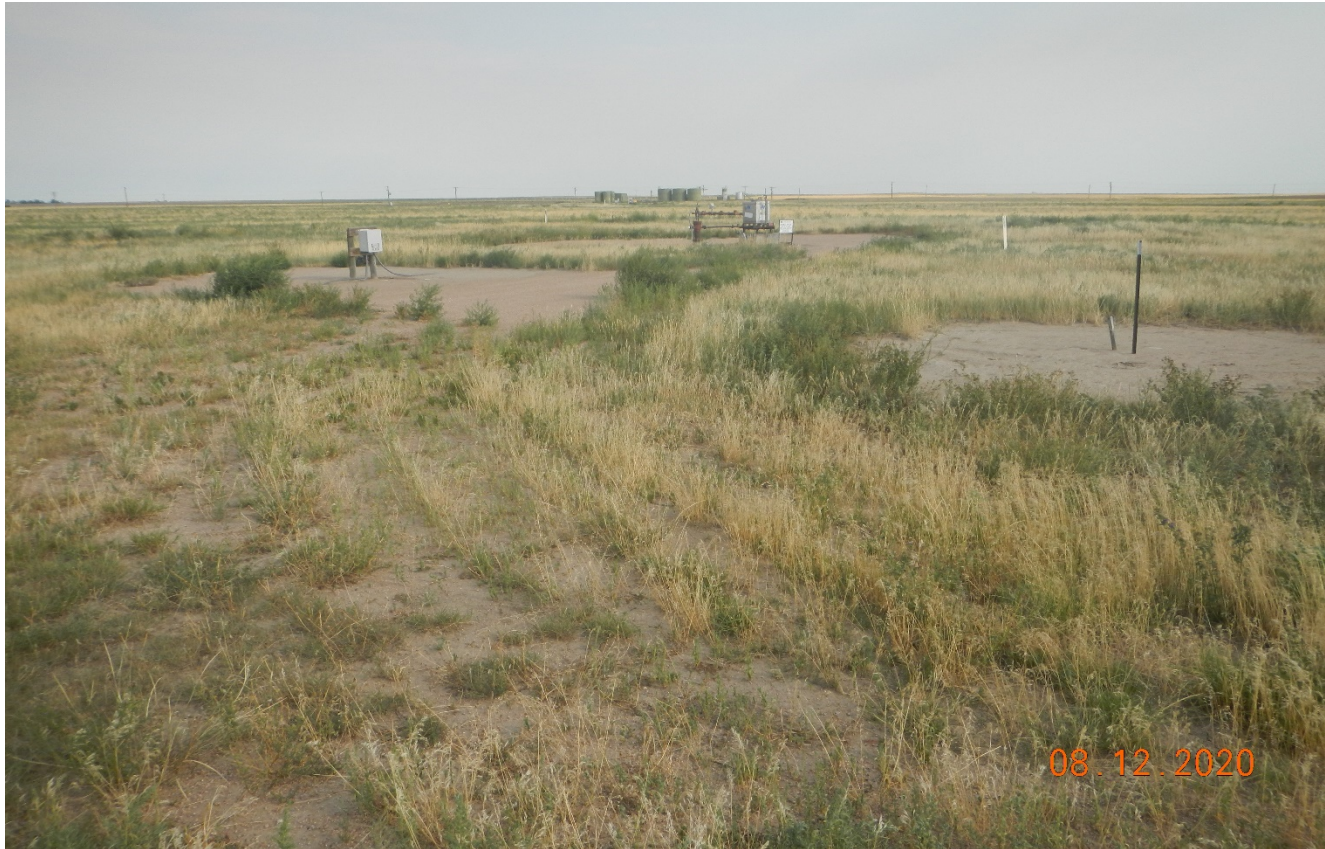
Photo 1. Facing northwest toward the location. There is an active well at the location listed under another operator. It does not appear that the [JONES #35-26](#) well was ever drilled.

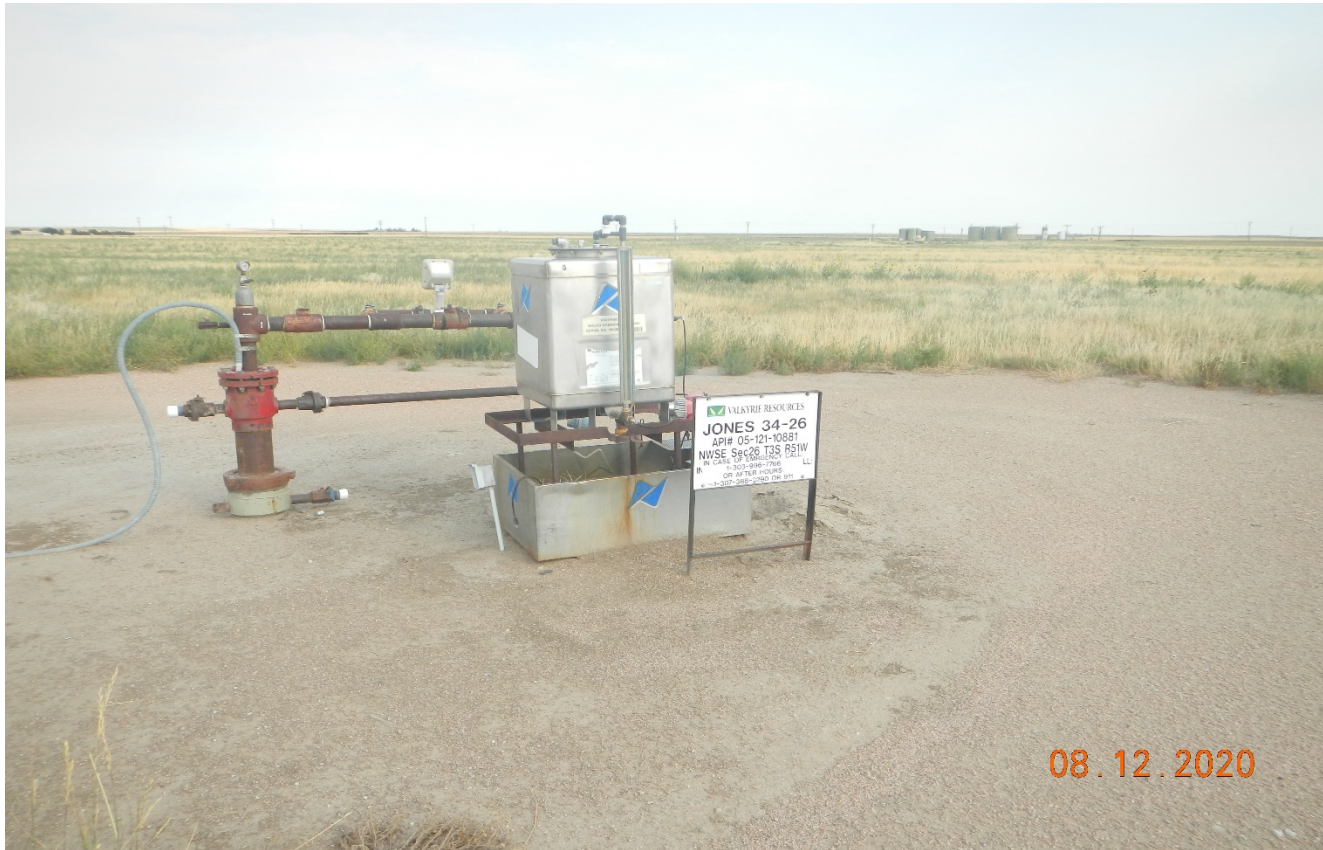
Photo 2. The active well at the location is the JONES #34-26 well listed under another operator. No other well or equipment was observed.
