Inspection Photos
Location Name: Opal 14-34
Location ID: 318936

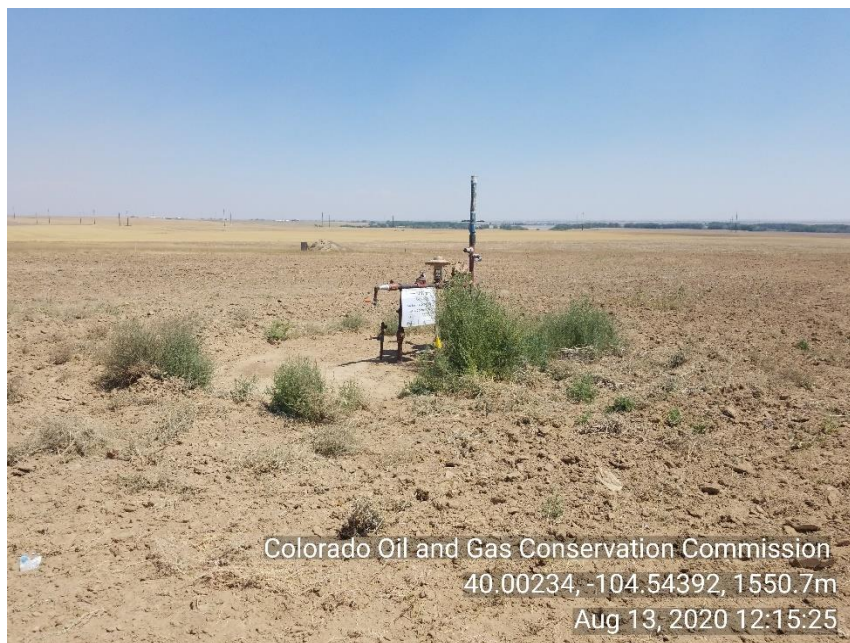
Photo 1 WH Flow line valves appear to be closed. Weeds around well head

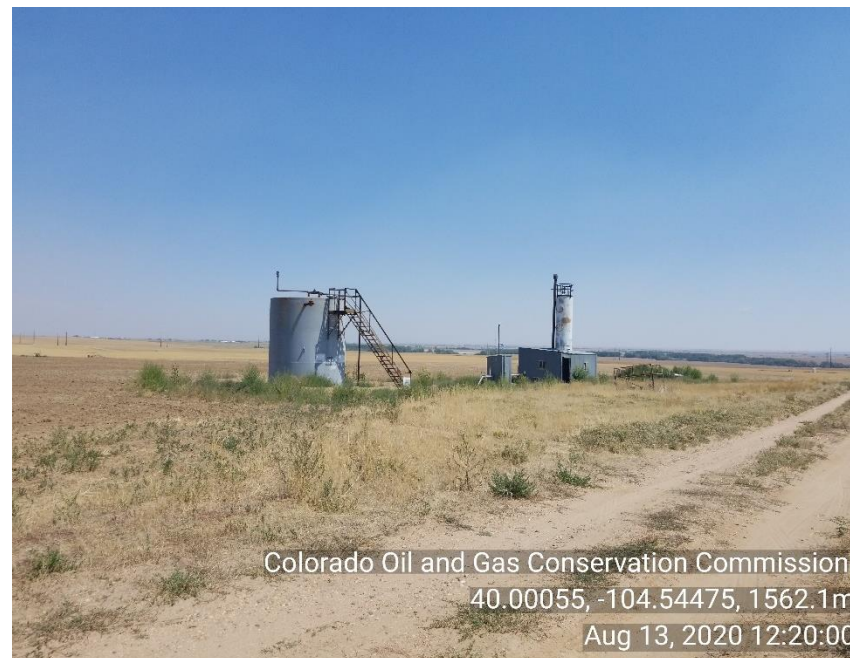
Photo 2 loc pic. Weeds on location and around equipment.

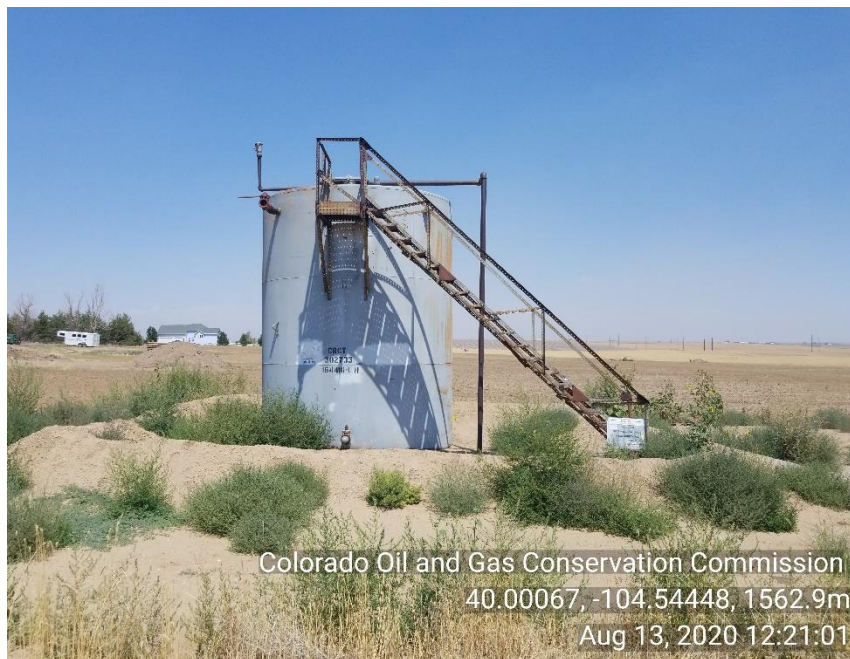
Photo 3 Crude oil tank. Weeds in and around containment. NFPA placards missing, no tank volume, Tank needs to be painted tank visible from county road.

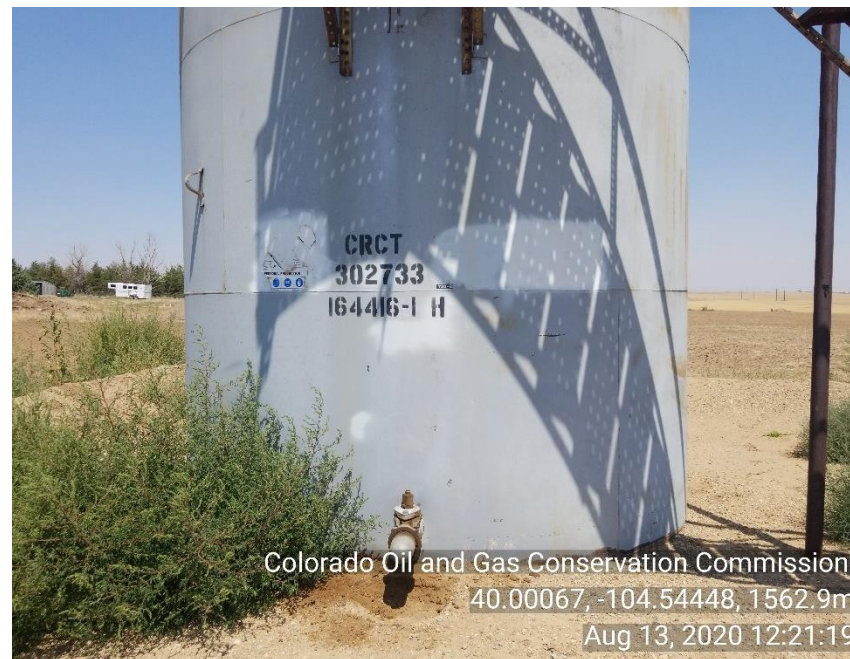
Photo 4 Stained soil under crude tank load out line. Mechanical issuer valve appears to be leaking. WEEDS

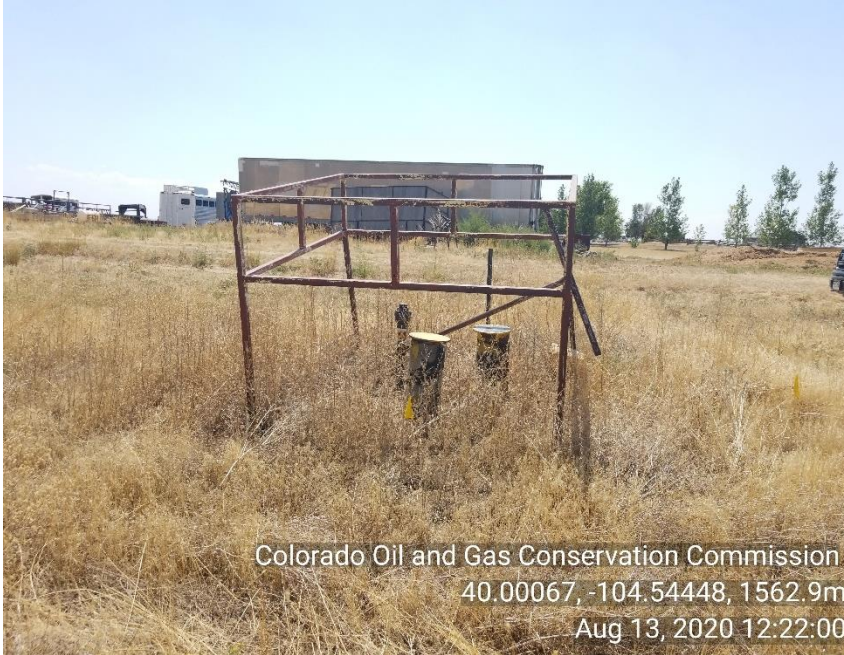
Photo 5 WEEDS and Risers not LOTO.

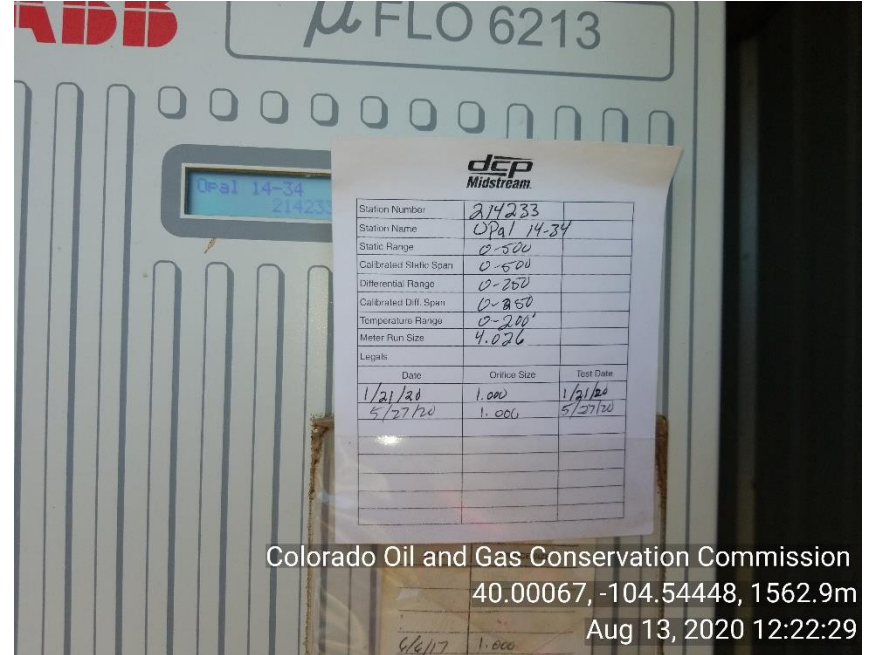
Photo 6 meter test.

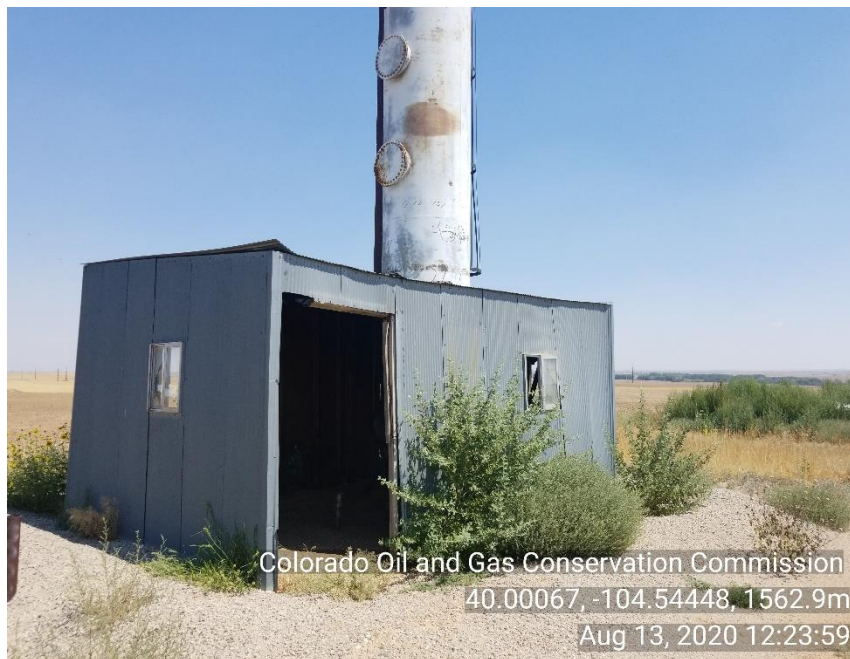
Photo 7 Vertical separator and house. WEEDS

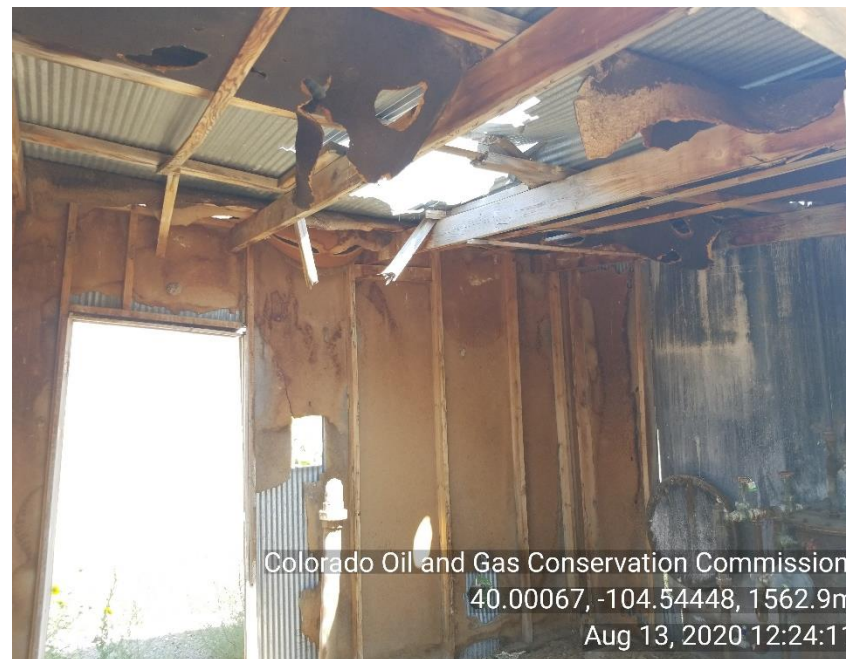
Photo 8 Vertical separator house in disrepair.

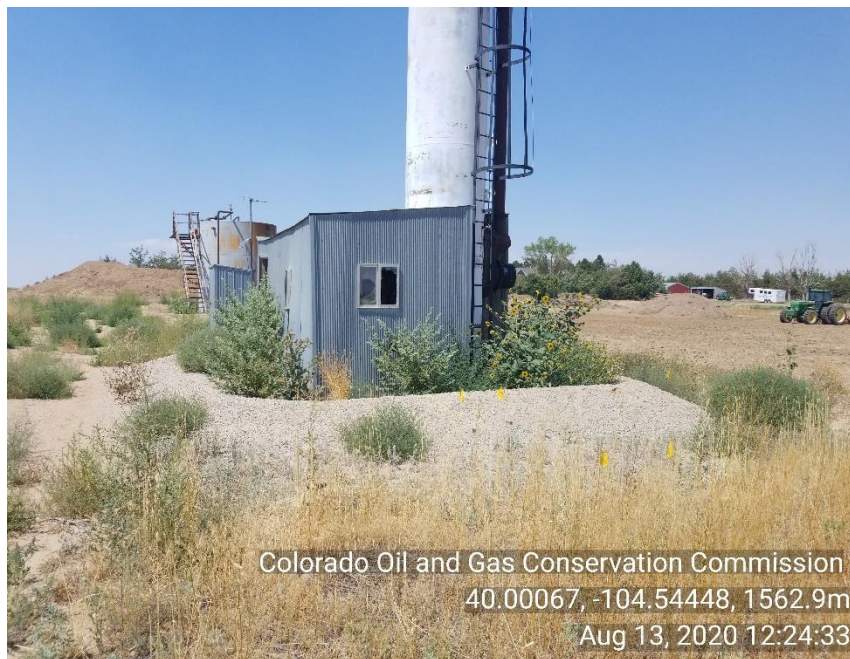
Photo 9 WEEDS on location and around equipment.

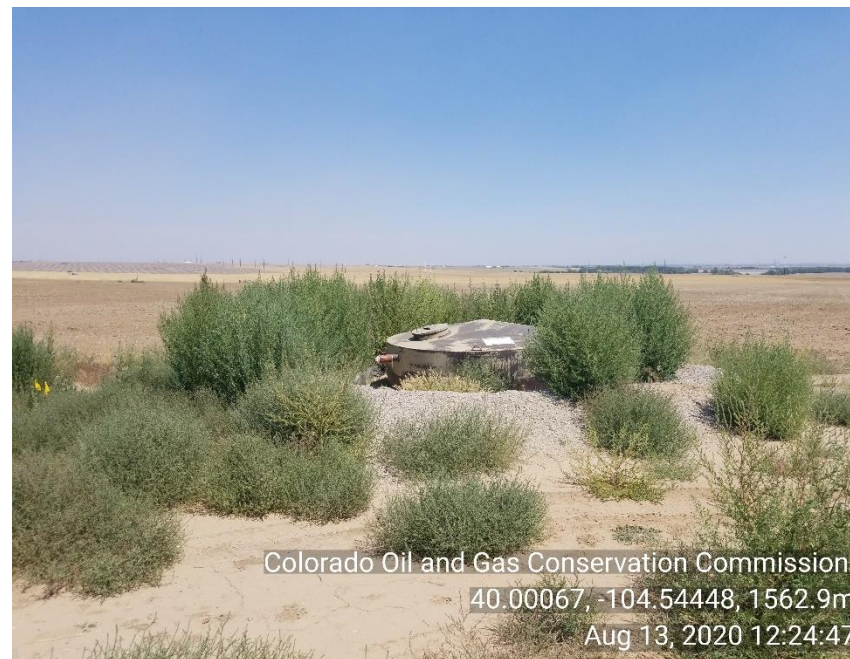
Photo 10 produced water tank. WEEDS and NFPA placards faded and tank volume faded.

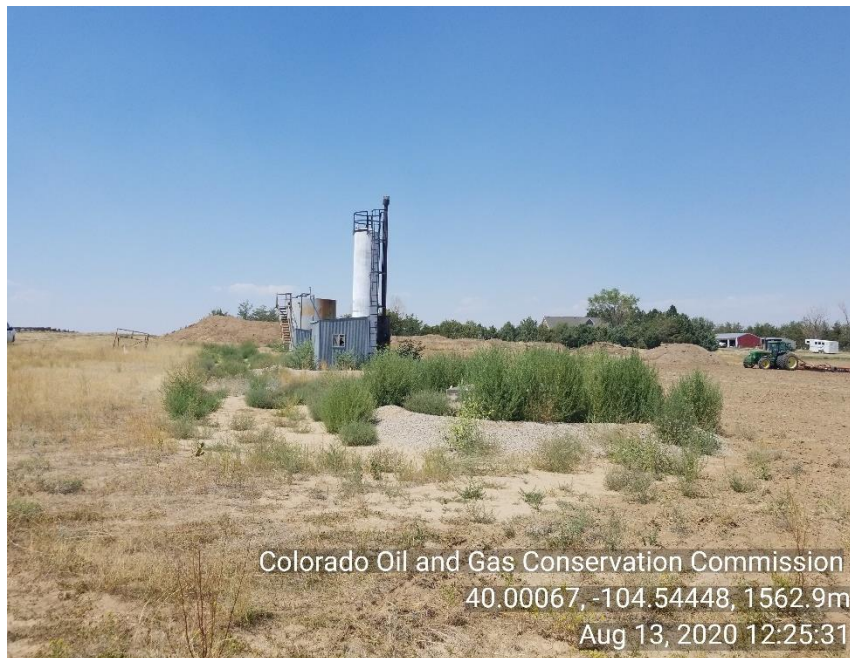
Photo 11 loc pic. Weeds on location and around equipment.
