Inspection Photos
Operator: BP America
API: 067-08835
Date: 8/13/2020

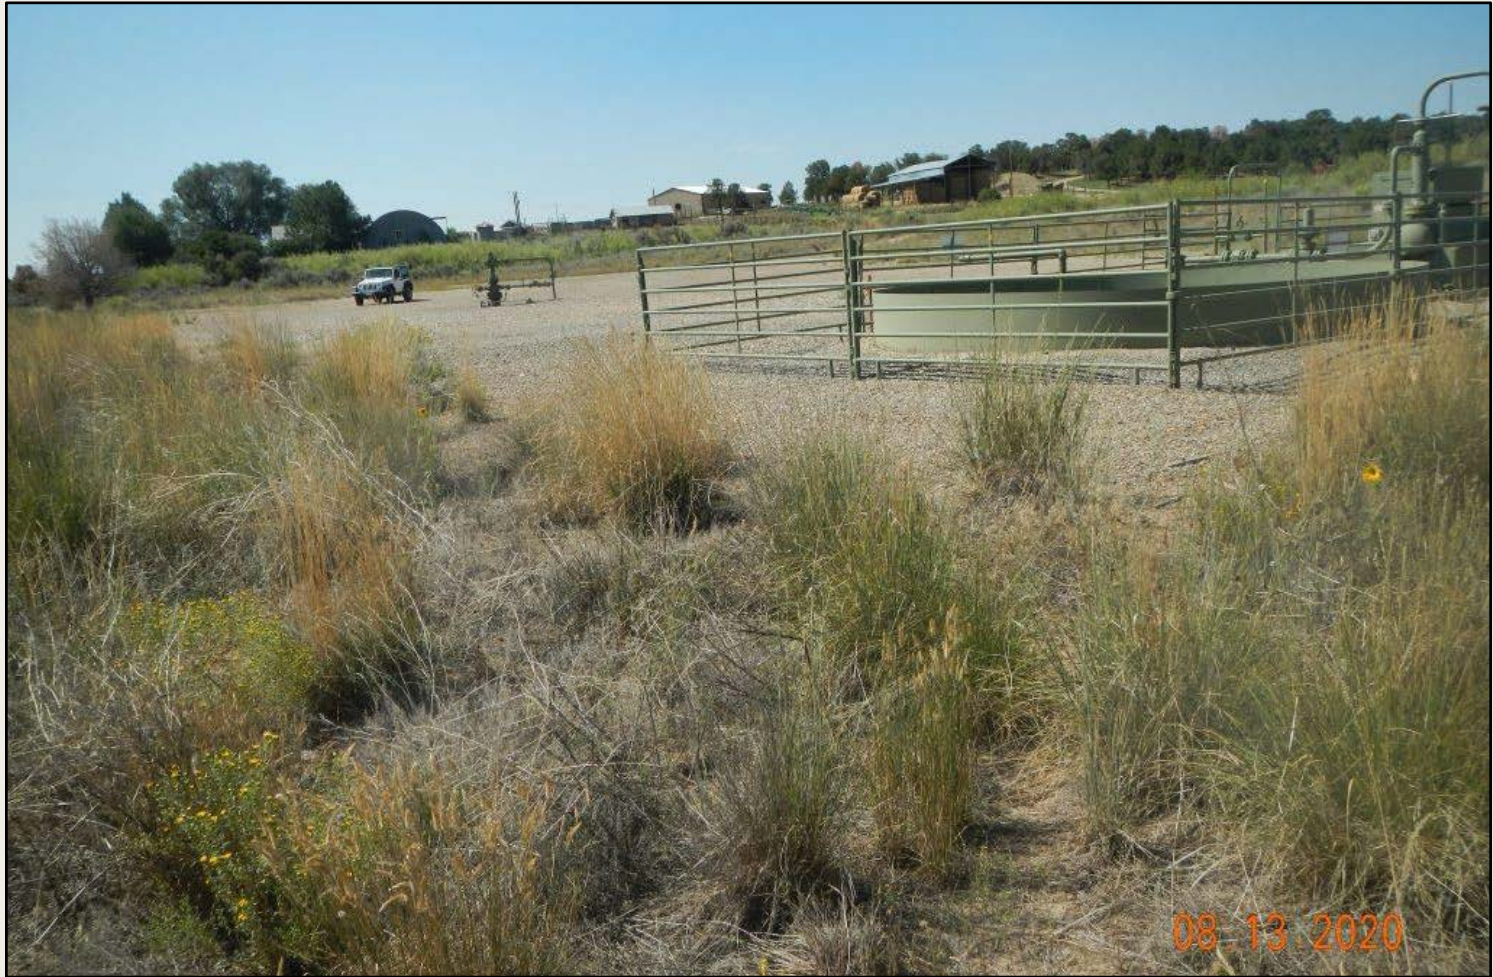
Photo 1. View of the project area from the northeastern corner facing center.

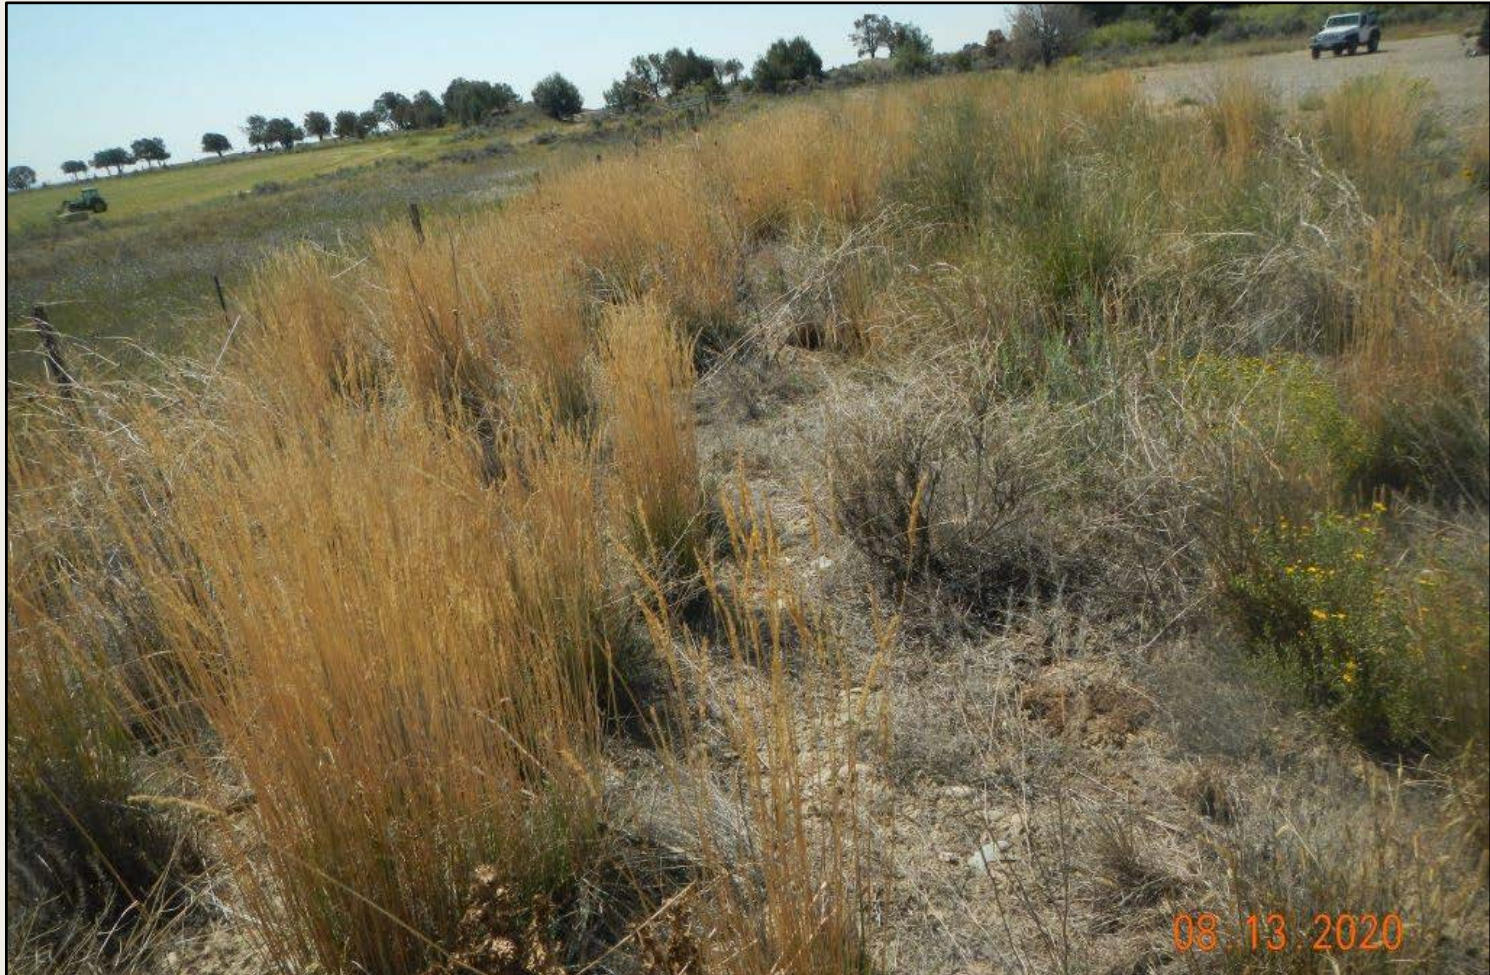
Photo 2. View of the eastern project area from the northeastern corner facing southward. Revegetation is progressing with crested wheatgrass, intermediate wheatgrass, and western wheatgrass.

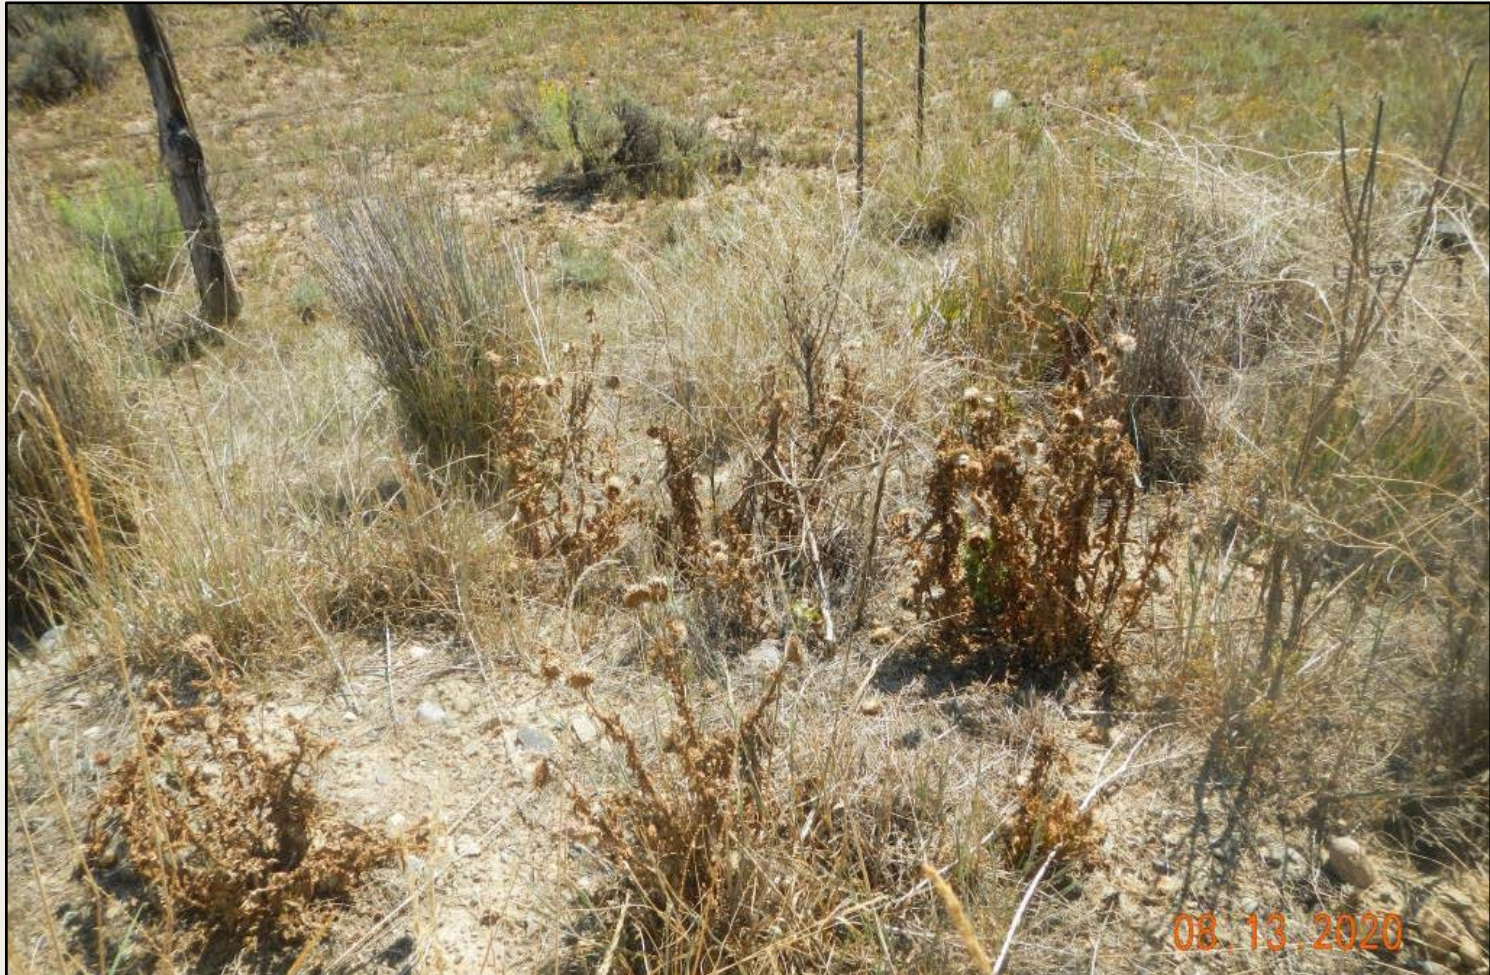
Photos 3. View of musk thistles that appear to be herbicide treated within the project area.

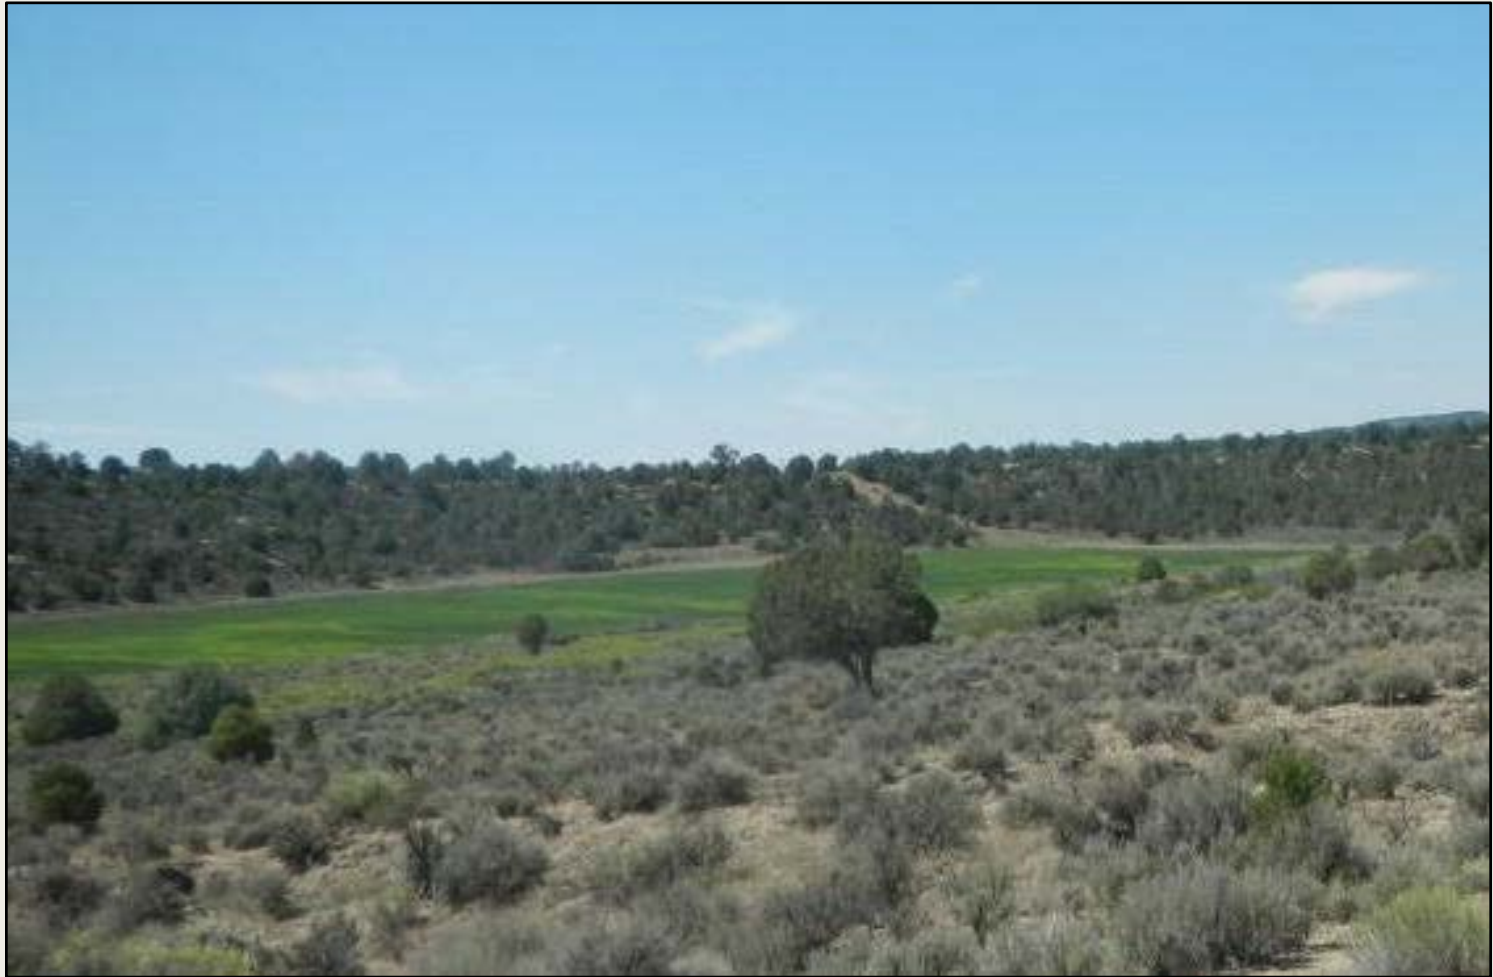
Photo 4. View of reference area comprised of a mosaic of sagebrush shrubland and irrigated grass field.
