Inspection Photos
Operator: BP America
API: 067-09624
Date: 8/13/2020

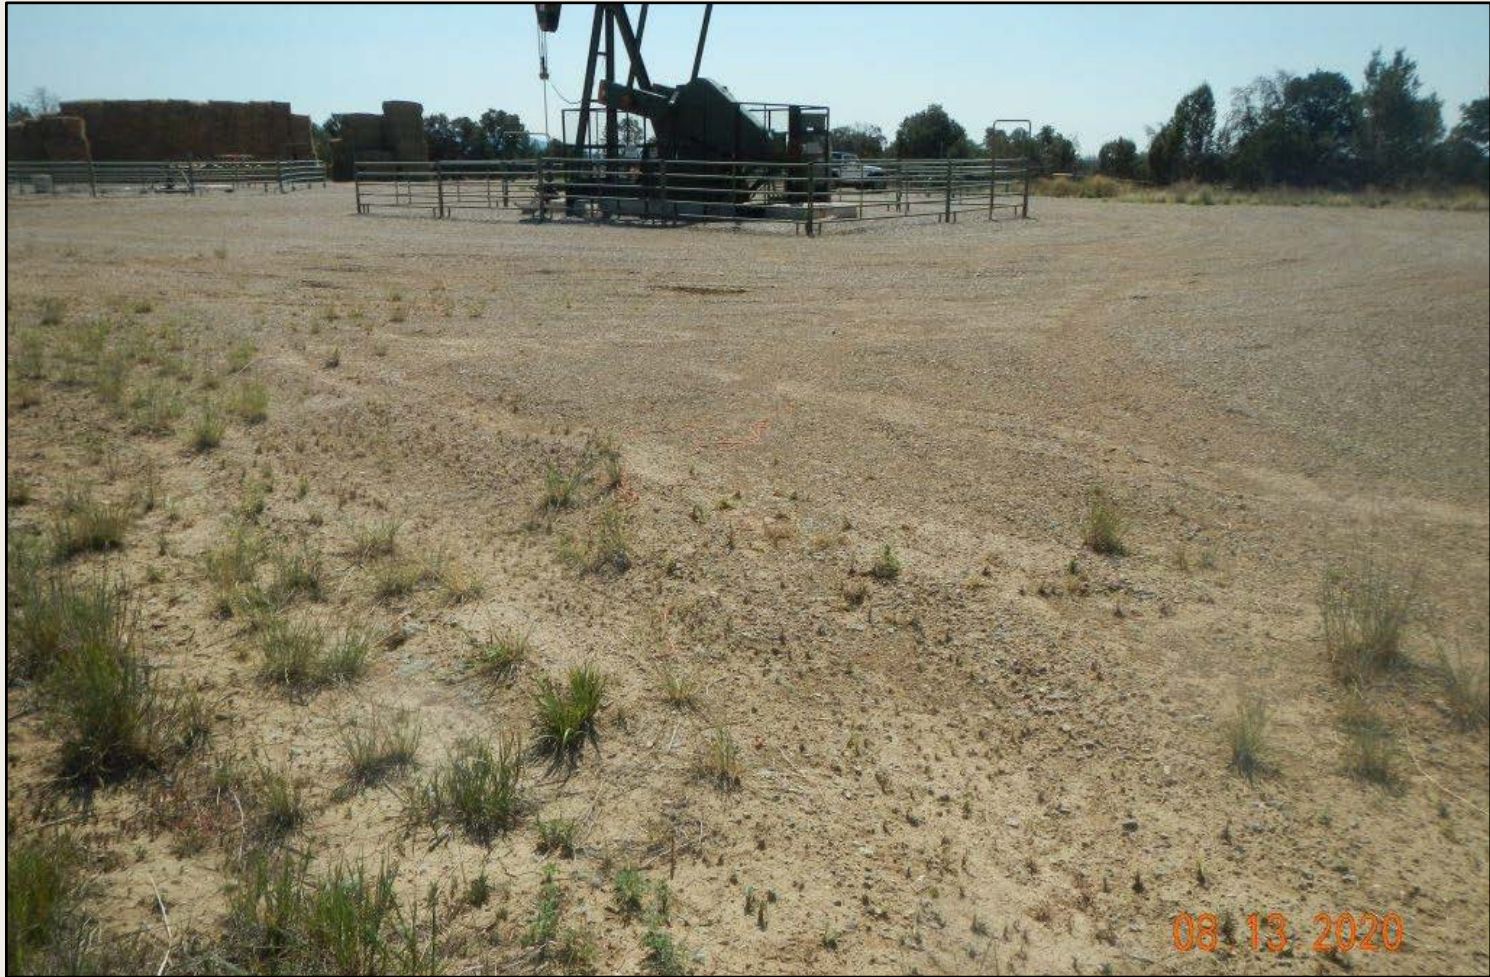
Photo 1. View of the project area from the northwestern corner facing center.

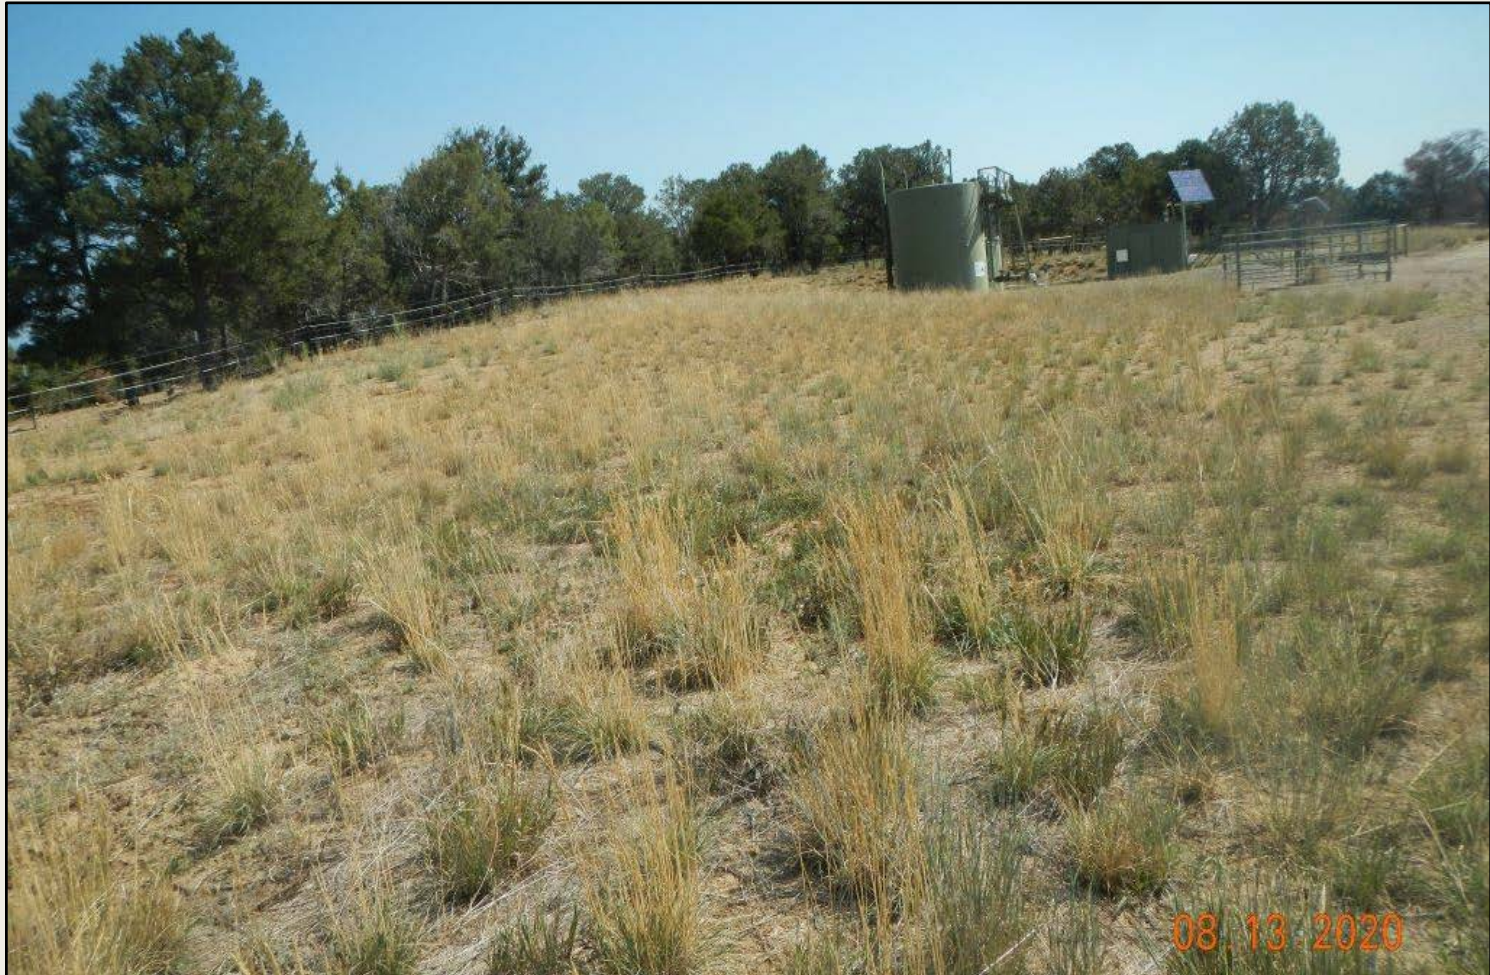
Photo 2. View of the northern project area from the northwestern corner facing eastward. Hay identified during previous inspection is moved off of the working area south of the well pad.

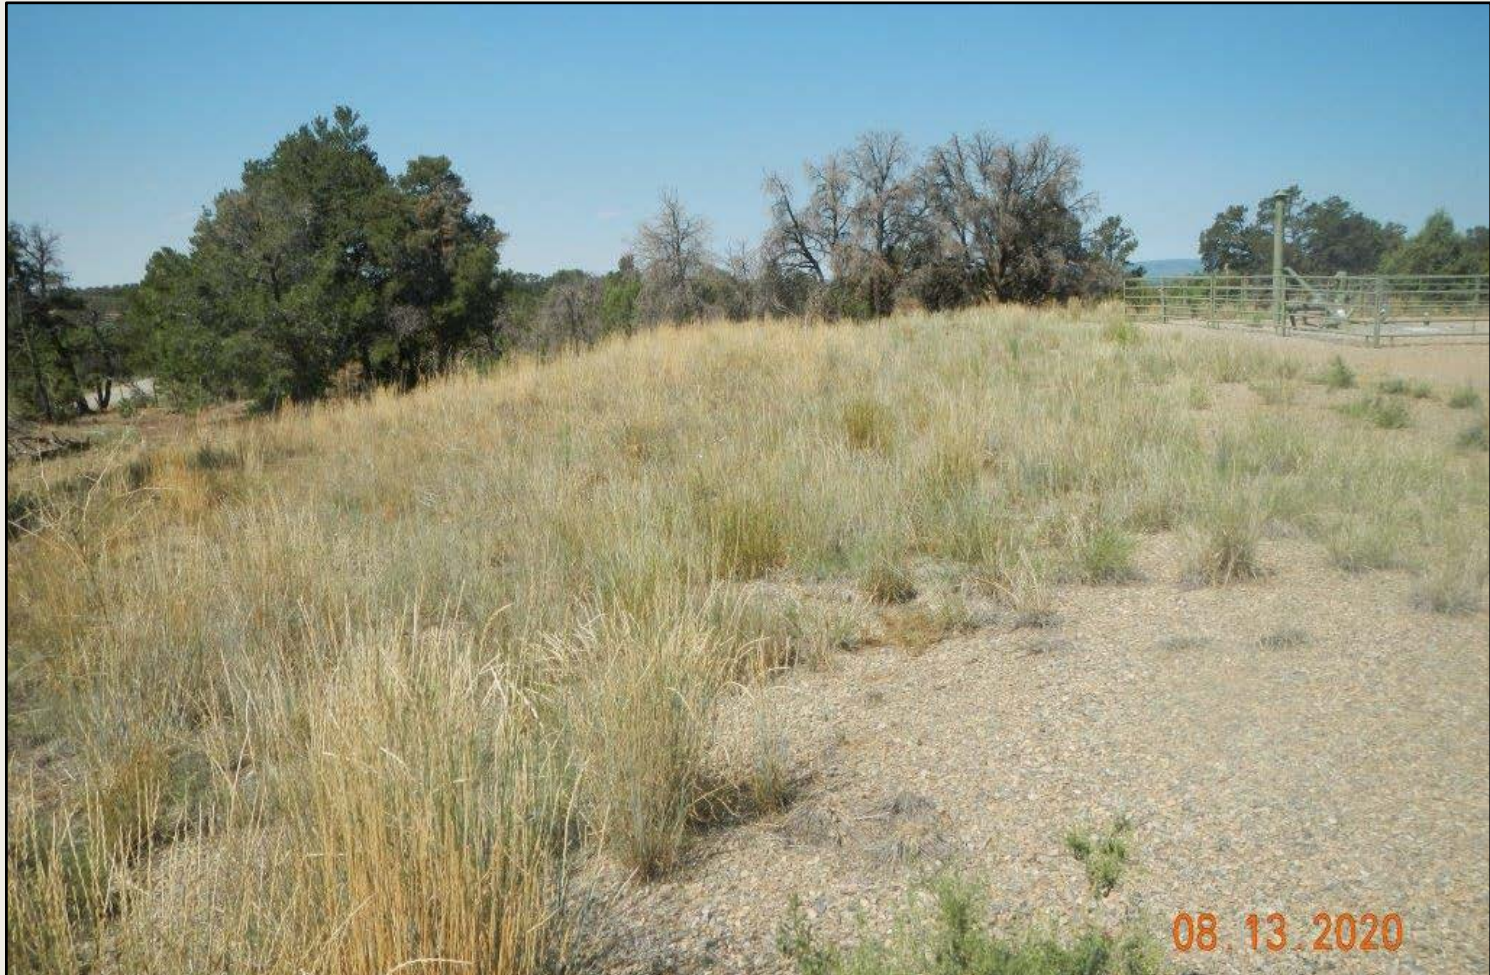
Photos 3. View of the southern project area from the well pad entrance facing westward. Revegetation is progressing, largely with crested wheatgrass and western wheatgrass.

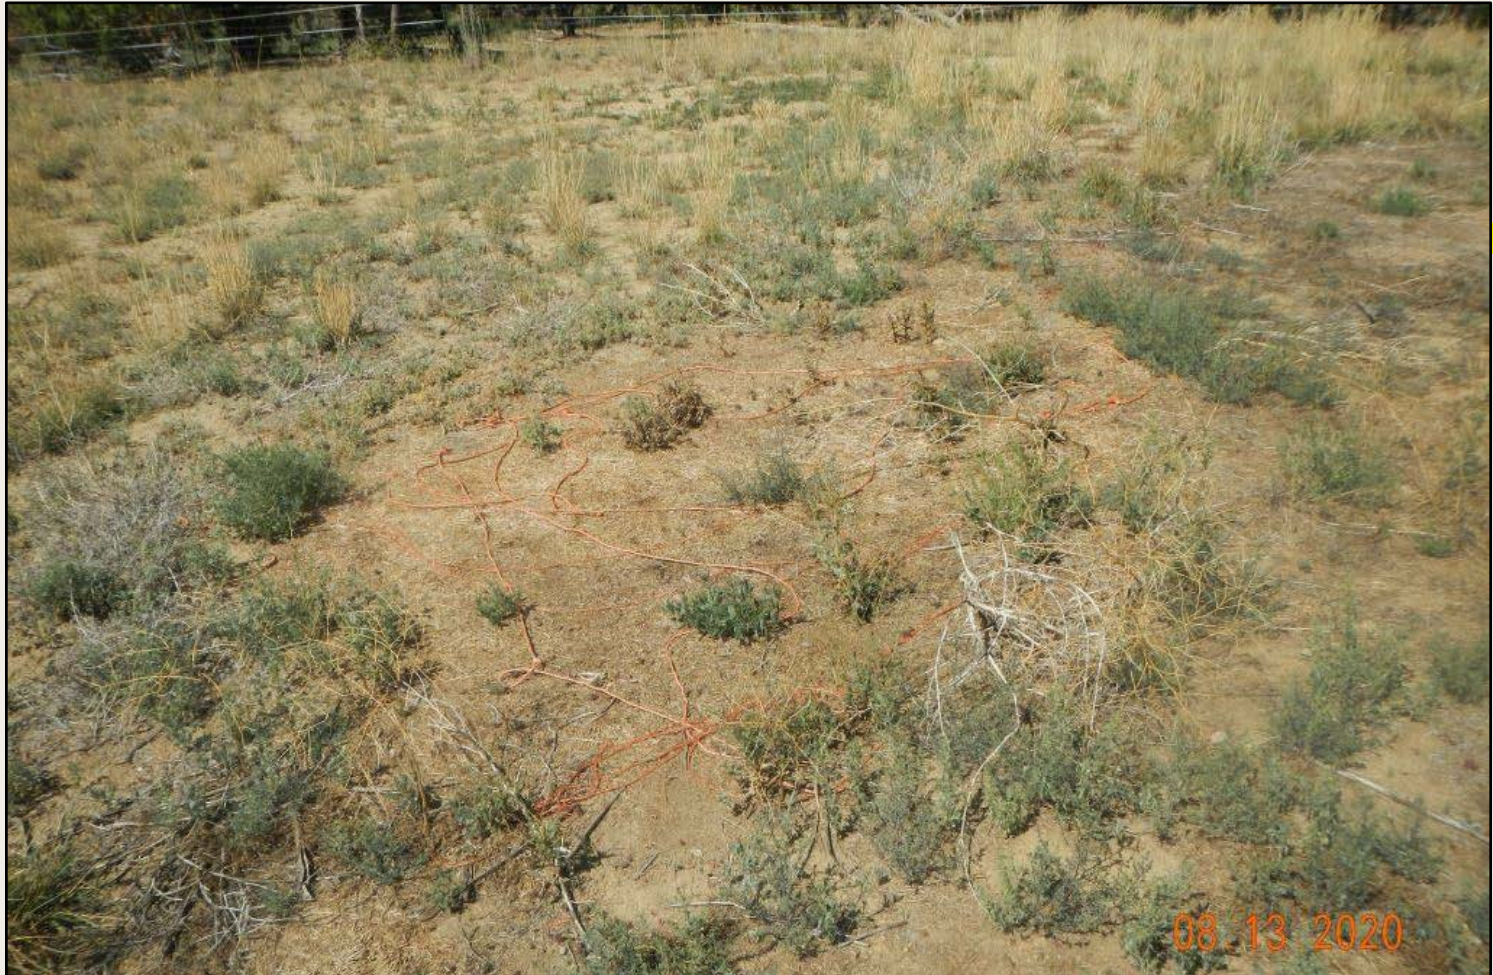
Photos 4. View of twine debris within the interim reclamation area.

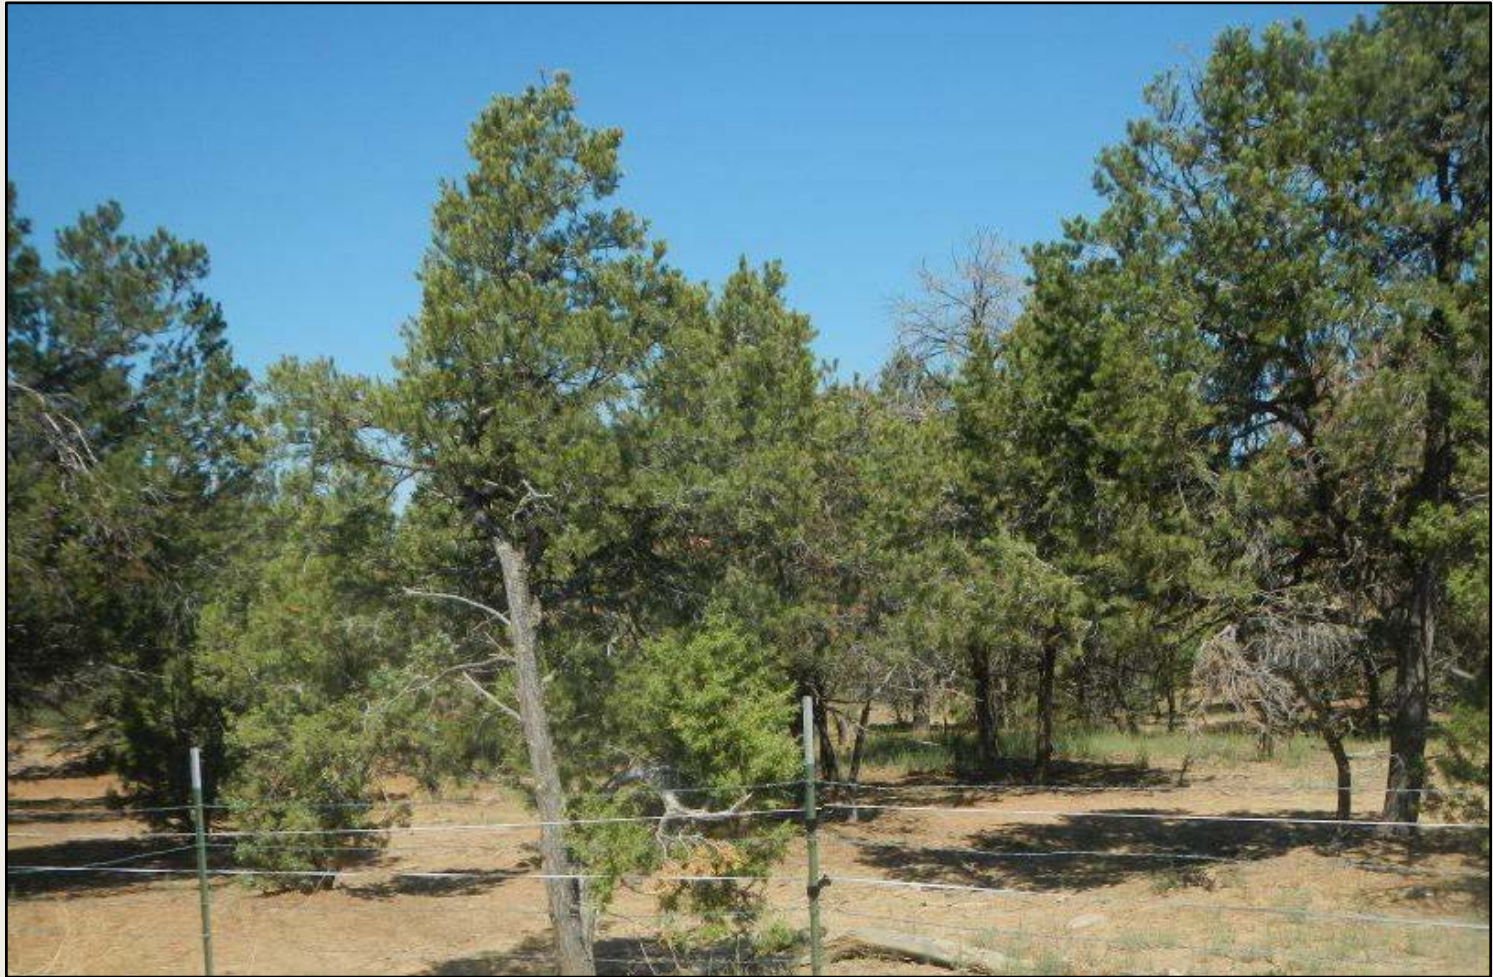
Photo 5. View of reference area comprised of pinyon and juniper woodland with grasses such as western wheatgrass in the understory.
