Interim Reclamation and Stormwater Inspection

August 13, 2020

Operator: KERR MCGEE OIL & GAS ONSHORE LP - #47120

Location ID: 336152

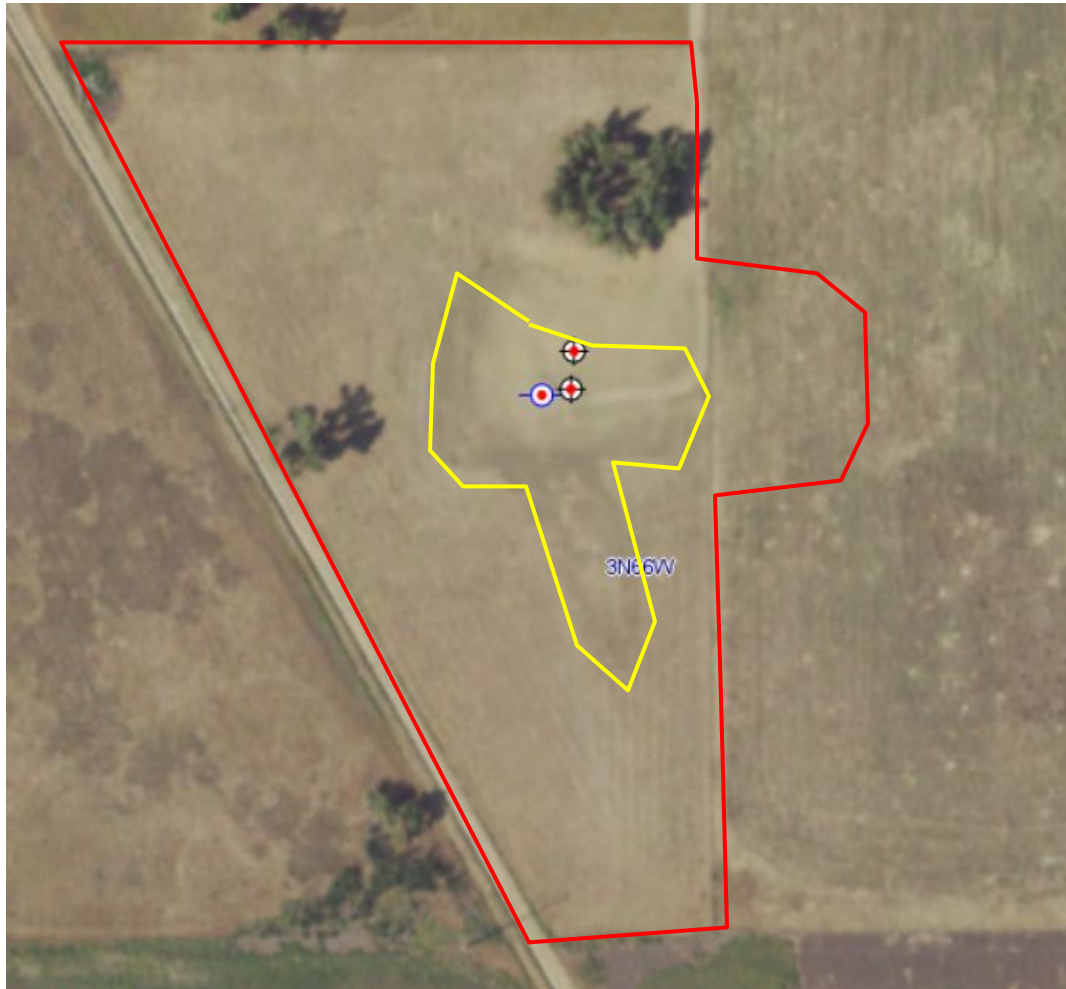
Photo 1. COGCC GISOnline aerial imagery taken 2017. Imagery illustrates an area (red polygon) illustrating the approximate area of disturbance from a release that occurred in April 2014. An approximate area of 1.4 acres (yellow polygon) illustrates the extent of smooth brome establishment, which is the desired surface owner vegetation. All other areas have failed to establish smooth brome.

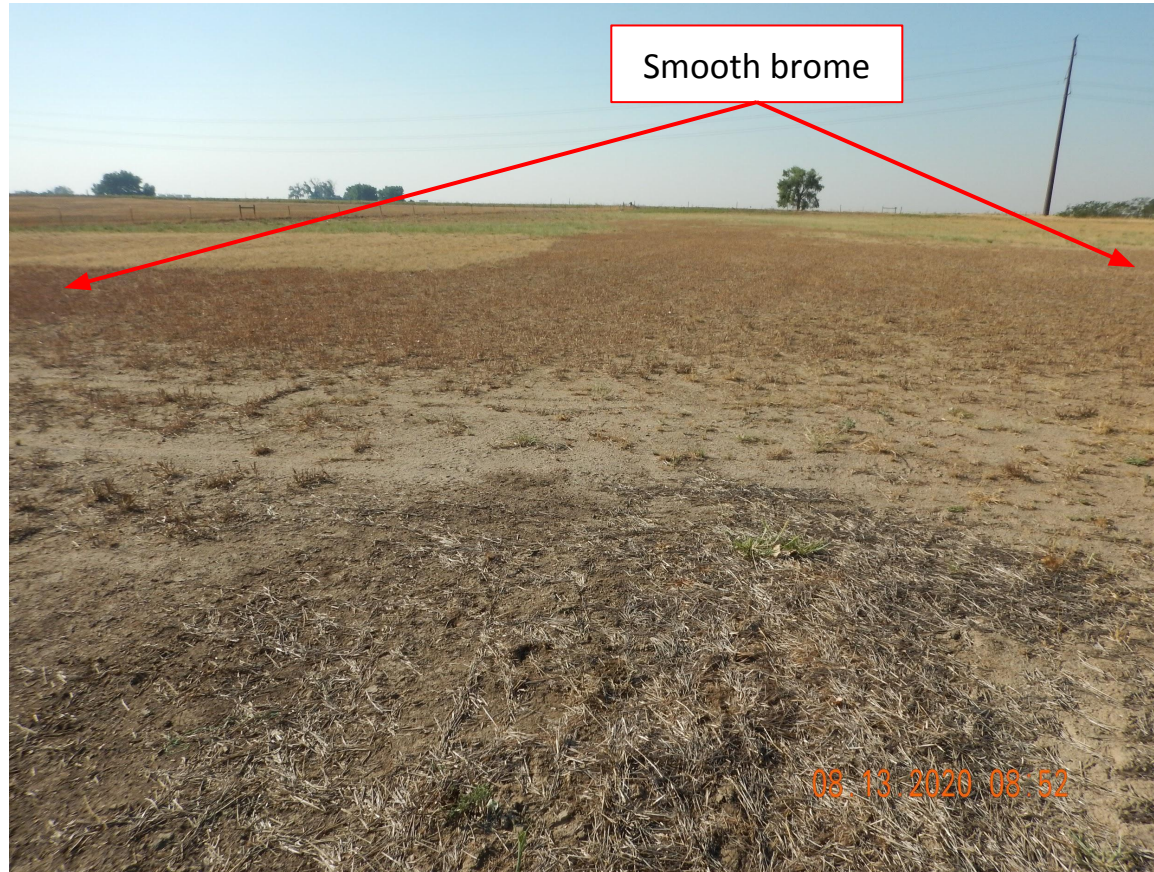
Photo 2. Photo taken from the well area, facing South. Photo illustrates where smooth brome (darker vegetation) has established.

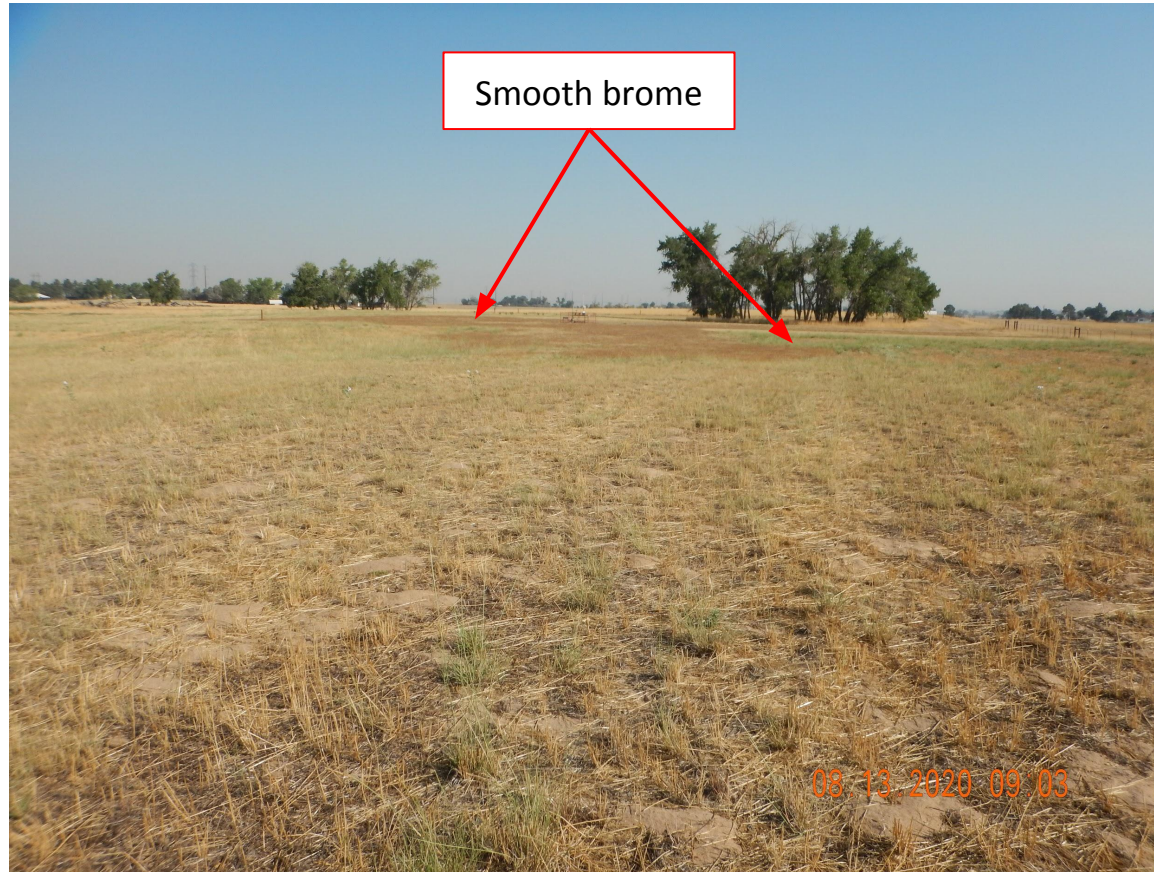
Photo 3. Photo taken from the southern area, facing North. See comments under Photo 2.

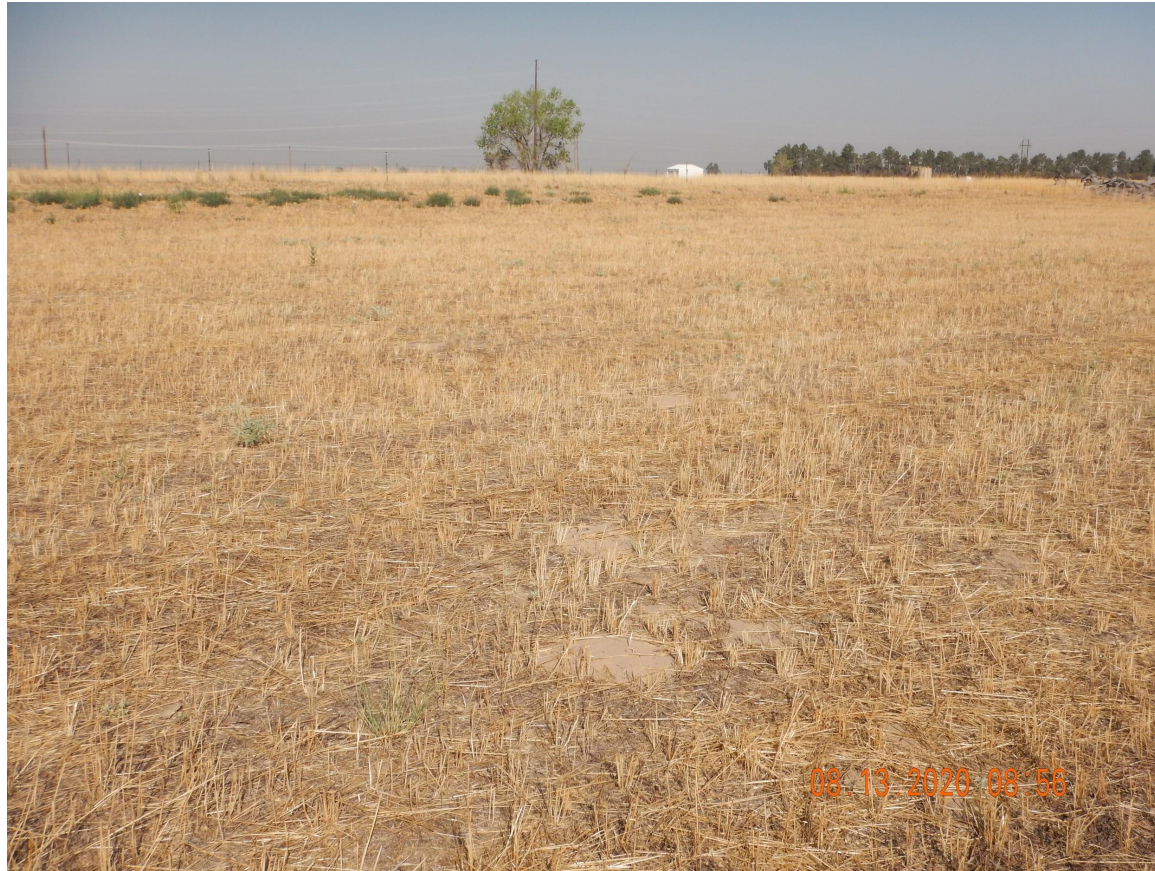
Photo 4. Photo taken from the northwestern area, facing Northwest. Photo illustrates the Operator has mowed the area but no smooth brome establishment. The mowed vegetation consists mostly of cereal rye (*Secale cereale*) which is not the desirable surface owner vegetation.

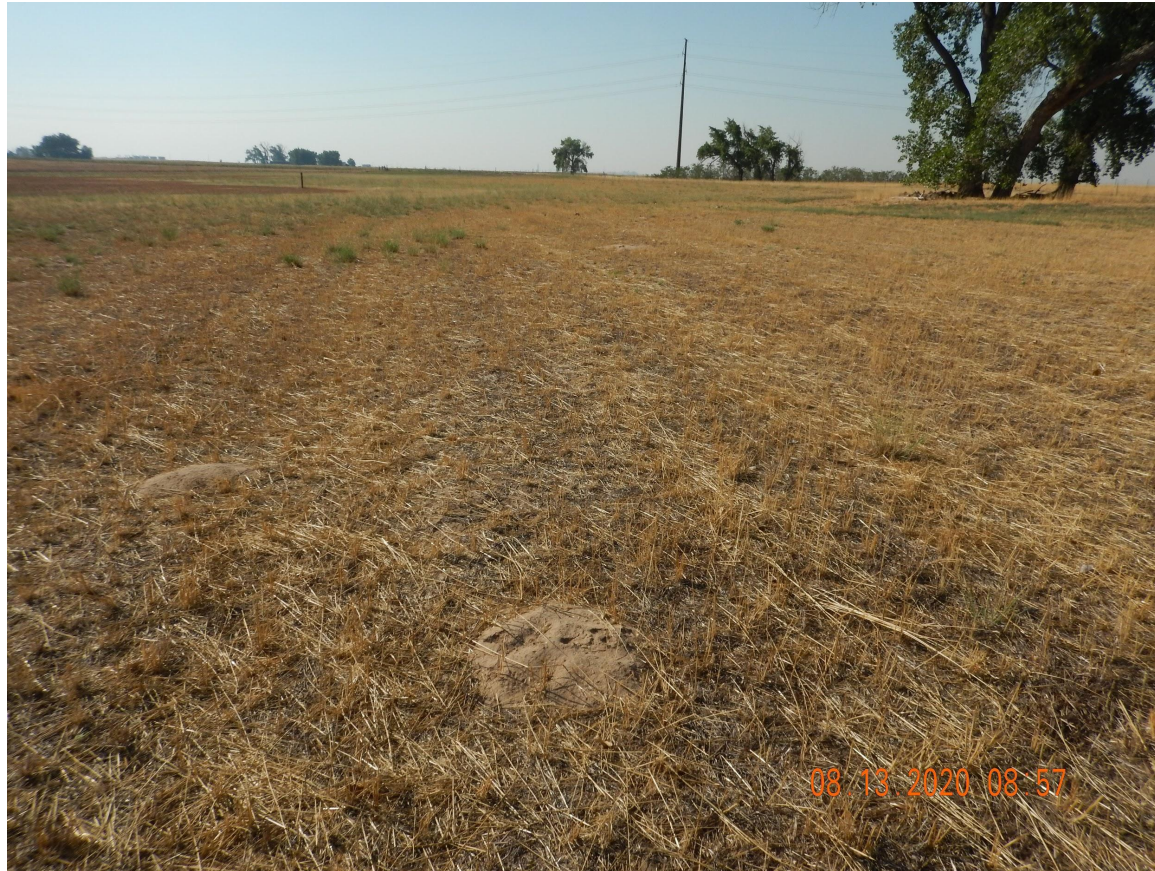
Photo 5. Photo taken from the northwestern area, facing South. See comments under Photo 4.

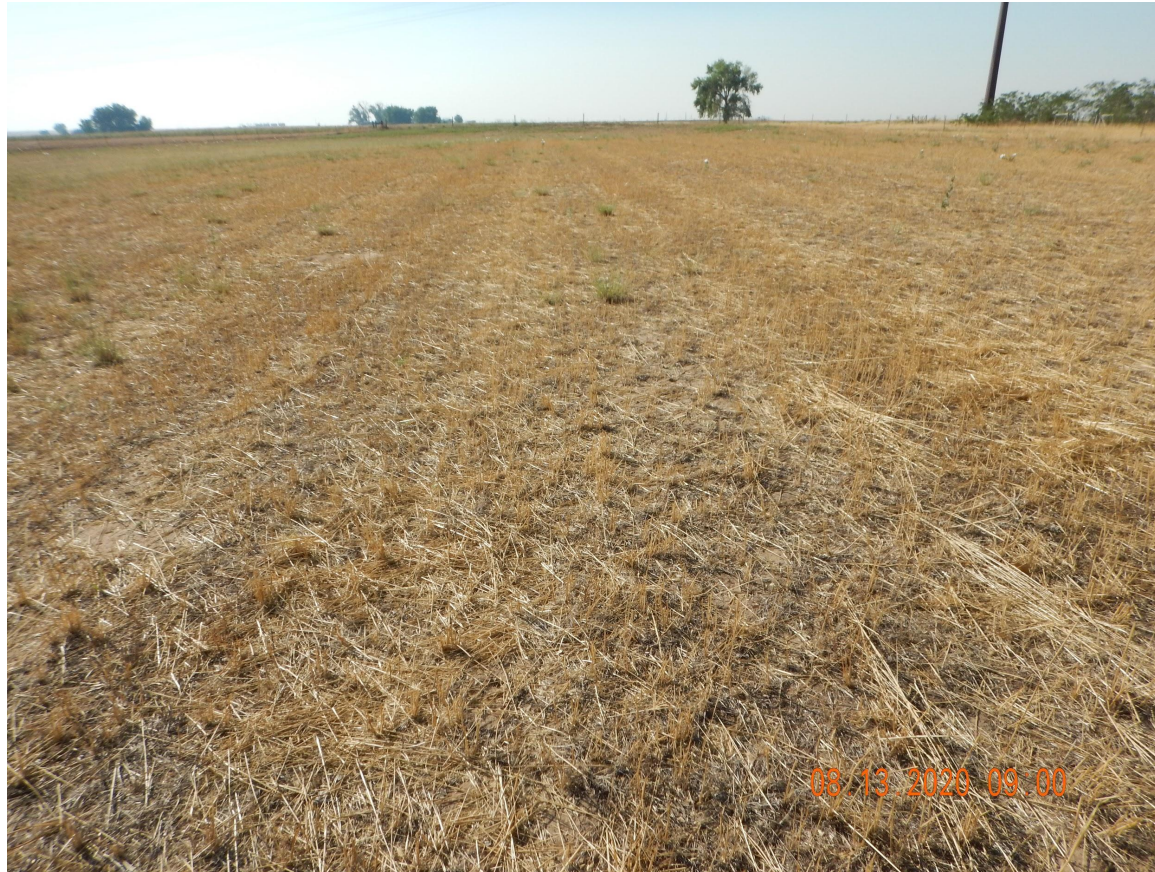
Photo 6. Photo taken from the western area, facing South. See comments under Photo 4.

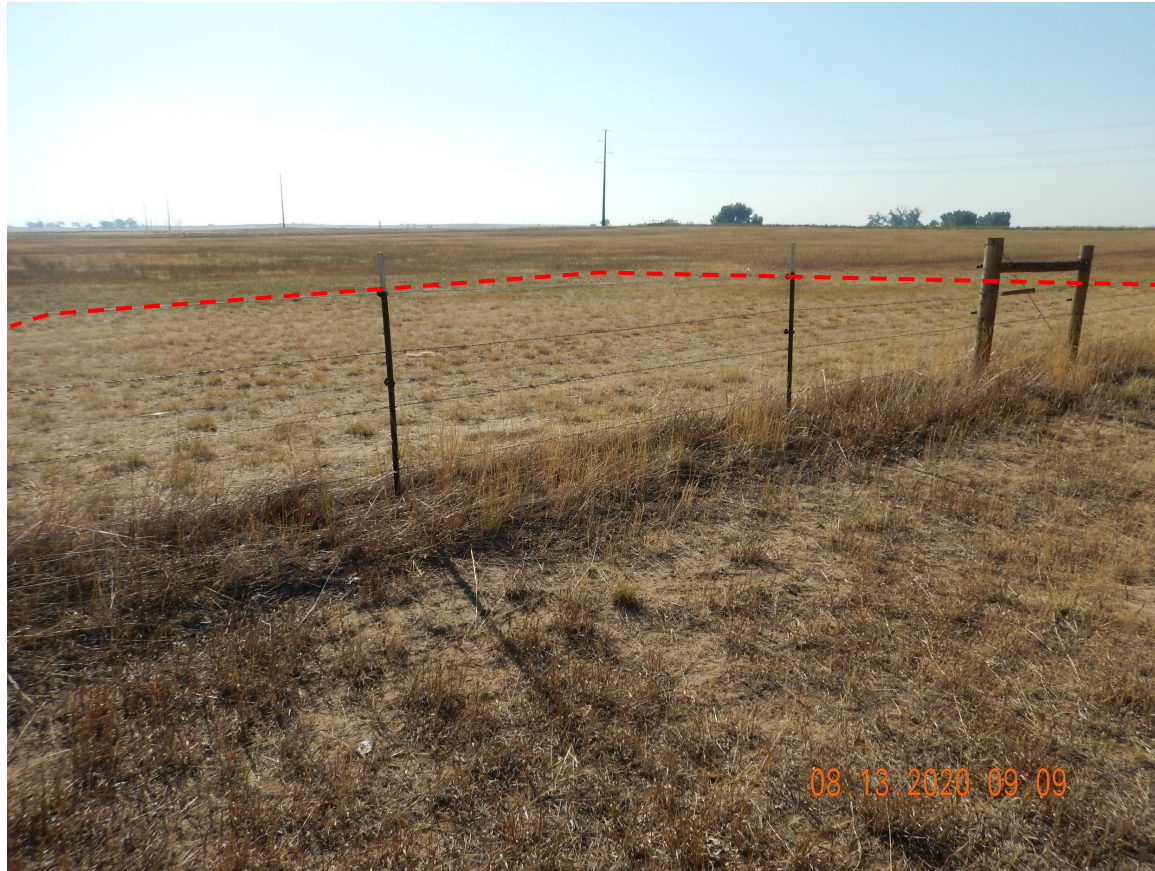
Photo 7. Photo taken from the eastern area, facing Southeast. Photo illustrates the eastern extent of the release which the Operator will have to perform additional reclamation activities.

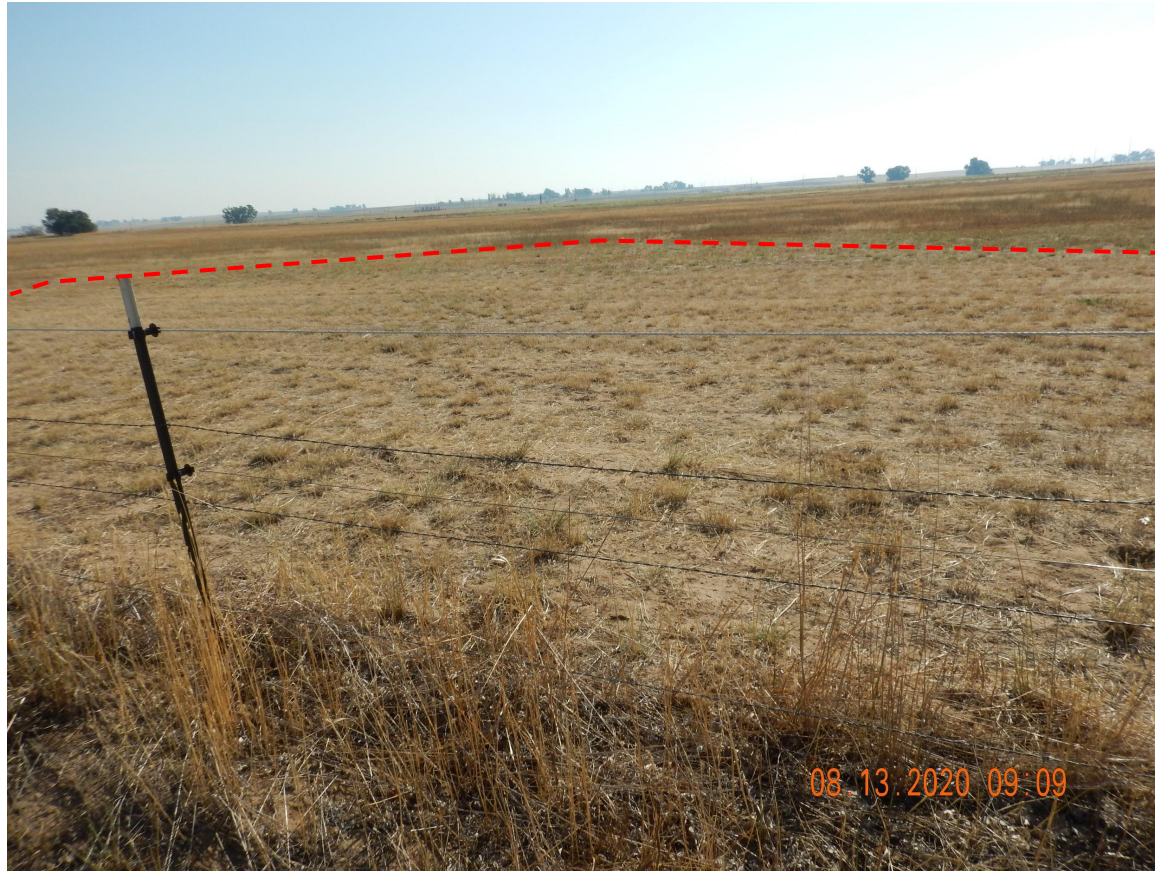
Photo 8. Photo taken from the eastern area, facing East. See comments under Photo 7.

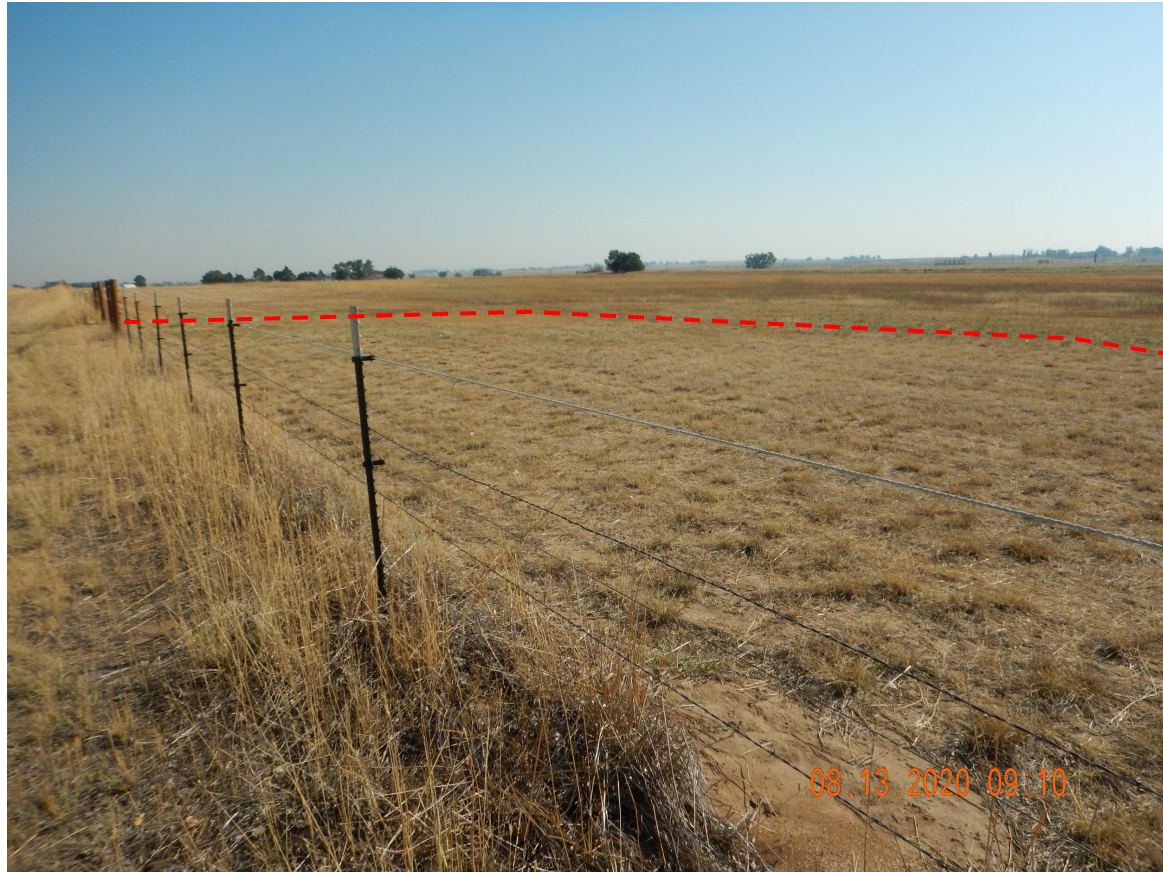
Photo 9. Photo taken from the eastern area, facing Northeast. See comments under Photo 7.

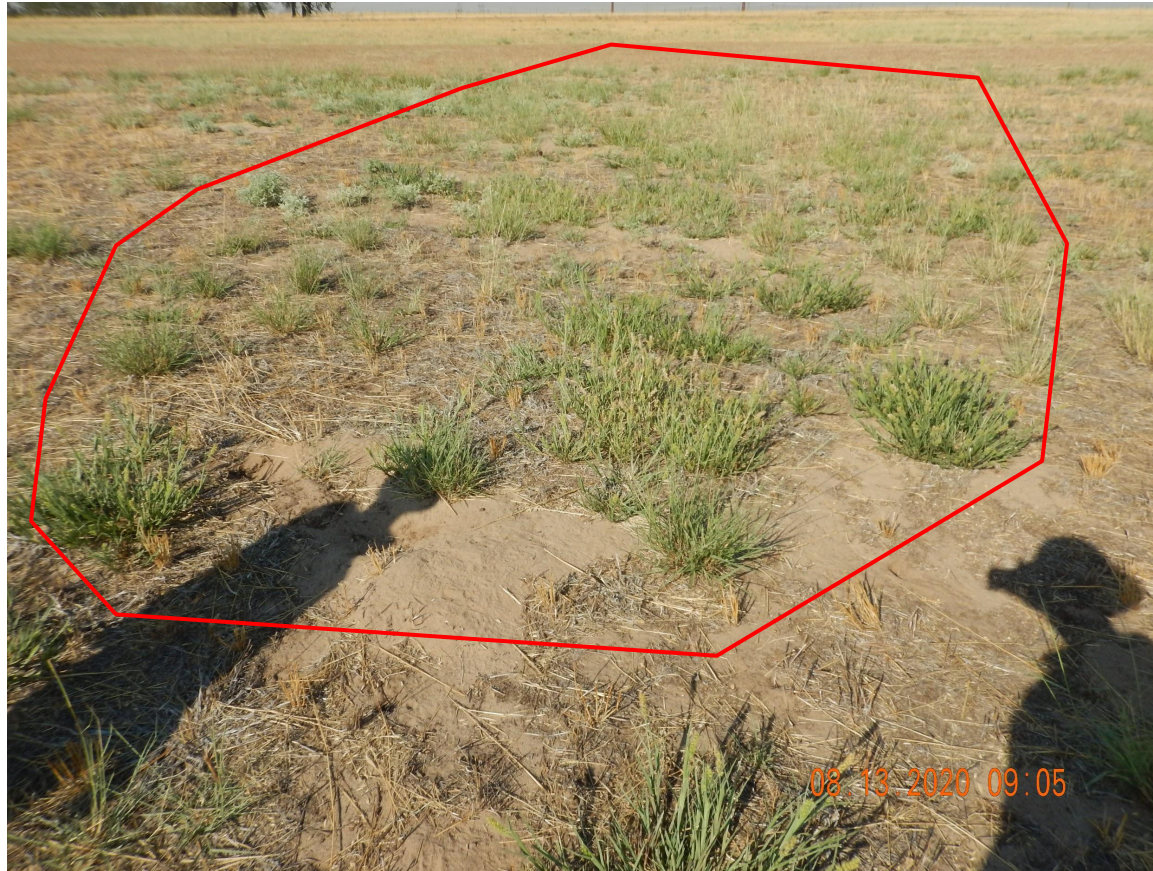
Photo 10. Photo taken from the eastern area, facing West. Photo illustrates an undesirable plant species, Longspine sandbur (*Cenchrus longispinus*). Operator has been conducting ongoing weed management to control this and other undesirable species.

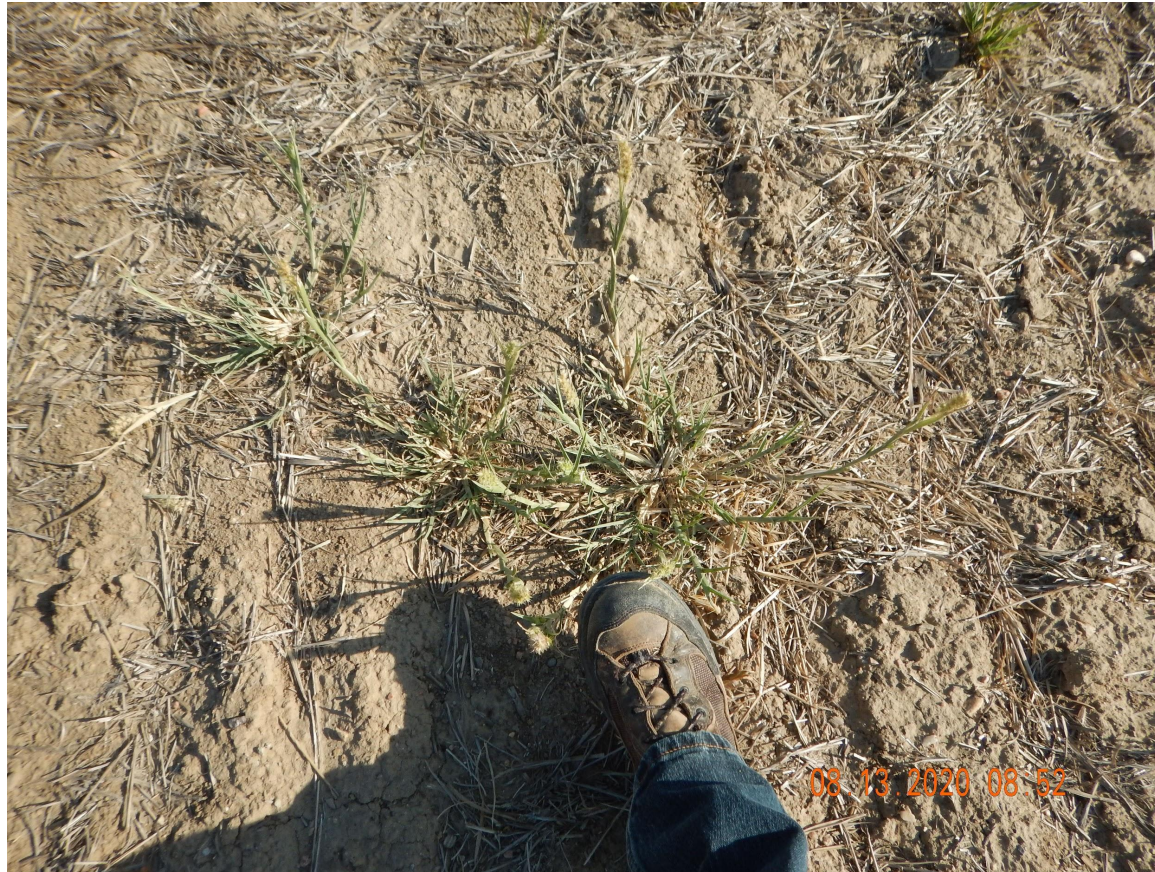
Photo 11. Close up photo taken of an undesirable plant species, Longspine sandbur (*Cenchrus longispinus*).
