# Inspection Photos

Operator: Catamount Energy  
API: 067-05427  
Date: 8/18/2020

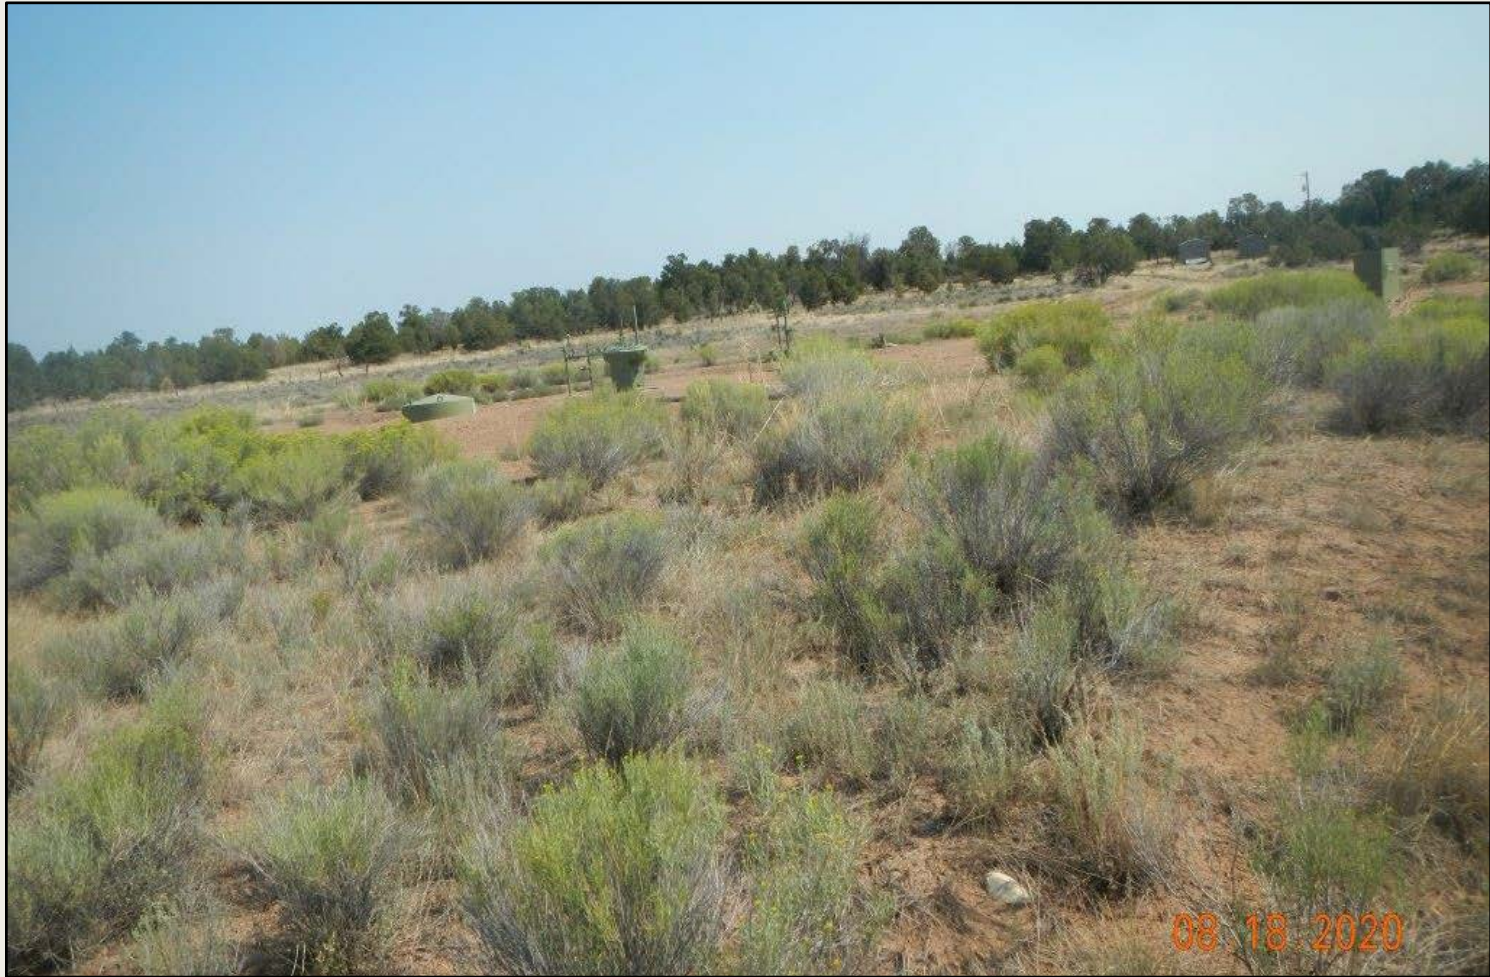
Photo 1. View of the project area from the southwestern corner facing center.

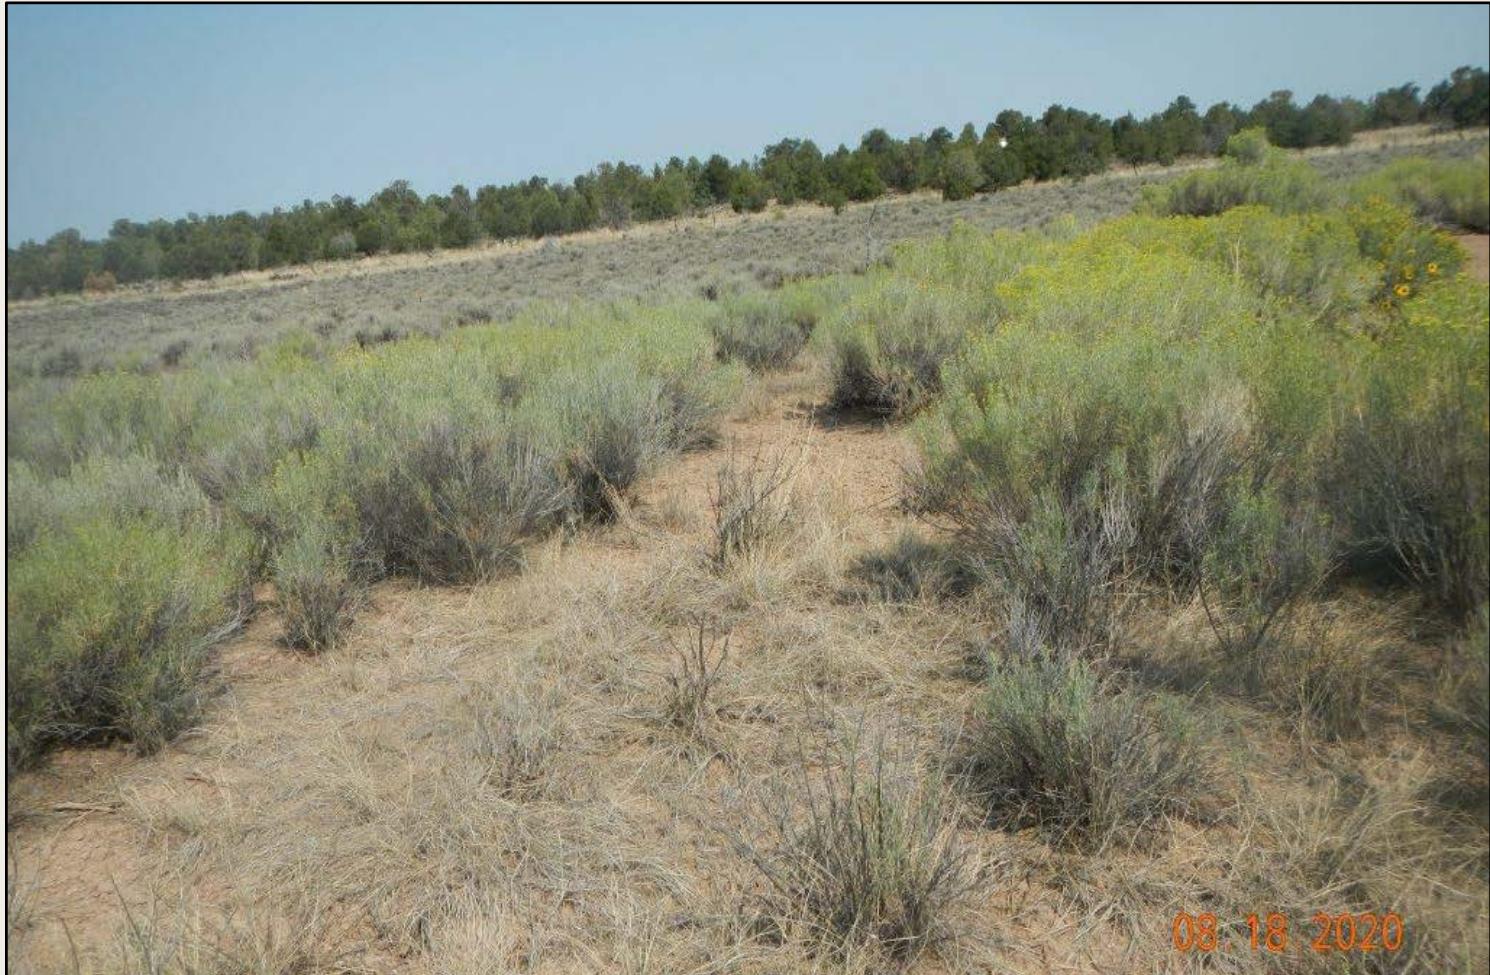
Photo 2. View of the western fill slope from the northwestern corner facing southward. Revegetation is progressing with dense rubber rabbitbrush, western wheatgrass, and crested wheatgrass.

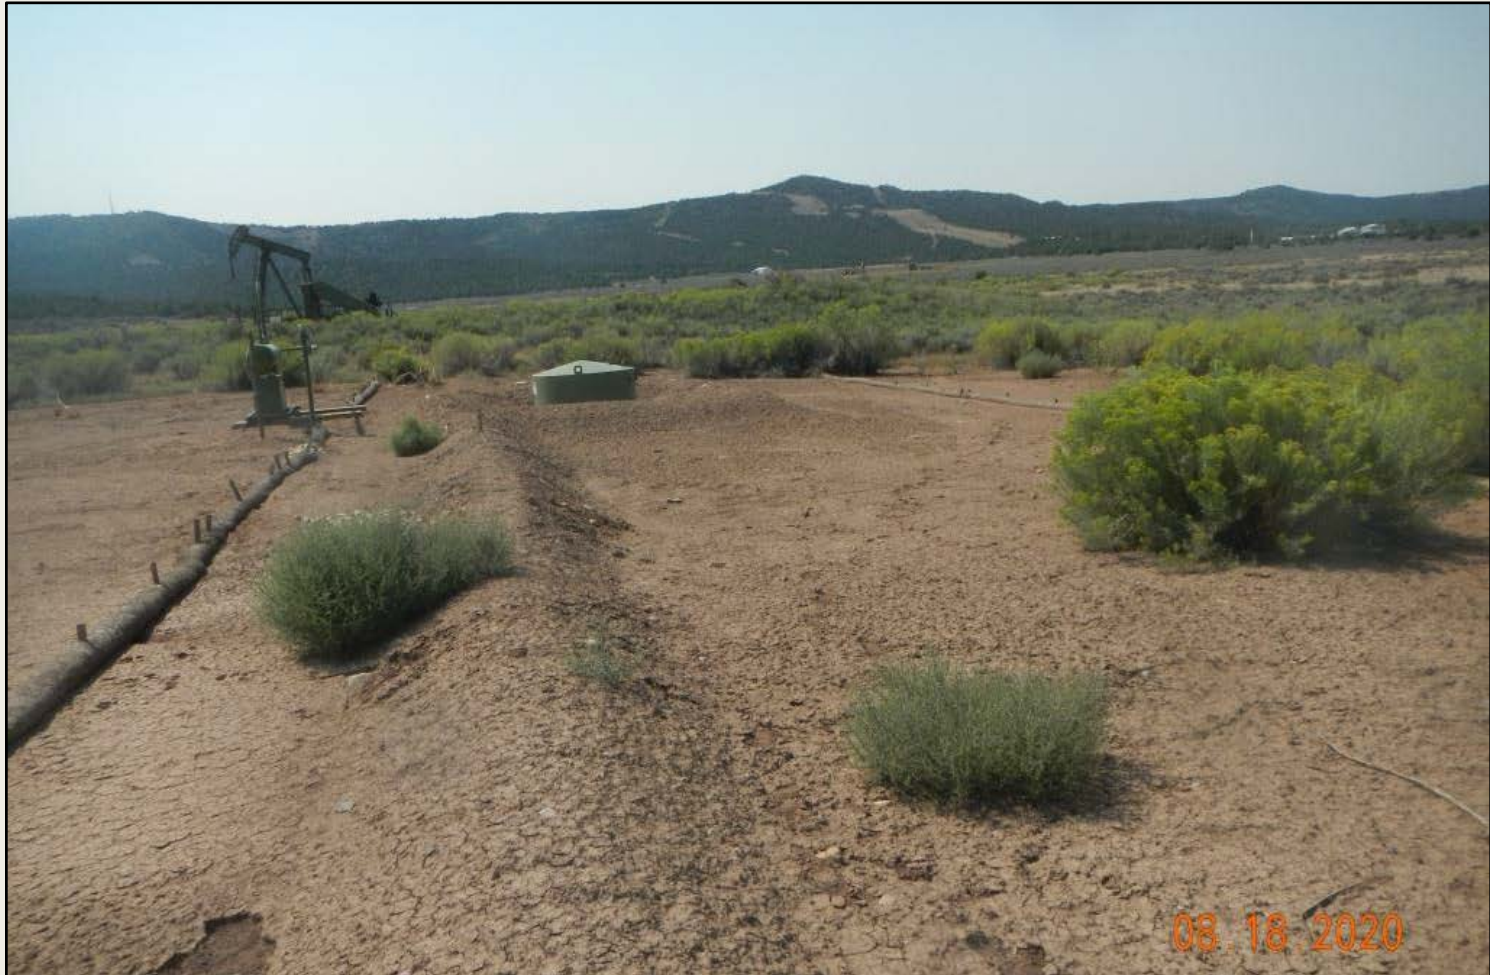
Photo 3. View of stormwater BMPs within the western project area, appear to be functioning at this time.

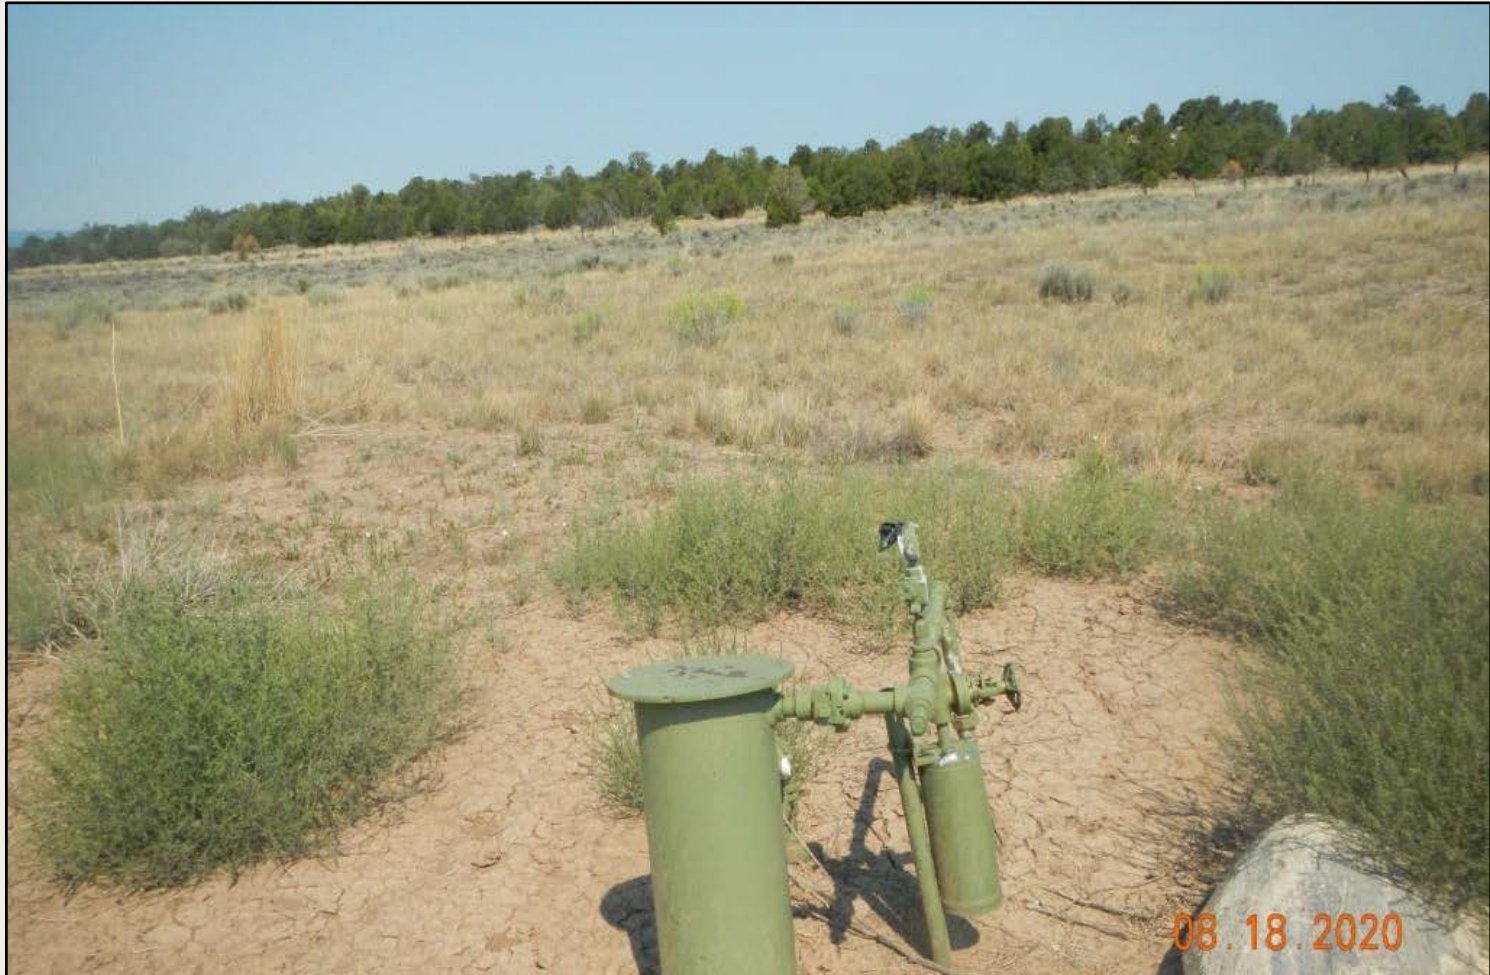
Photo 4. View of house tap within the northern project area.
