Inspection Photos  
Operator: Elm Ridge  
API: 067-05467  
Date: 8/18/2020

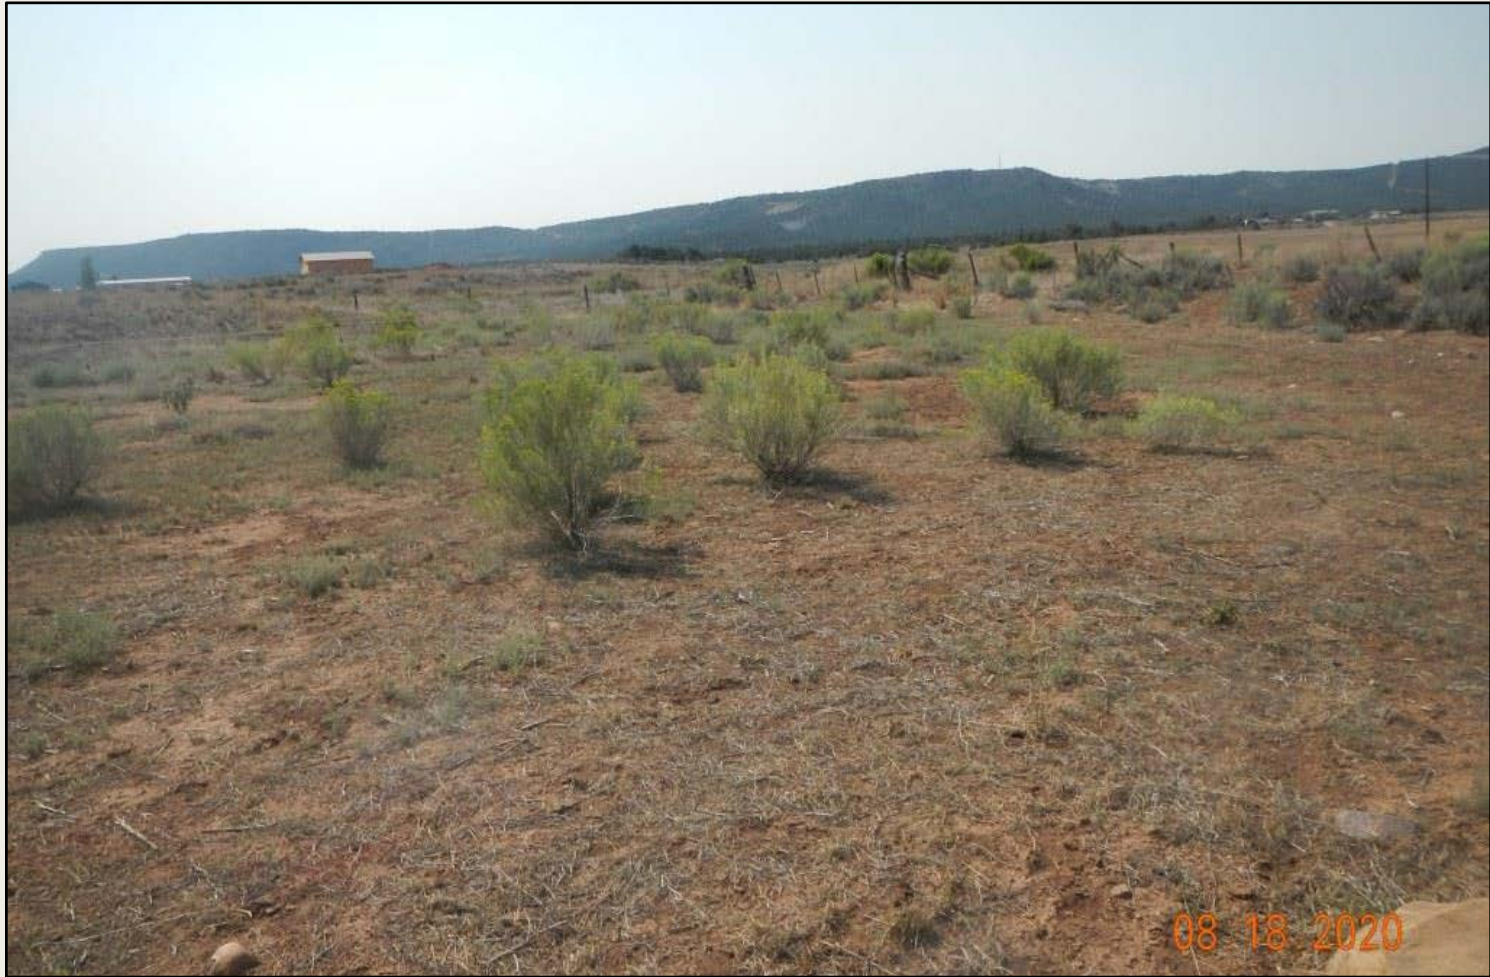
Photo 1. View of the project area from the northern edge facing center. Revegetation is progressing in a grazed condition with grasses not in identifiable condition and rubber rabbitbrush.

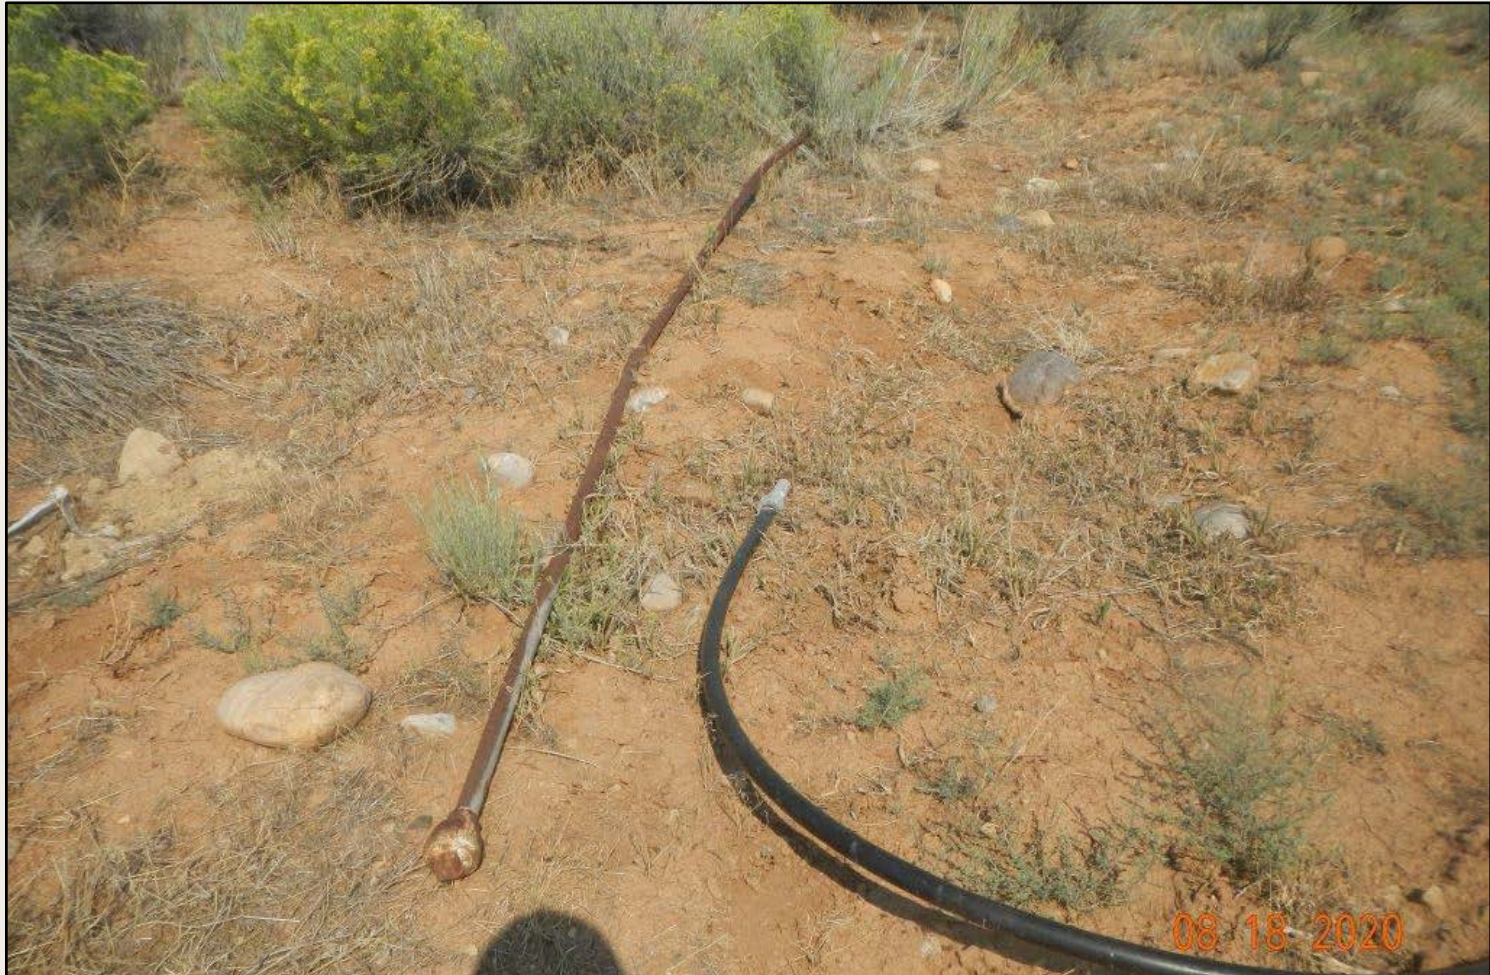
Photo 2. View of tubing that remains in the project area after domestic tap equipment is removed.

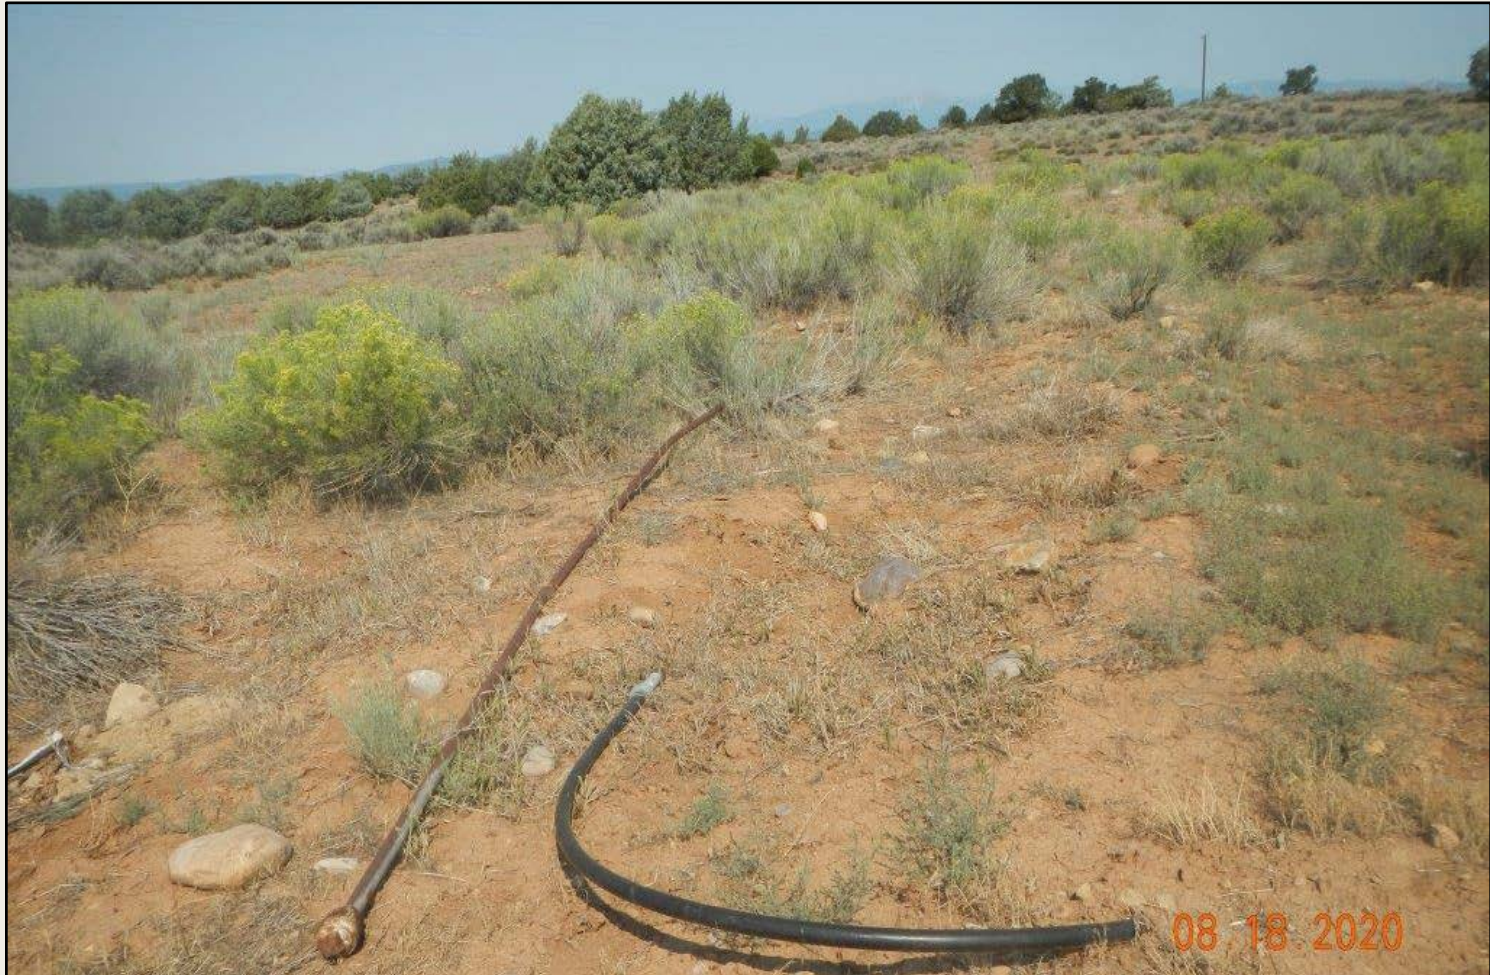
Photo 3. Another view of tubing that remains after domestic tap was removed, facing northward.
