Inspection Photos
Operator Name: STEHLE OIL COMPANY
Facility ID: 312978
ILES DOME (OWP) 3

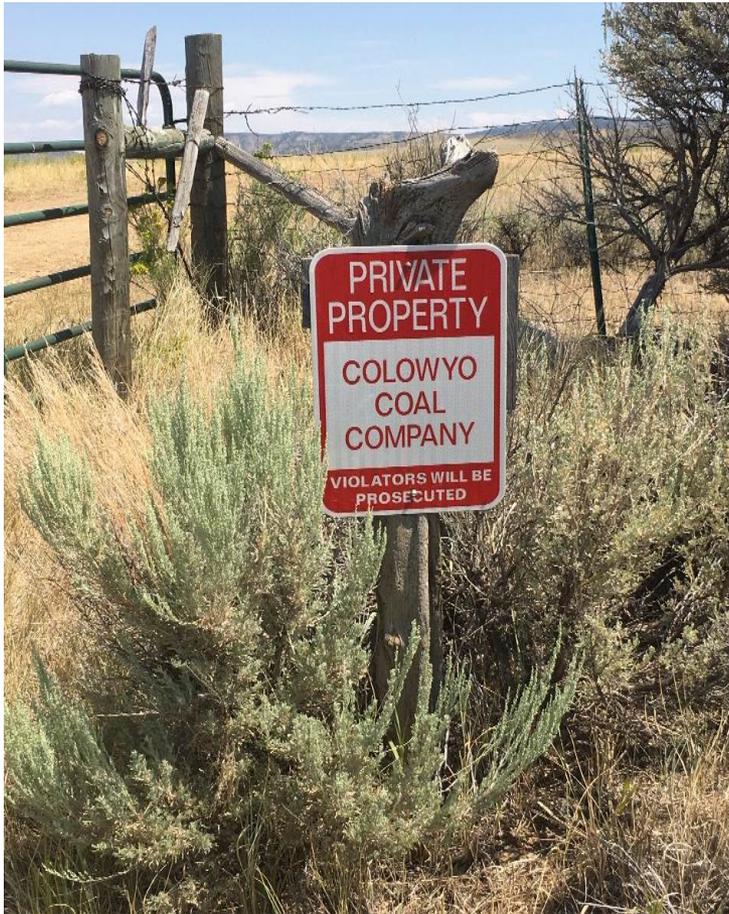
Land owner entrance sign, Locked Gate at entrance to access road, Check in at COLOWYO guard office on HWY 13

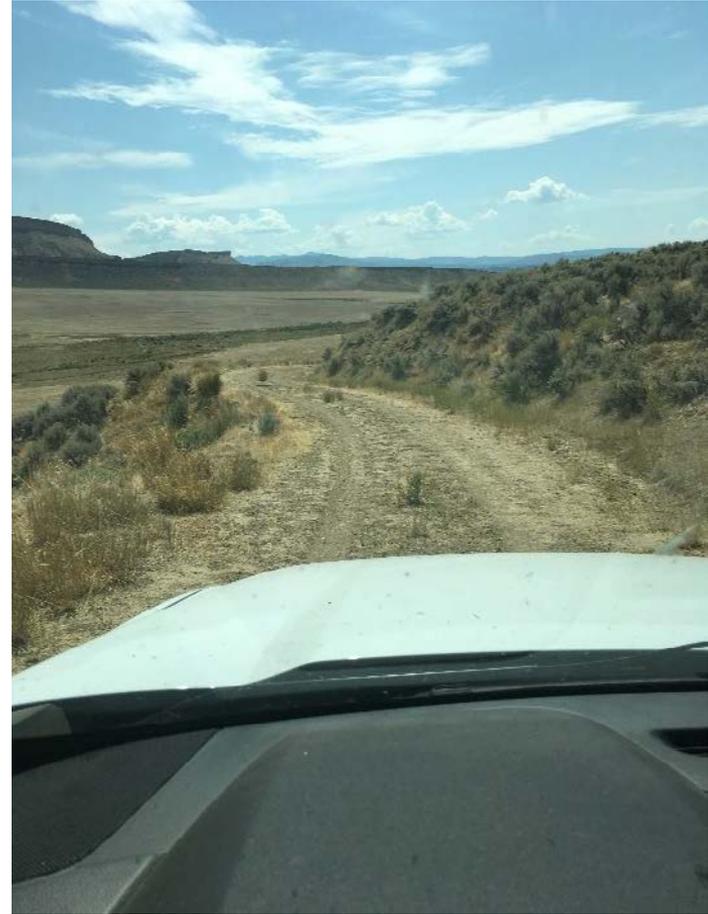
Access road in good condition

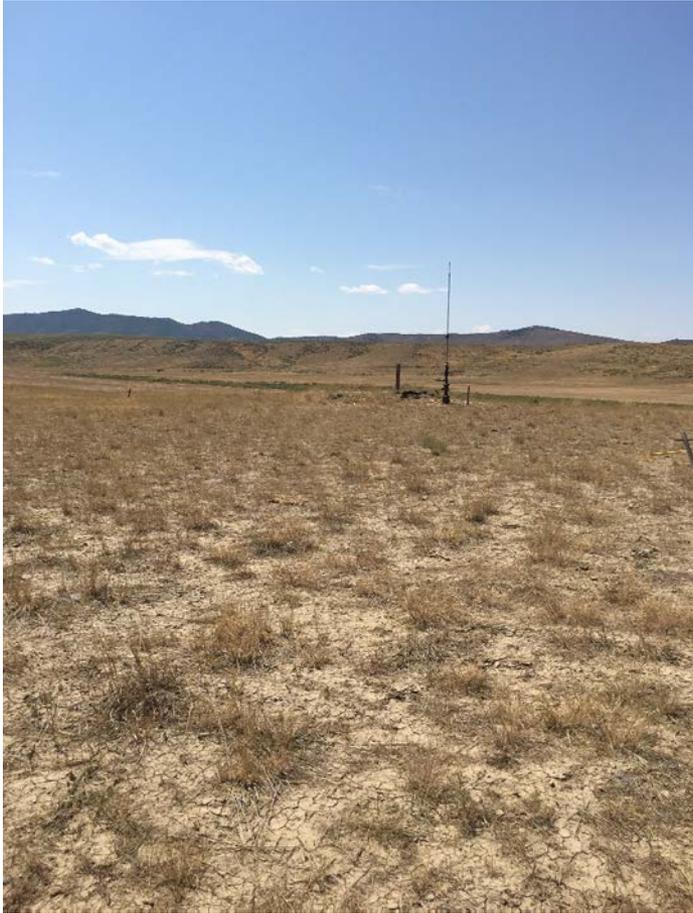
Location photo, No fence installed, open range grazing land

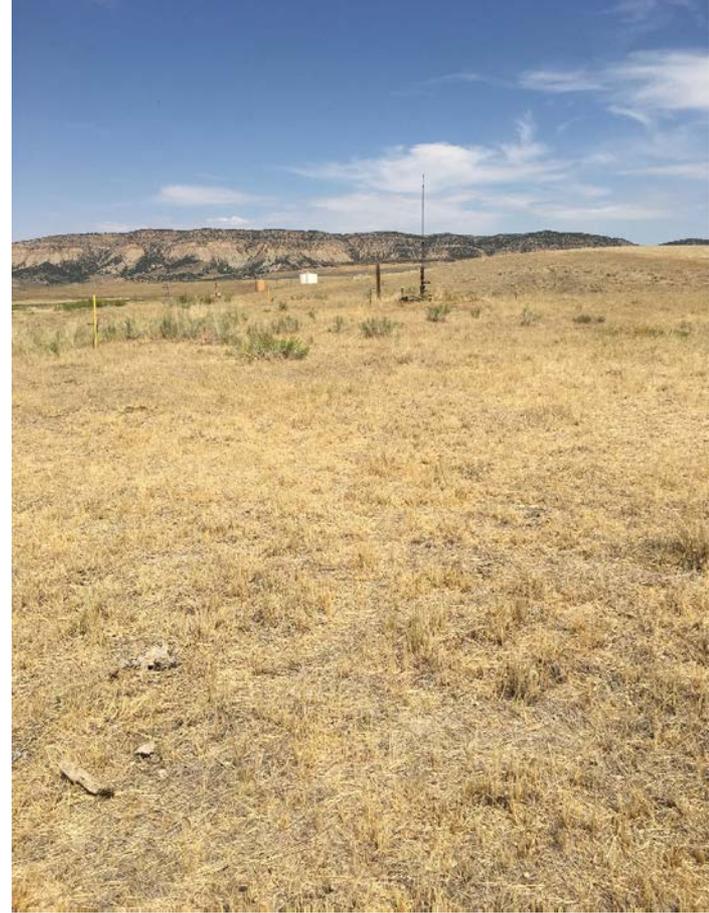
Location photo with location 312758 white storage tank in background

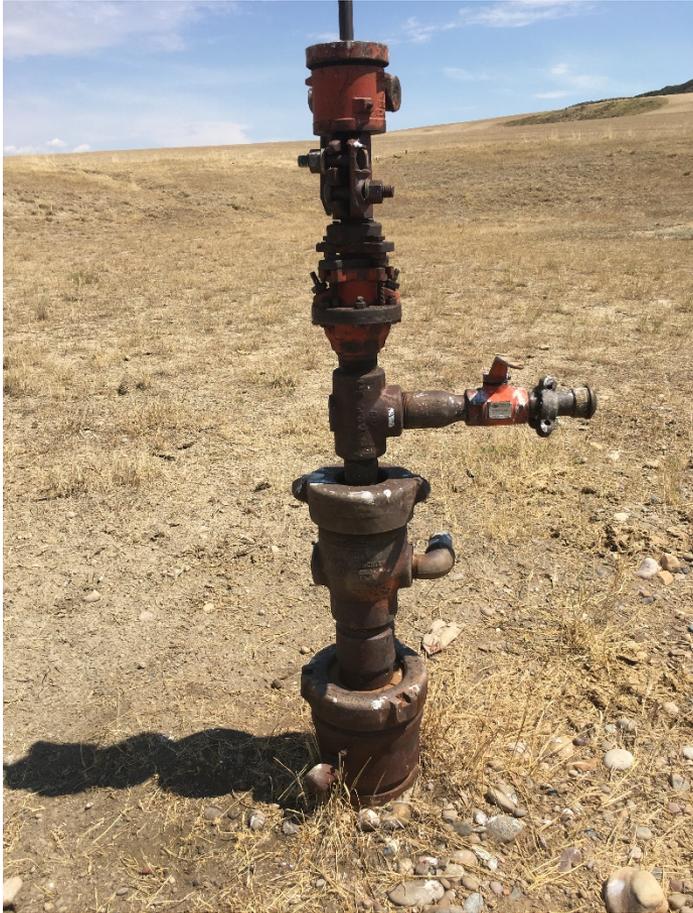
Wellhead

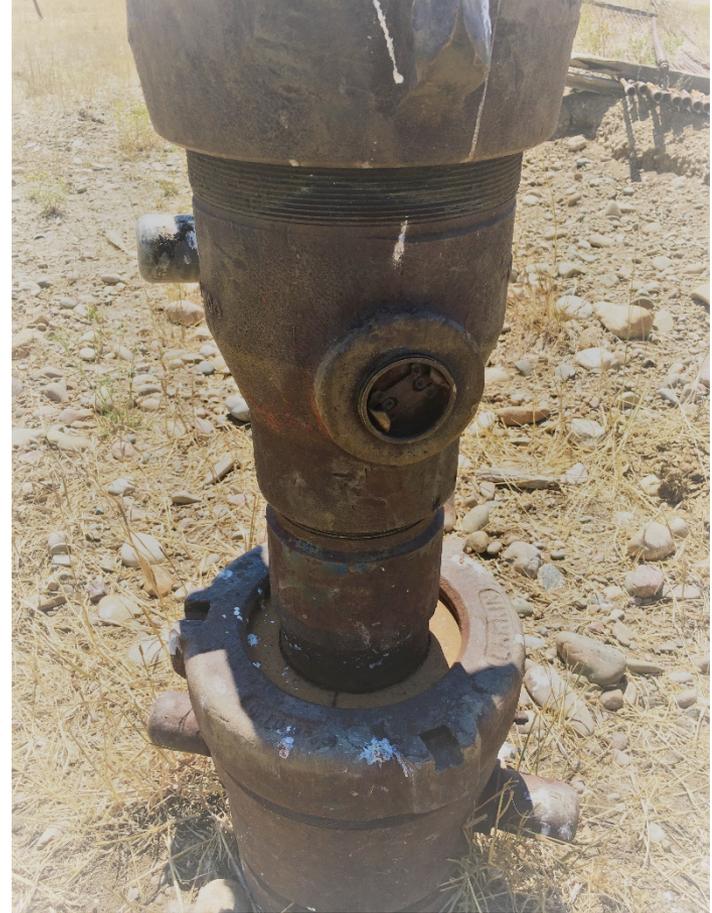
**Wellhead with 55gal drum bung
installed**

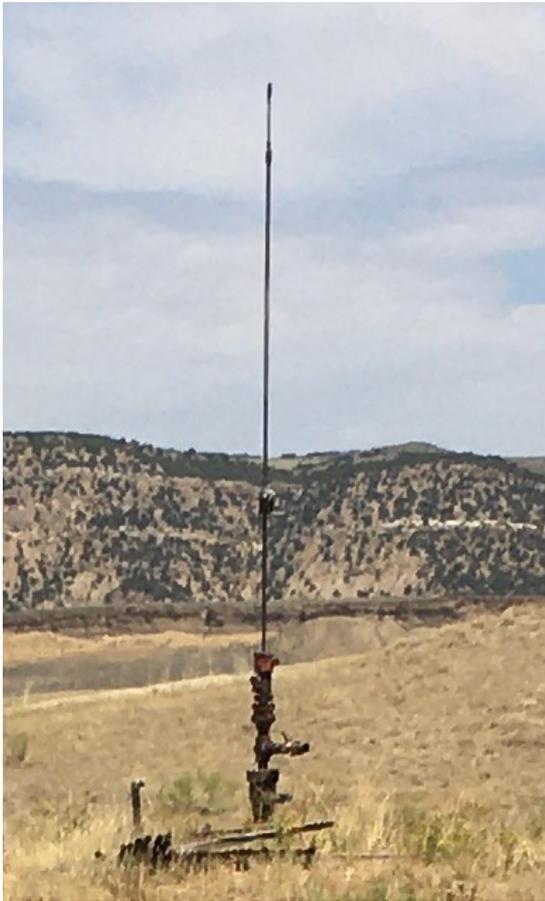
Wellhead with Polished rod installed in wellhead

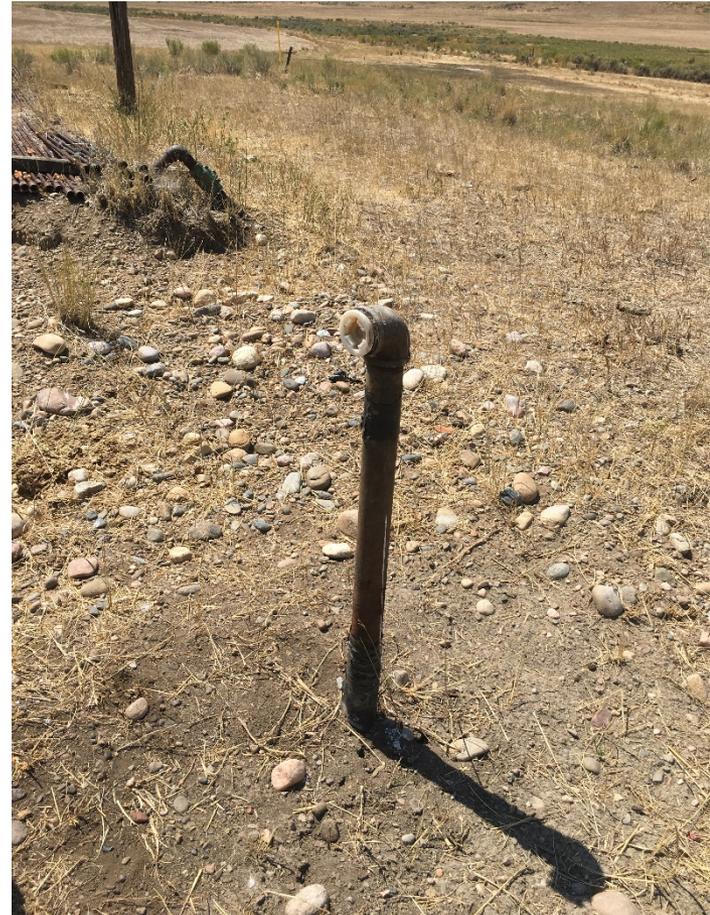
One riser on location, might be off location flowline to location 312758

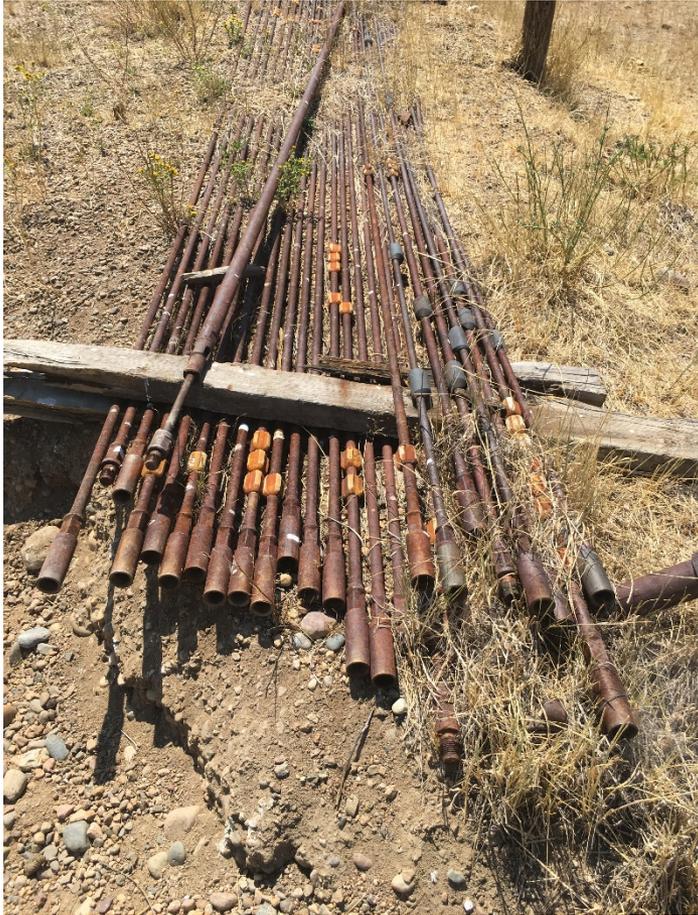
Pump and sucker rods staged by wellhead

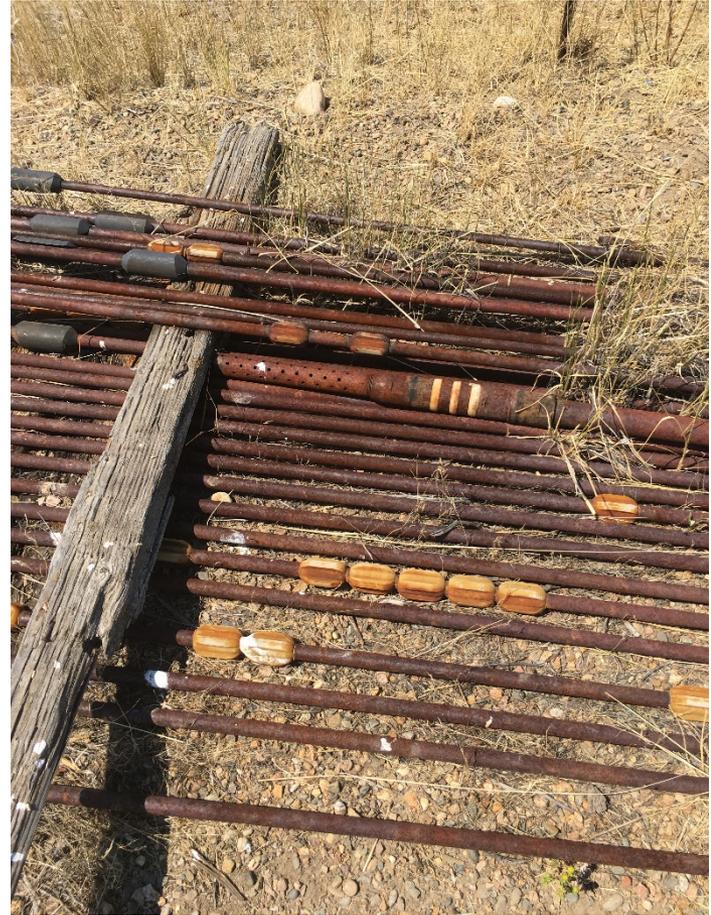
Photo of pump and filter screen
