# Final Reclamation Inspection

Operator: EDDY OIL COMPANY - 26420

Location ID: 322675

Inspection Photos  
Location Name: DUPPER #2  
Location ID: 322675

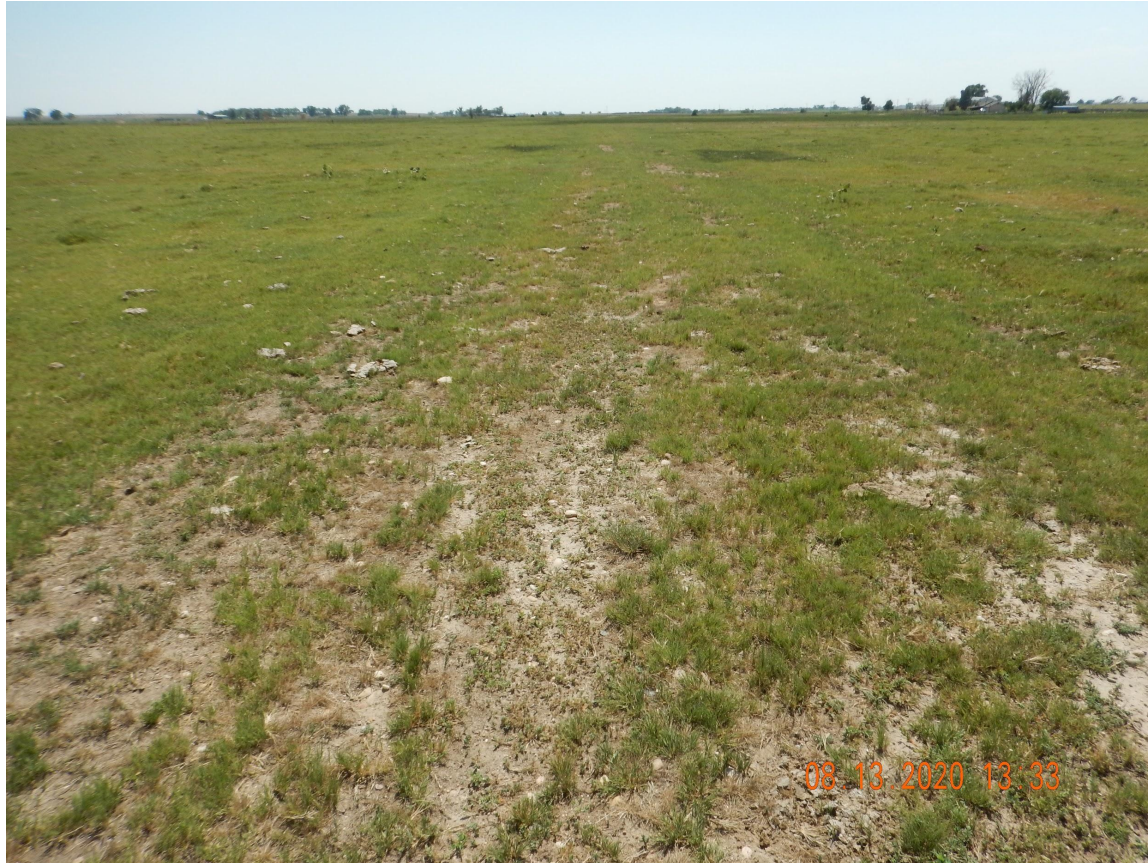
**Photo 1.** Photo taken from the northern access road, facing South. Photo illustrates vegetative growth within the access road; however, it is not uniform and reflective of reference area vegetative levels.

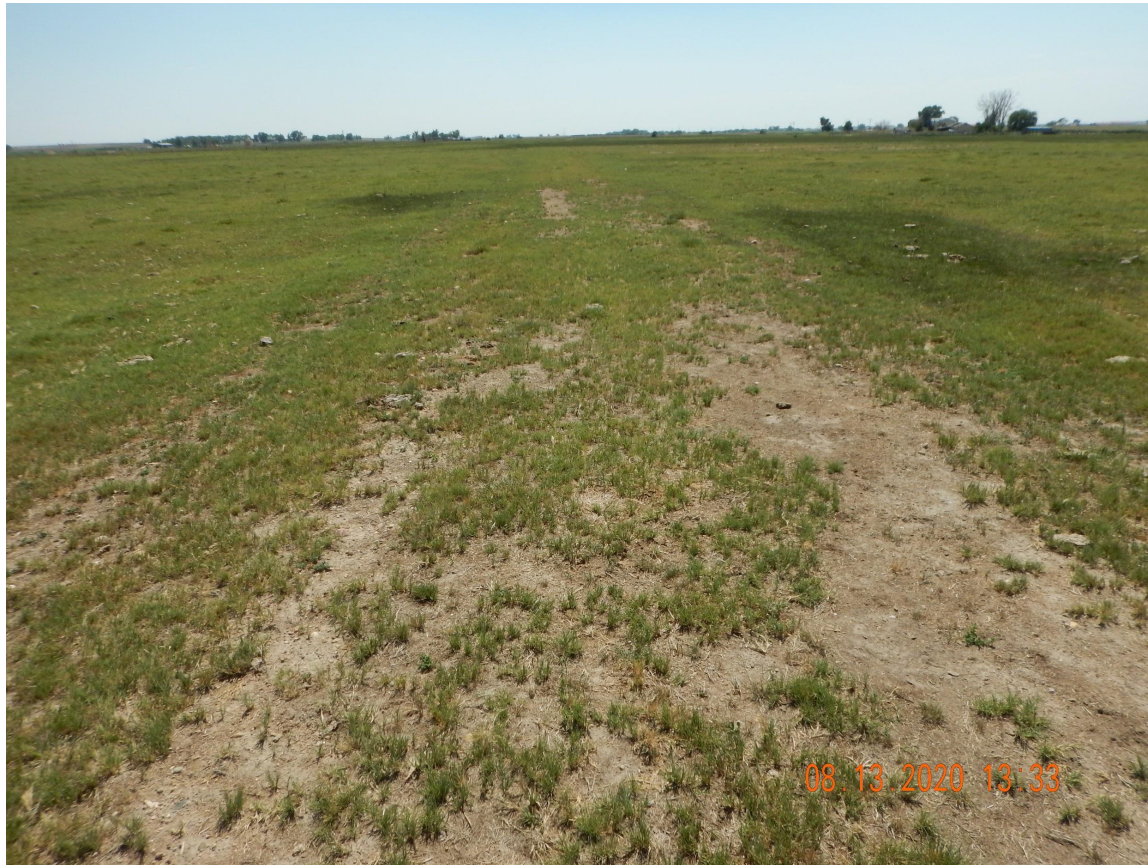
**Photo 2.** Photo taken from another portion of the access road, facing South. See comments under Photo 1.

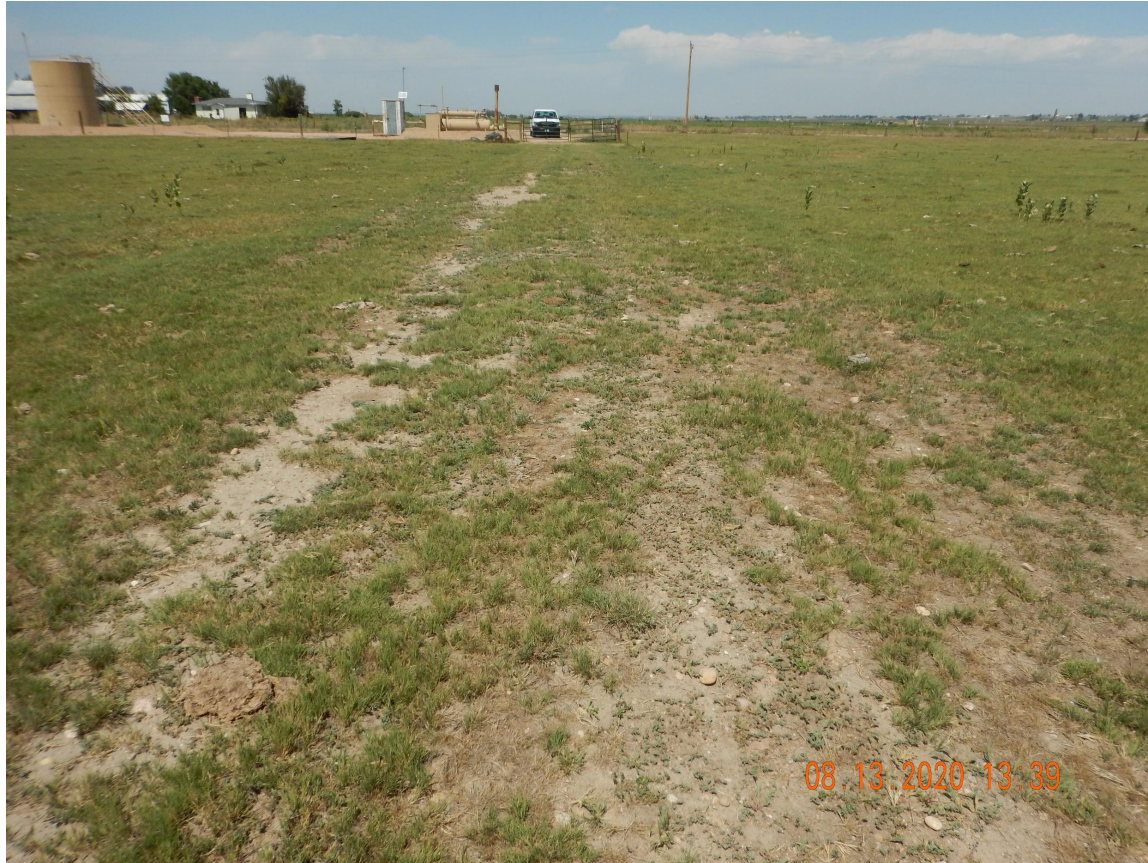
**Photo 3.** Photo taken from another portion of the access road, facing North. See comments under Photo 1.

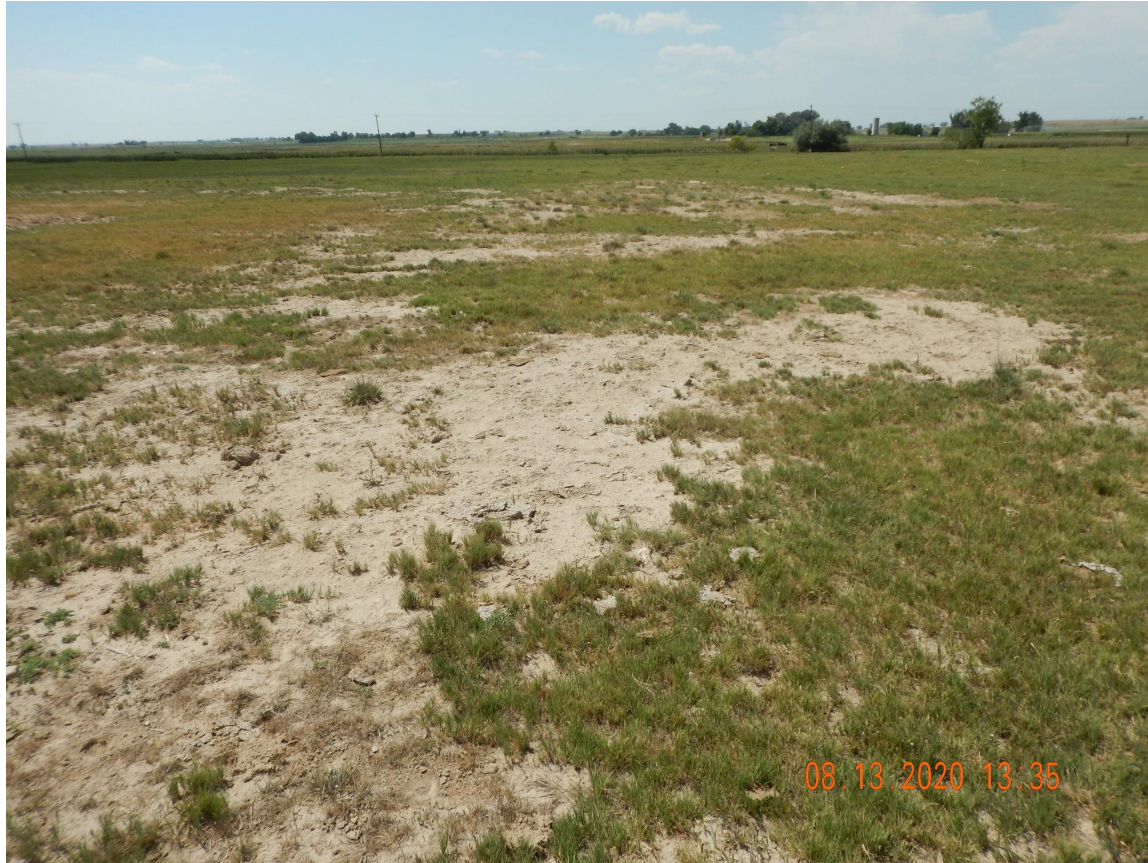
**Photo 4.** Photo taken from western well location, facing West. See comments under Photo 1.

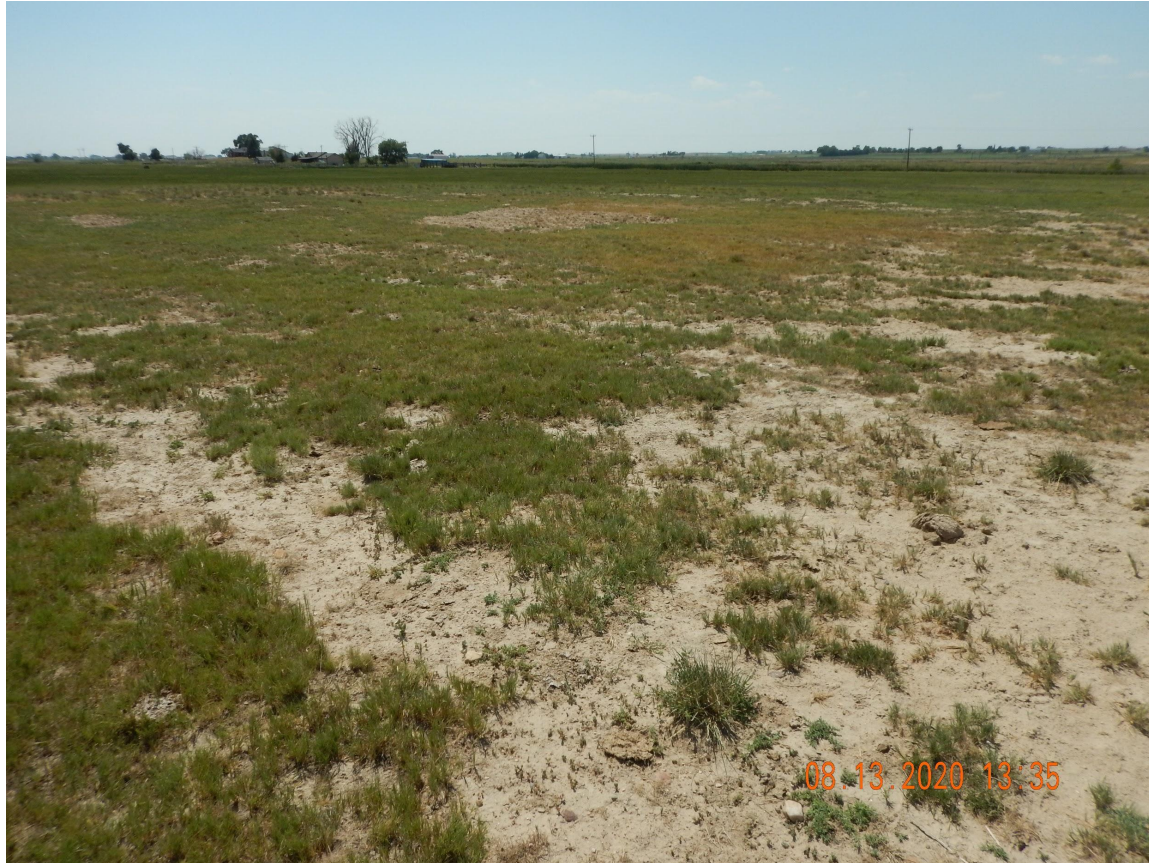
**Photo 5.** Photo taken from western well location, facing Southwest. See comments under Photo 1.

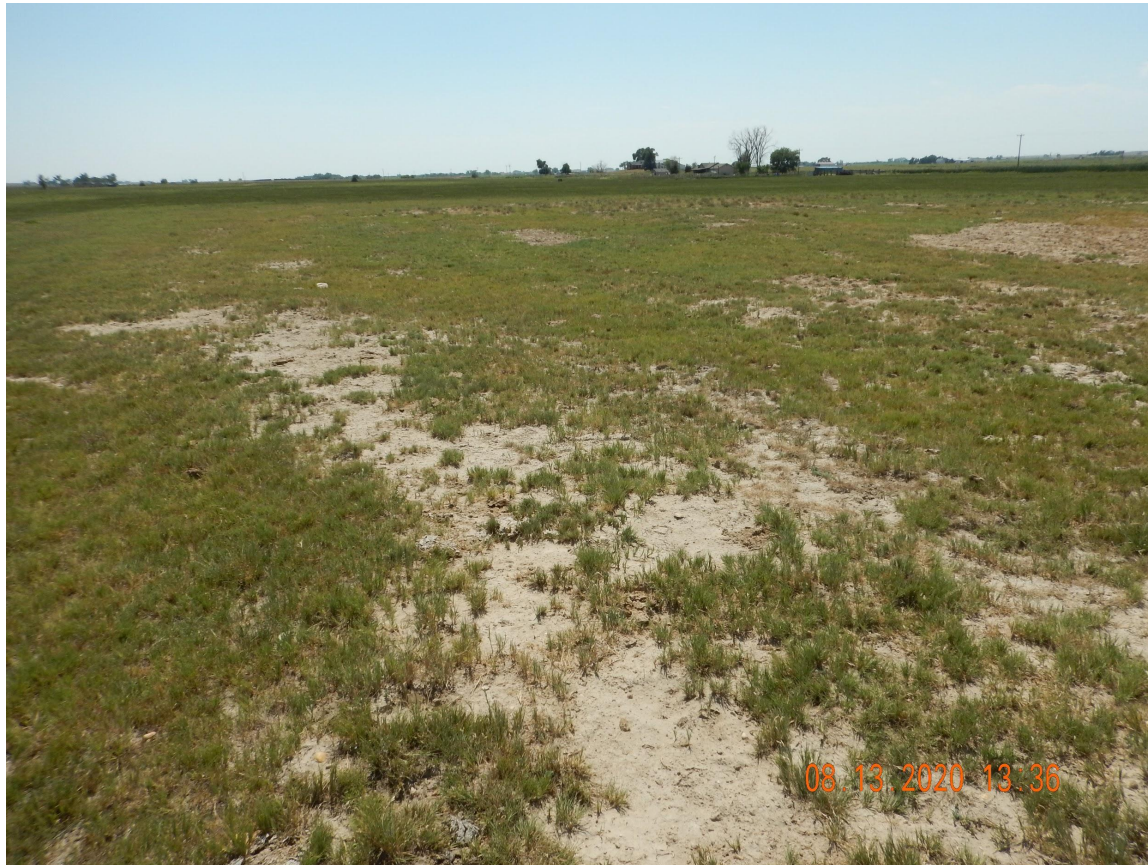
**Photo 6.** Photo taken from western well location, facing South. See comments under Photo 1.

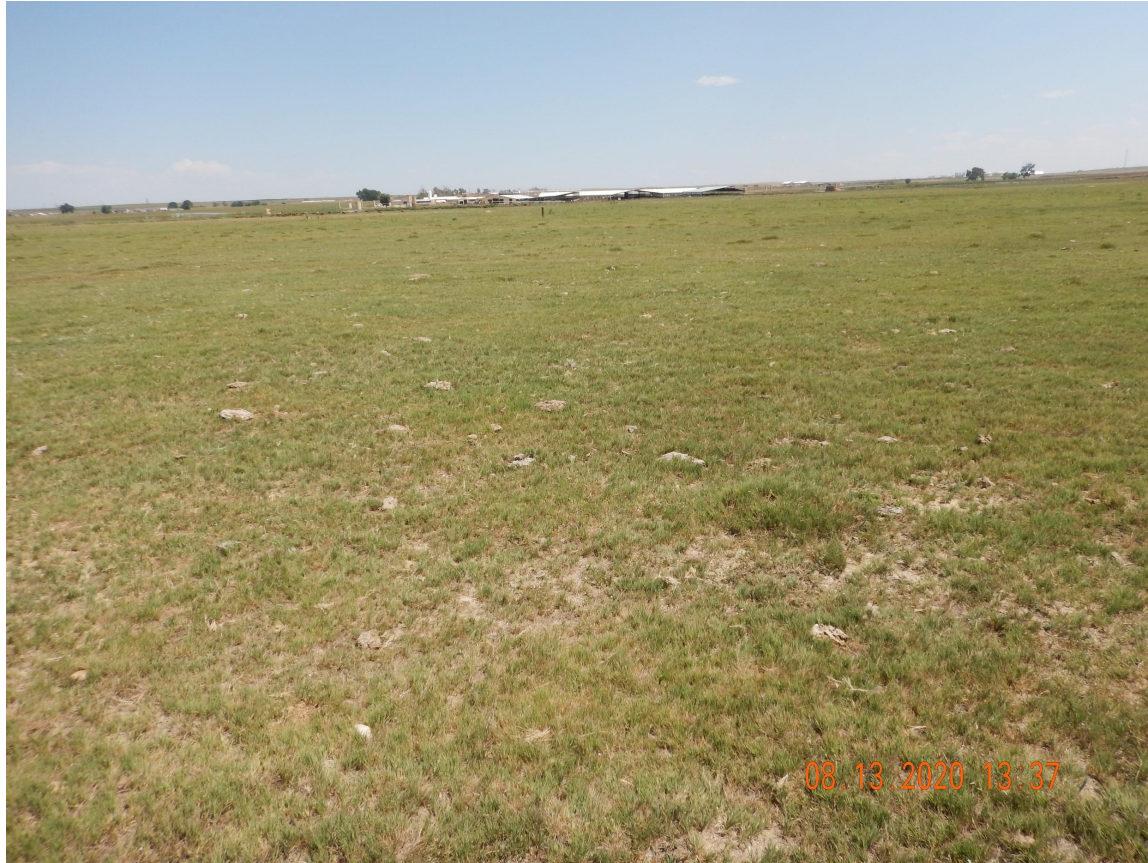
**Photo 7.** Reference photo taken east of the well location, facing East. See comments under Photo 1.
