Inspection Photos
Operator: BP America
API: 067-08794
Date: 8/20/2020

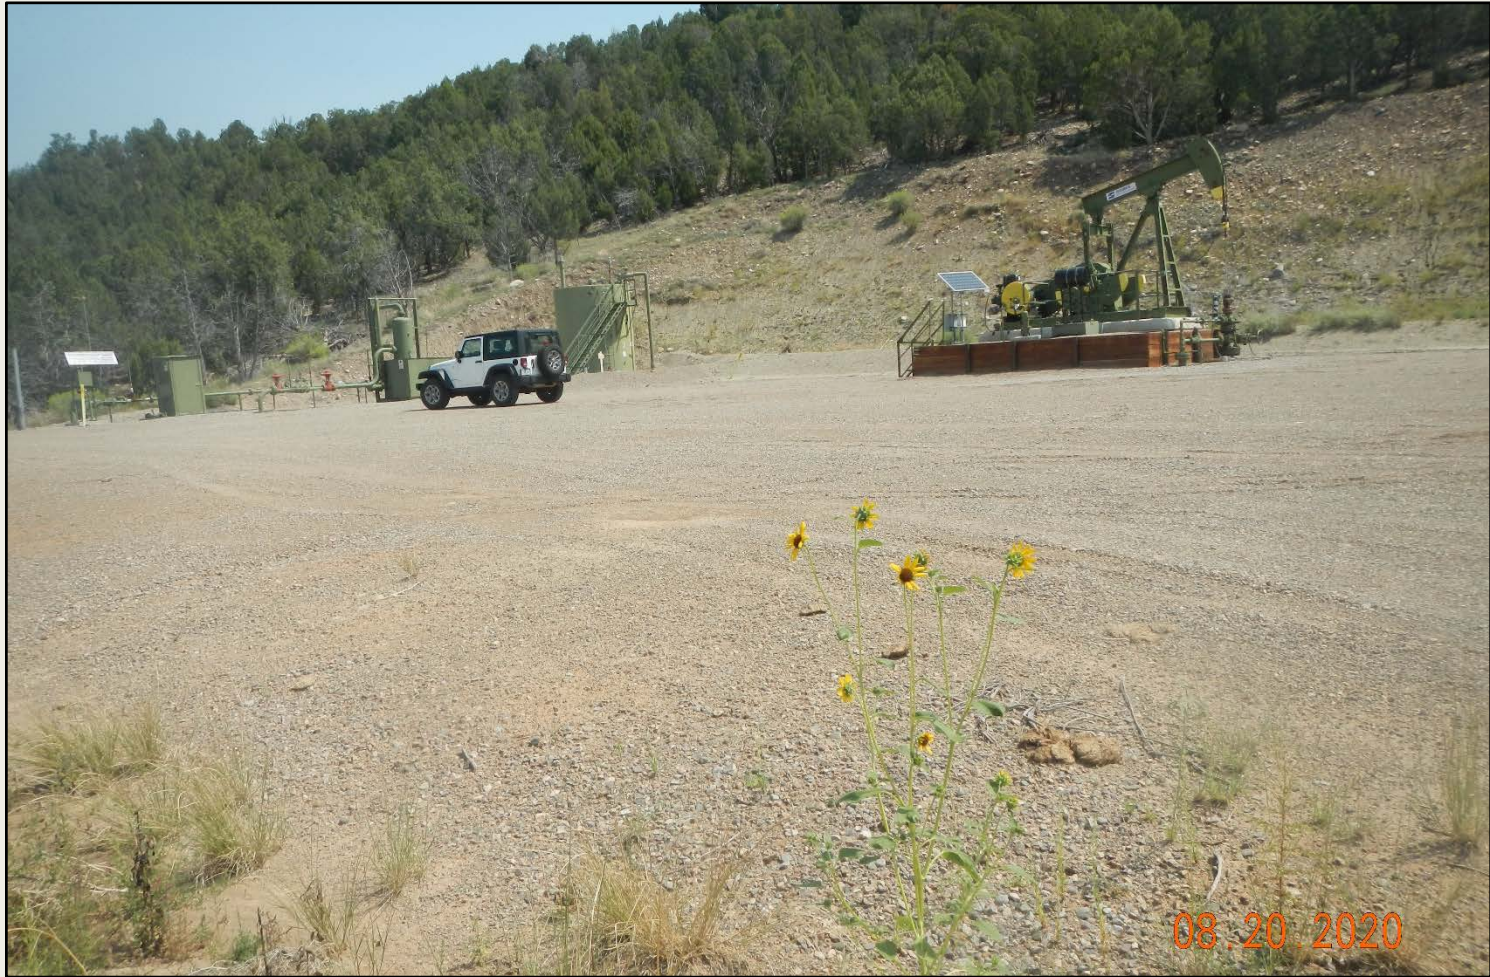
Photo 1. View of the BP well from the southeastern corner facing center.

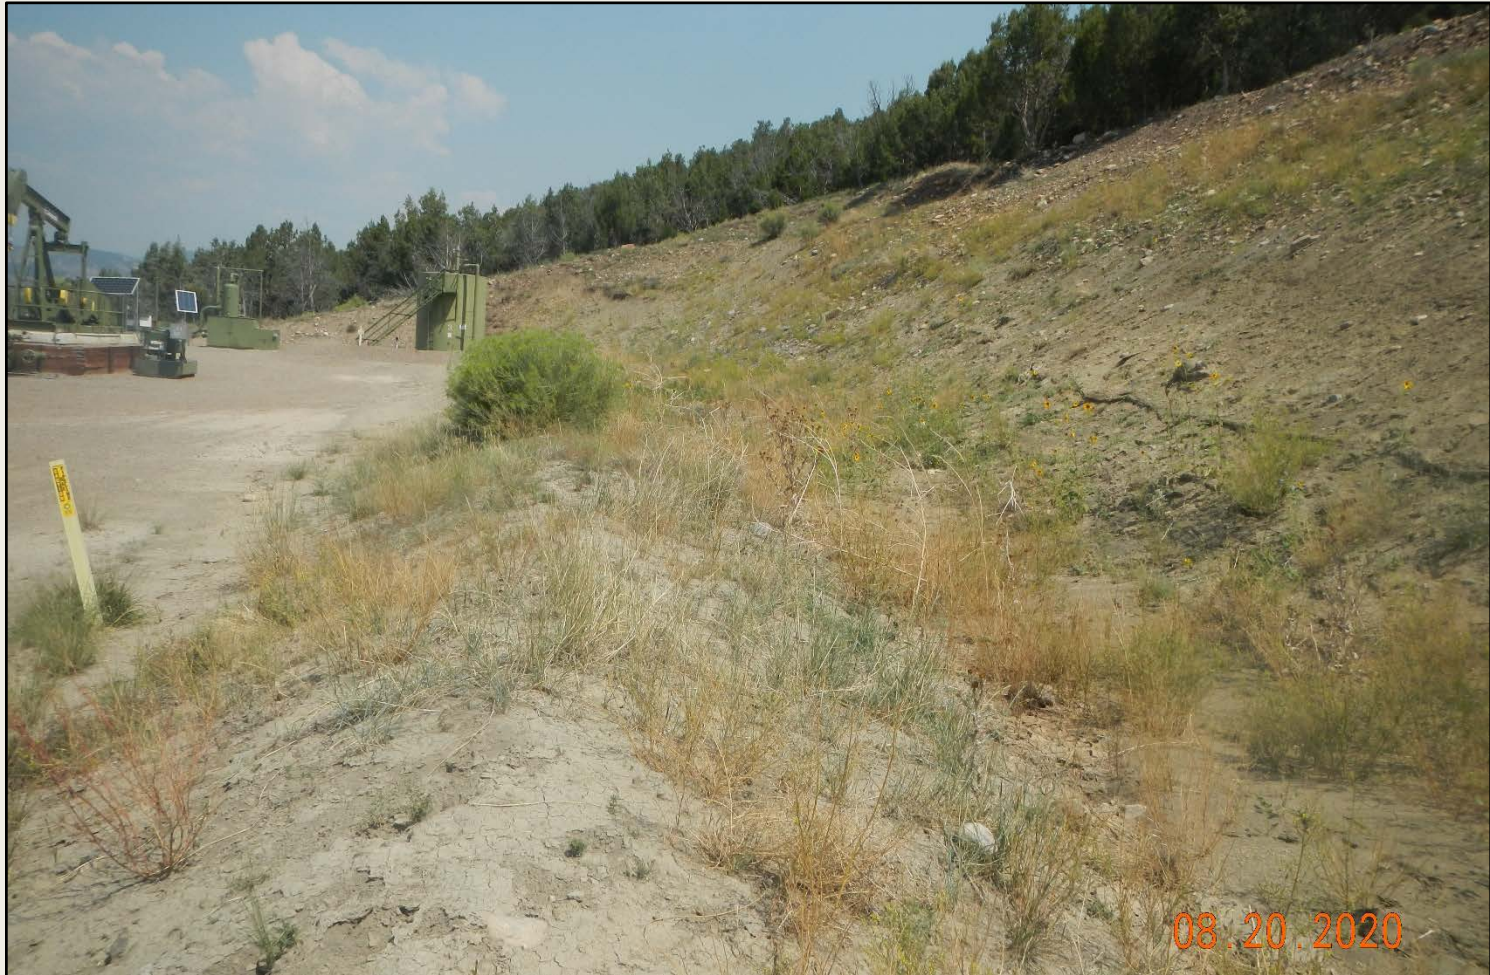
Photo 2. View of the eastern project area facing northward. Revegetation is progressing in portions of the interim reclamation area with grasses and shrubs such as western wheatgrass and rubber rabbitbrush.

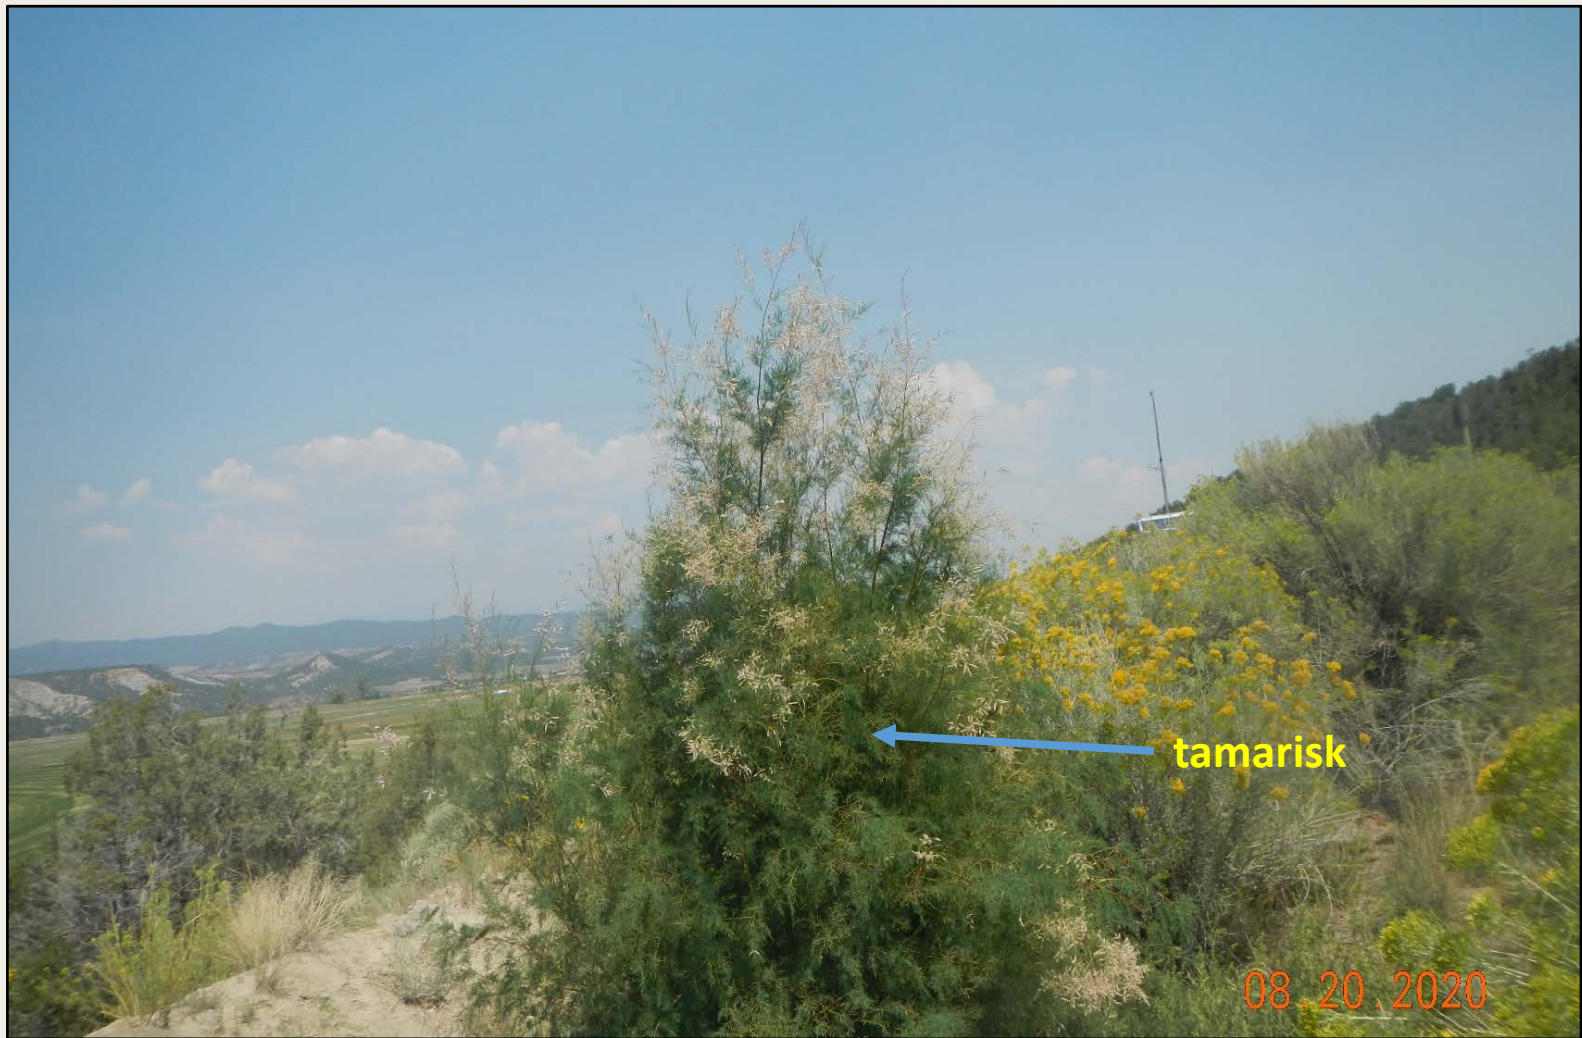
Photo 3. View of tamarisk tree in the southwestern project area. Tamarisk is a state and county-listed noxious weed.

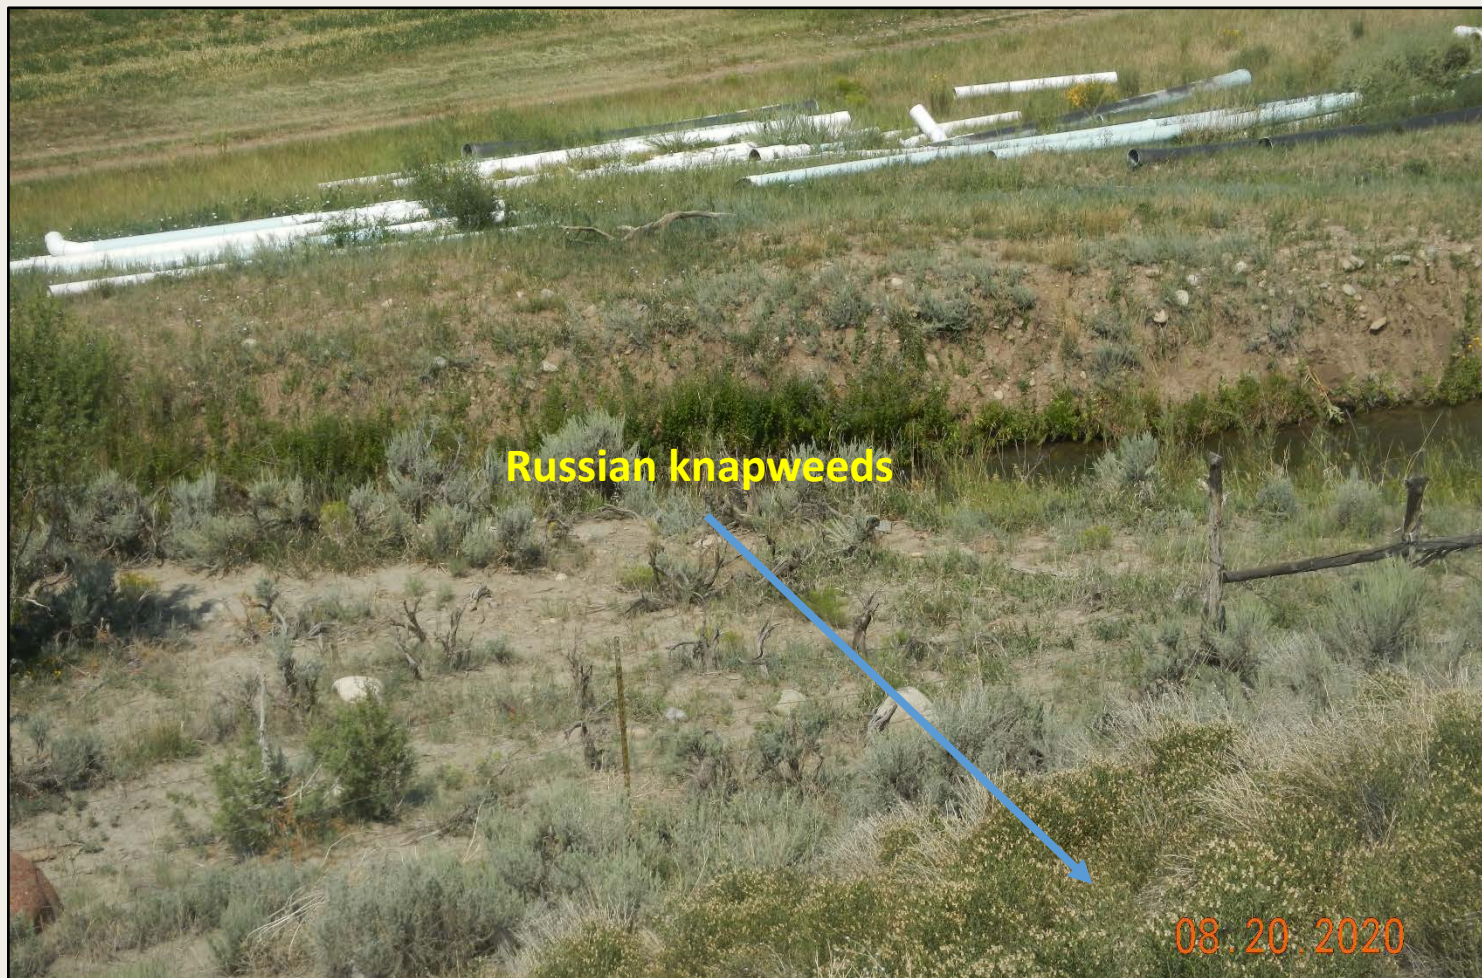
Photo 4. View of dense Russian knapweeds growing on the northwestern fill slope. Approximately 2000 individuals observed.

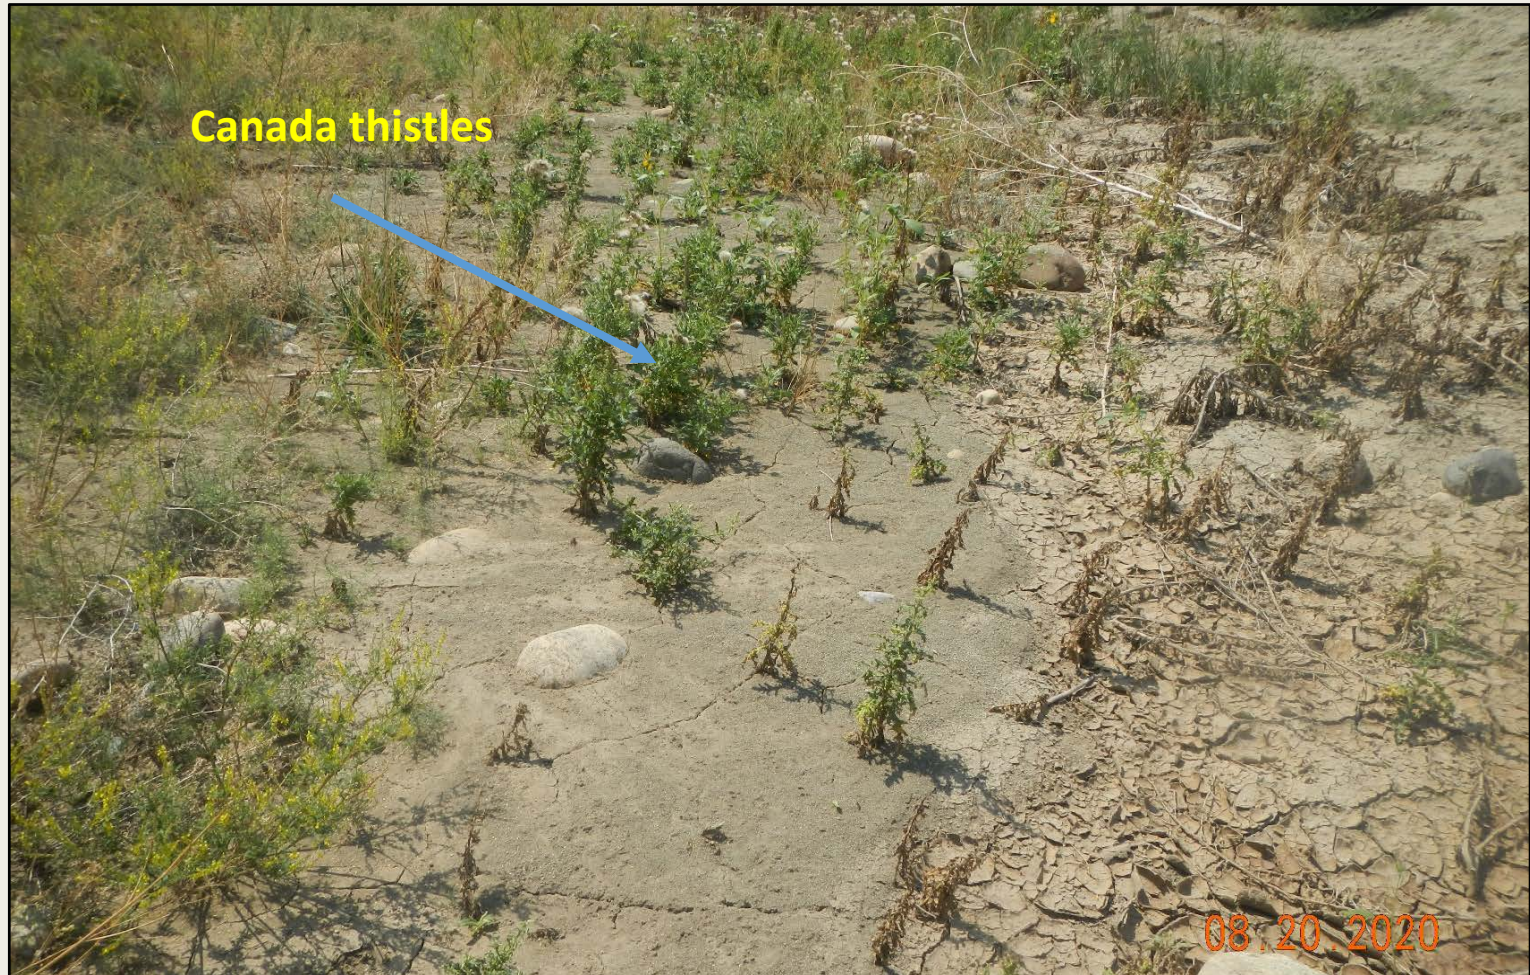
Photo 5. View of Canada thistles within the eastern fill slope. Approximately 300 Canada and Scotch thistles observed here.

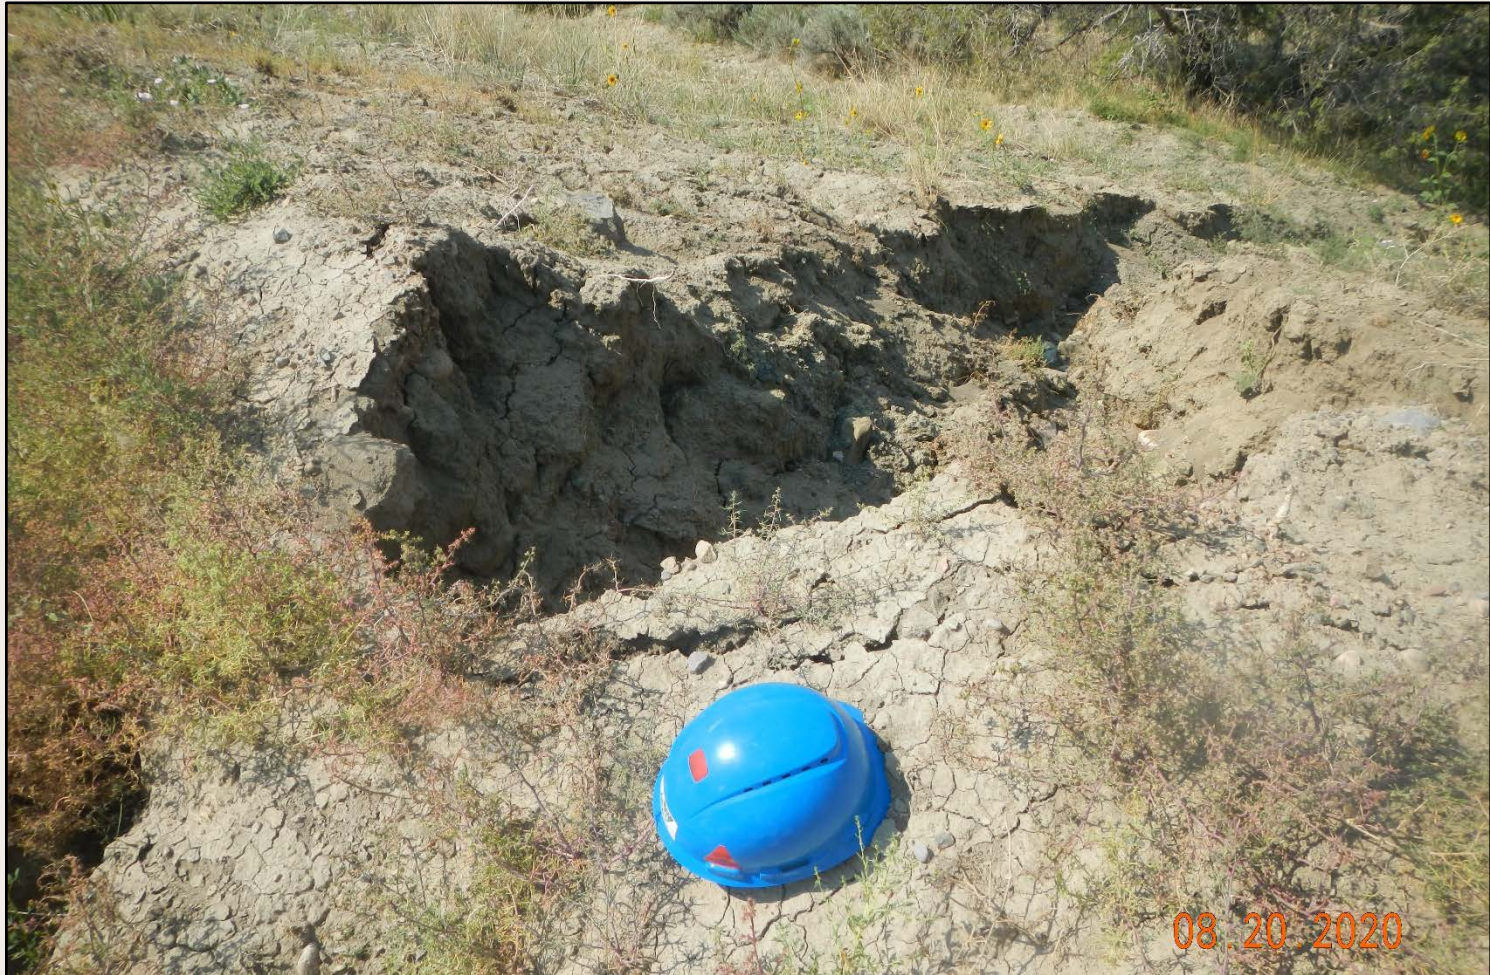
Photo 6. View of erosional gully in the western fill slope, approximately 3-4 feet wide and deep (facing down-slope from top of slope). Hard hat in place for scale.

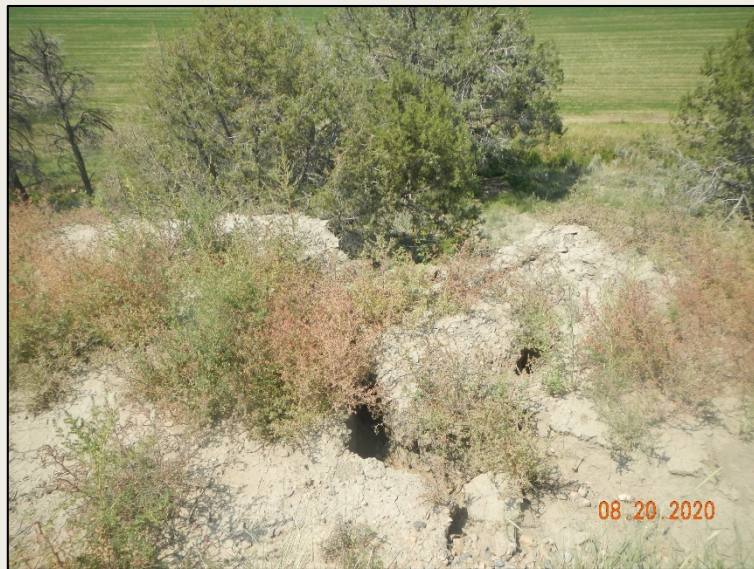
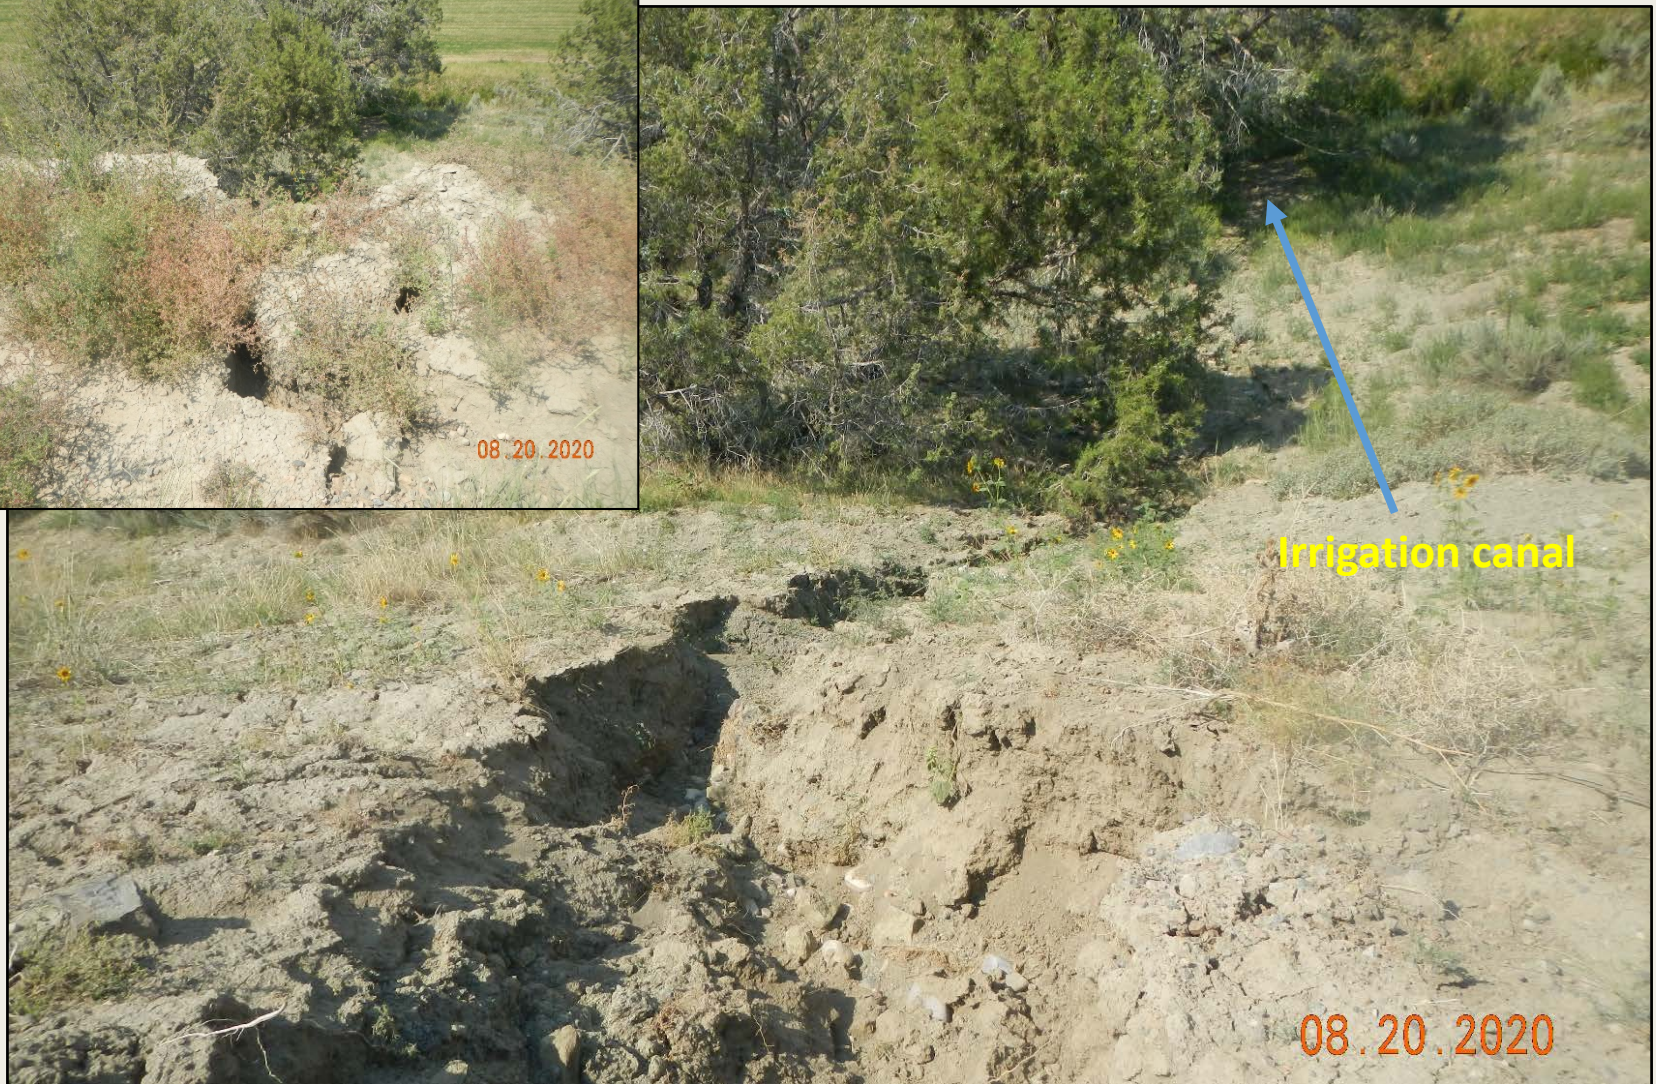
Photo 7. Downslope view of gully shown in Photo 6. Sediment from erosional events is flowing to adjacent irrigation canal. Inset shows top of slope where stormwater tunnels through the berm and eroding the slope.

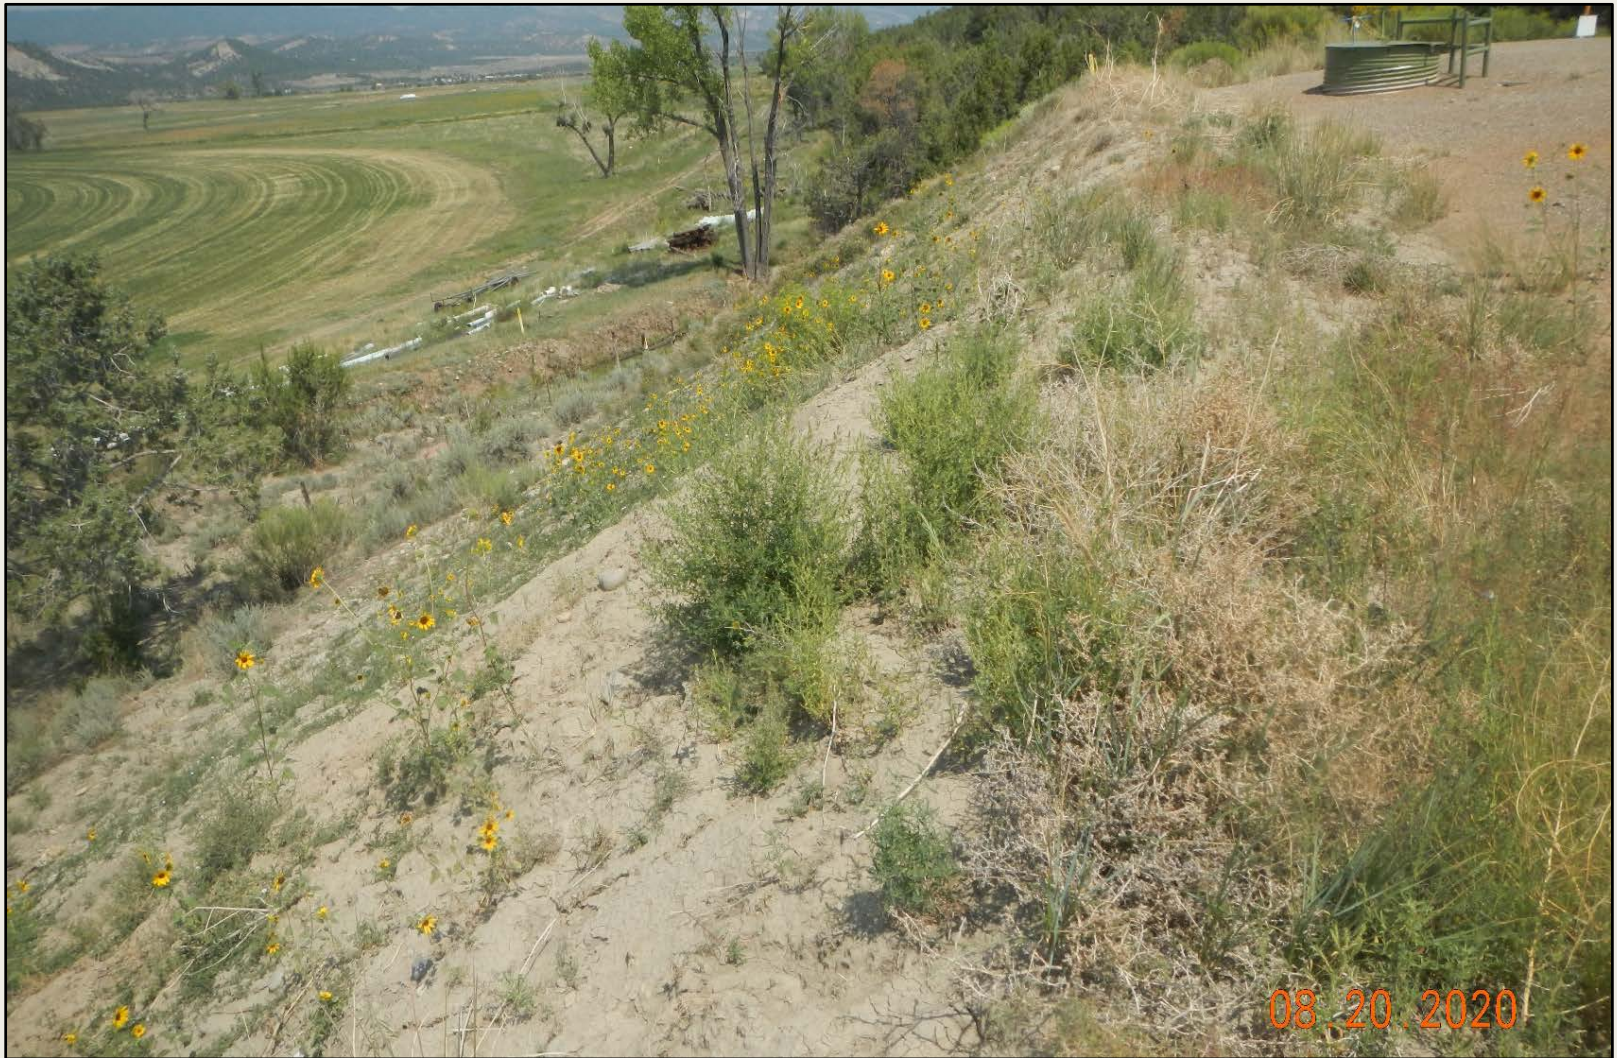
Photo 8. View of the well pad fill slope facing northward. Scattered desirable vegetation such as western wheatgrass and Indian ricegrass present, but the majority of the slope remains unstabilized with bare soils or weeds such as Russian thistle.

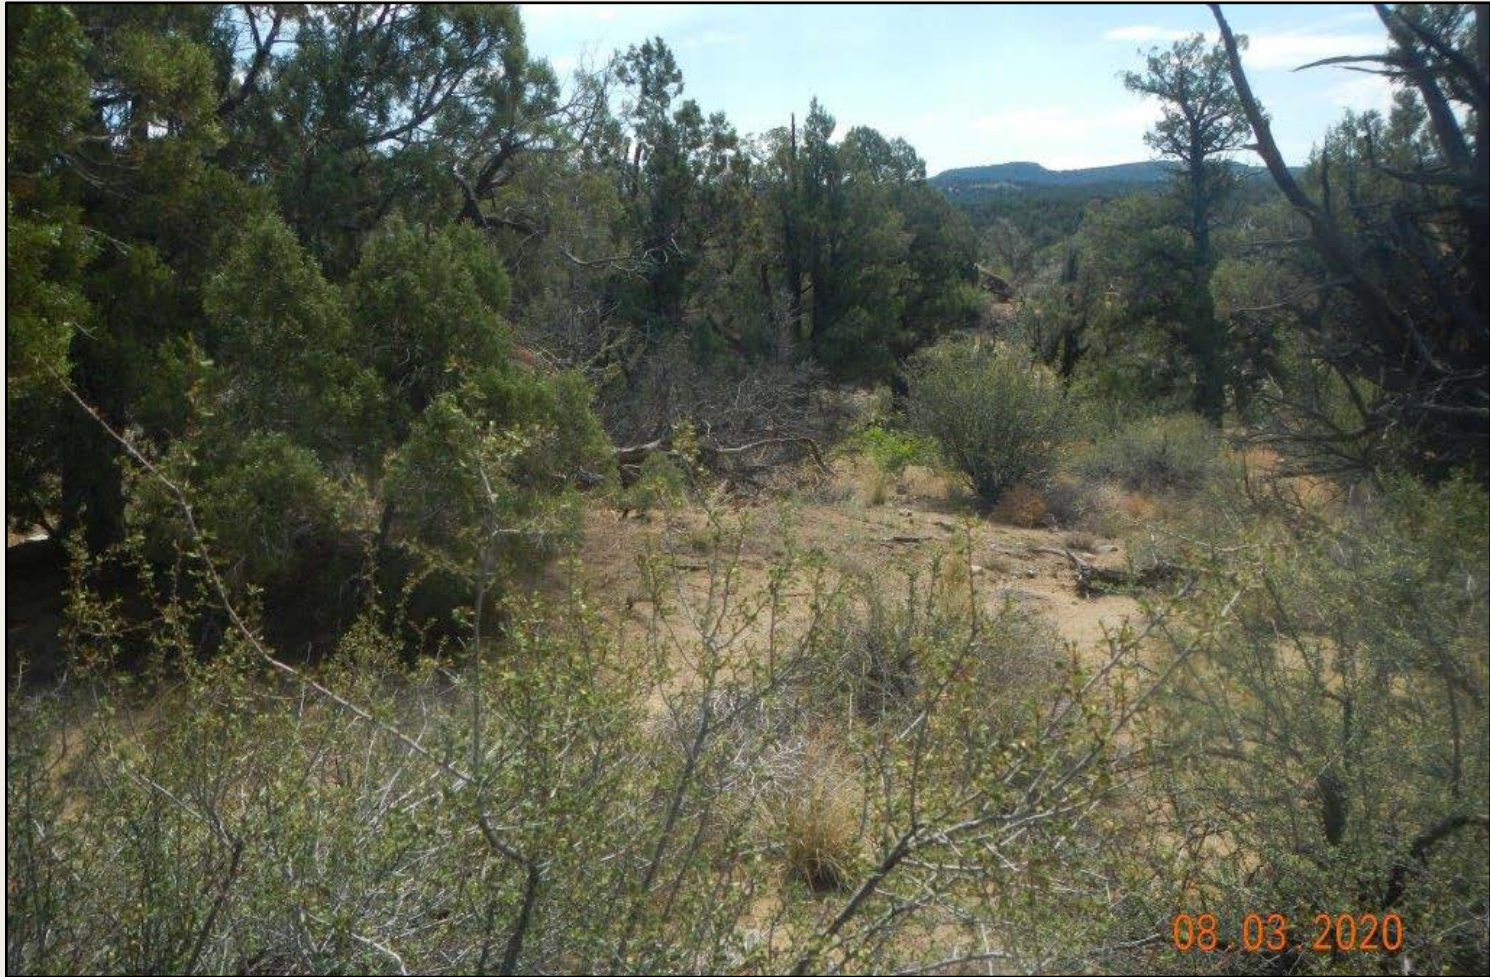
Photo 9. View of reference area comprised of pinyon/juniper woodland vegetation with understory of shrubs and grasses/forbs such as antelope bitterbrush, mountain mahogany, Indian ricegrass and *Heterotheca villosa*.
