**Inspection Photos**  
**Operator: Hilcorp Operating**  
**API: 067-08111**  
**Date: 8/20/2020**

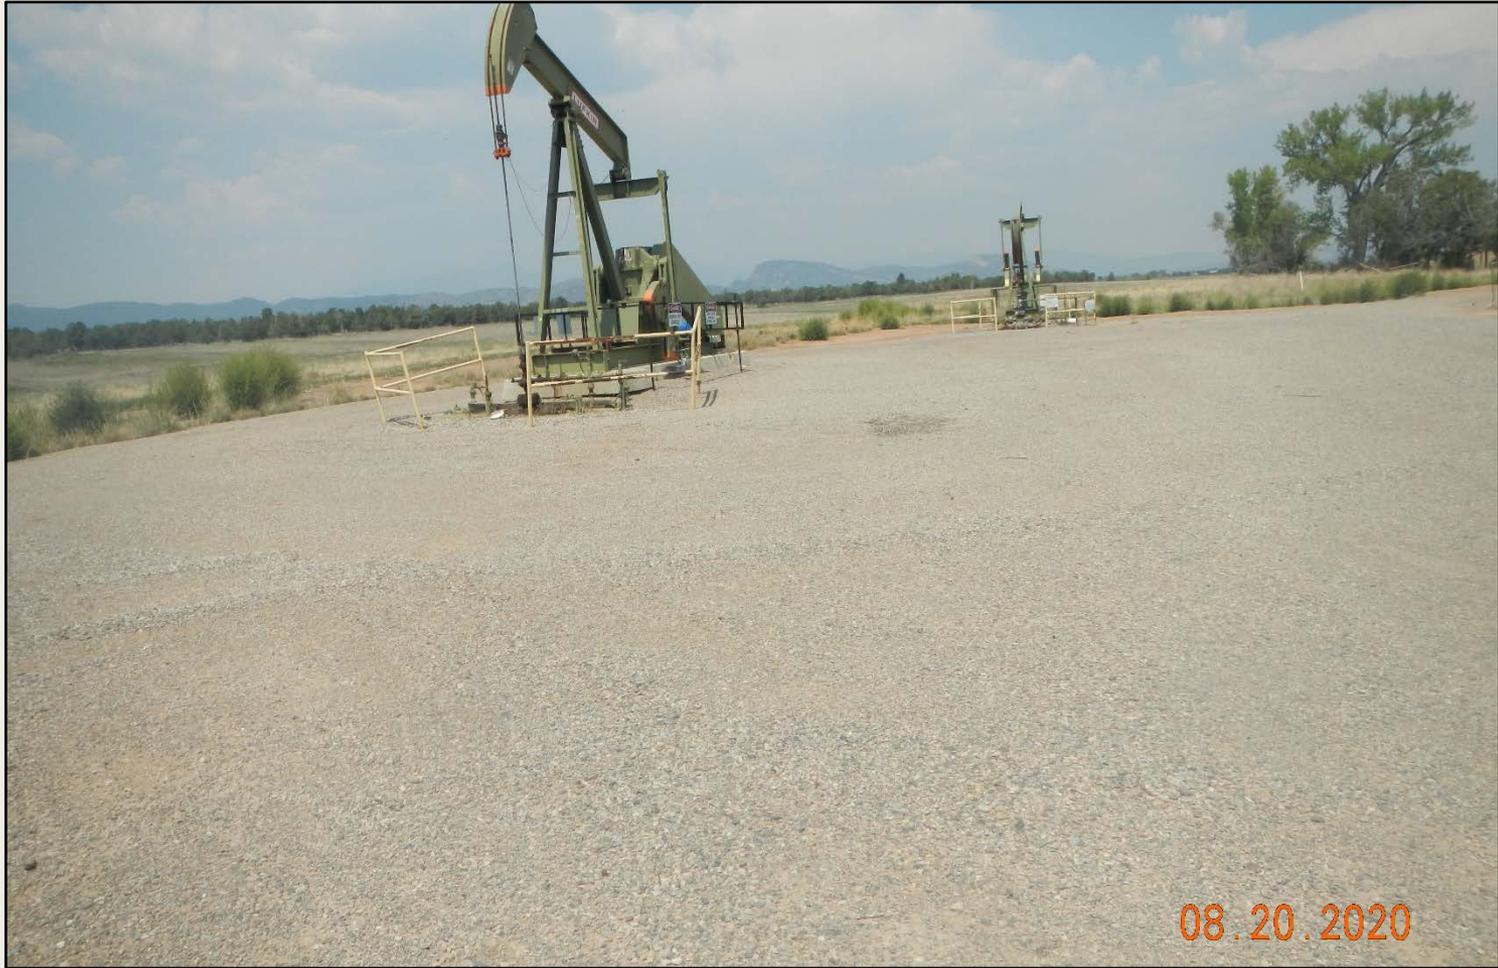
Photo 1. View of the project area from the well pad entrance facing center.

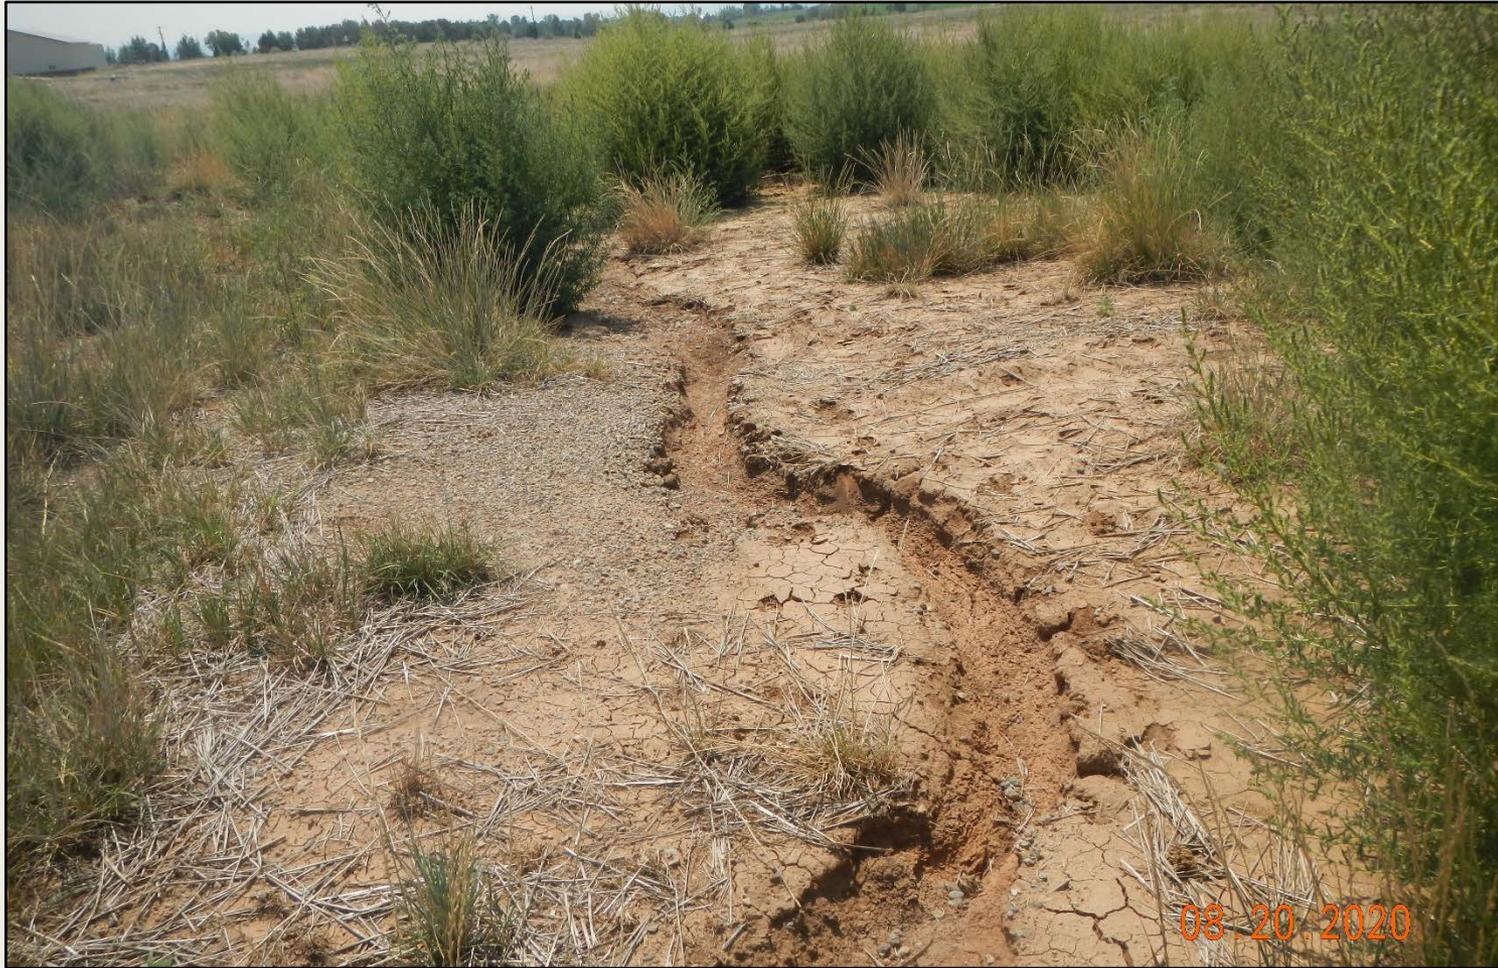
Photo 2. View of erosional channel approximately 1 foot wide and deep, eroding the western project area.

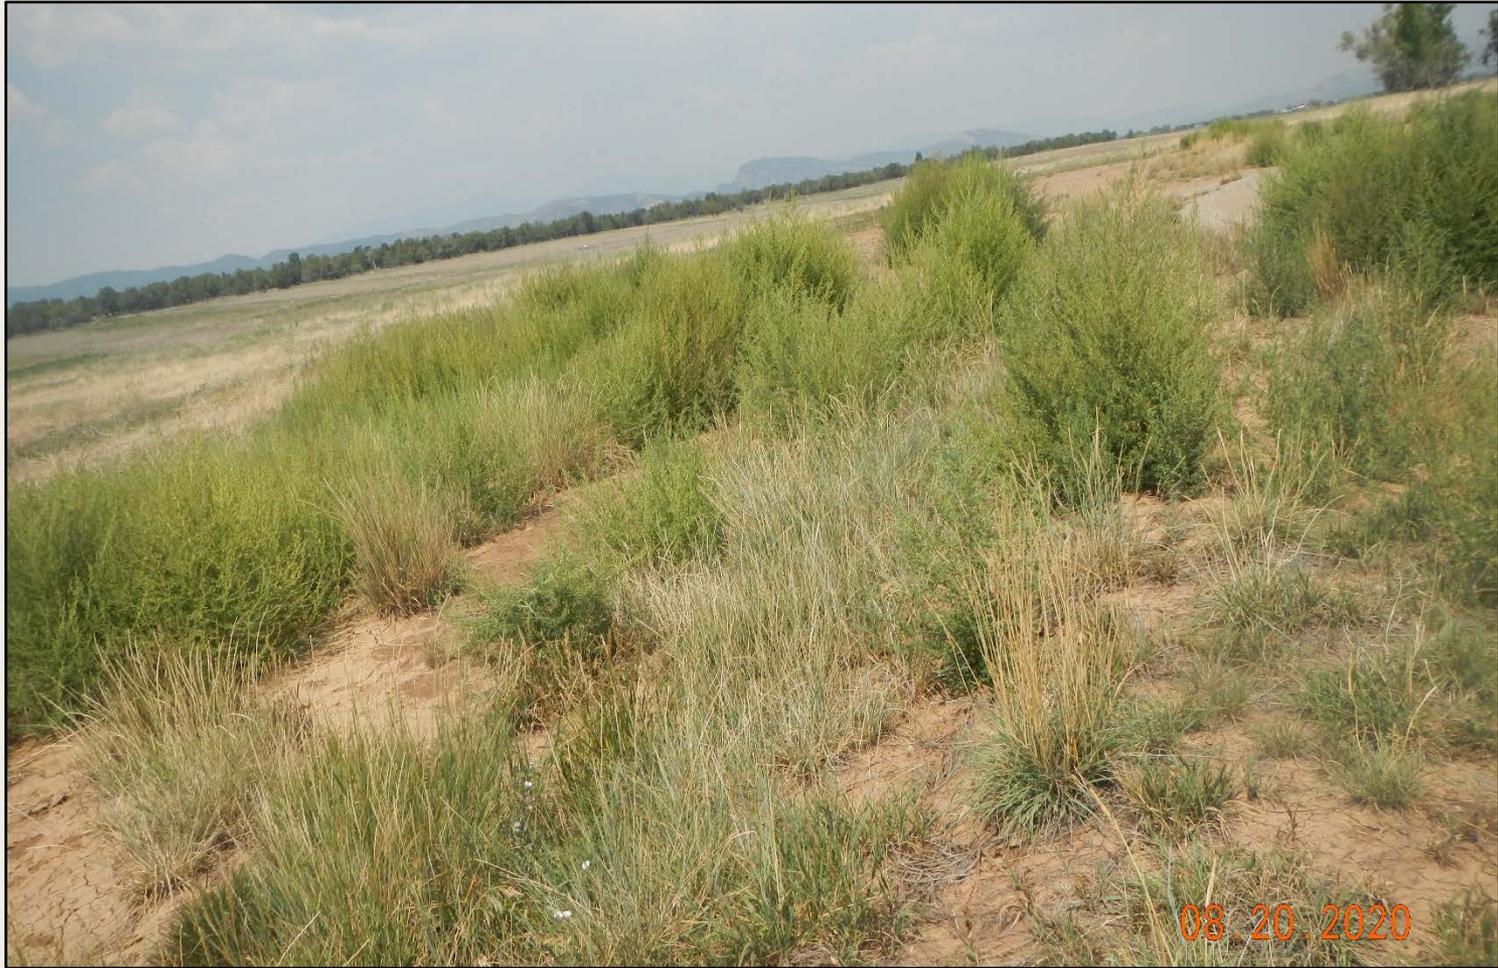
Photo 3. View of the western project area from the southwestern corner facing northward. Revegetation is progressing in portions with crested wheatgrass and western wheatgrass. Sparse revegetation remains in the recent remediation area within the western project area.

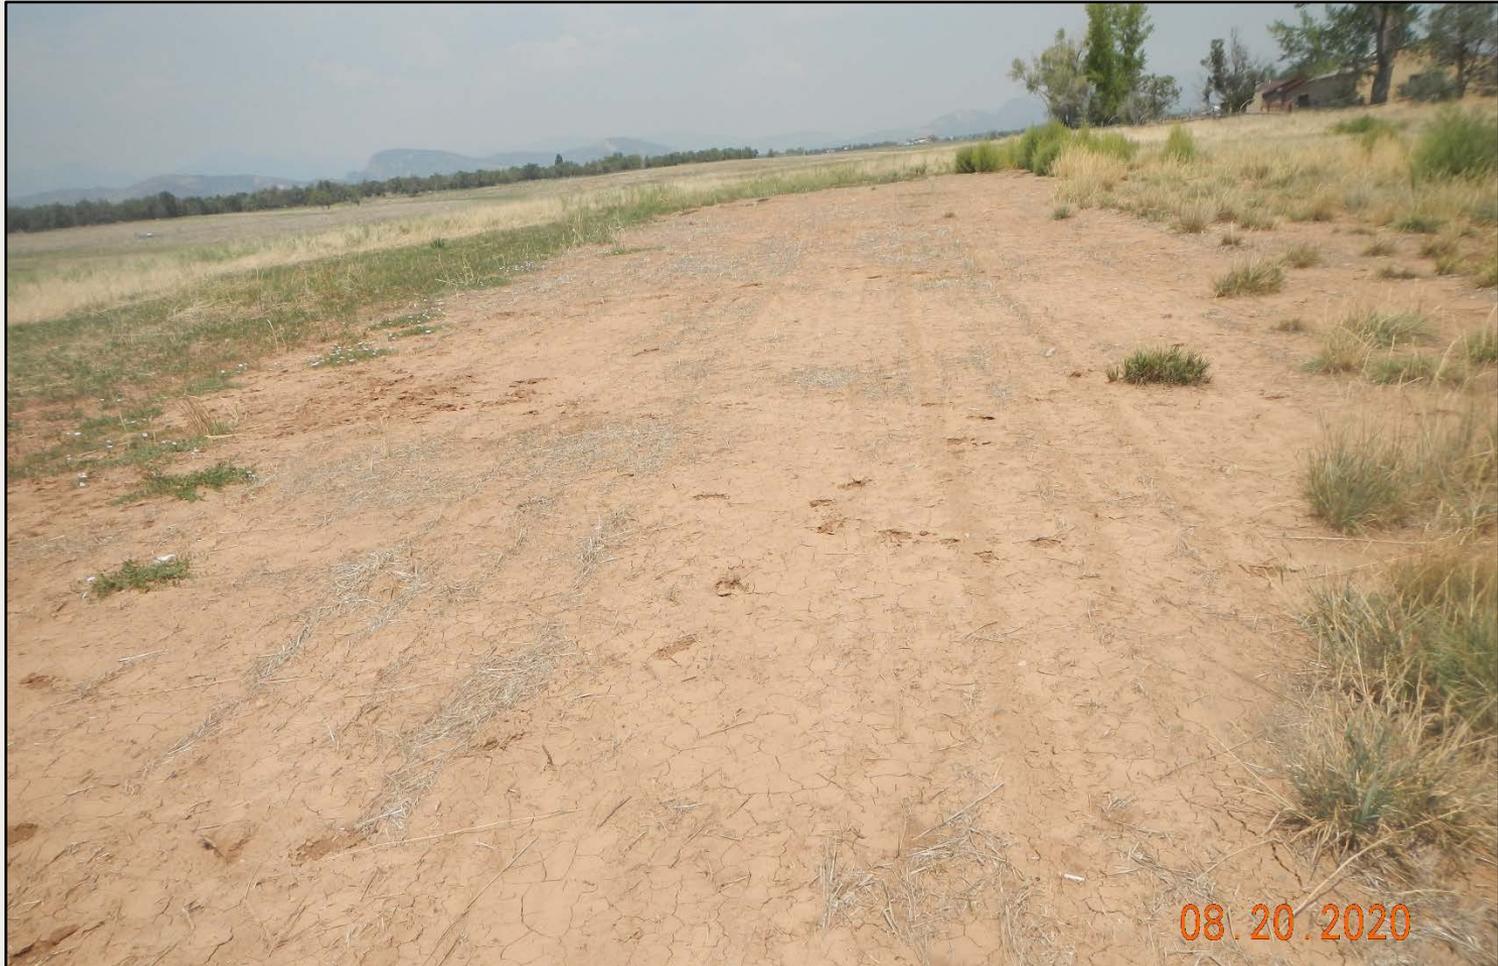
Photo 4. View of remediation area in the northwestern project area. Little desirable vegetation is becoming established here. Revegetation needs to be monitored and re-seeded if desirable vegetation is not becoming established.

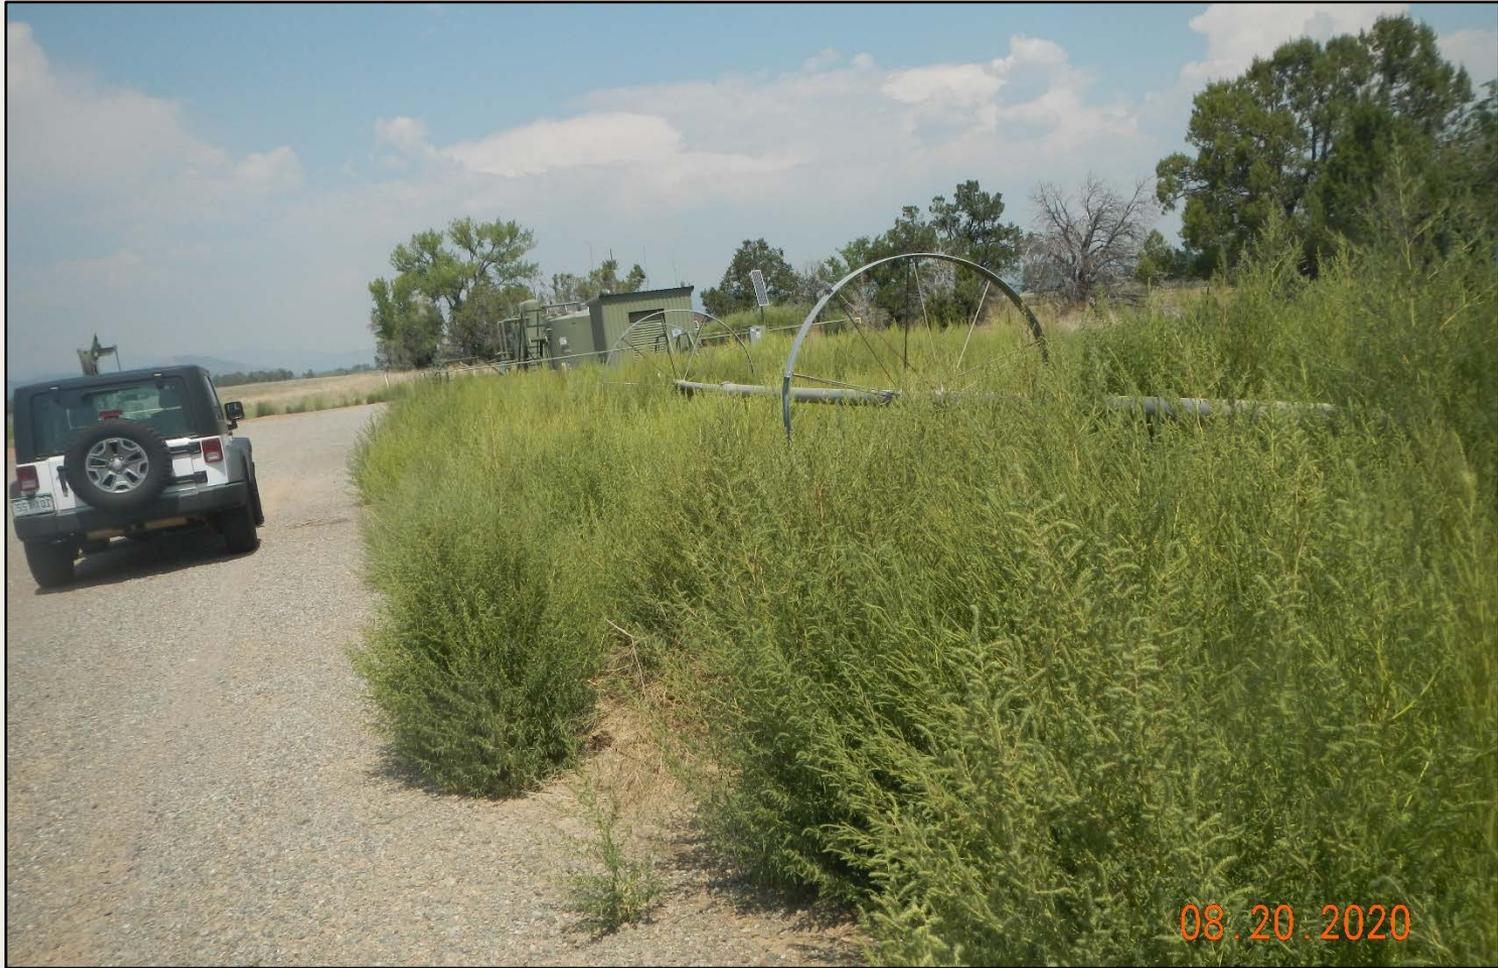
Photo 5. View of dense kochia up to 6-feet tall within the southeastern project area.

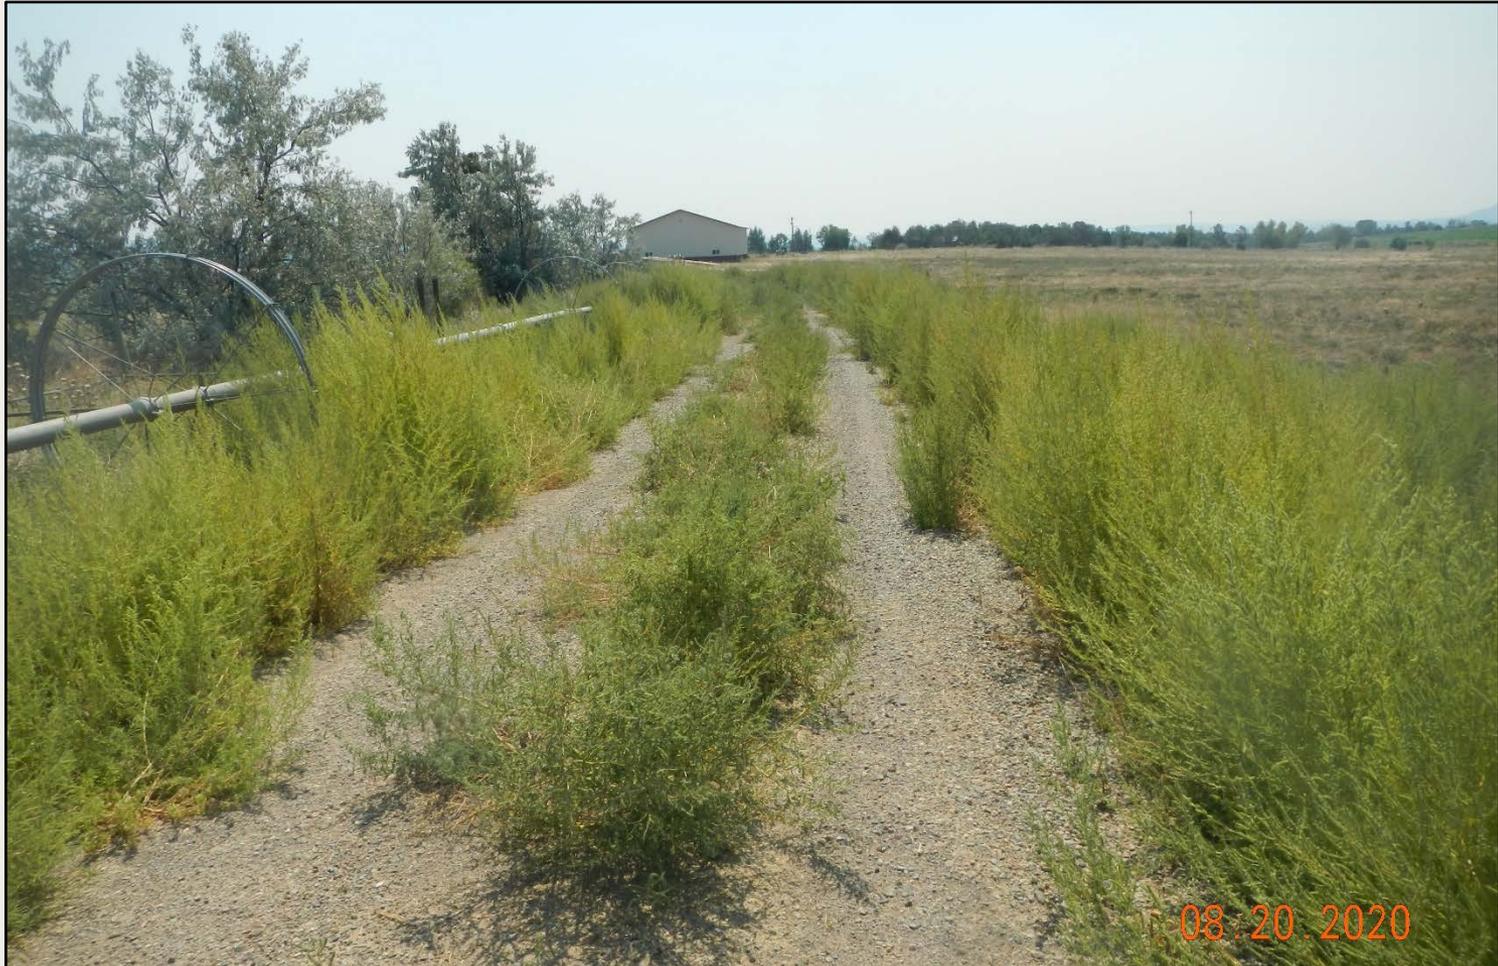
Photo 6. View of dense kochia growing along and within the access road, facing southward.

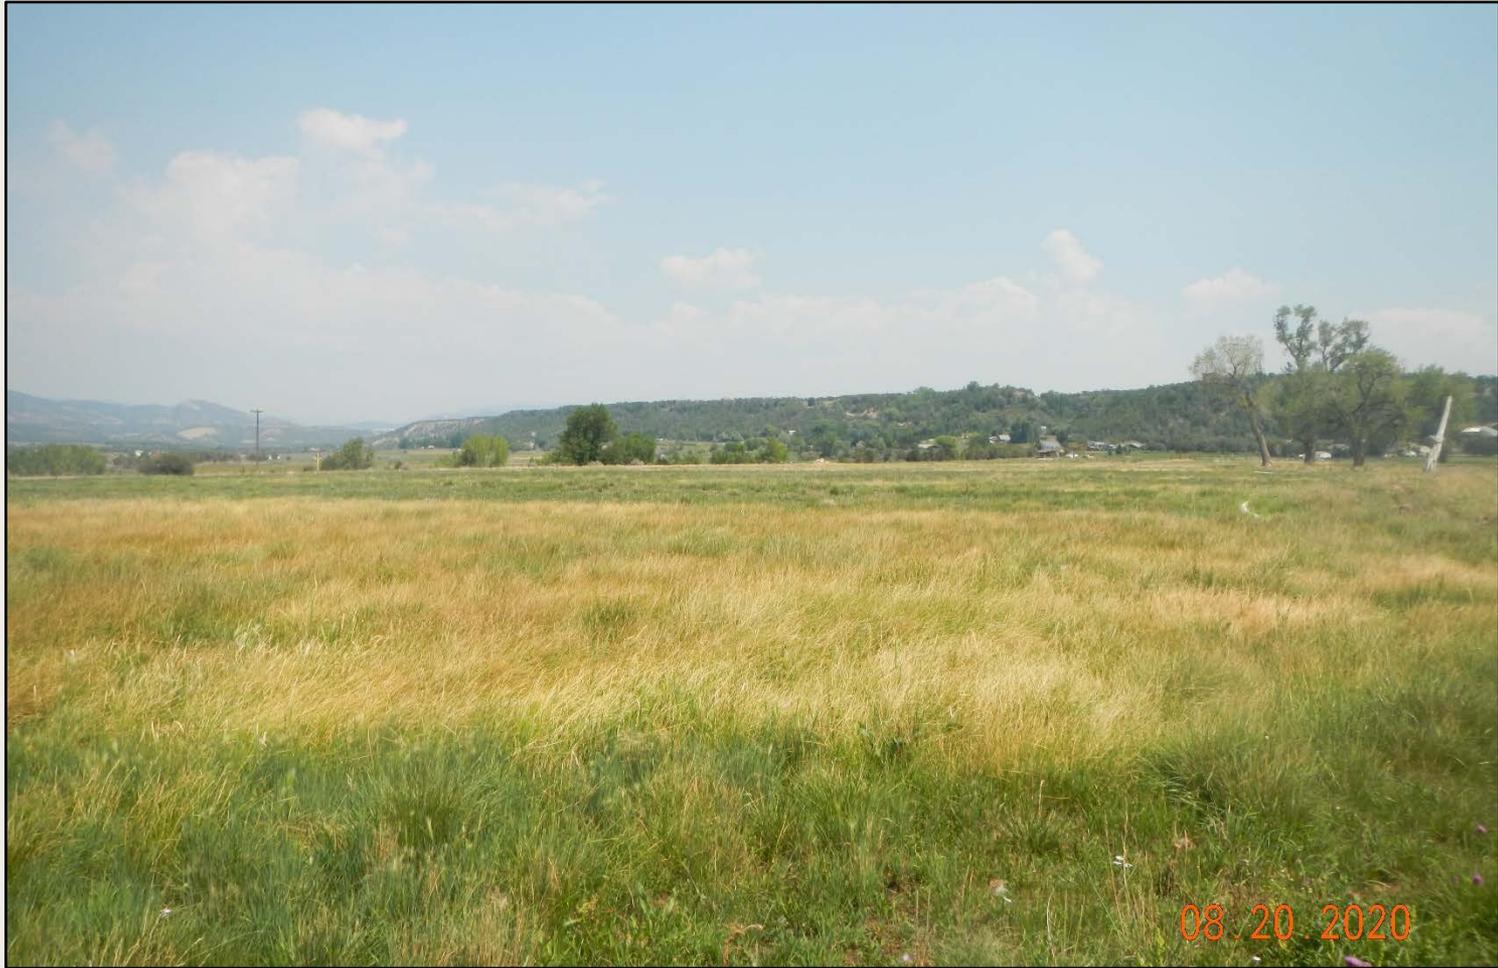
Photo 7. View of reference area comprised of irrigated grass field with grasses such as smooth brome, foxtail barley, and wheatgrasses.
