Reclamation Inspection

Operator: NOBLE ENERGY INC - #100322

Location ID: 287848

Location Name: CENTRALIZED LAND TREATMENT FACILITY

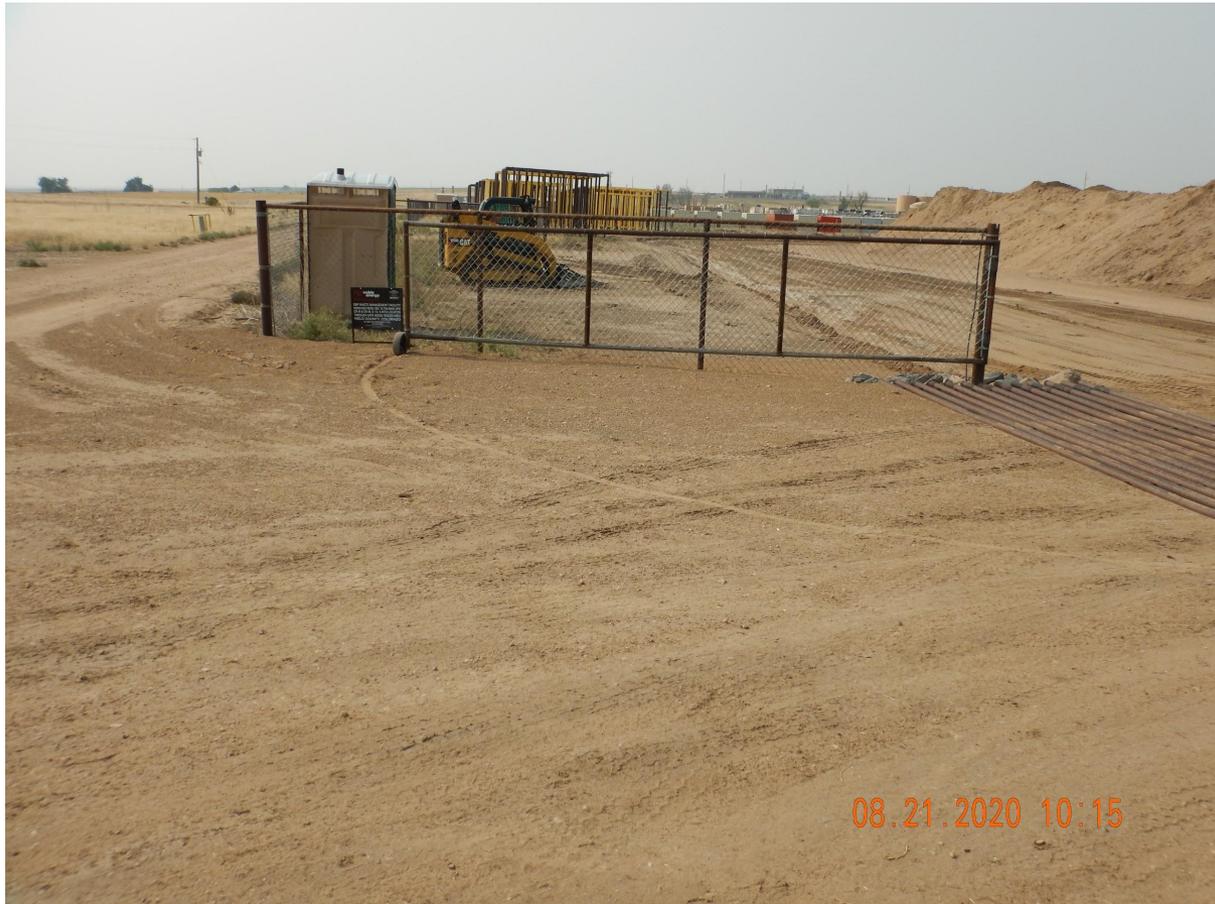
Photo 1. Photo taken from the gated entrance, facing South. Photo illustrates the Operator sign has been updated and entry is now secured.

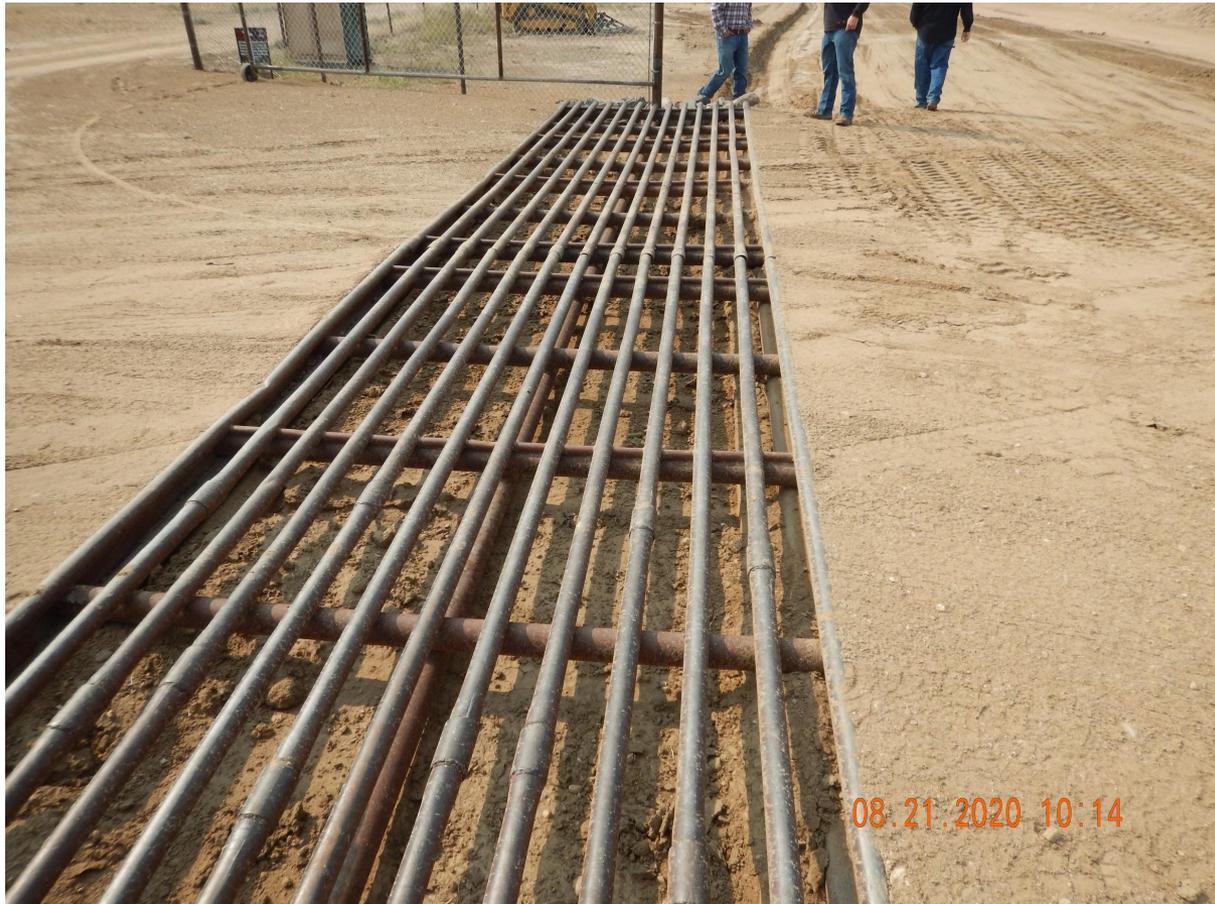
Photo 2. Photo taken from the gated entrance, facing South. Photo illustrates stormwater controls have been installed to manage stormwater that flows onto and off the location.

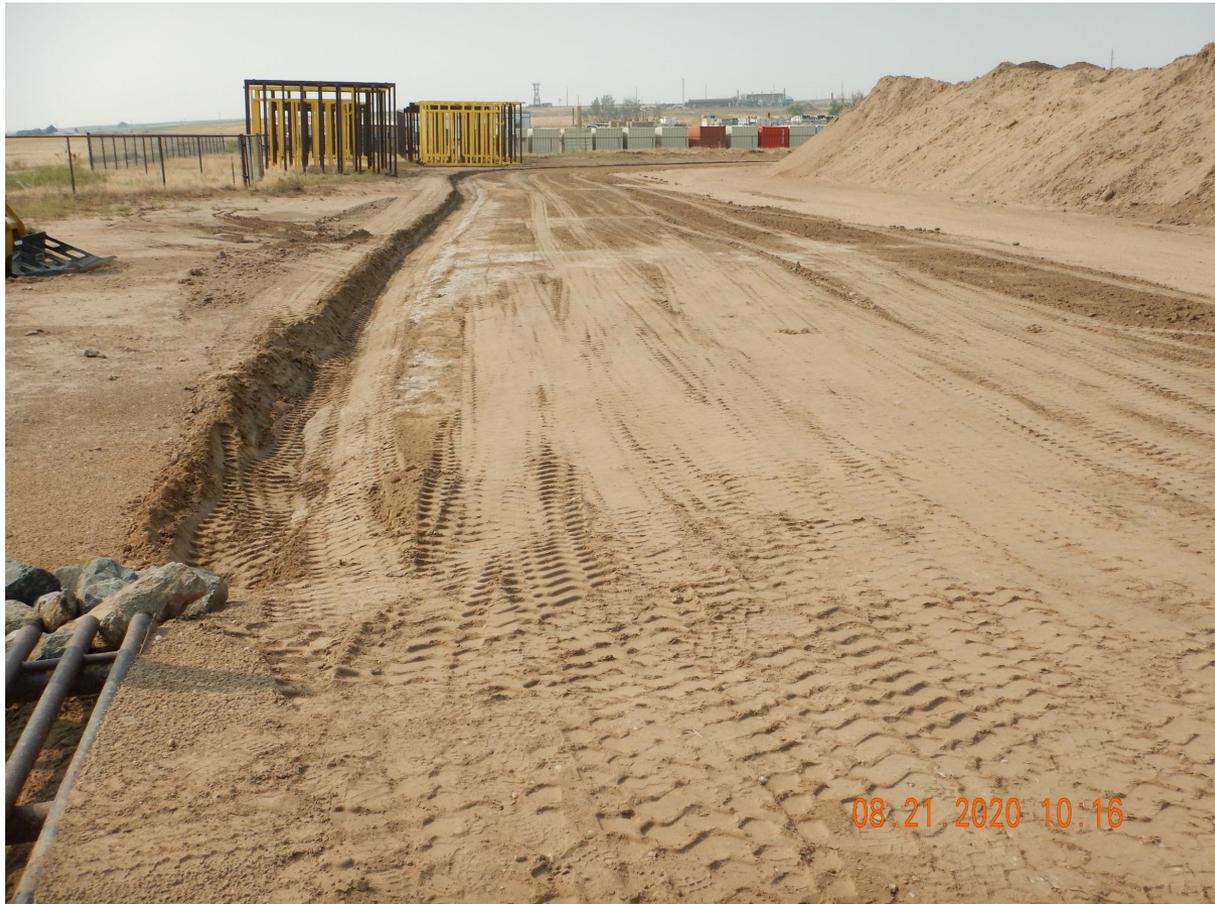
Photo 3. Photo taken from the gated entrance, facing South. Photo illustrates stormwater controls have been installed to manage stormwater that flows onto and off the location.

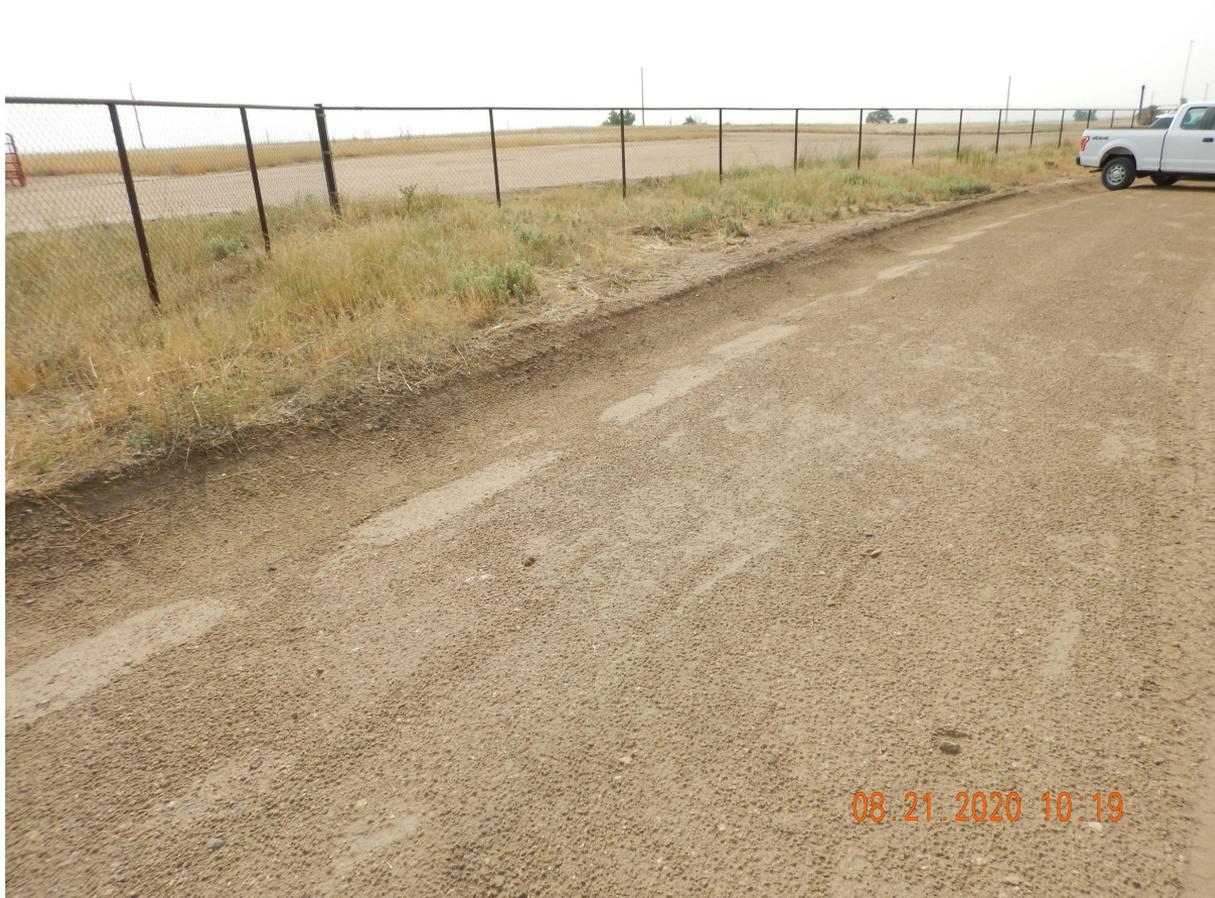
Photo 4. Photo taken from the northeastern location, facing South. Photo illustrates stormwater controls have been installed to manage stormwater that flows onto and off the location.

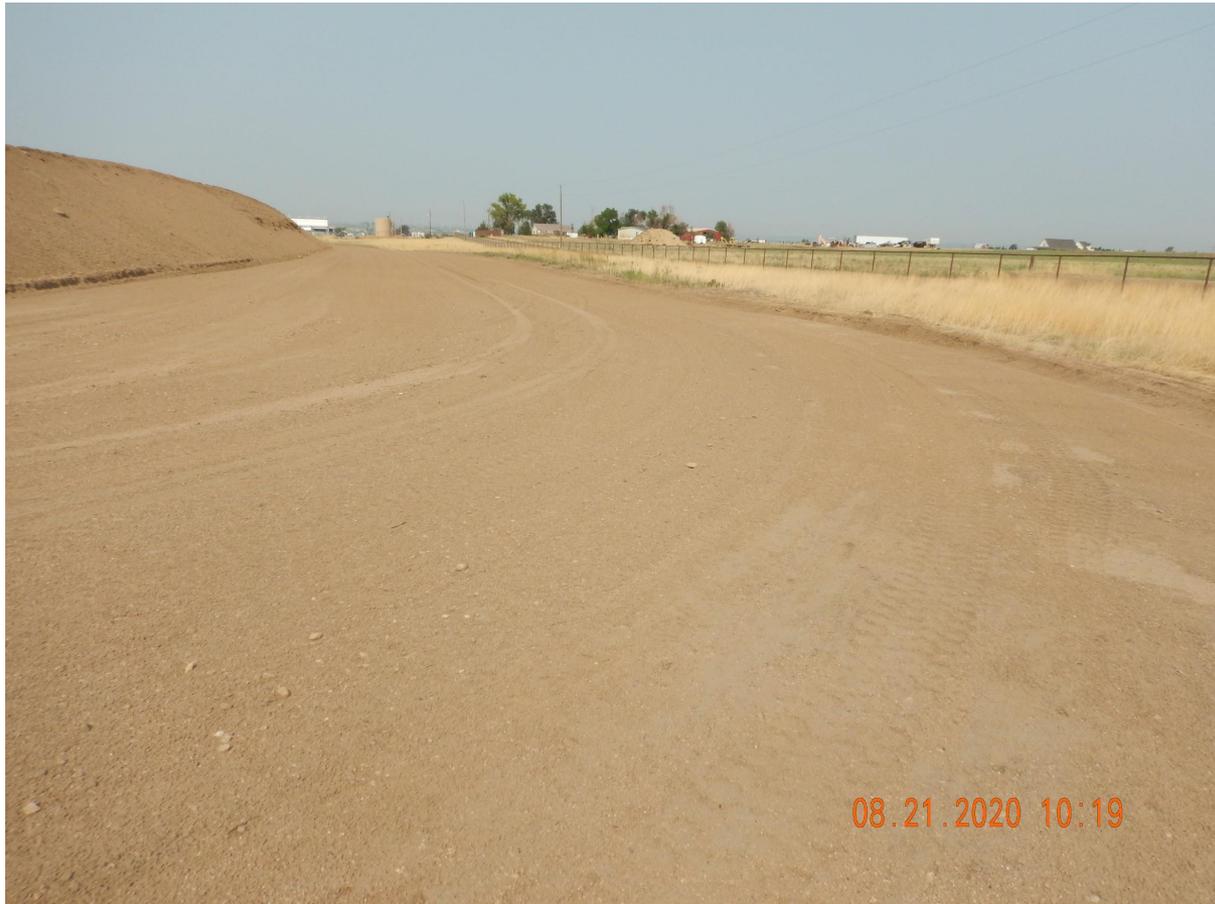
Photo 5. Photo taken from the northeastern location, facing West. Photo illustrates trash and debris has been removed.

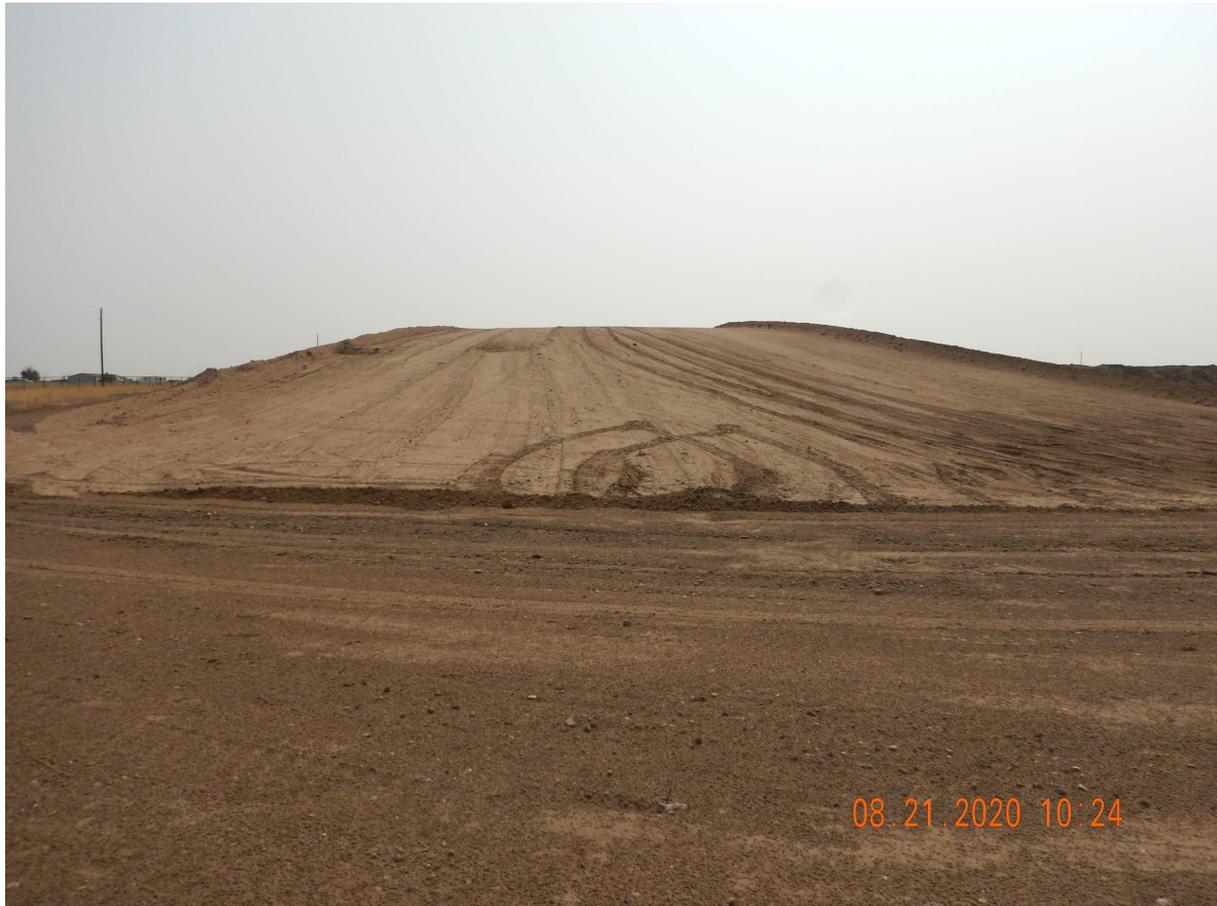
Photo 6. Photo taken from the northwestern location, facing East. Photo illustrates a stockpile of fill material used for interim reclamation locations.

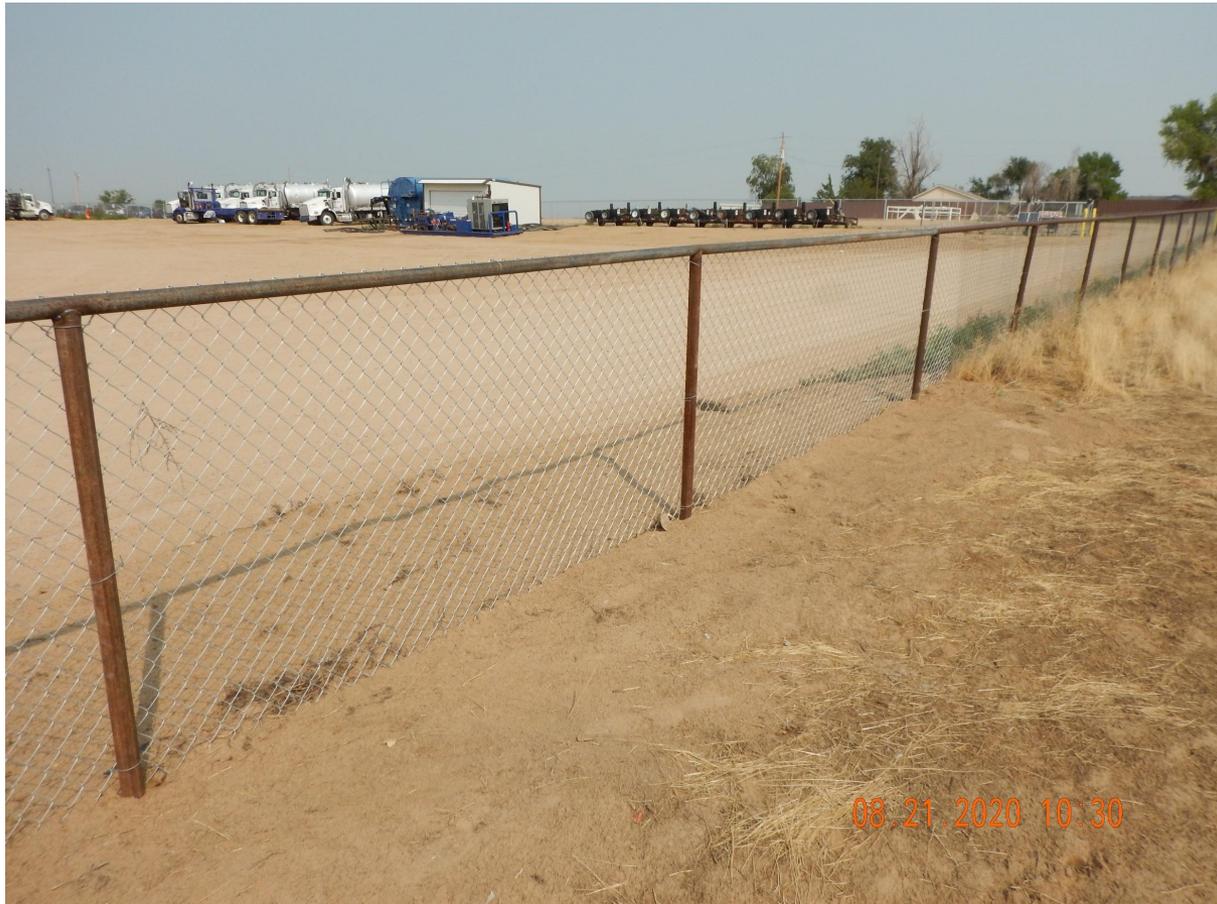
Photo 7. Photo taken from the northwestern location, facing Northwest. Photo illustrates a section of fence has been repaired.

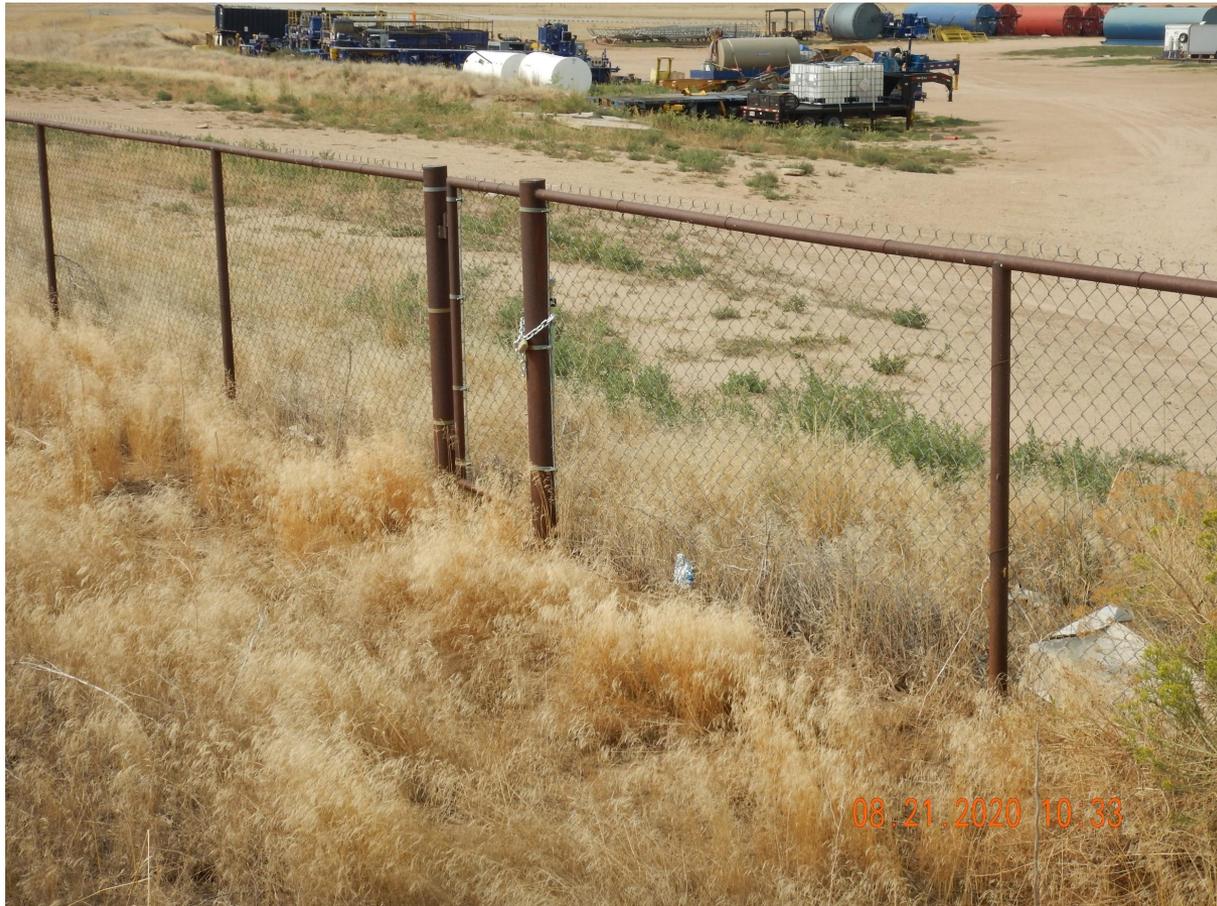
Photo 8. Photo taken from the western location, facing Southwest. Photo illustrates gate has been closed and secured.

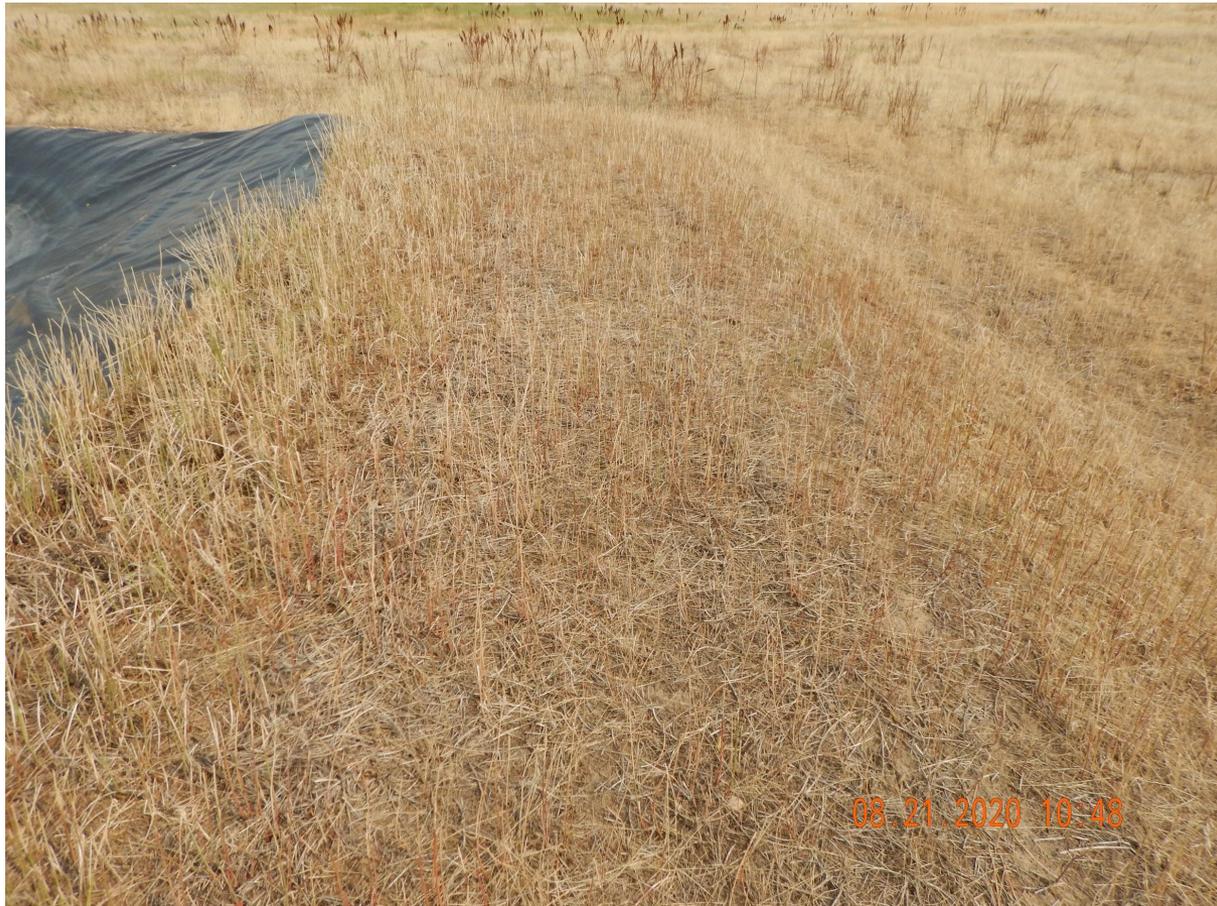
Photo 9. Photo taken from the northeastern detention pond located along the western boundary of the facility, facing North. Photo illustrates the noxious weed, Leafy spurge, has been controlled with herbicides.

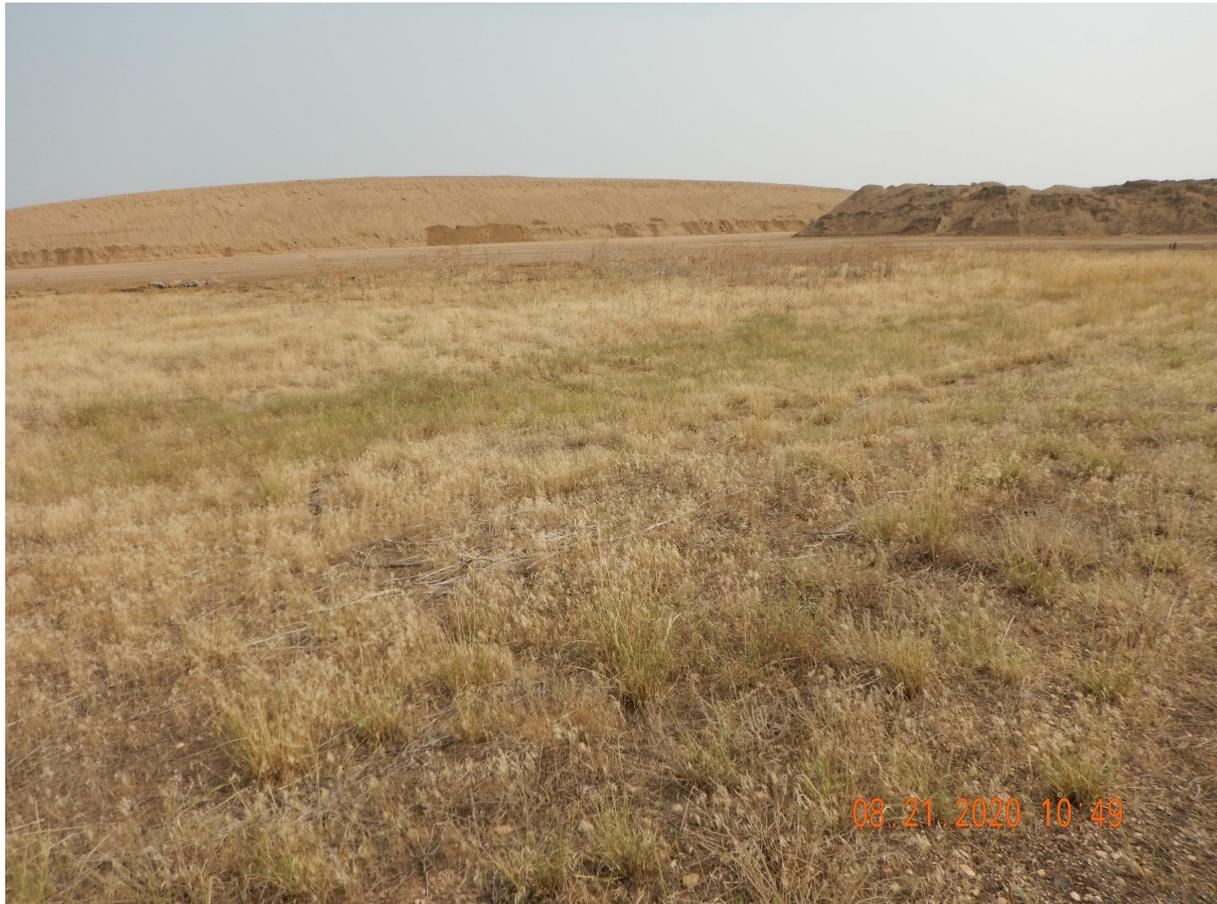
Photo 10. Photo taken from the central facility, facing Northeast. Photo illustrates the noxious weeds, Musk and Scotch thistle, have been controlled with herbicides.
