## Stormwater Inspection Report

<b>Operator:</b>	Laramie Energy, LLC
<b>Project:</b>	Cascade Creek
<b>Location:</b>	CC 697-16-16 Pad & Lower Loop Road
<b>Date:</b>	Thursday, August 20, 2020
<b>Weather:</b>	Overcast, Light Wind, Hi 99°, Lo 63°

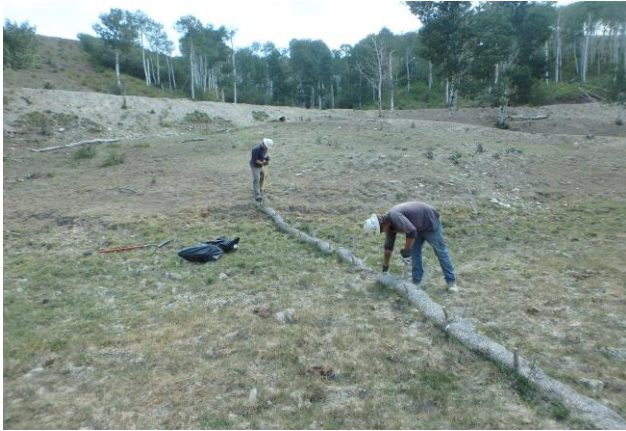
**Photo 1**

*Removing Wattle along Lower Loop Road*

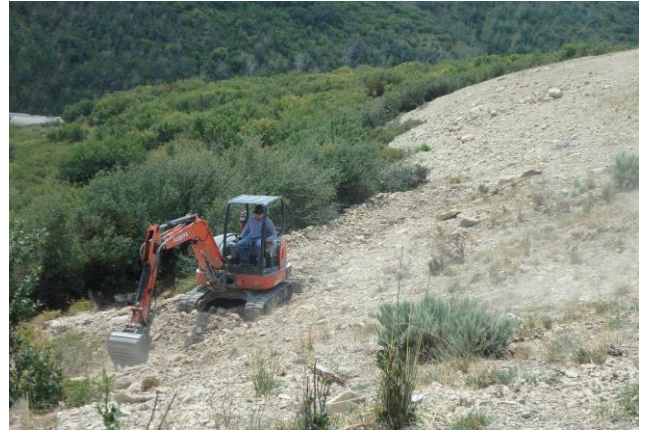
**Photo 2**

*Preparing the CC 697-16-16 for Wattle Installation*

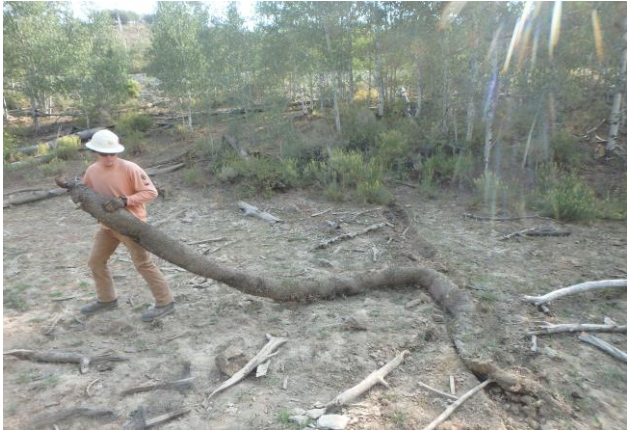
**Photo 1**

*Removing Wattle from the Lower Loop Road*

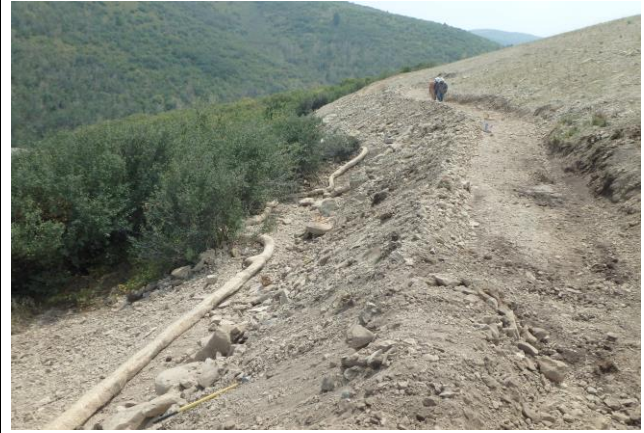
**Photo 2**

*Laying Out Wattle on CC 697-16-16 Pad*

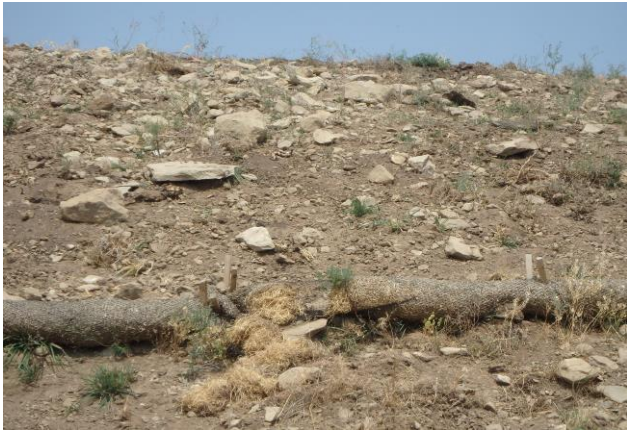
**Photo 3**

*Wattle Damaged on the CC 610-24-43*

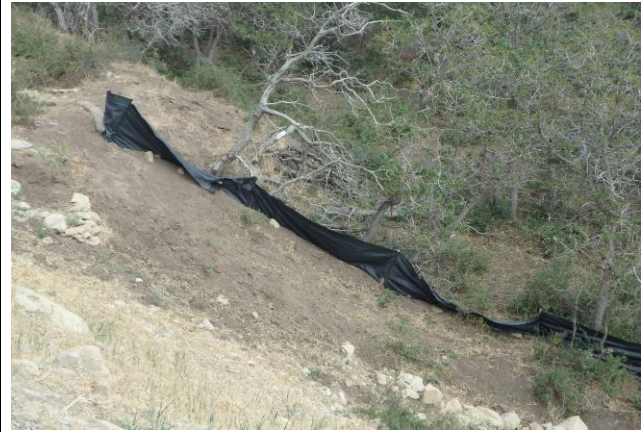
**Photo 4**

*Damaged Silt Fence on CC 610-21-41*

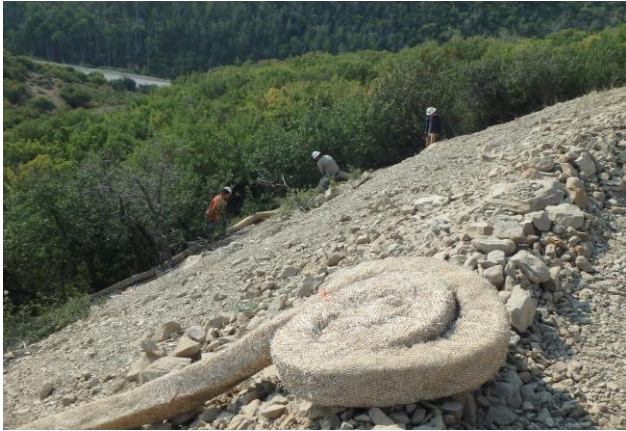
**Photo 1**

*Installing Excelsior Wattle on CC 697-16-16 Pad*

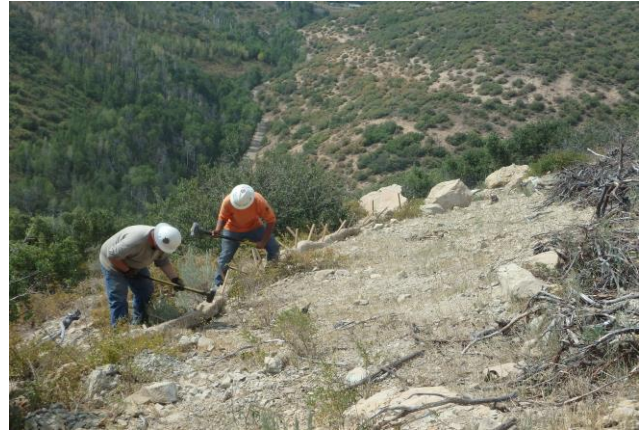
**Photo 2**

*Installing Excelsior Wattle on CC 697-16-16 Pad*

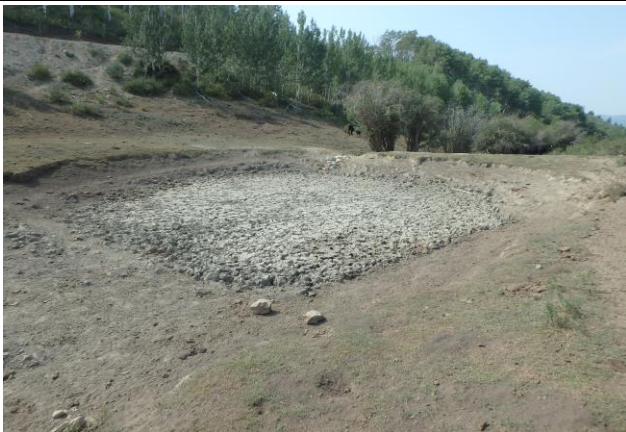
**Photo 3**

*Stock Pond on Lower Loop Road before Cleaned*

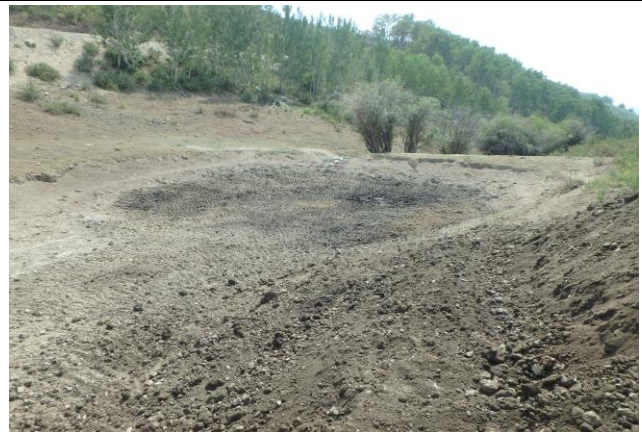
**Photo 4**

*Stock Pond on Lower Loop Road after Cleaned*

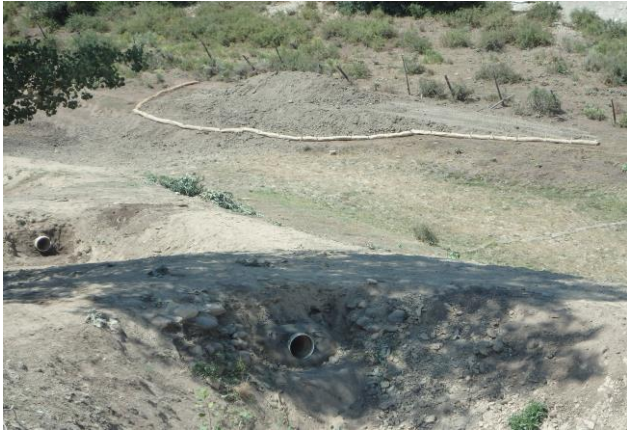
**Photo 1**

*BMPs Installed Below the Lower Loop Road*

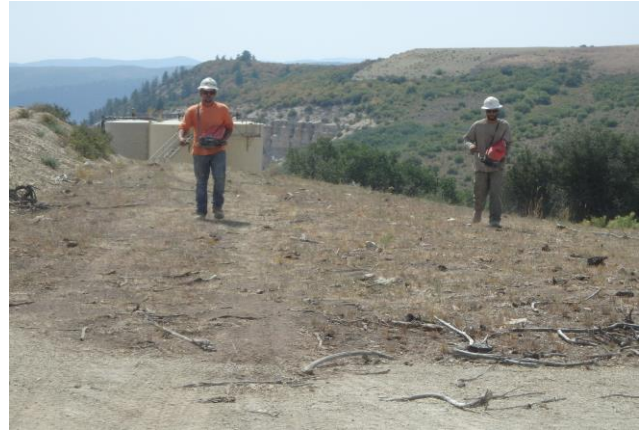
**Photo 2**

*Seeding the Northern End of CC 697-16-16 Pad*

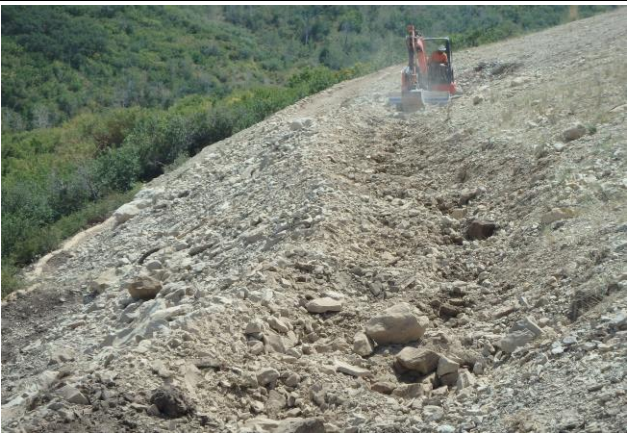
**Photo 3**

*Pockmarking Previously Installed Water Bars*

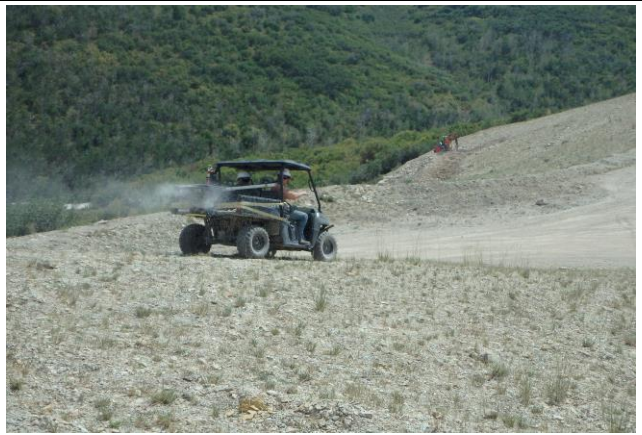
**Photo 4**

*Spreading Fertilizer on the CC 697-16-16 Pad*
