COLORADO
Oil & Gas Conservation
Commission
Department of Natural Resources

WRD Unit 29-33

API: 05-103-09920

Inspection: 700403078

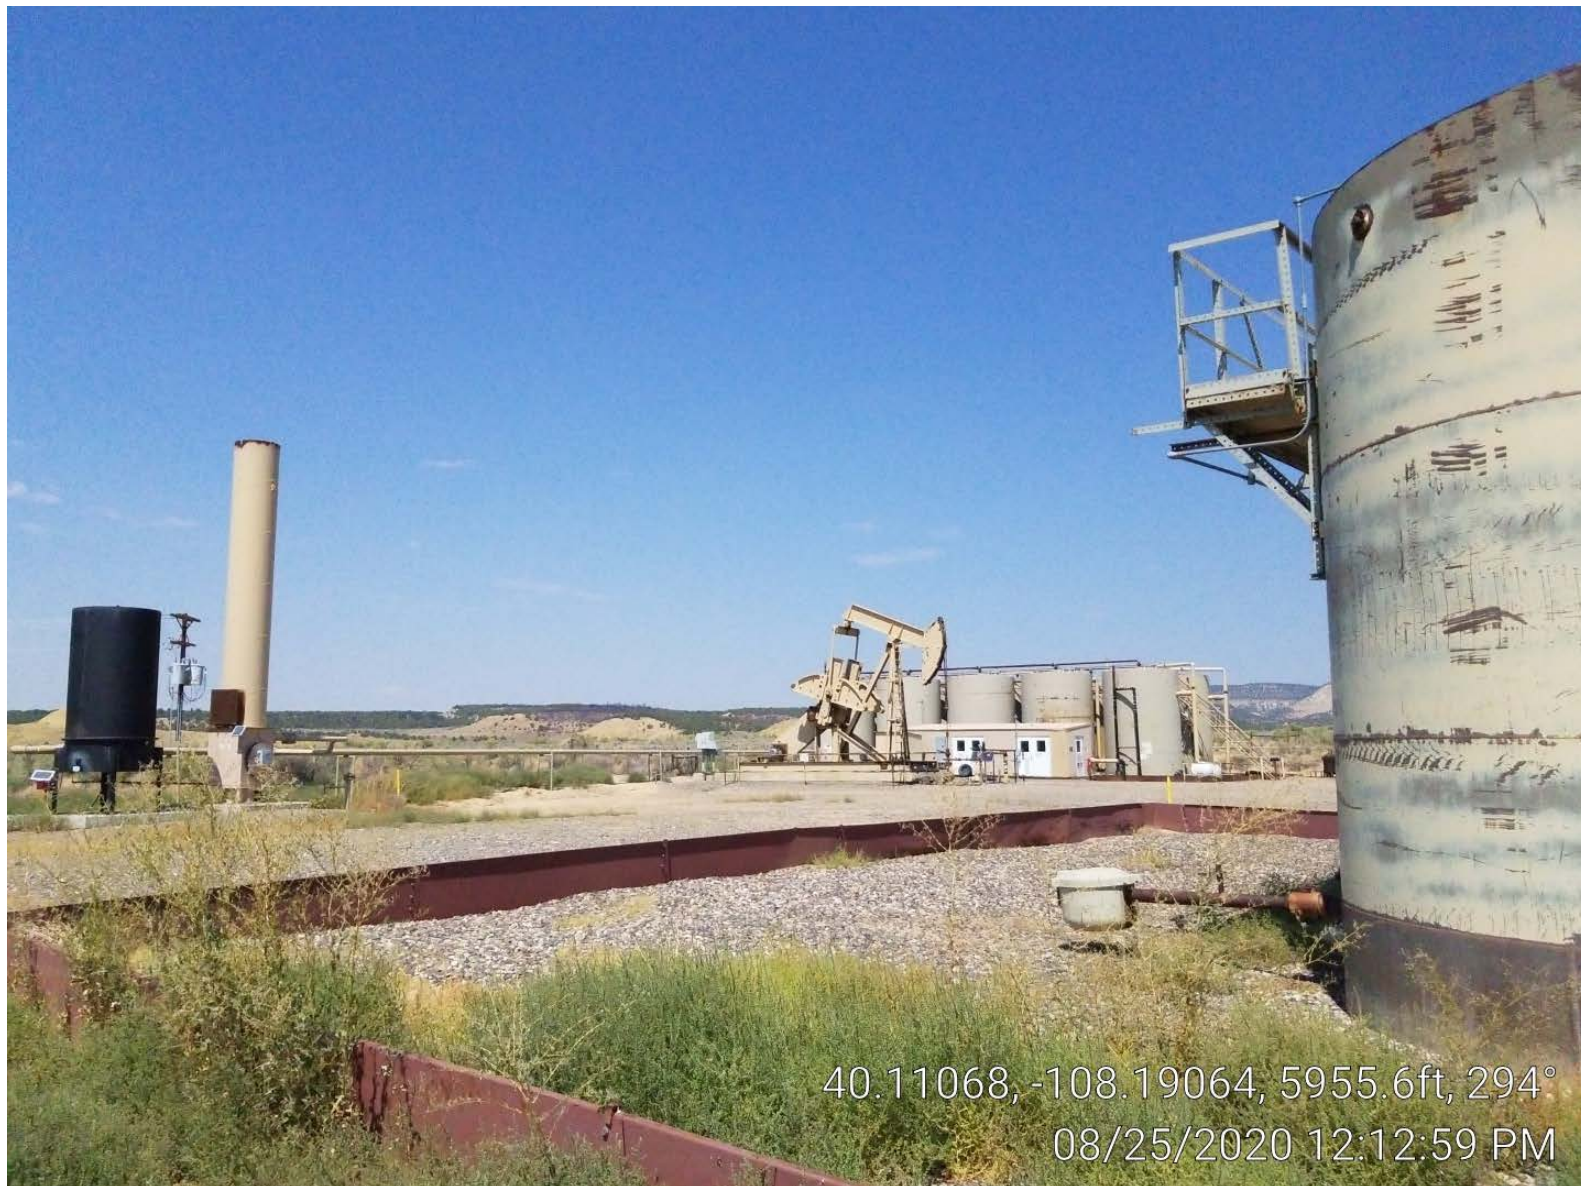
Photo 1. Location.

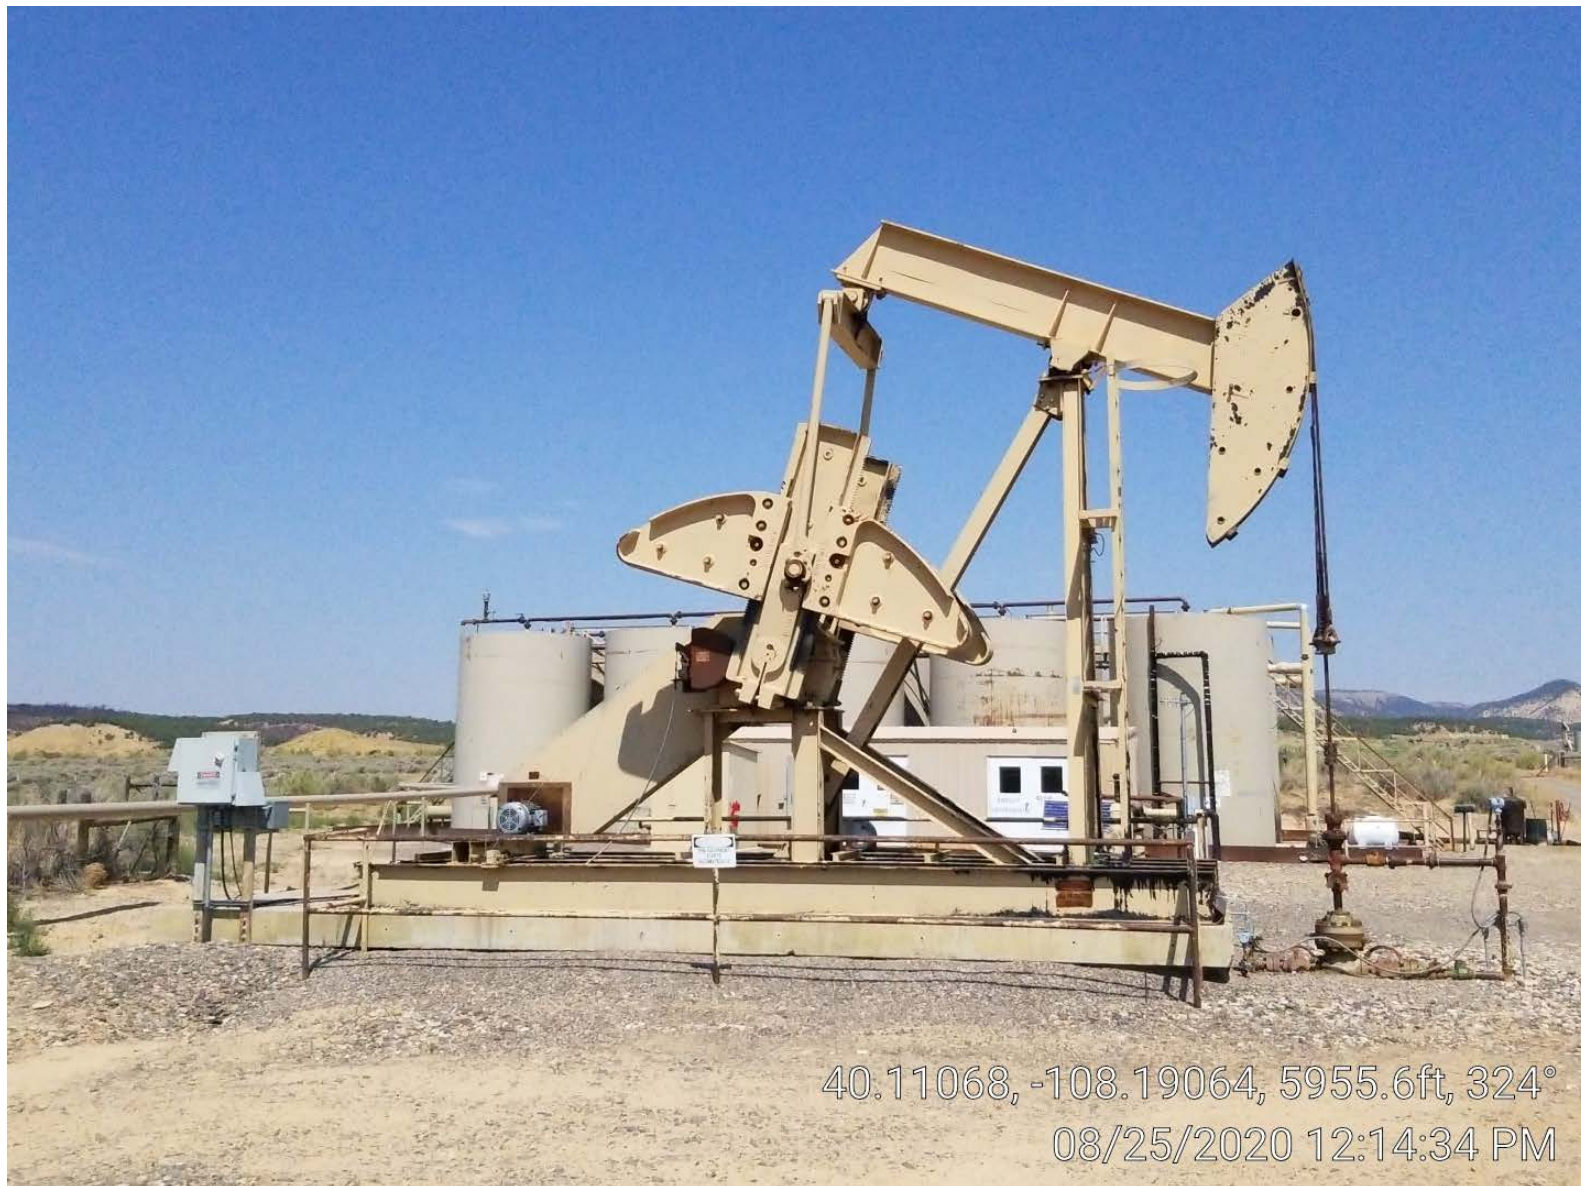
Photo 2. Pump jack.

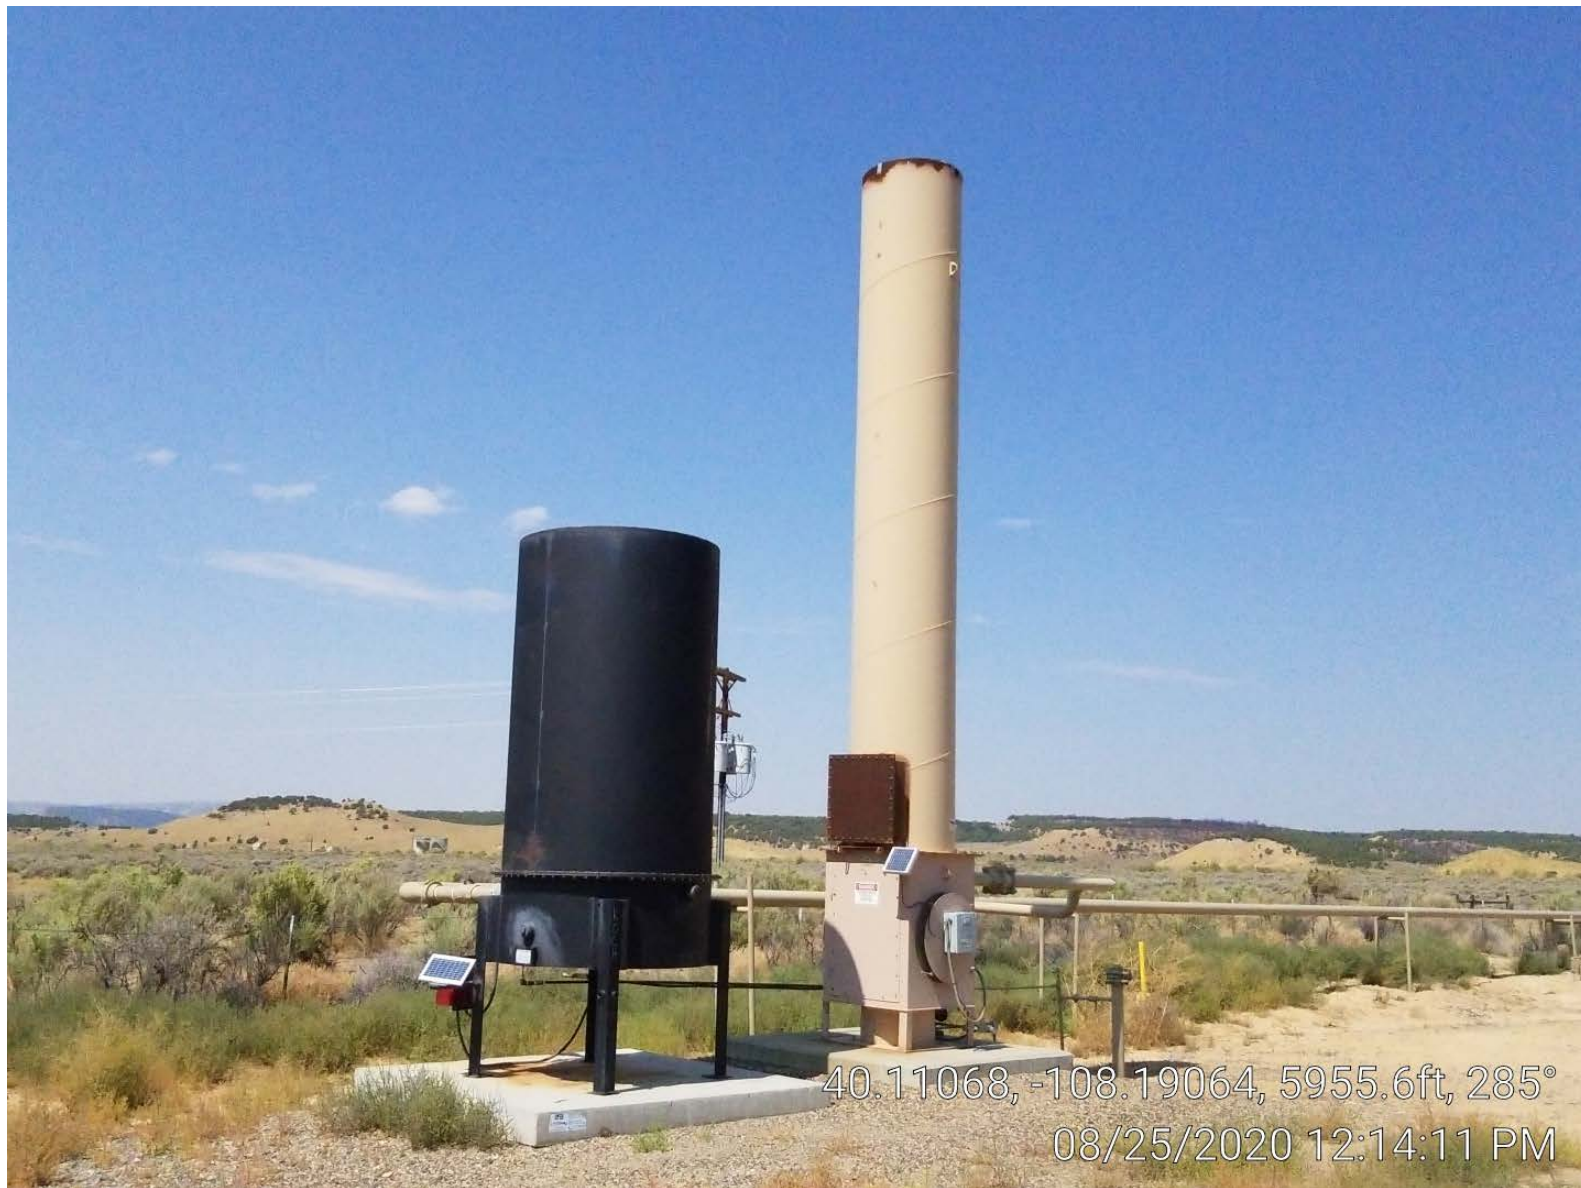
Photo 3. Emission control devices.

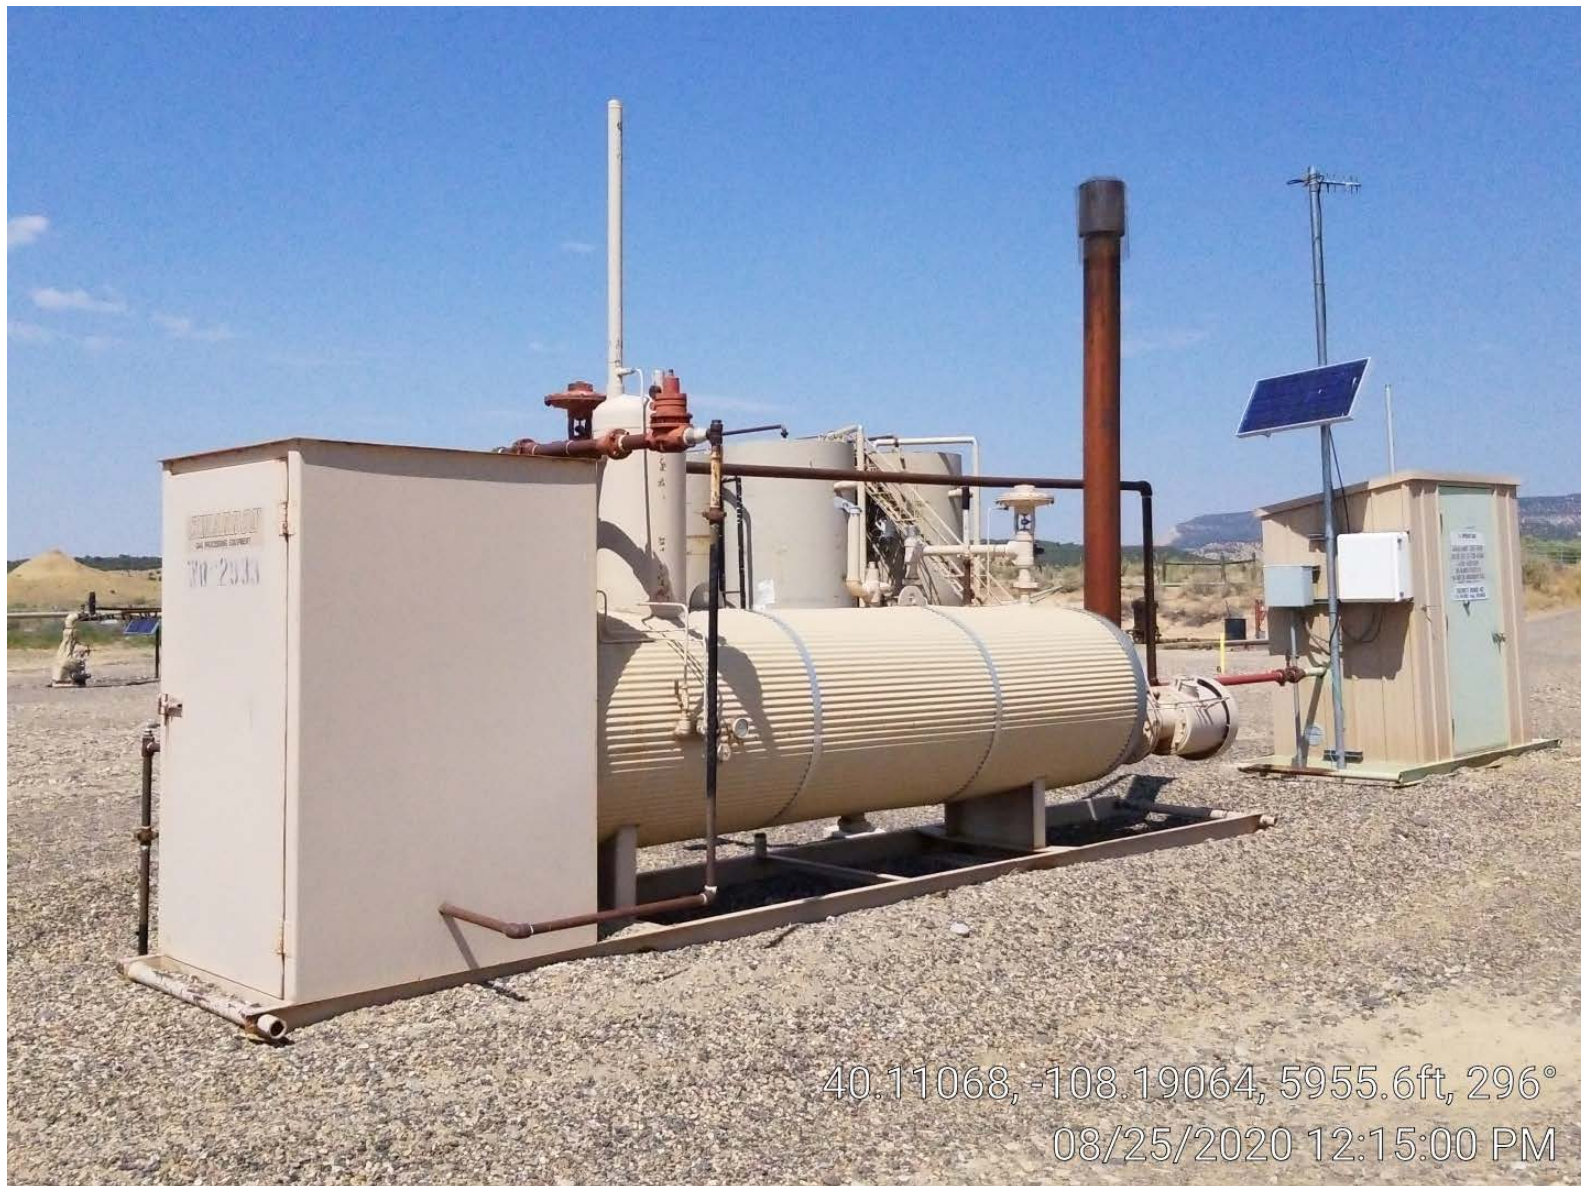
Photo 4. Separator & meter building.

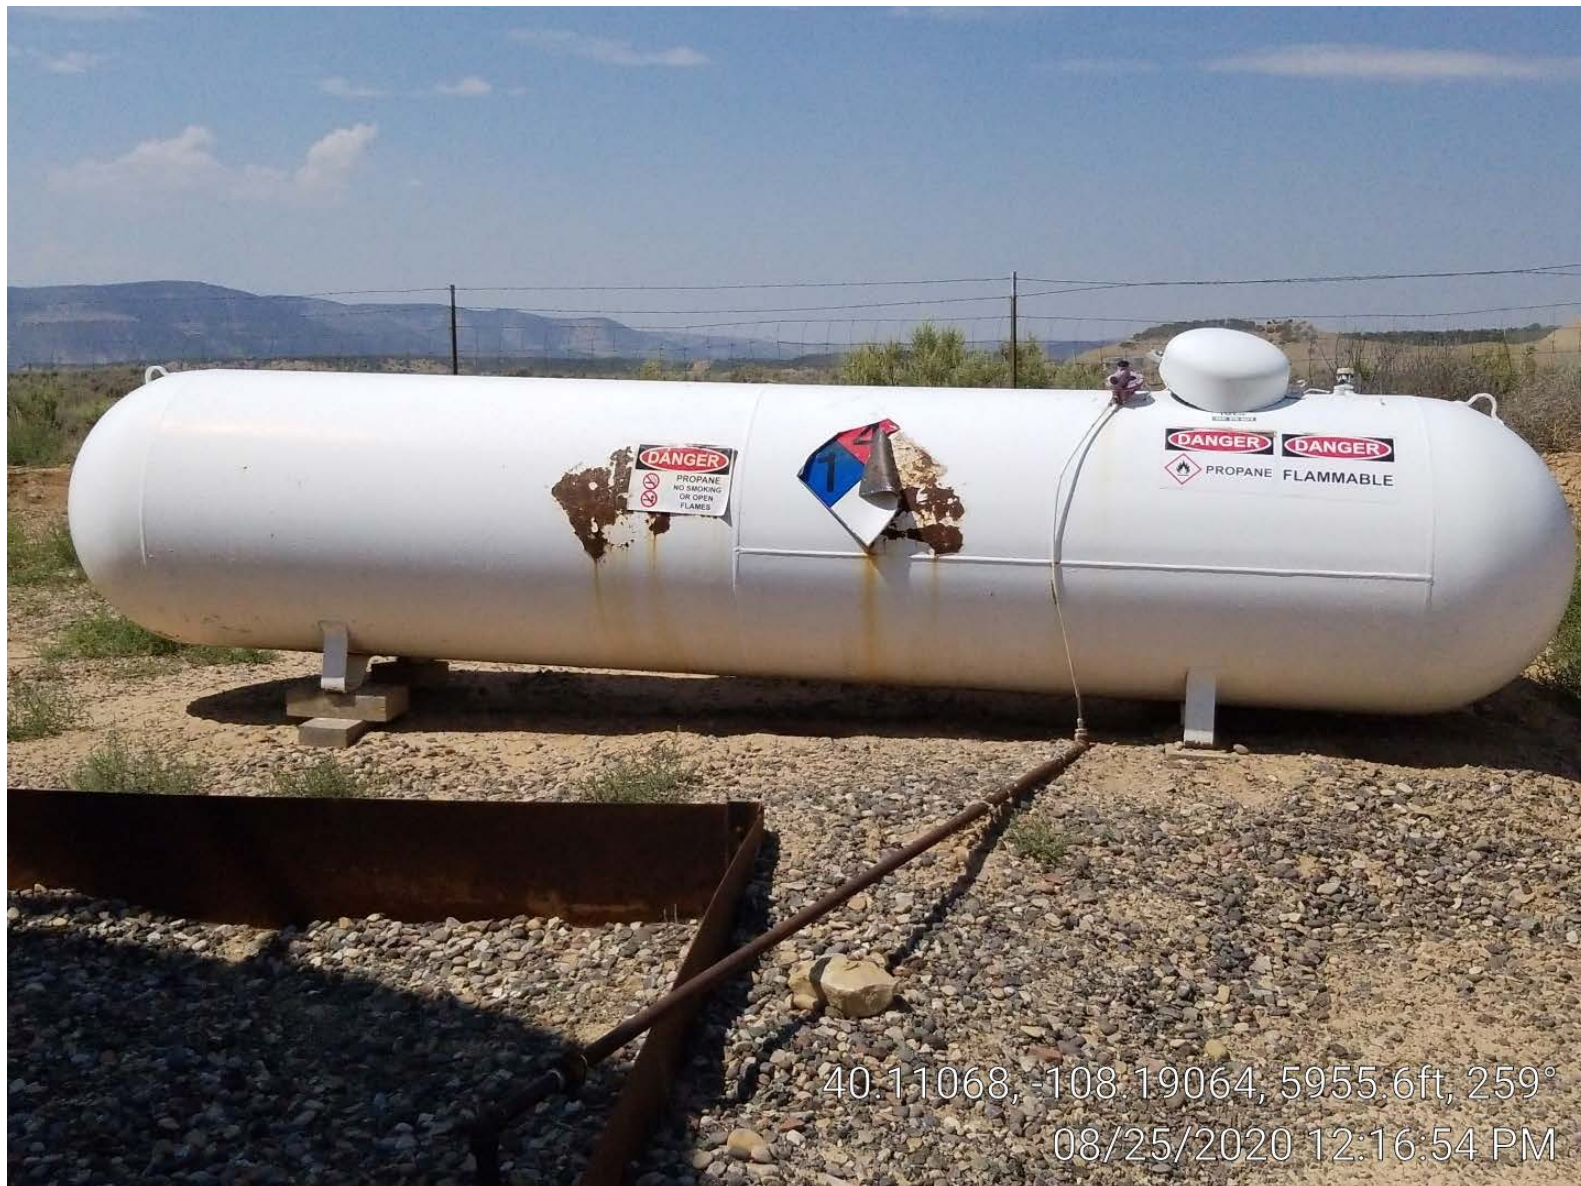
Photo 5. Propane tank.

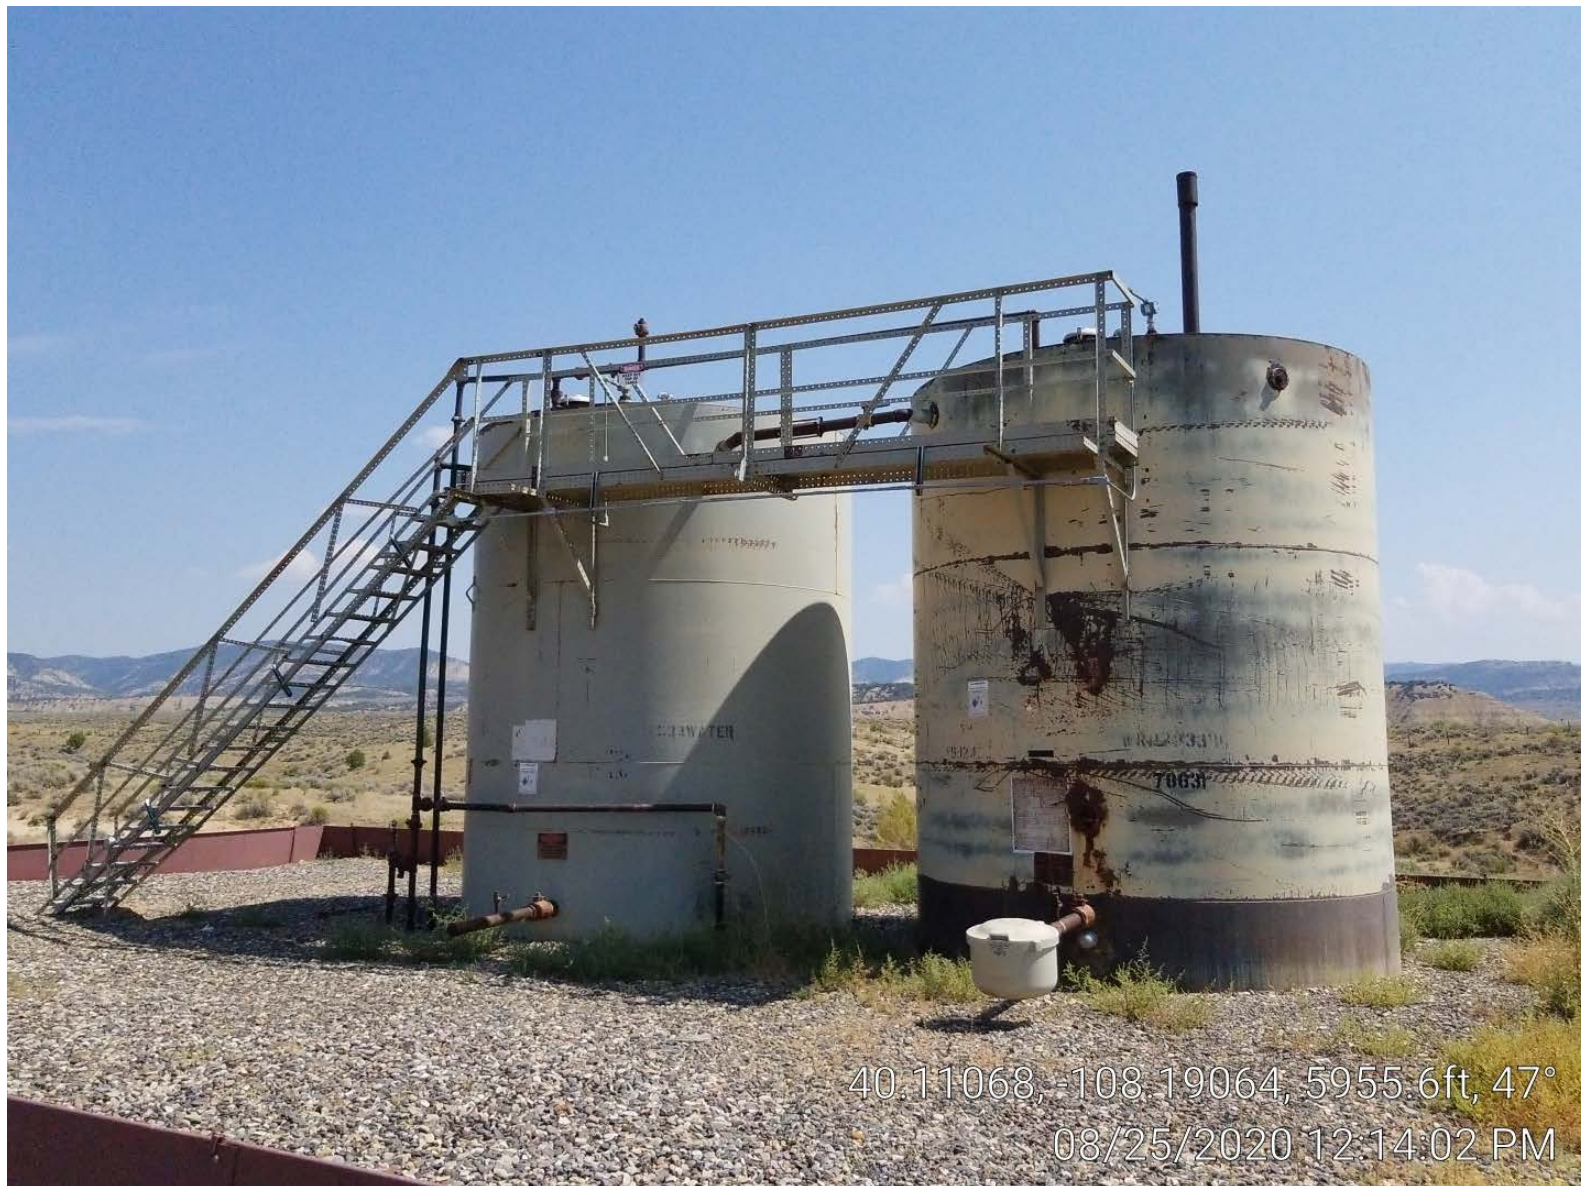
Photo 6. Tanks.

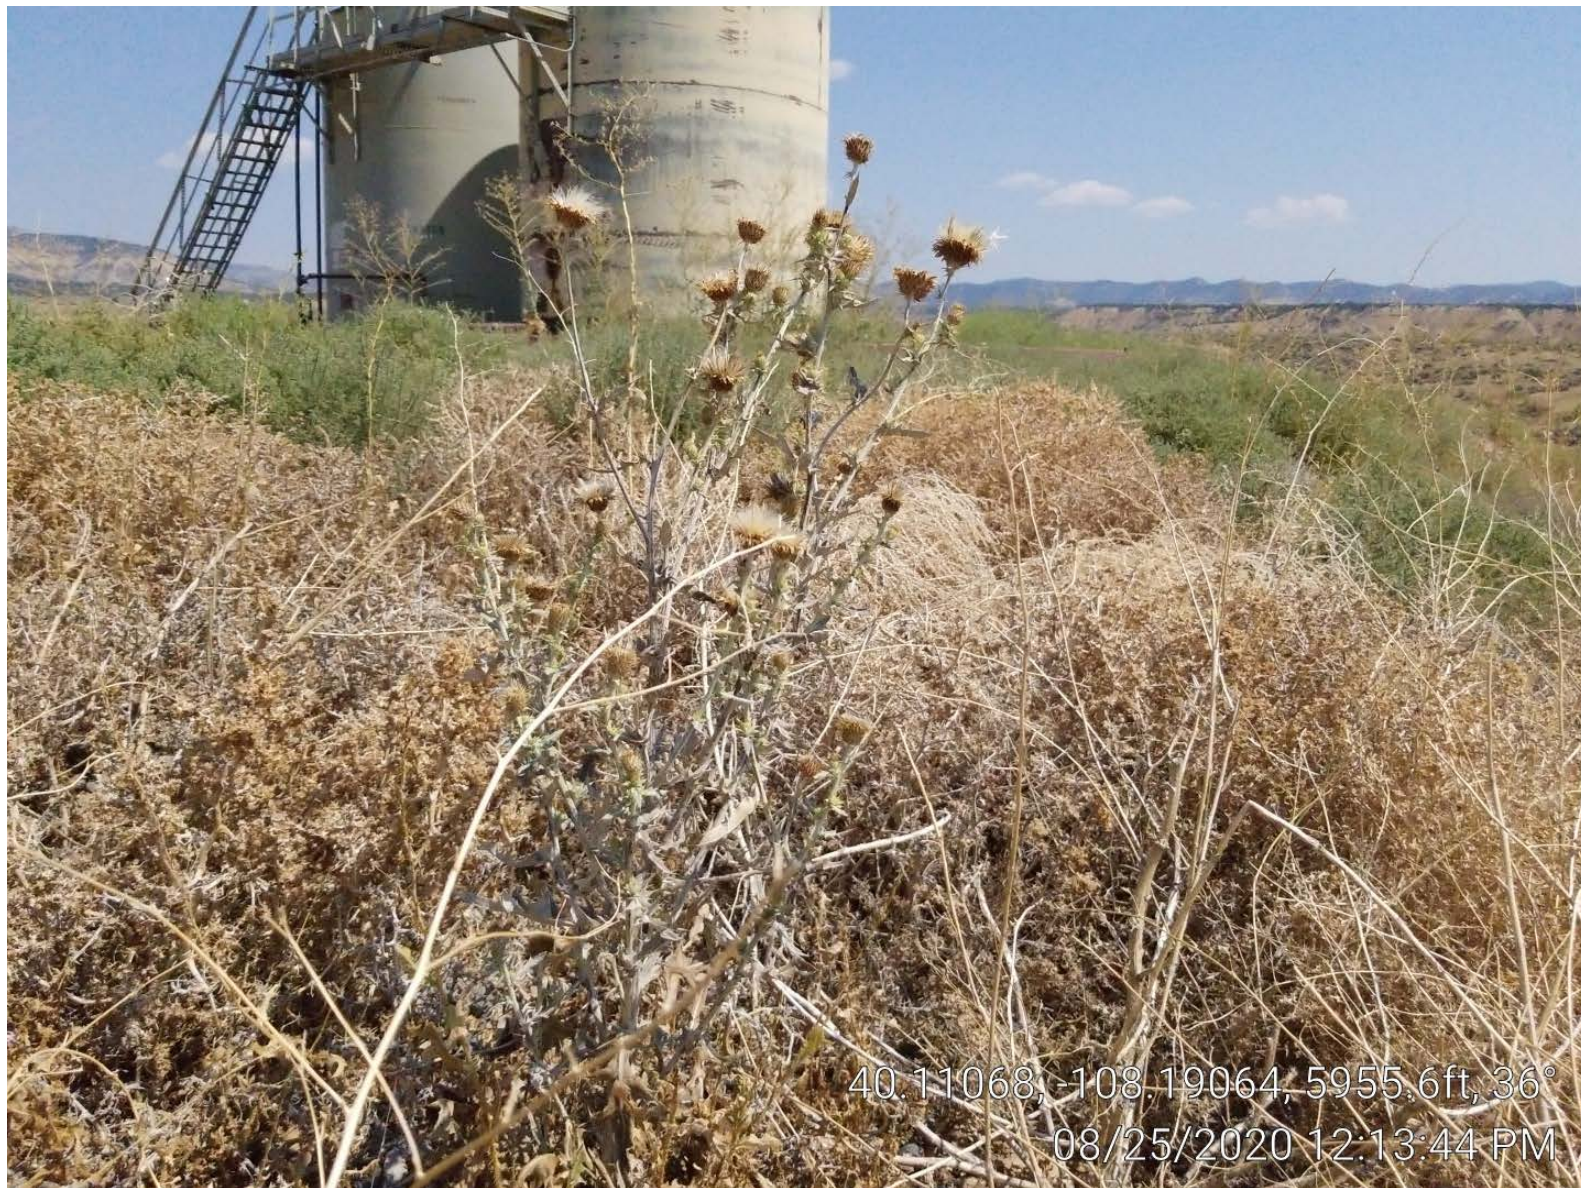
Photo 10. Thistle on location.

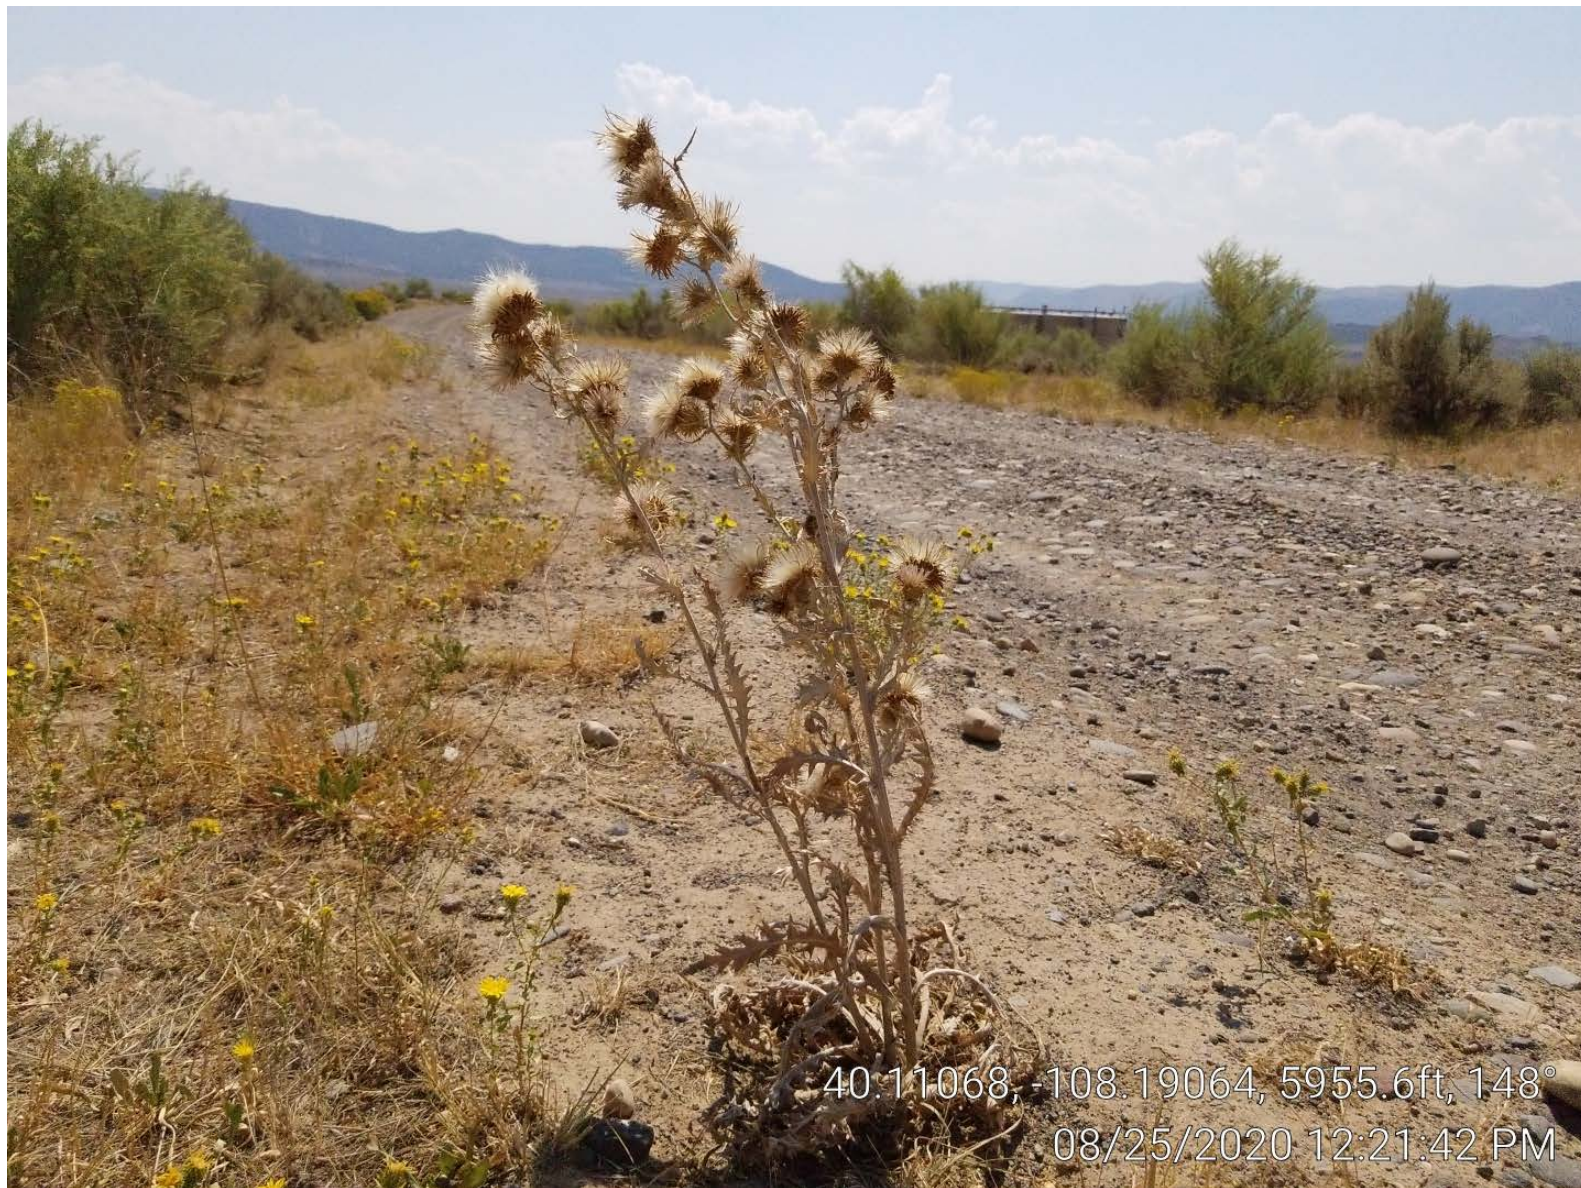
Photo 11. Thistle on road side.
