Inspection Photos
Operator: BP America
API: 067-08394
Date: 8/25/2020

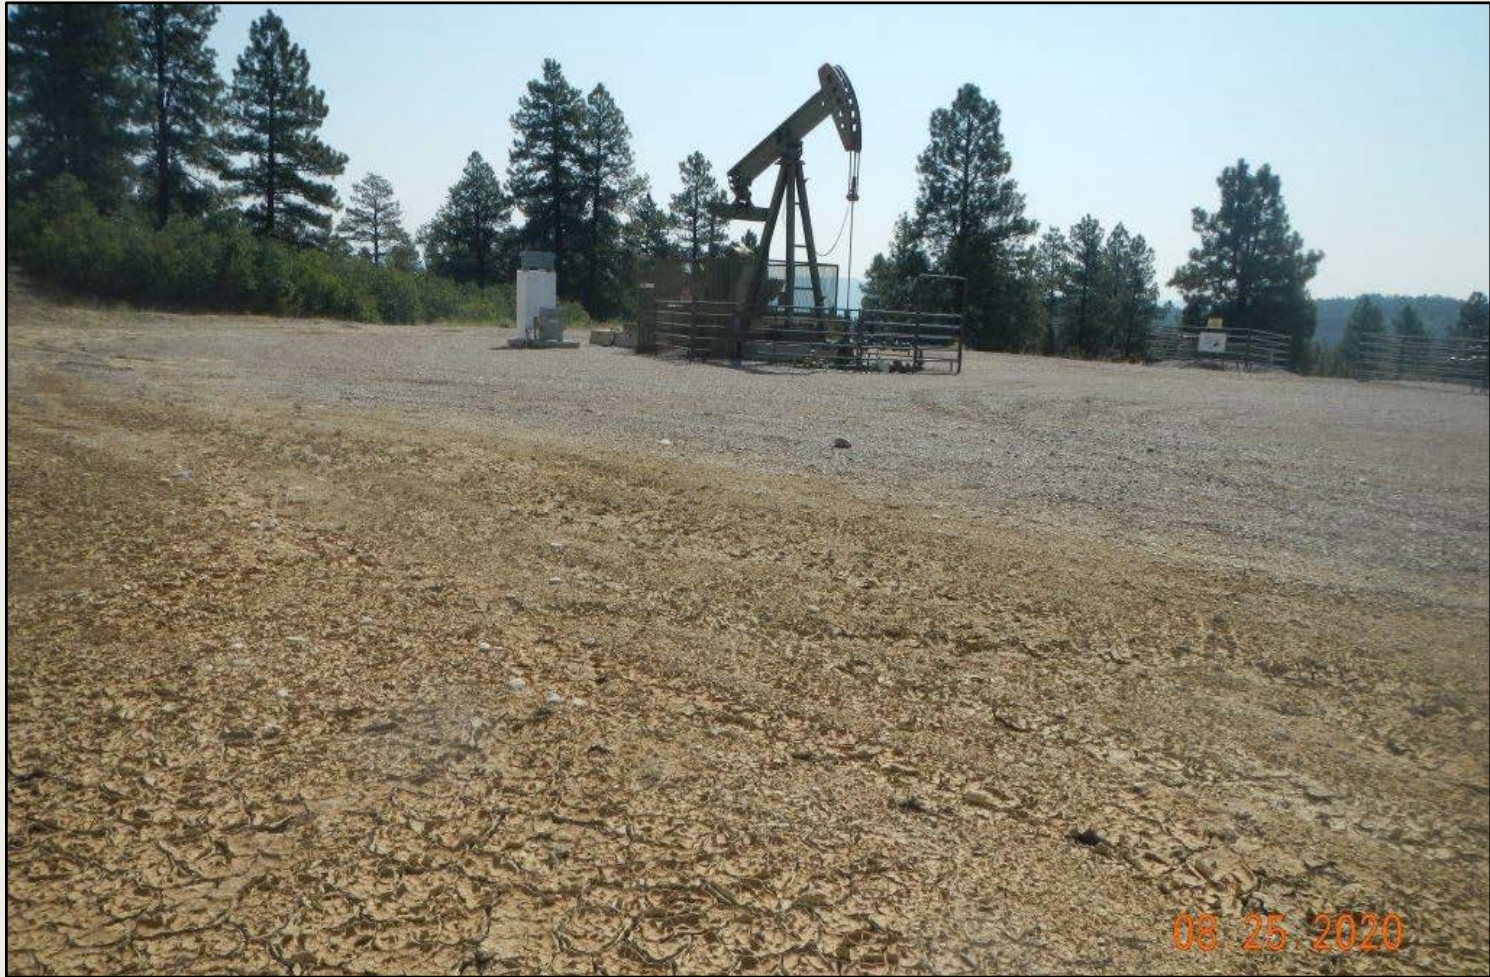
Photo 1. View of the project area from the northwestern corner facing center.

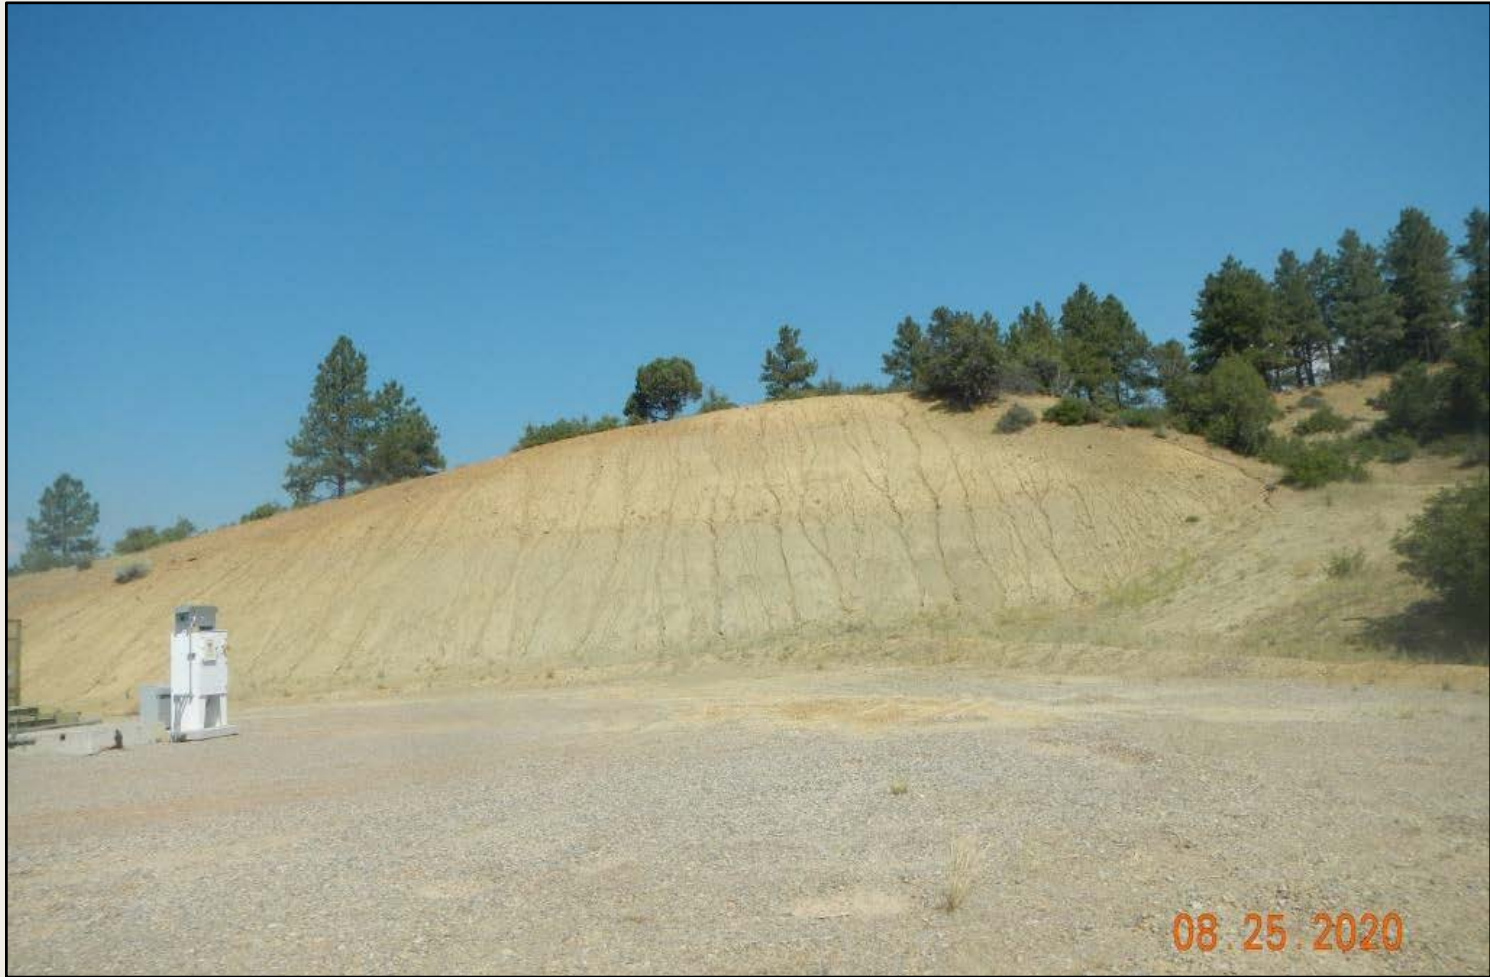
Photo 2. View of exposed and eroding soils on the northern cut-slope.

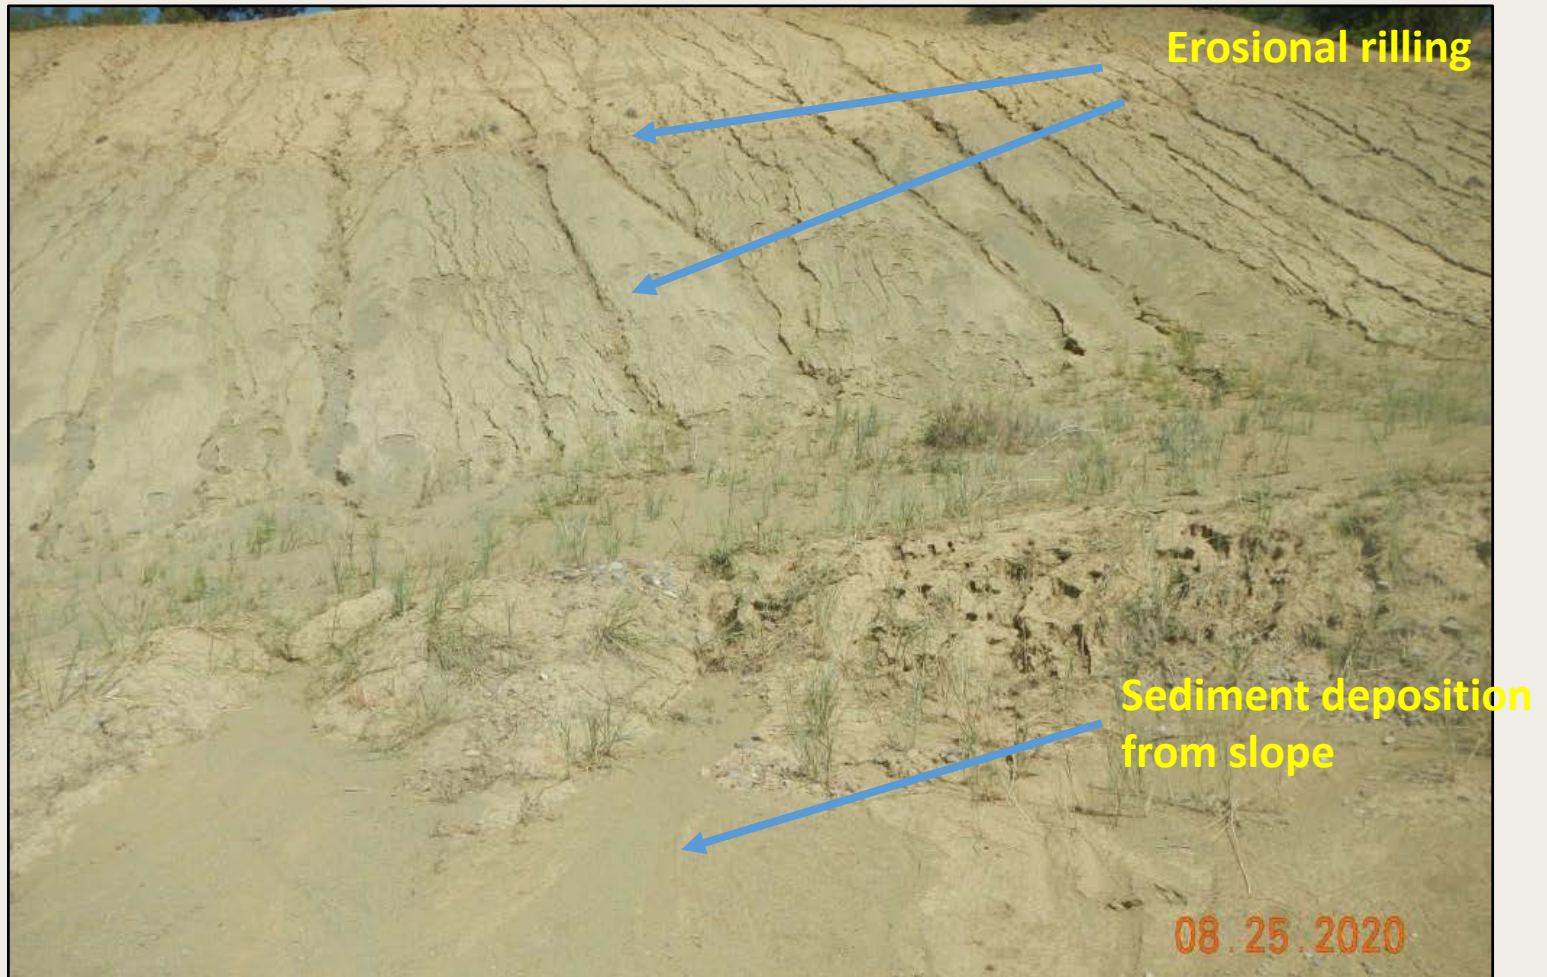
Photo 3. View of erosional rilling and sediment deposition at the toe of the northern cut-slope.

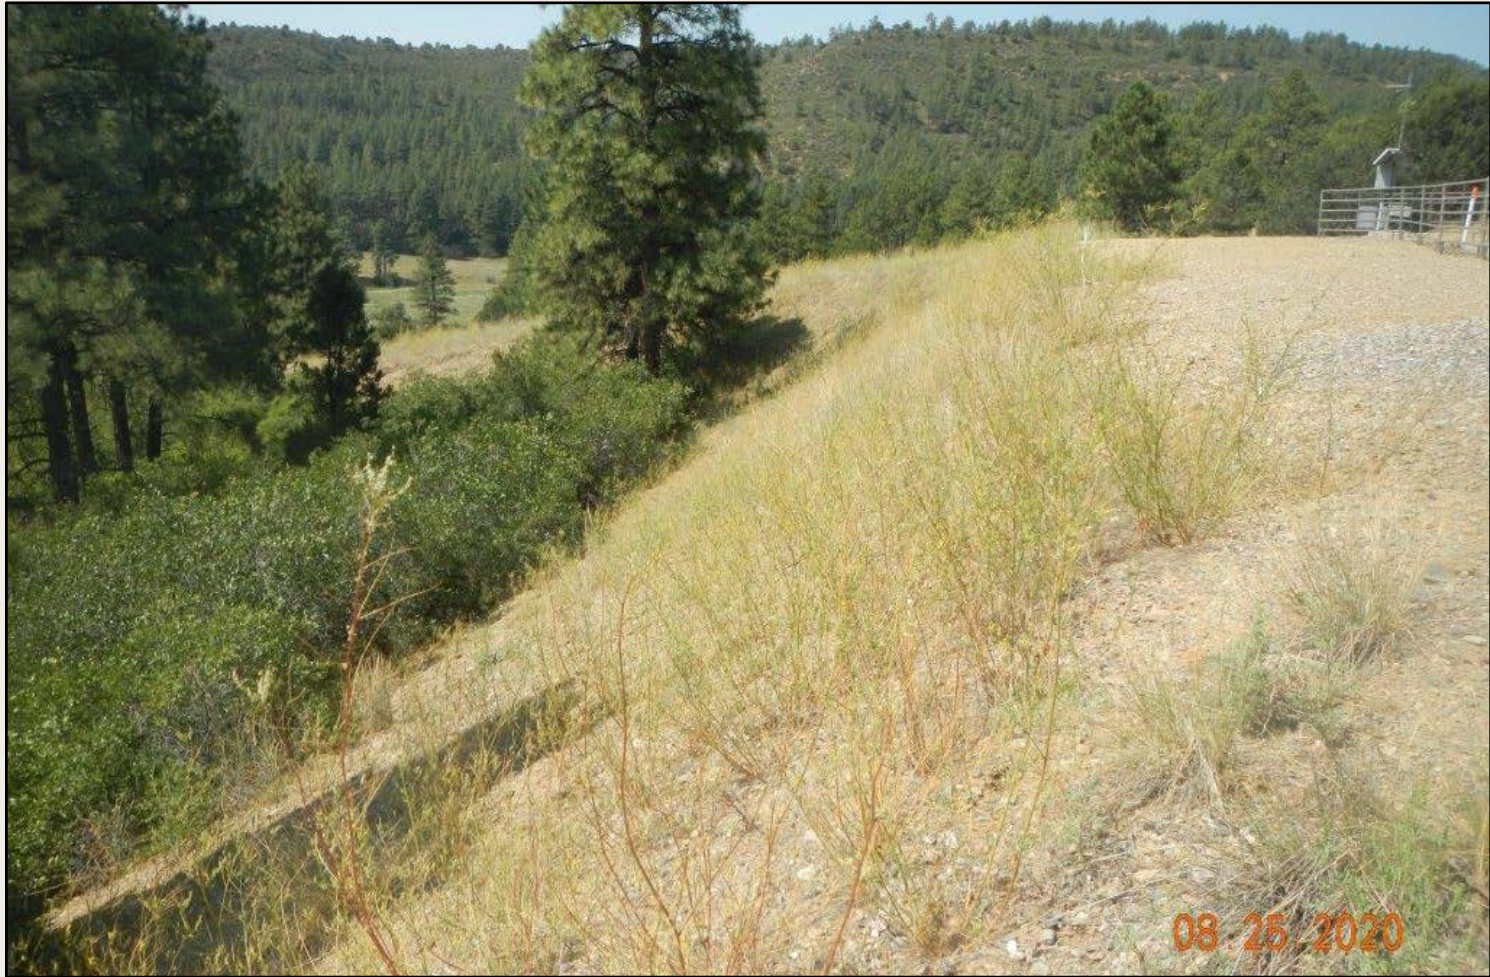
Photo 4. View of the southern fill slope, facing eastward. Revegetation is progressing with western wheatgrass and yellow sweetclover.
