Inspection Photos

API: 05-071-07960

Operator: PRESCO INC

Inspection Date: 8/25/2020

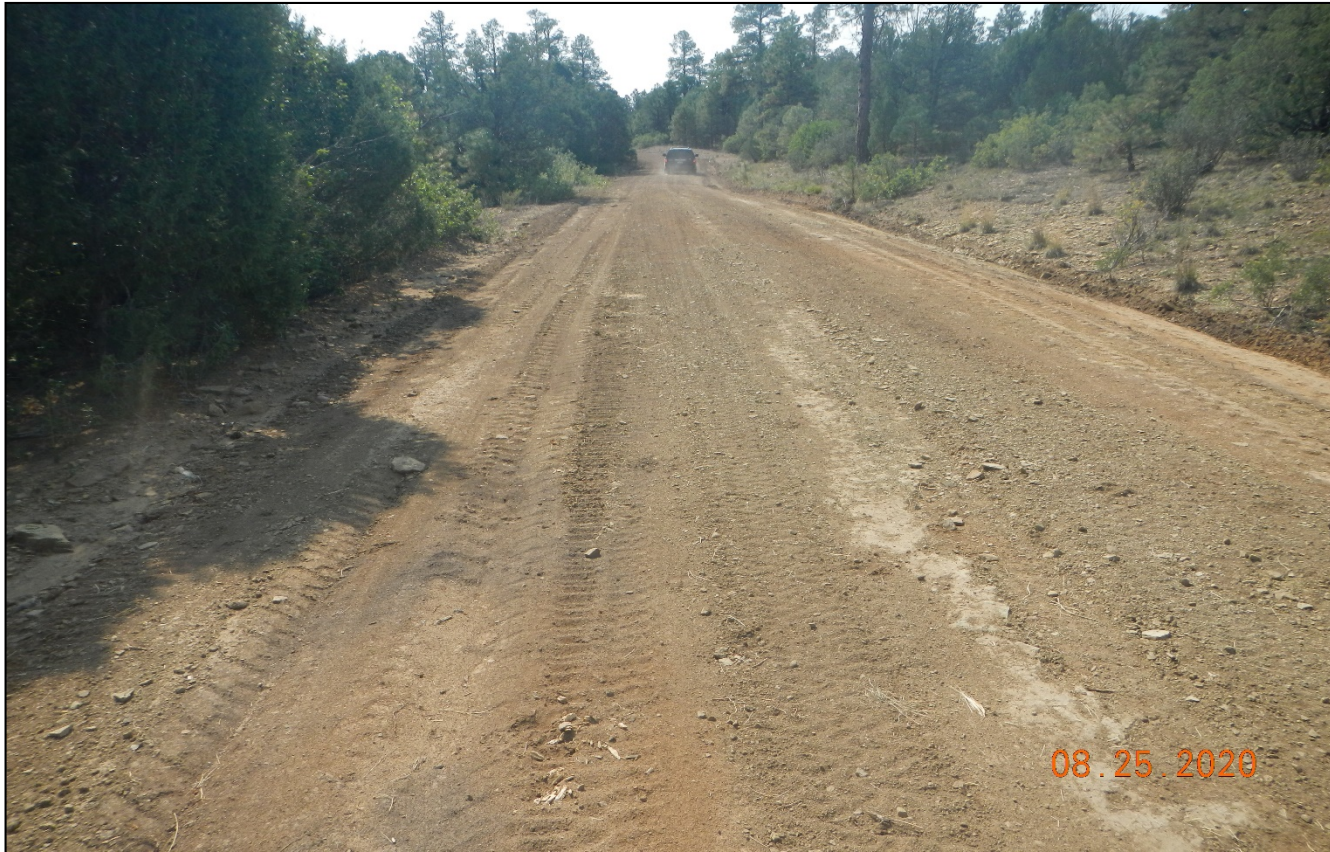
Photo 1. Facing south along the access road. The road was regraded along a portion of the road.

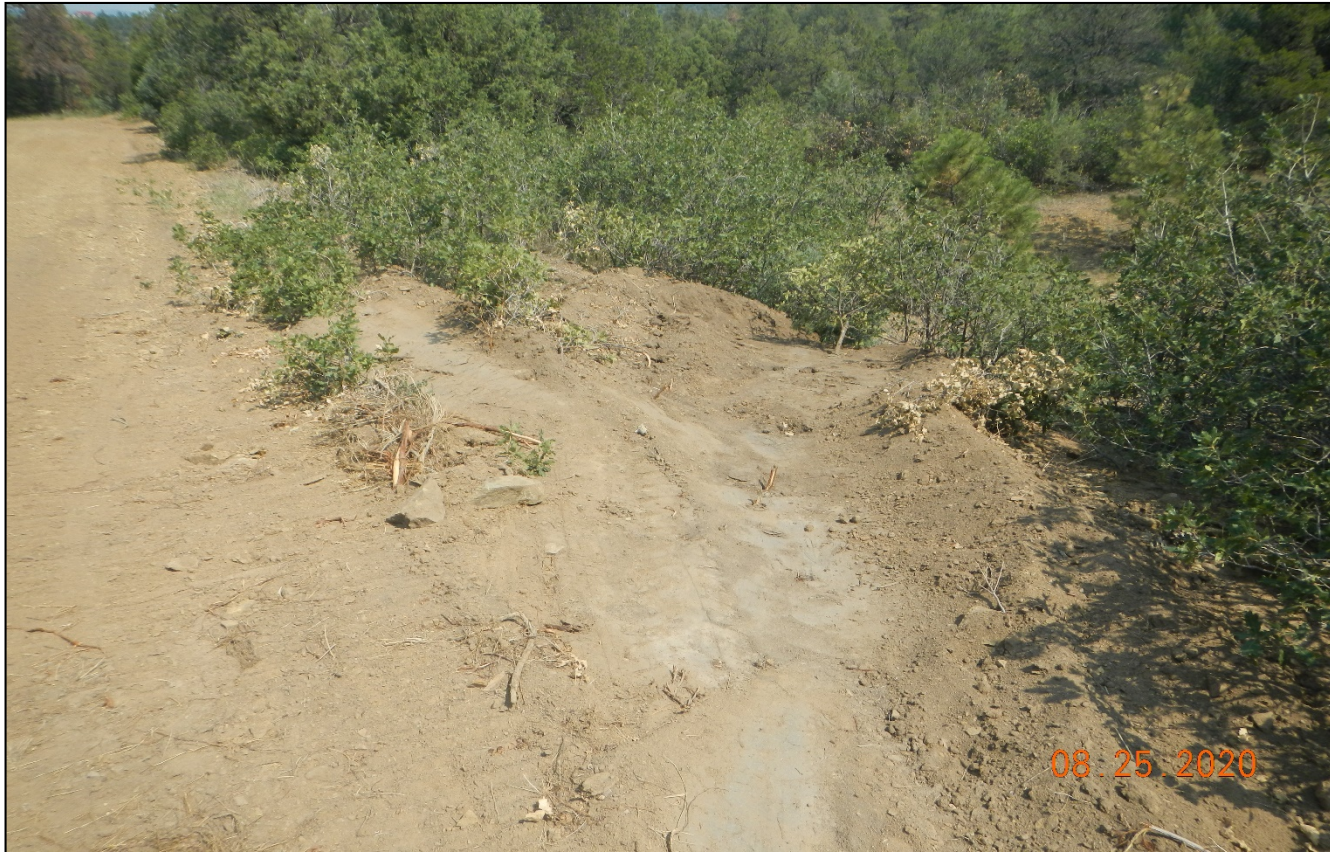
Photo 2. This runoff ditch was not properly installed. The disturbance along the side of the road will need to be seeded and stabilized.

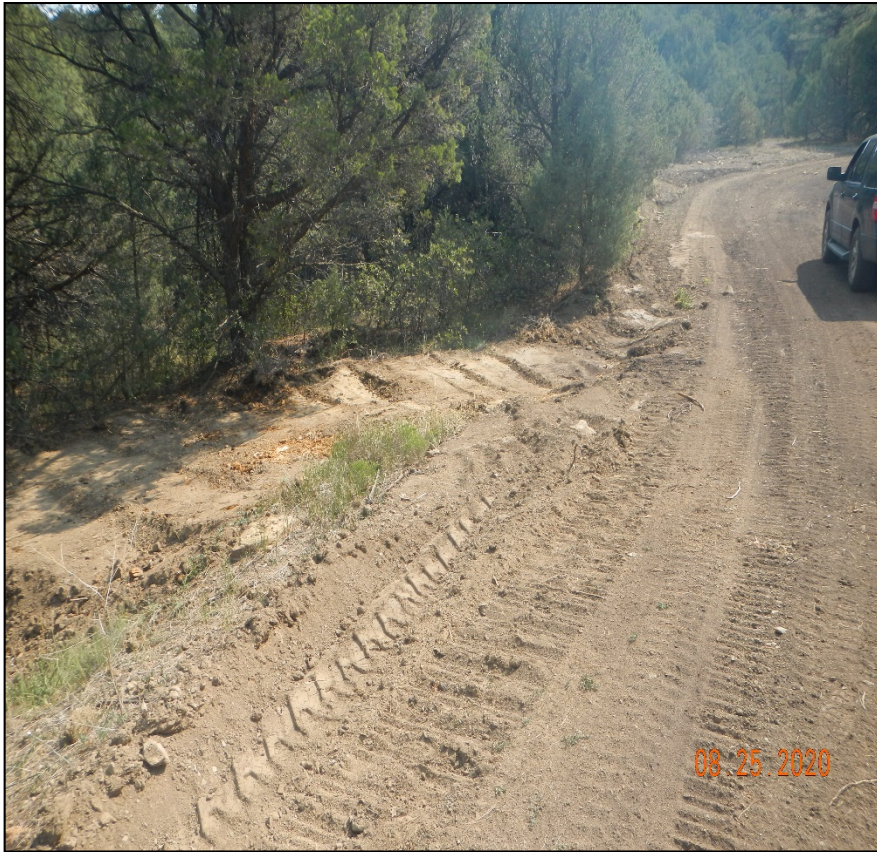
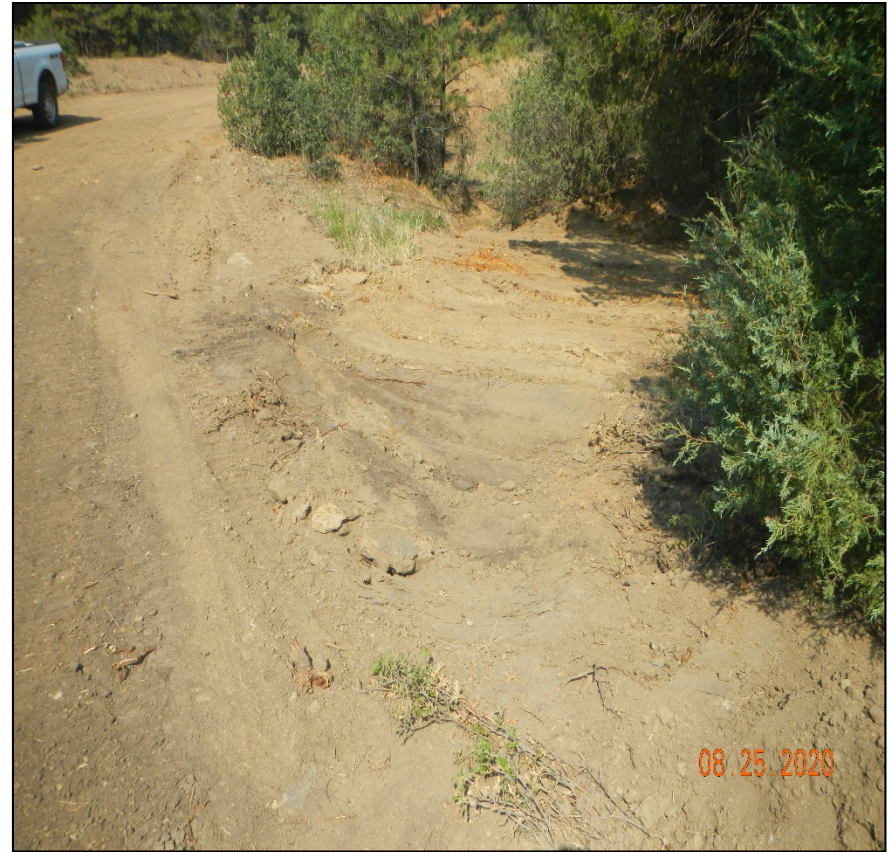
Photo 3. This is the area which an erosion gully was previously observed at Lat/Long:37.07589,-104.50931. The erosion gully was repaired and filled in however, this area needs to be stabilized. Stormwater is directed toward this area and will cause erosion if not properly stabilized.

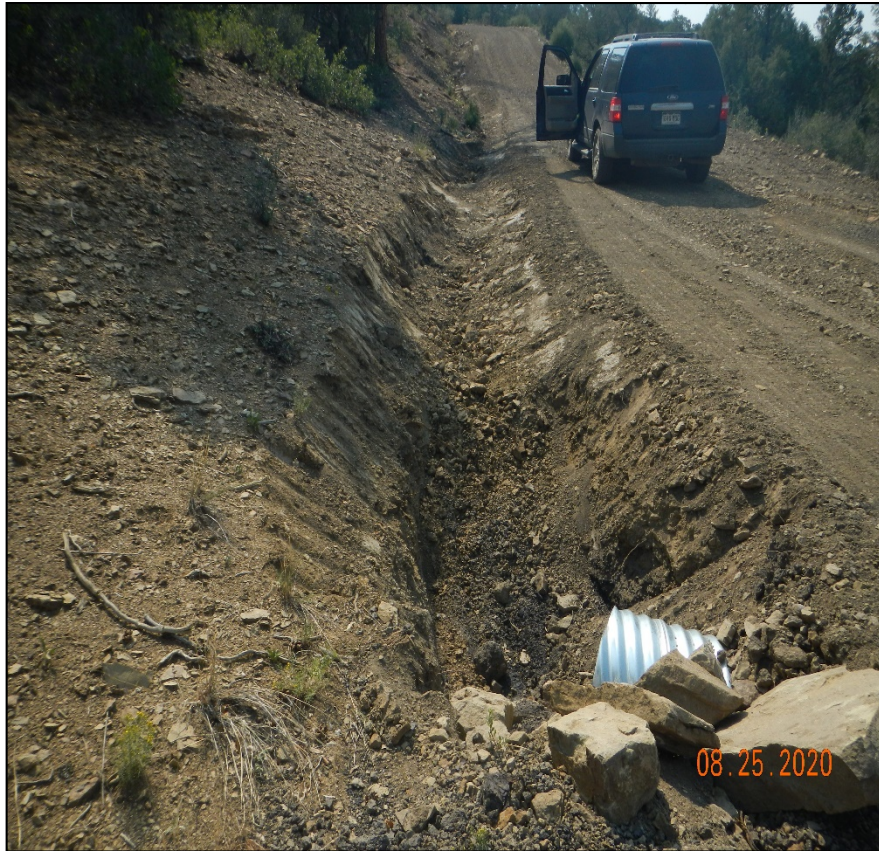
Photo 4. There are culverts installed along the road ascending this hillside.

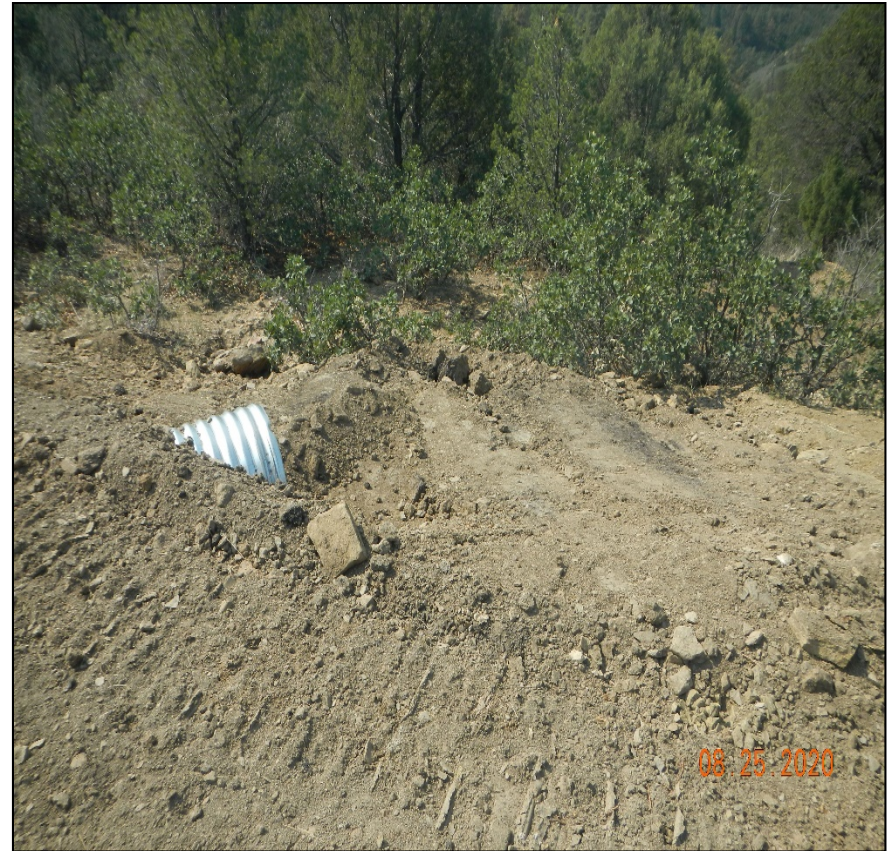
Photo 5. There is no culvert outlet protection installed to prevent erosion.

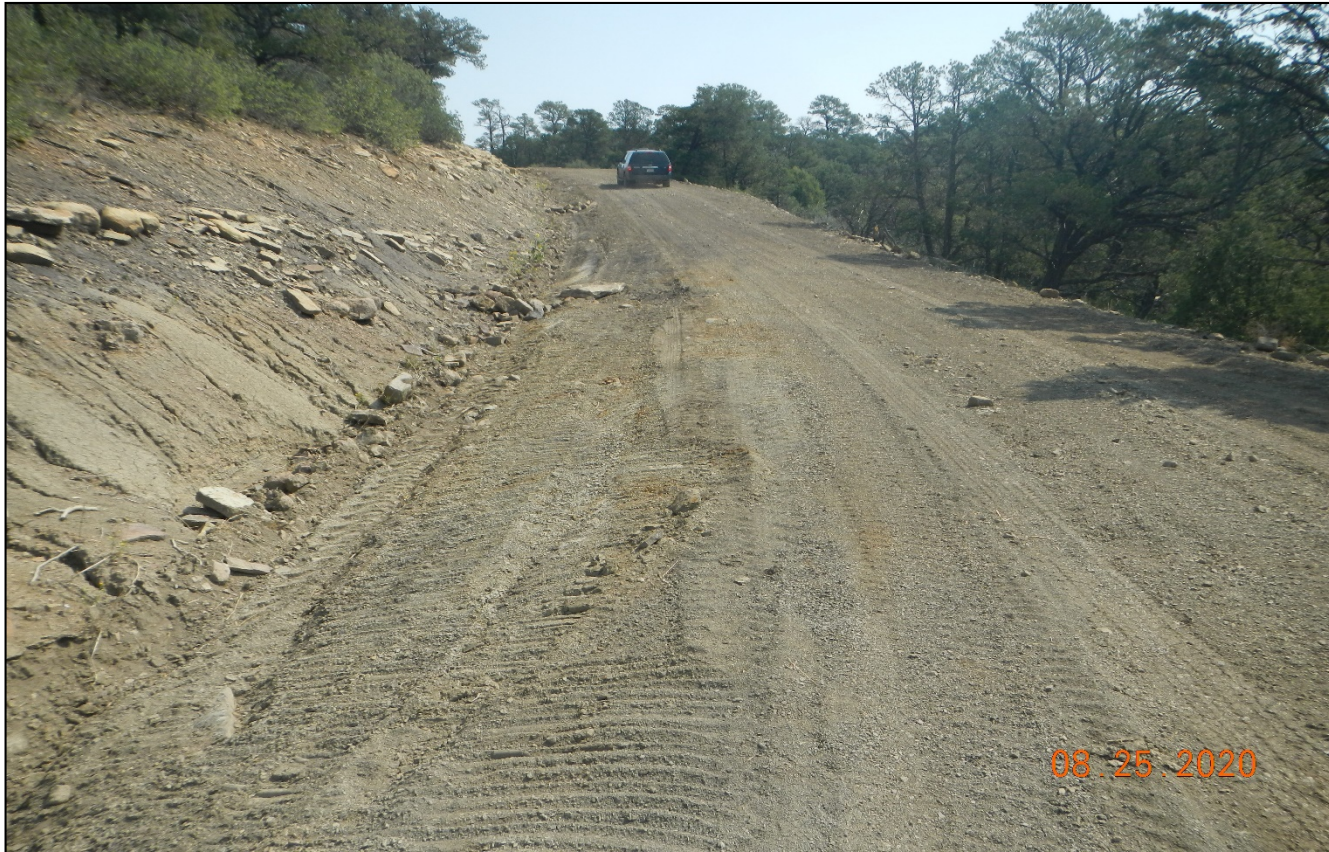
Photo 6. Facing southeast along the road ascending the hill side. The road was reggraded along a portion of the road. Additional rock check dams are needed along the side of the road to dissipate stormwater flow and prevent erosion.

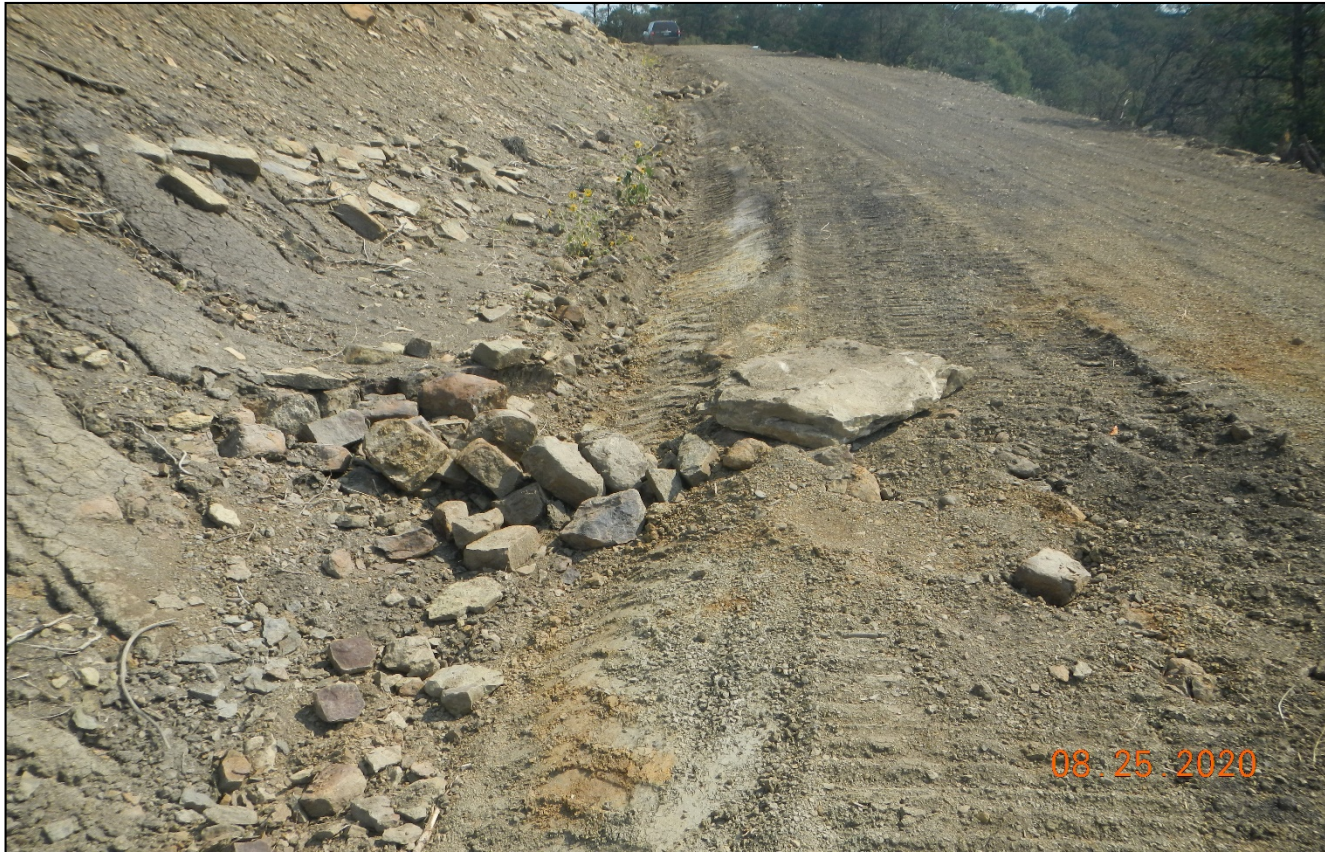
Photo 7. The rock check dams are not properly installed along the road side. Additional rock is needed and the check dams need to extend from side to side with the low point at the center of the check dam.

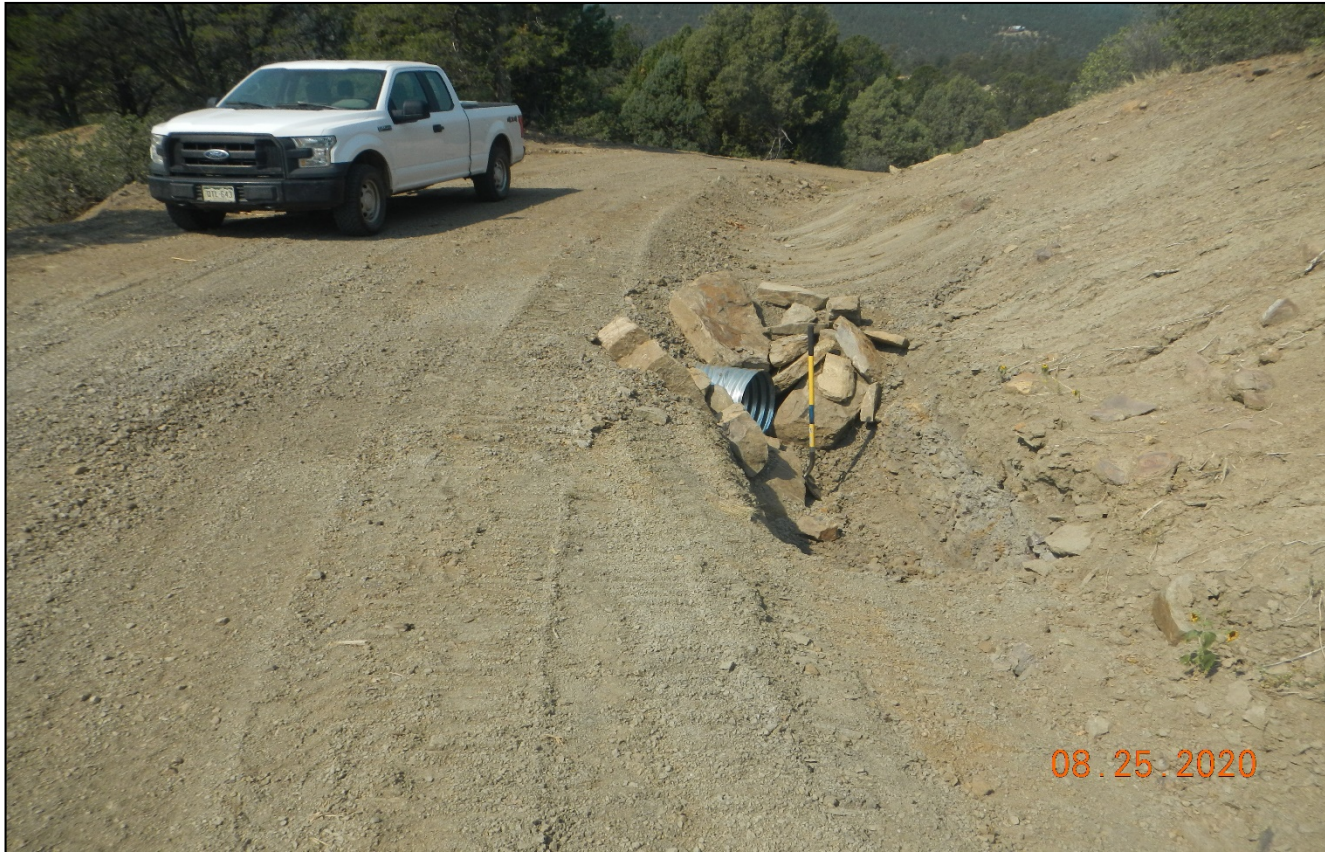
Photo 8. Facing toward the culvert inlet installed along the road.

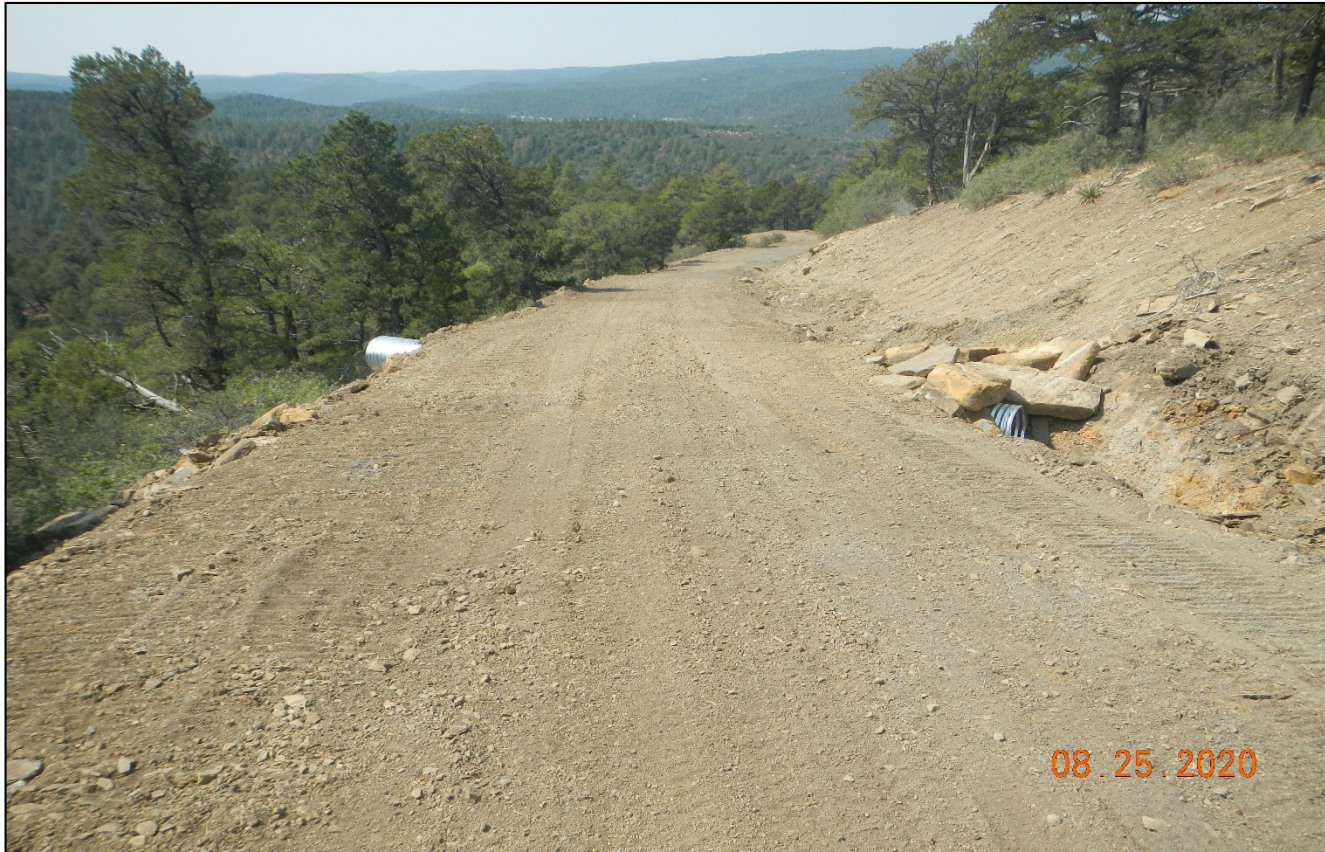
Photo 9. Facing southwest back down the road.

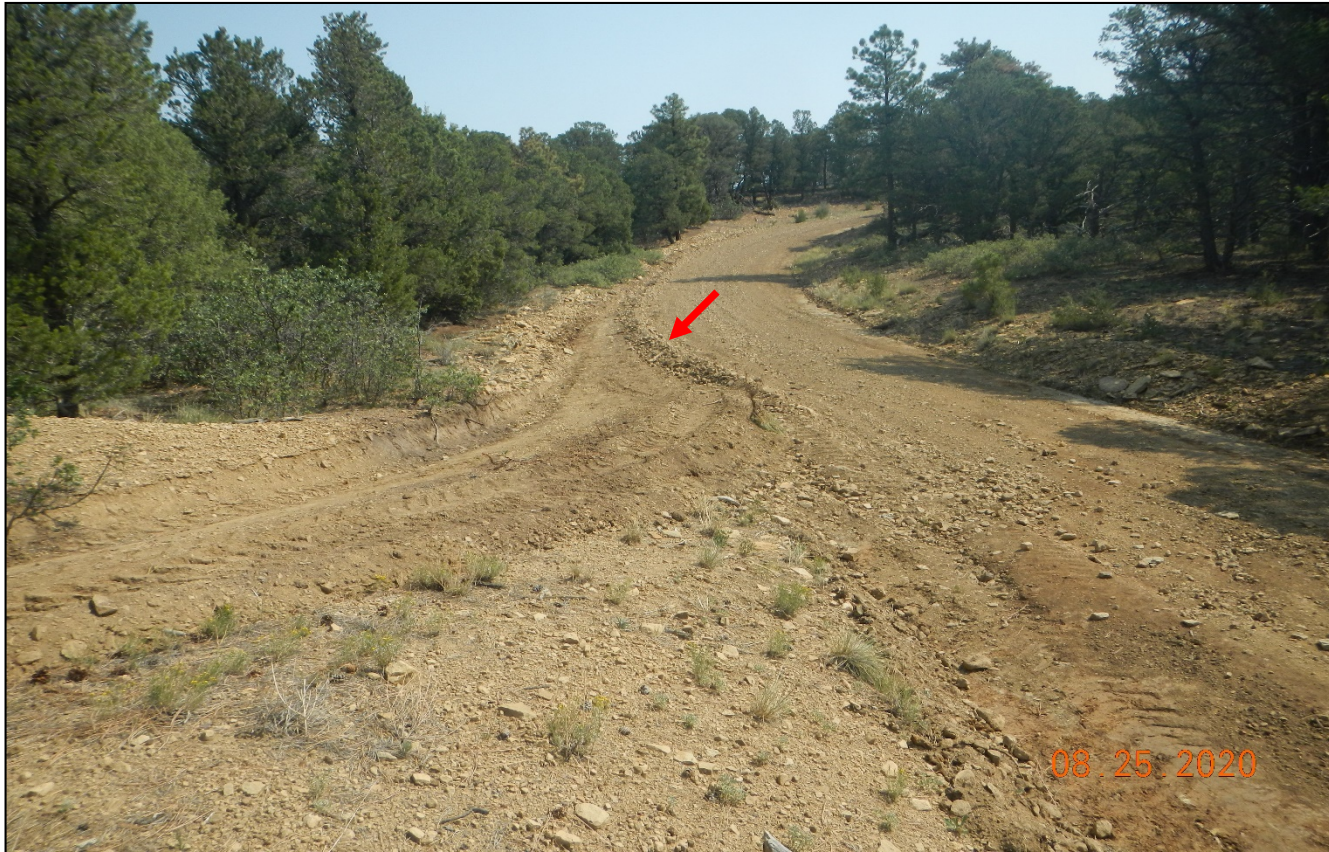
Photo 10. Facing east along the road. This area of the road was regraded however, a berm was left on the road which will interfere with stormwater flow.

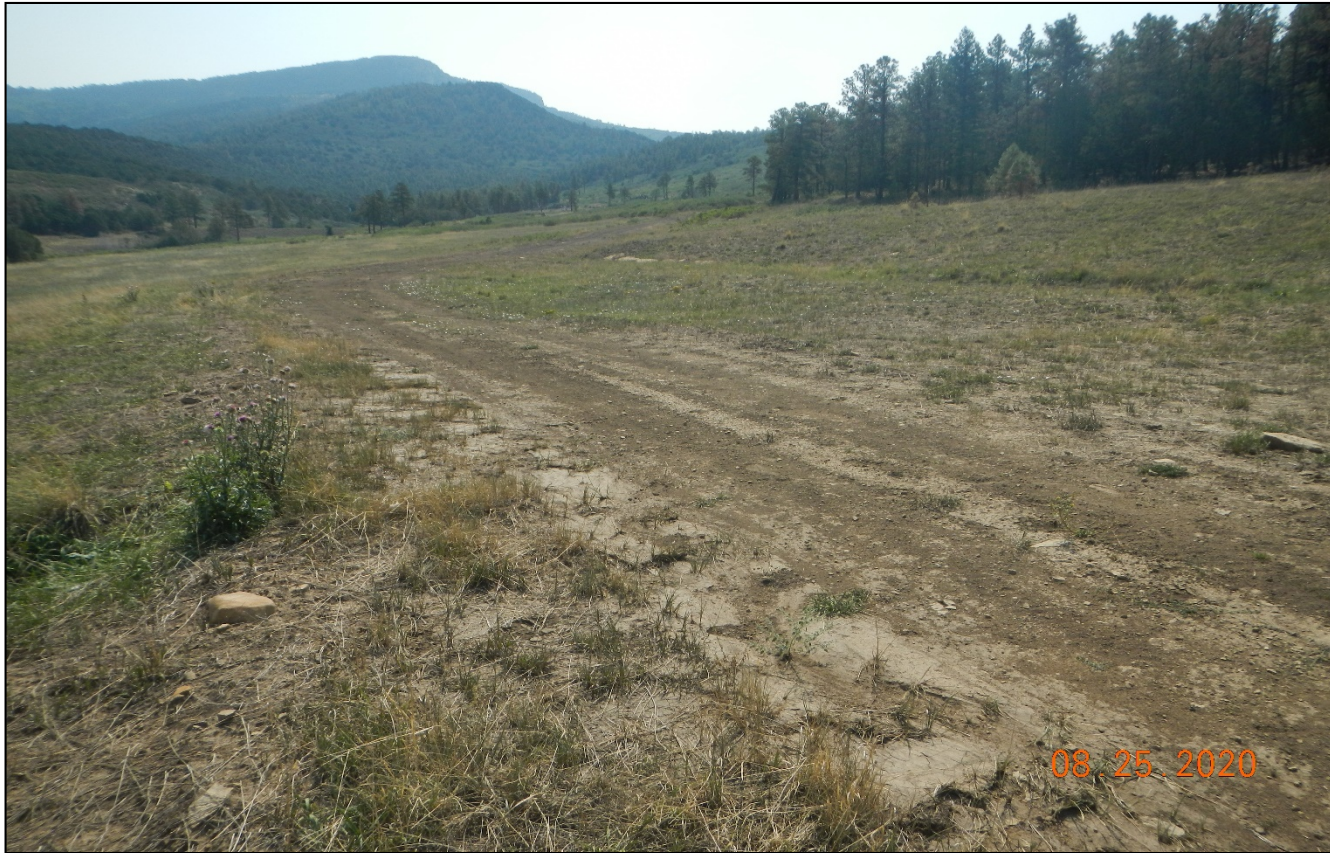
Photo 11. Facing southeast toward the location. The road continues past the location.

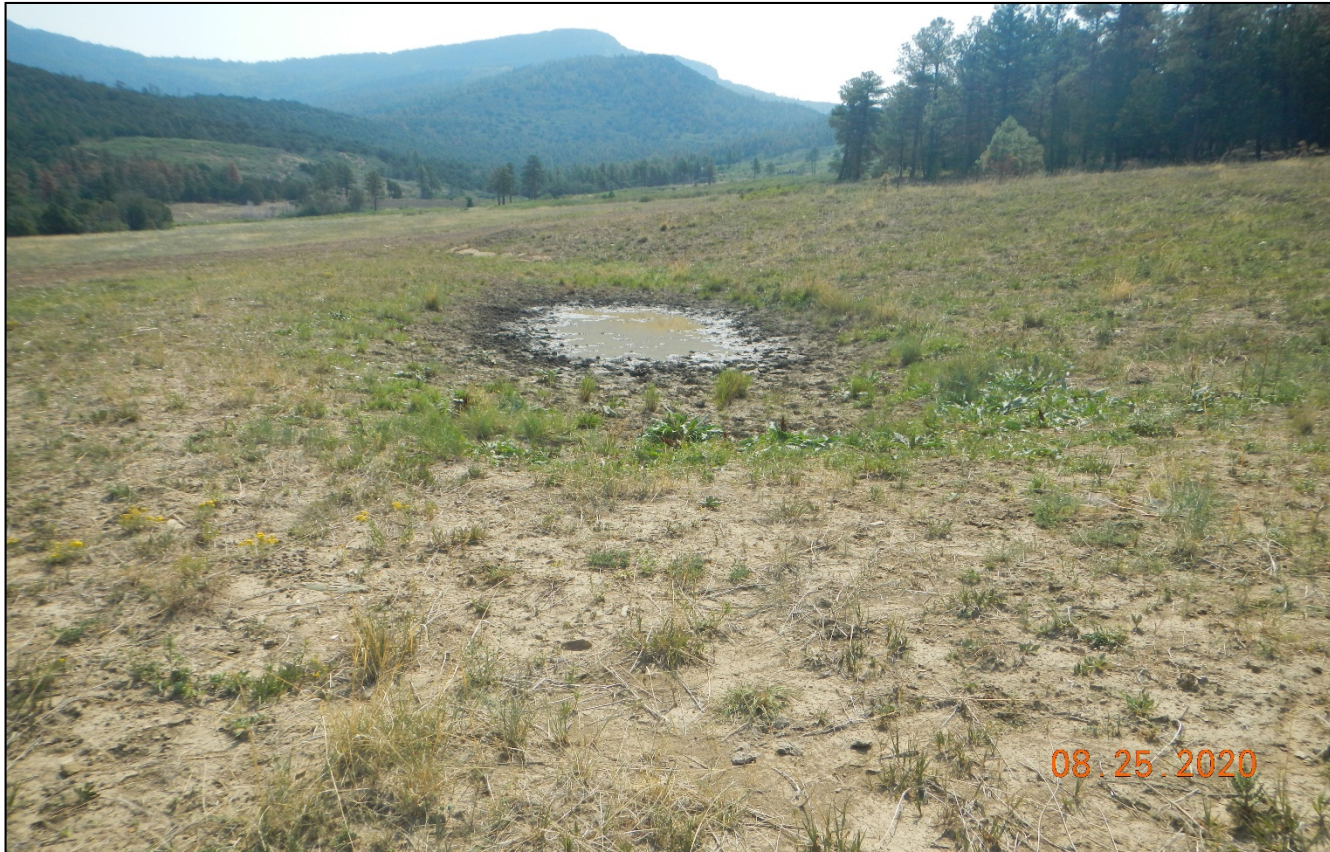
Photo 12. Facing southeast toward the location. A shallow pit remains per approved variance.
