ARGENTA 34-10 31-1

Corrective Actions Taken on the ARGENTA 34-10 31-1 for the COGCC
INC.

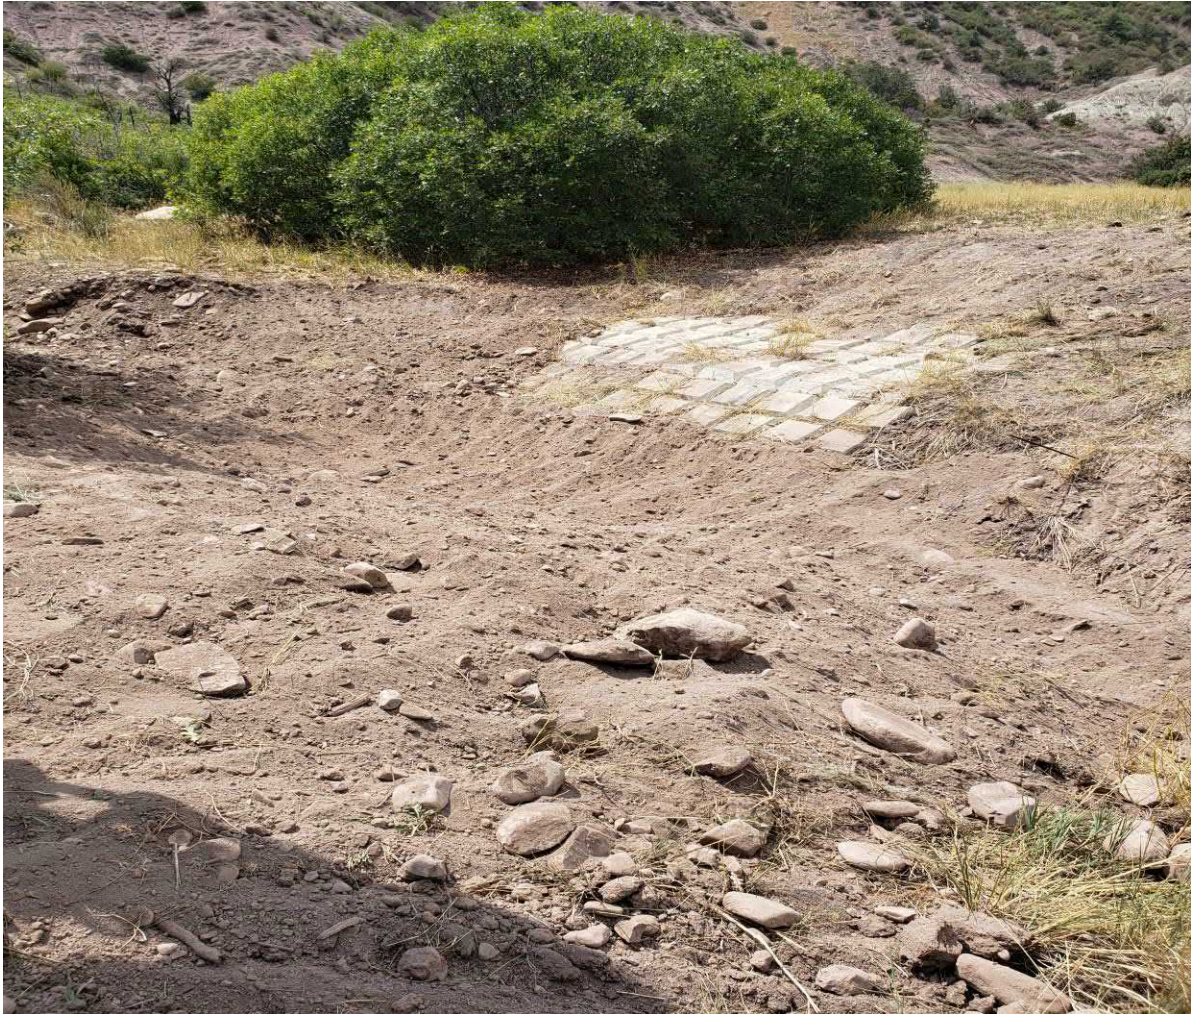
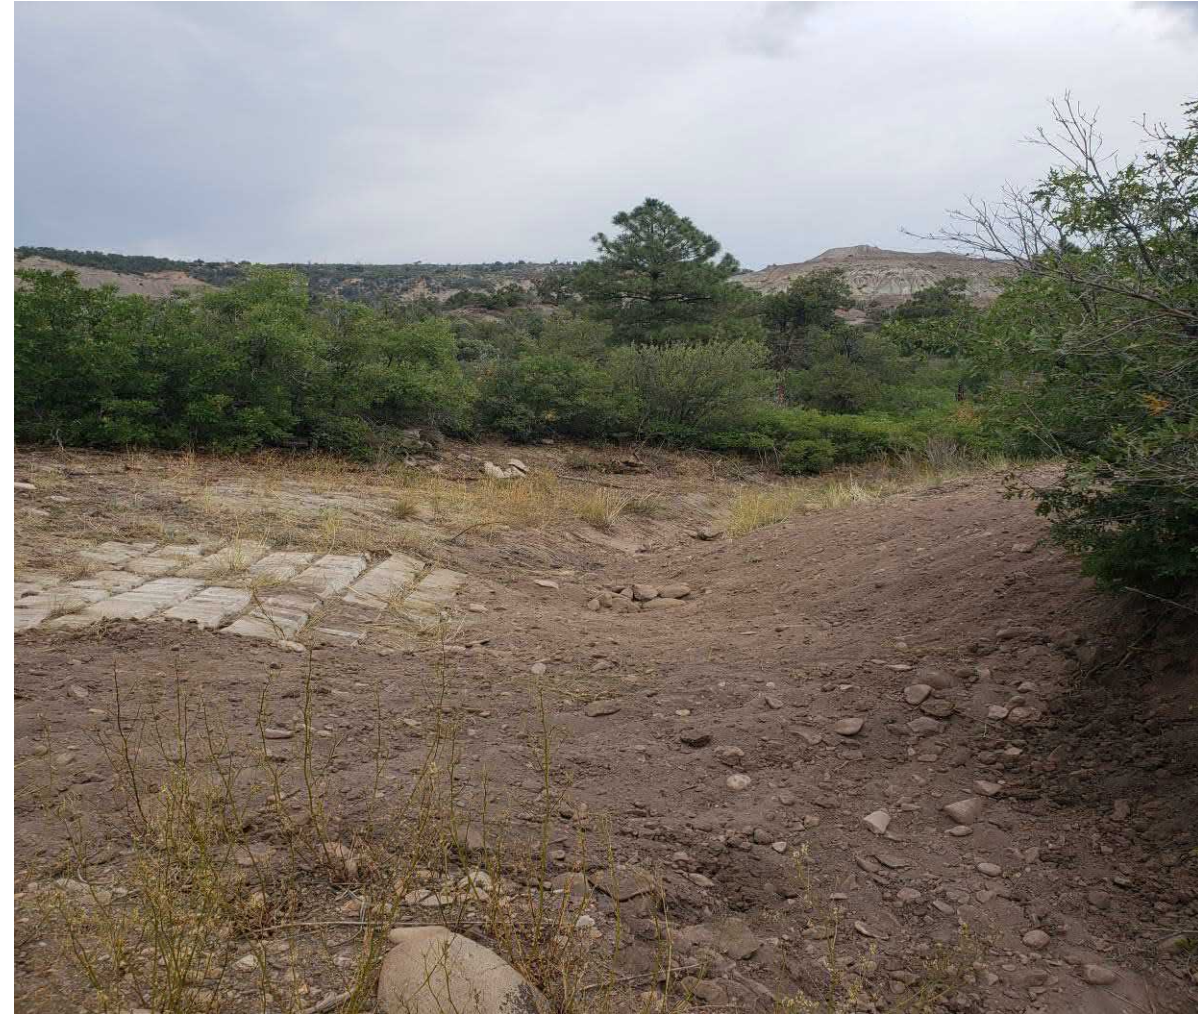
Reset cement BMP at the entrance to the reclaimed well pad. The BMP was not correctly installed originally.

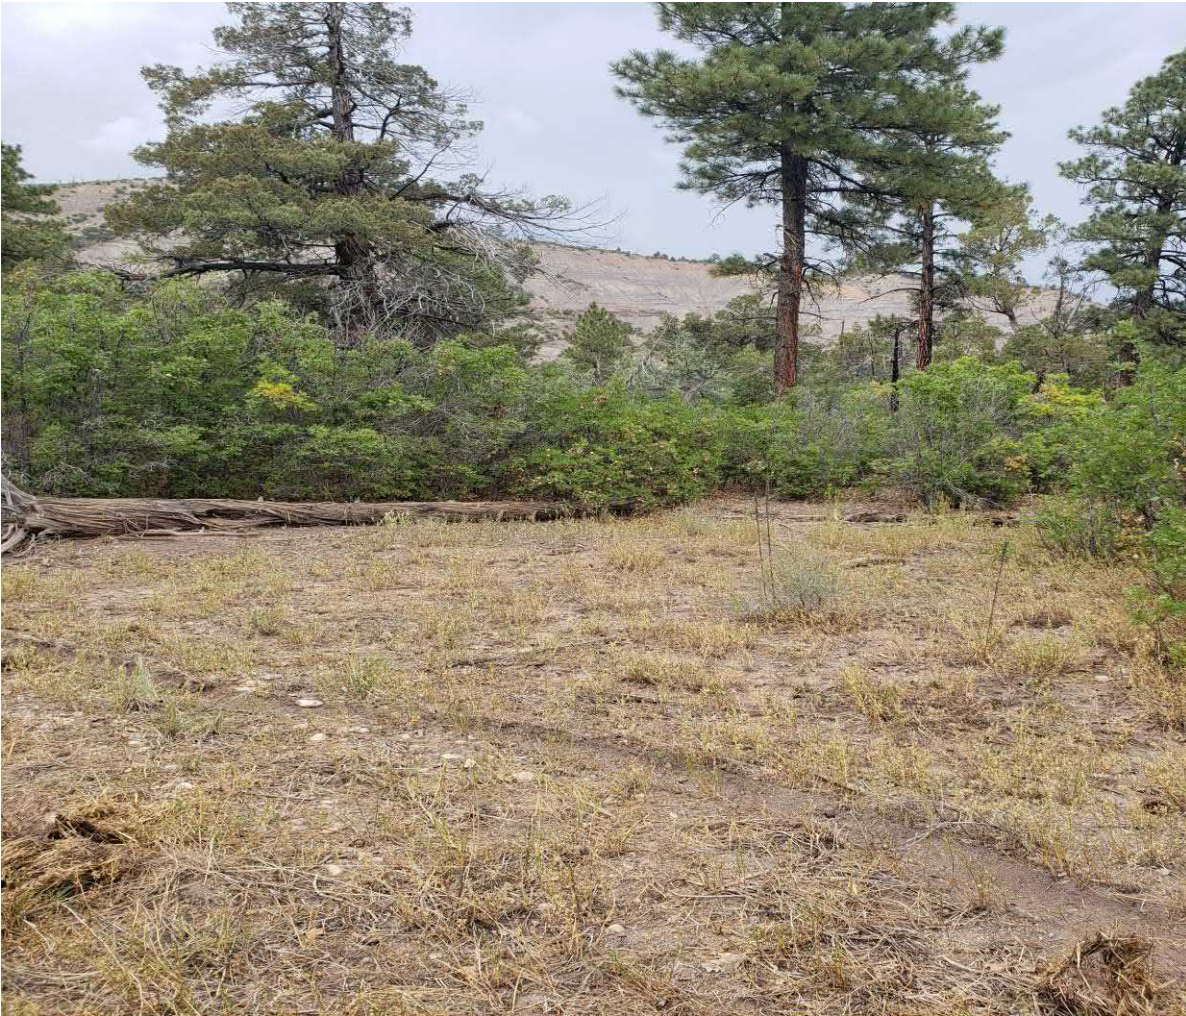
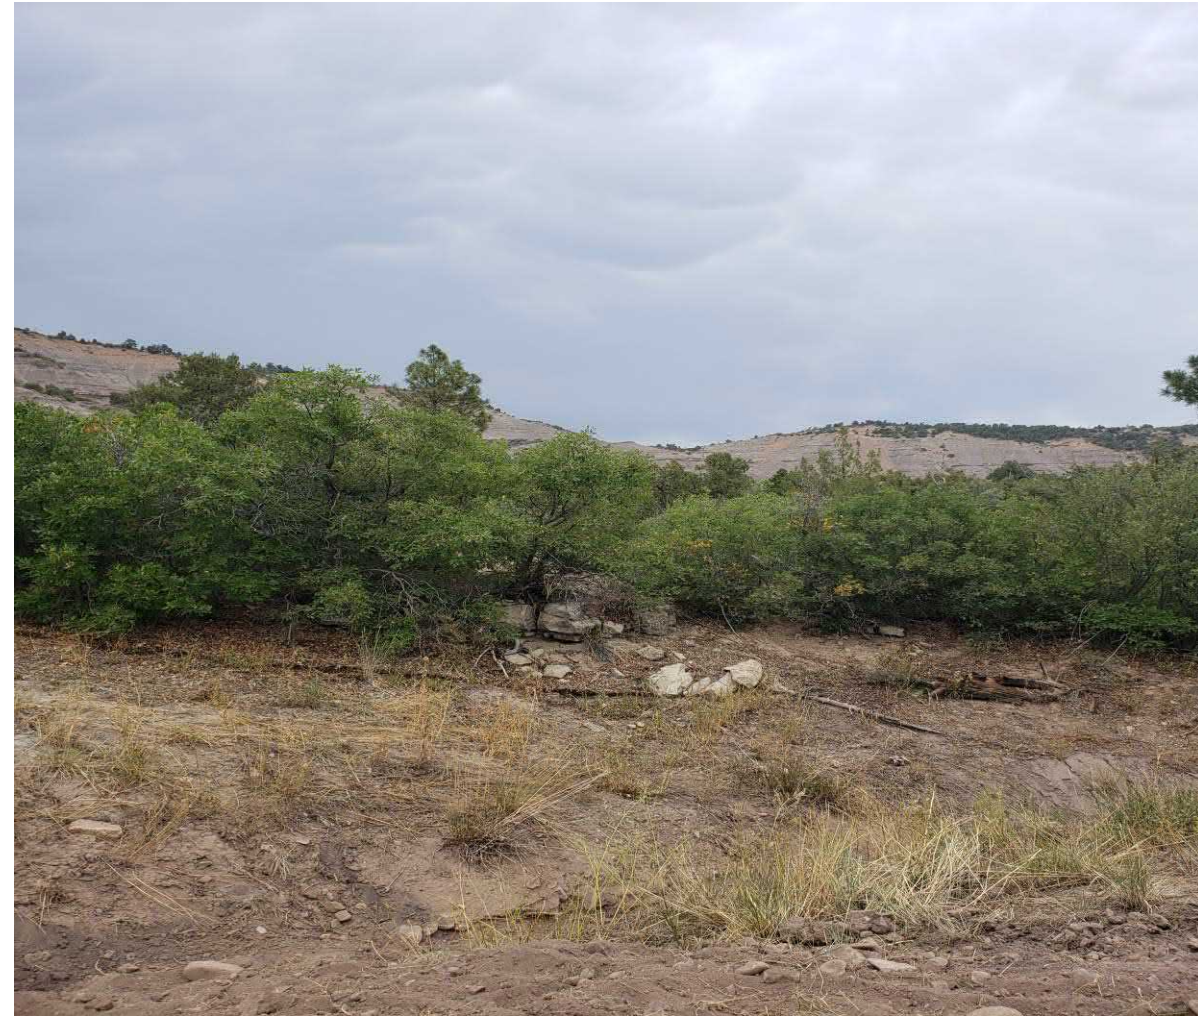
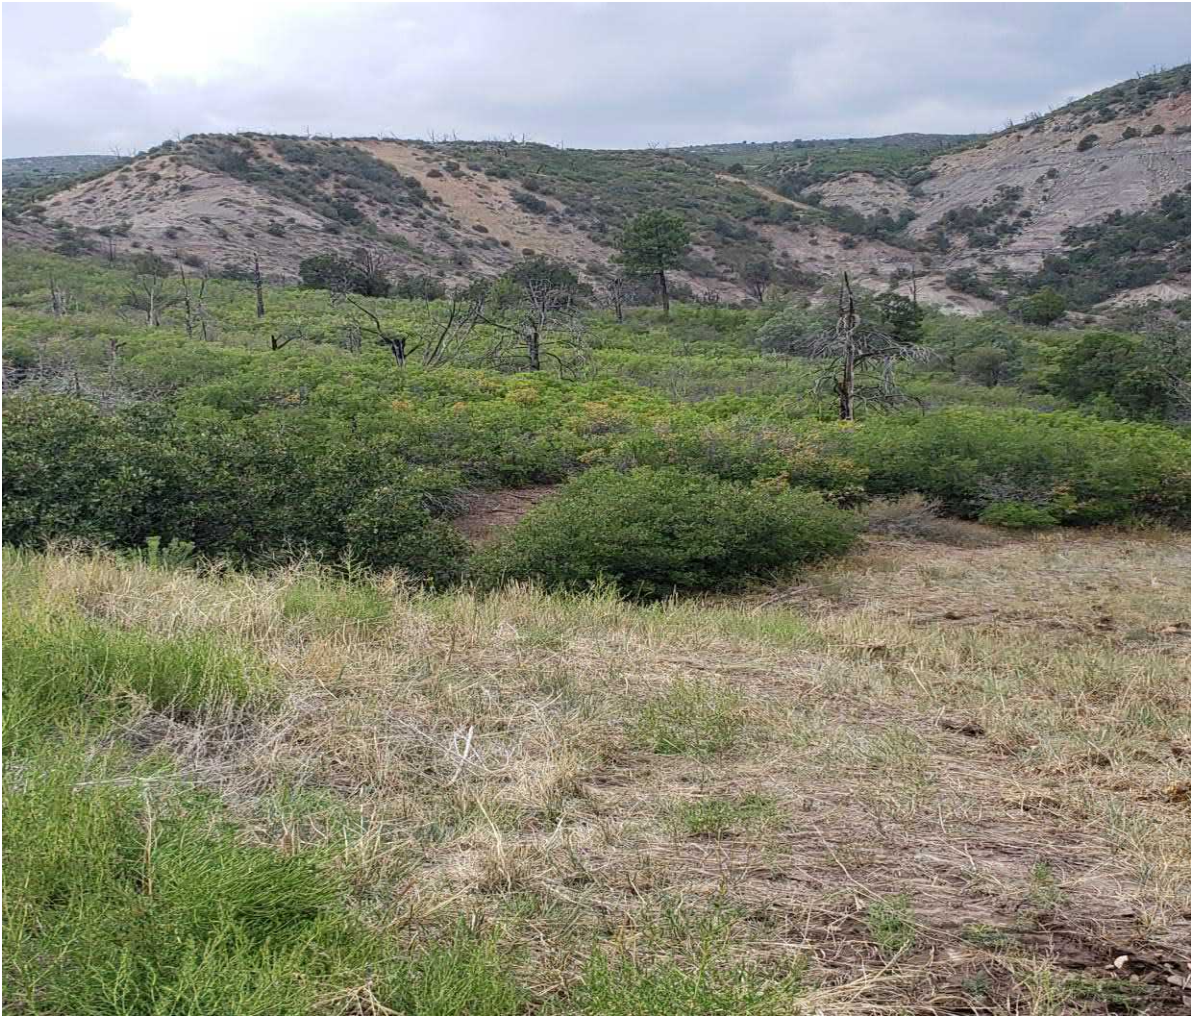
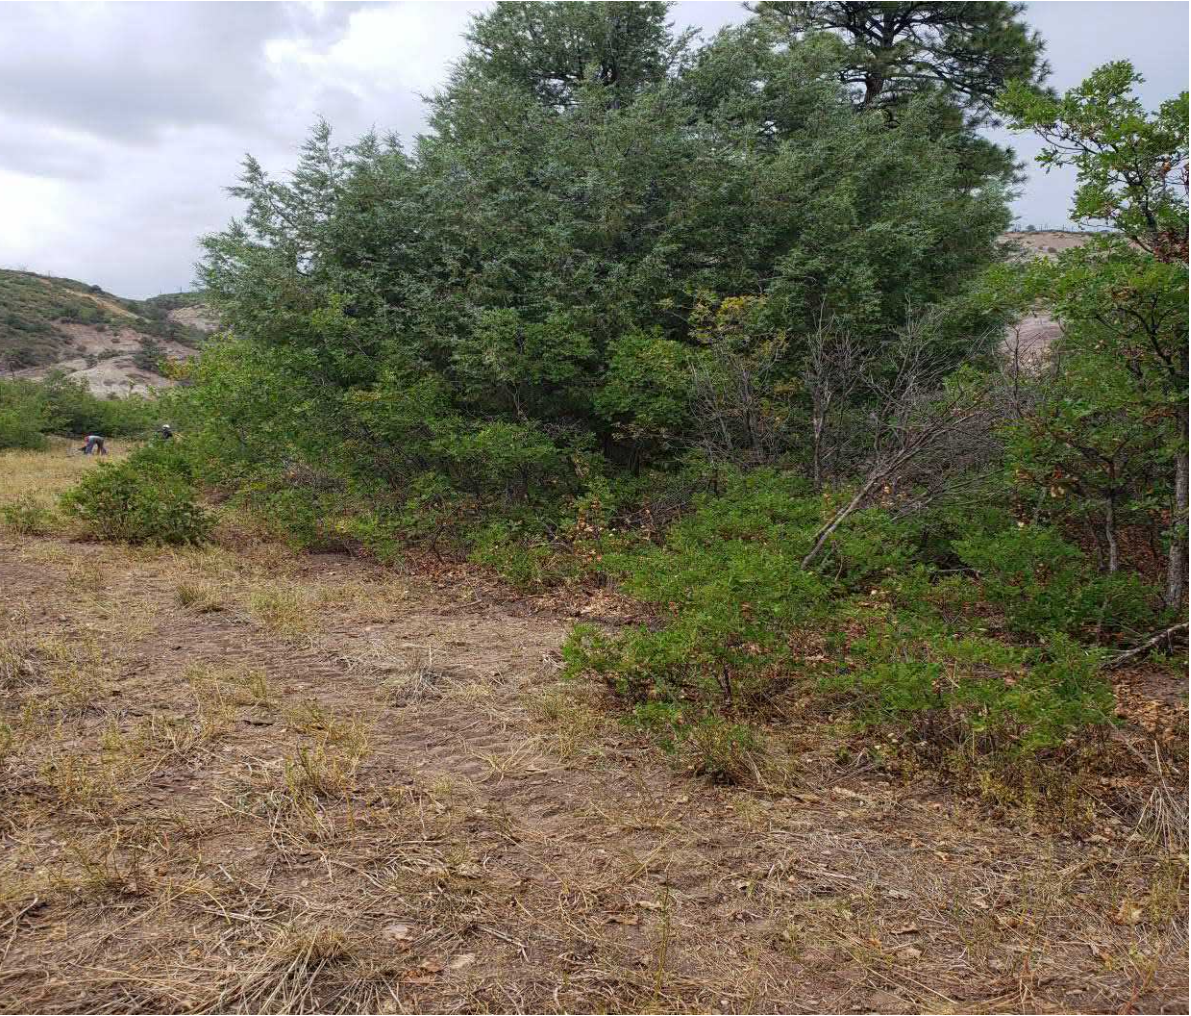
Removed all perimeter wattles on the reclaimed access road and well pad.

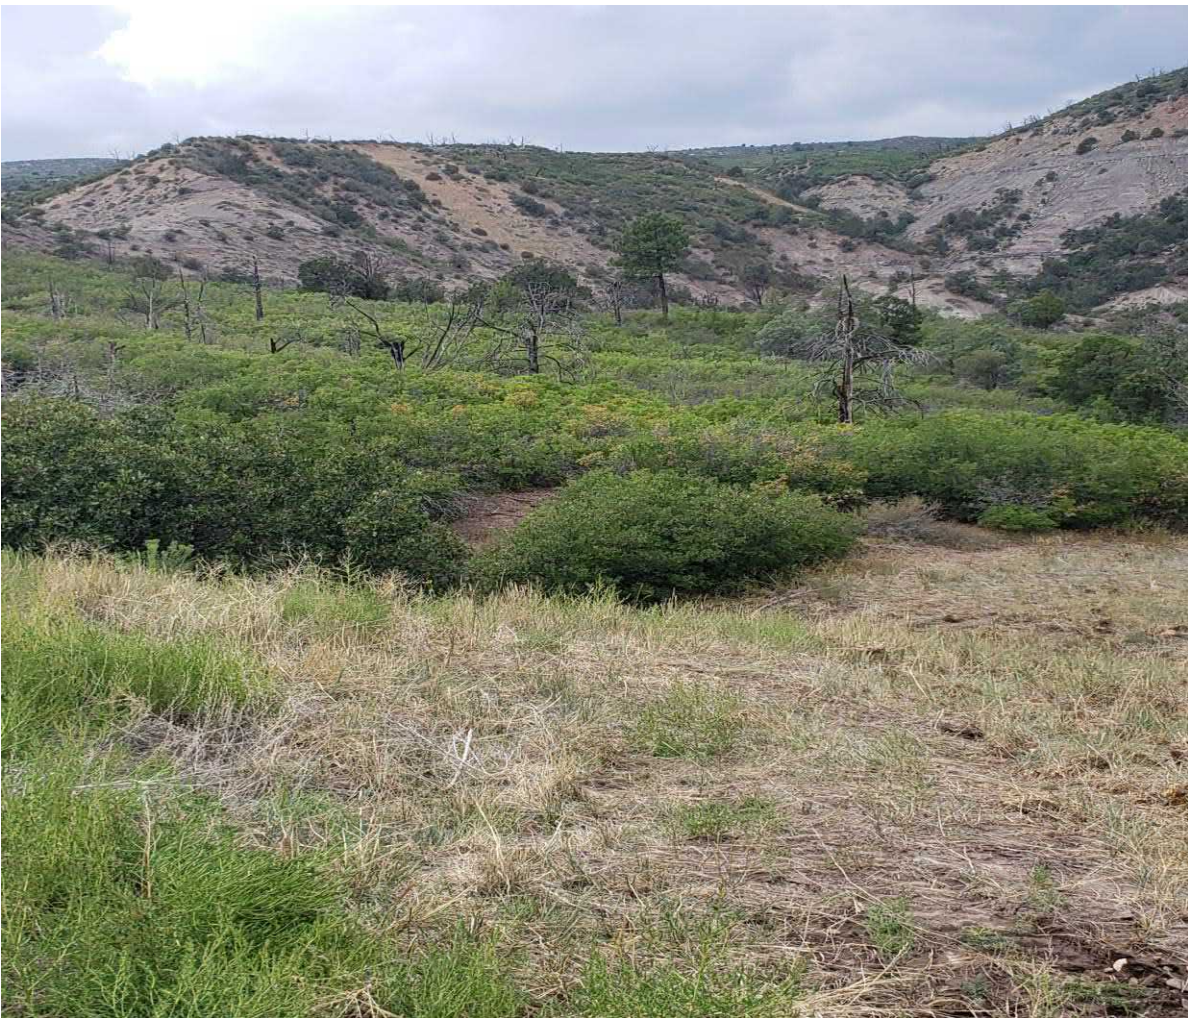
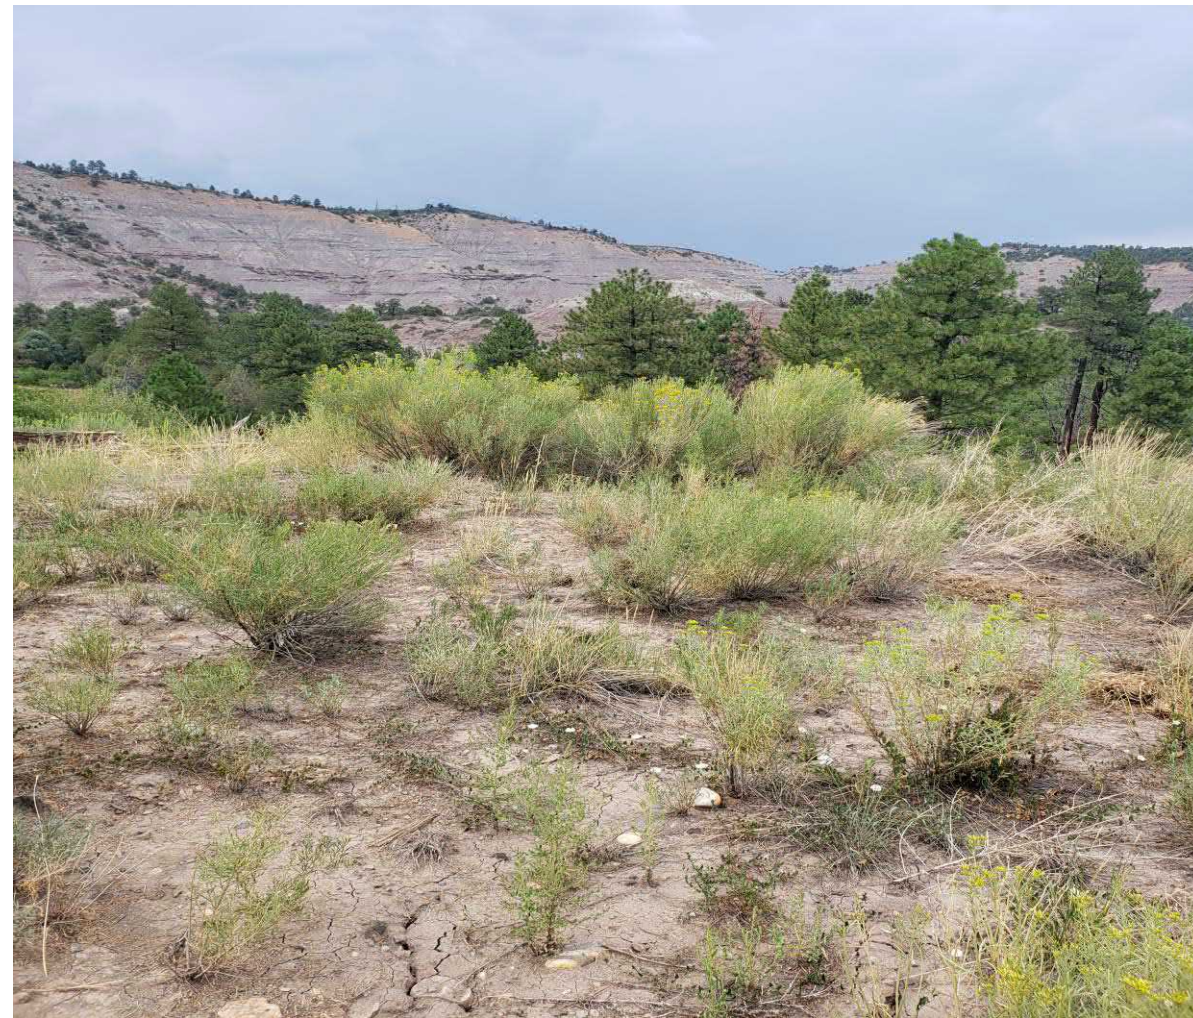
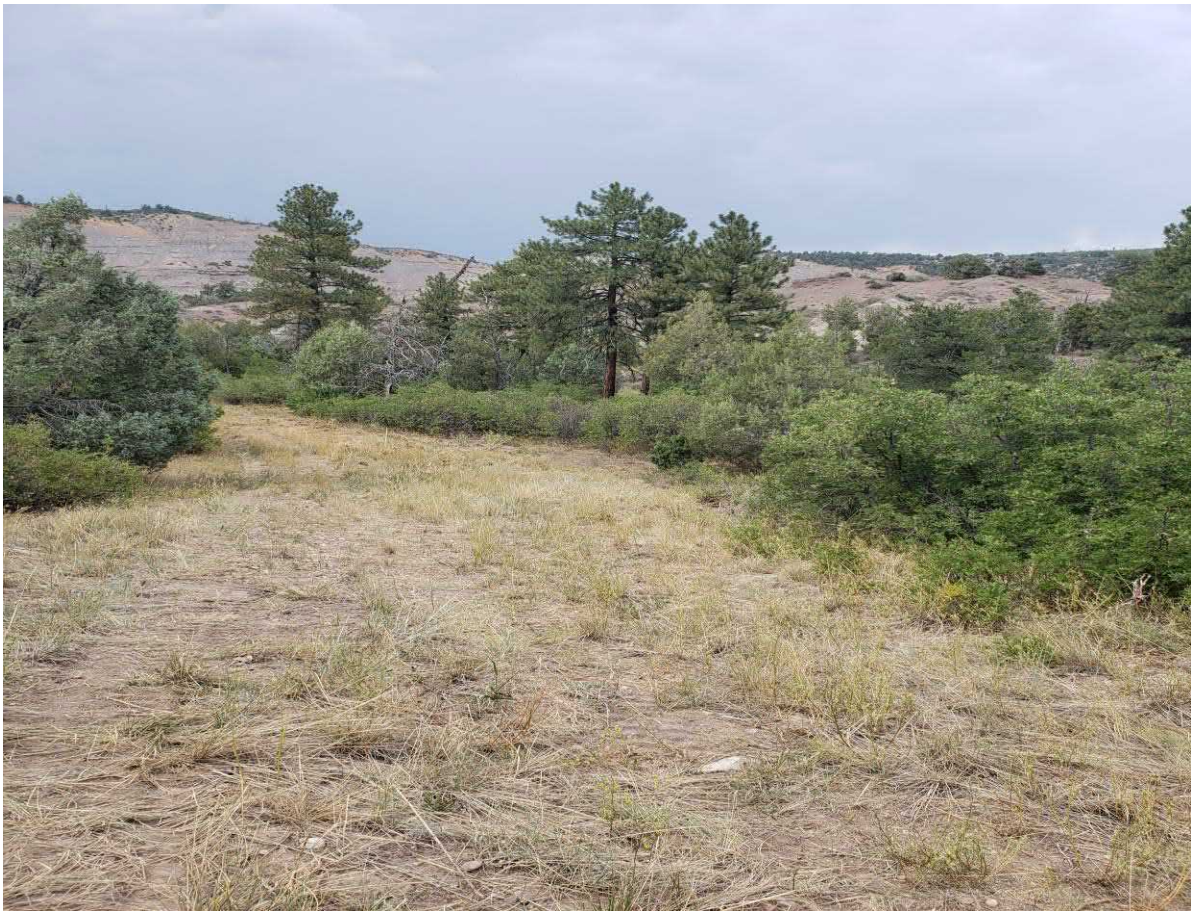
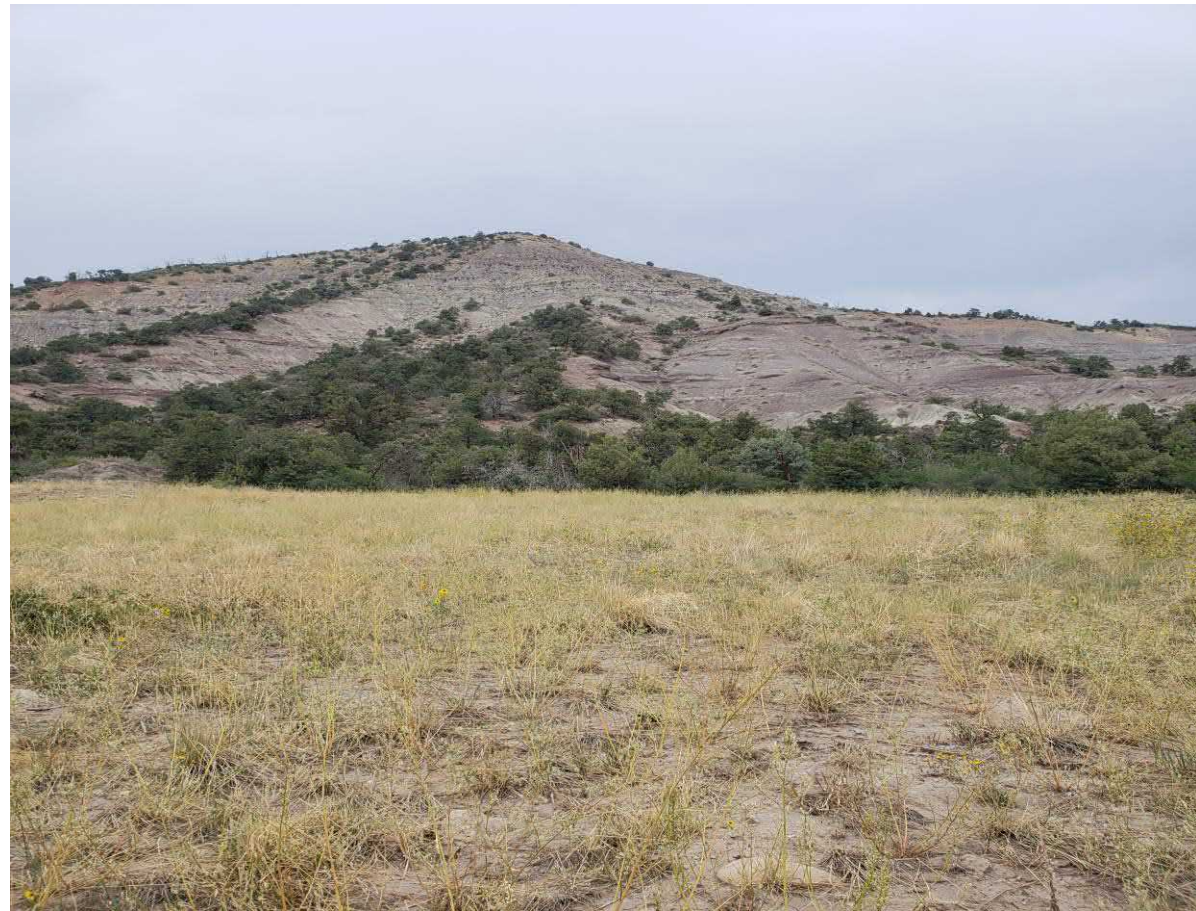
Removed, bagged, and disposed of the flowering Musk Thistles within the project area.
