Inspection Photos  
Operator: WPX Operating  
API: 067-05431  
Date: 8/18/2020

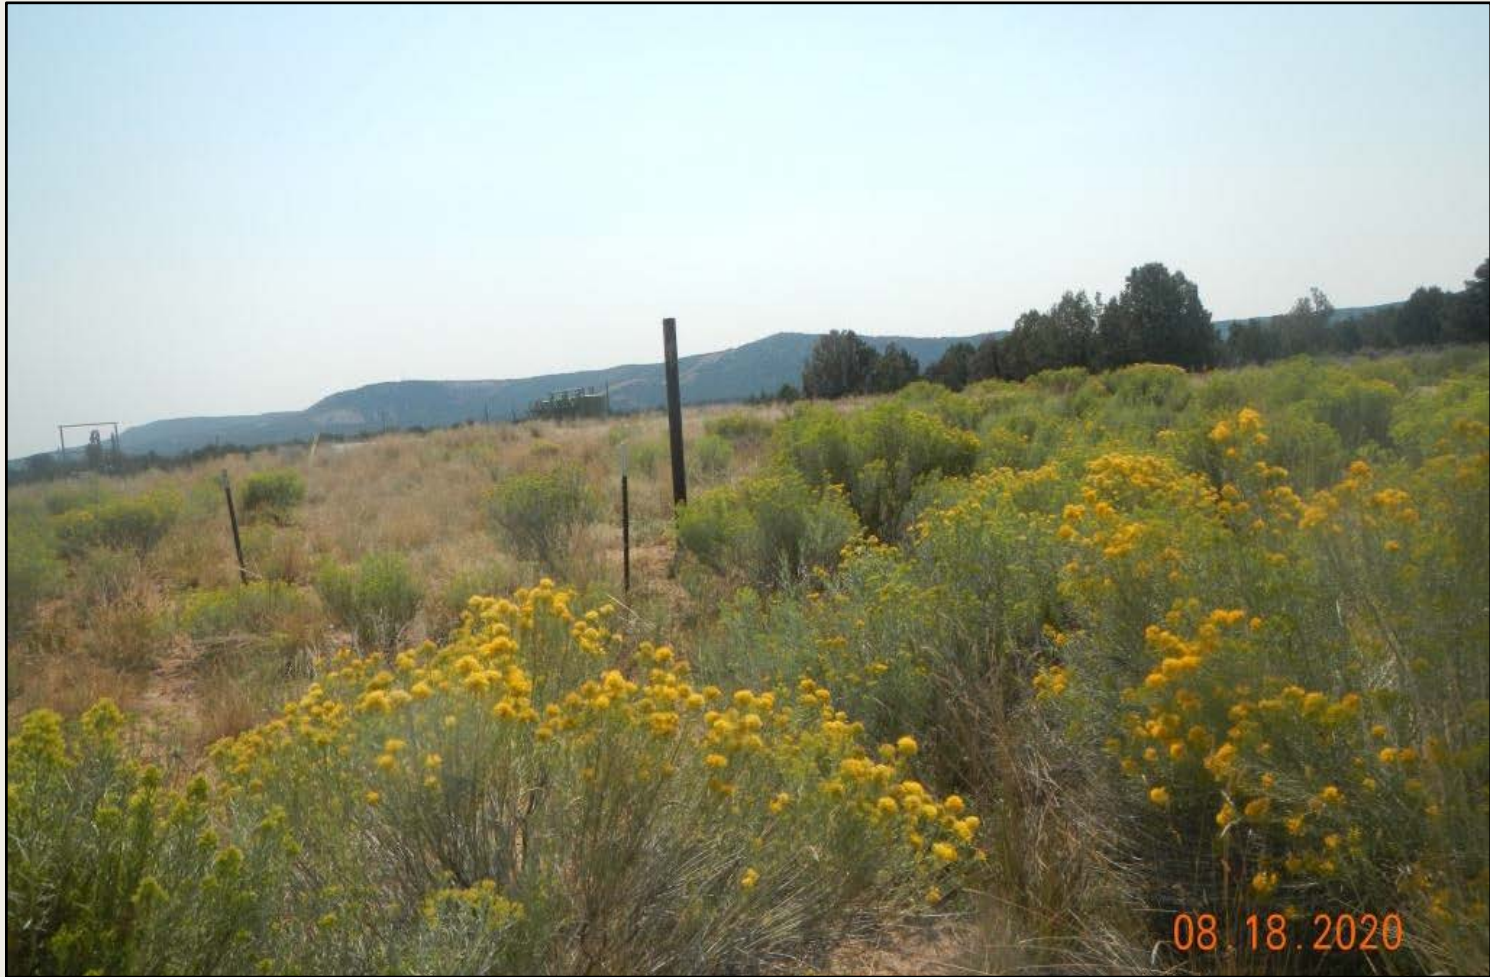
Photo 1. View of the project area from the northwestern edge facing center. Plugged well marker observed.

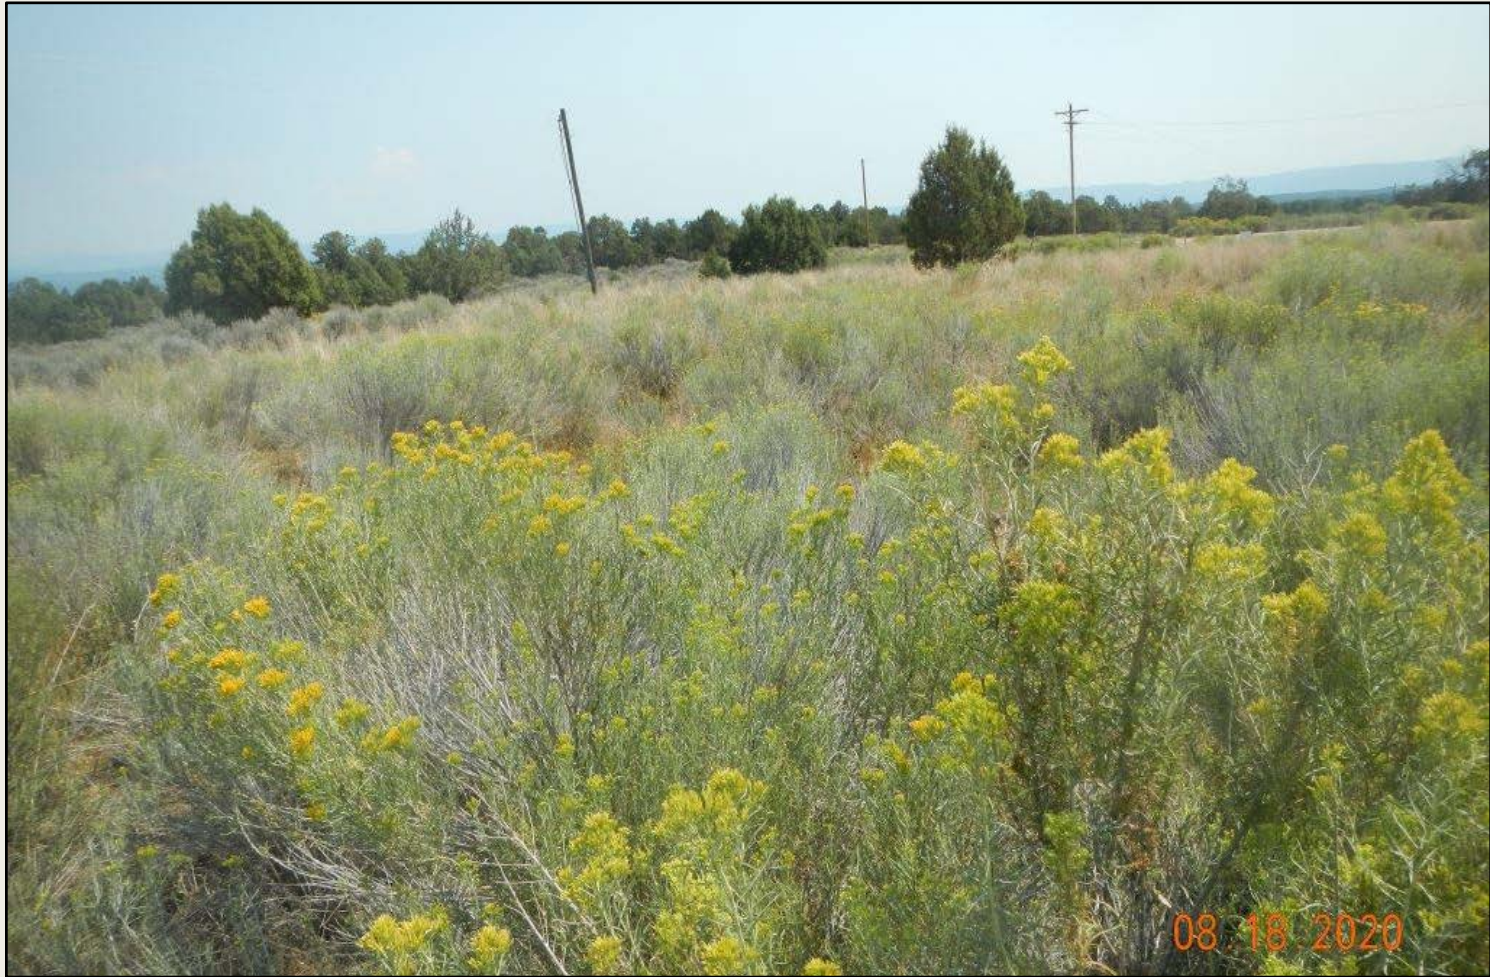
Photo 2. View of the northern project area, revegetation is progressing with rubber rabbitbrush, crested wheatgrass, and western wheatgrass.

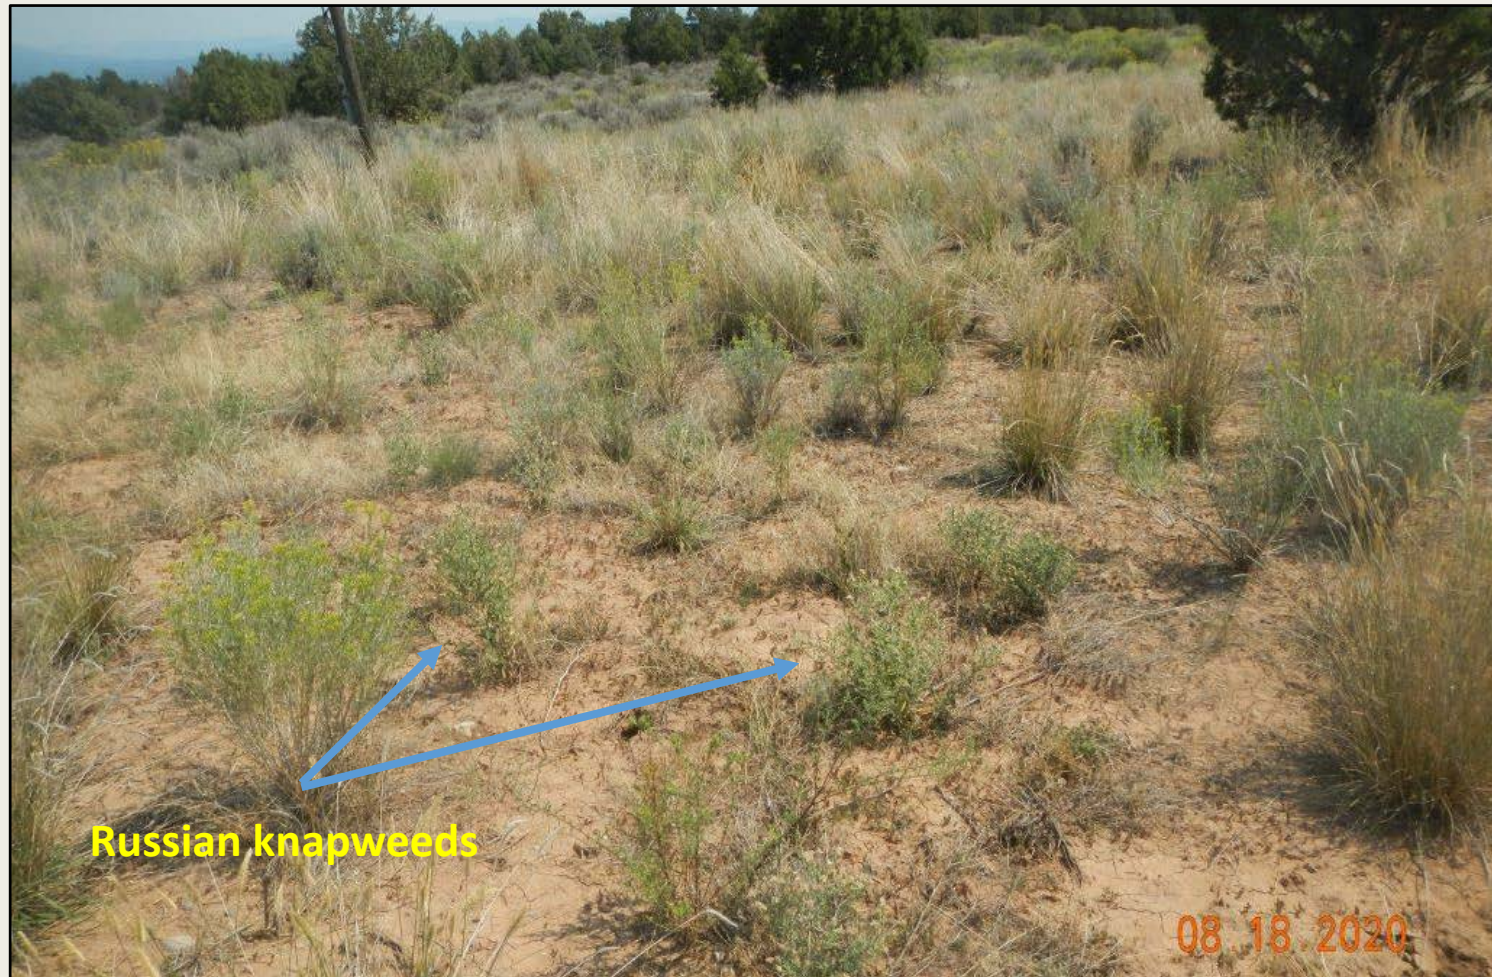
Photo 3. View of revegetation in the northern project area. Revegetation is approaching reclamation standards, however, approximately 200-300 Russian knapweeds interspersed within this portion of the reclamation area. Revegetation is progressing with crested wheatgrass, rubber rabbitbrush, squirreltail, and purple asters.

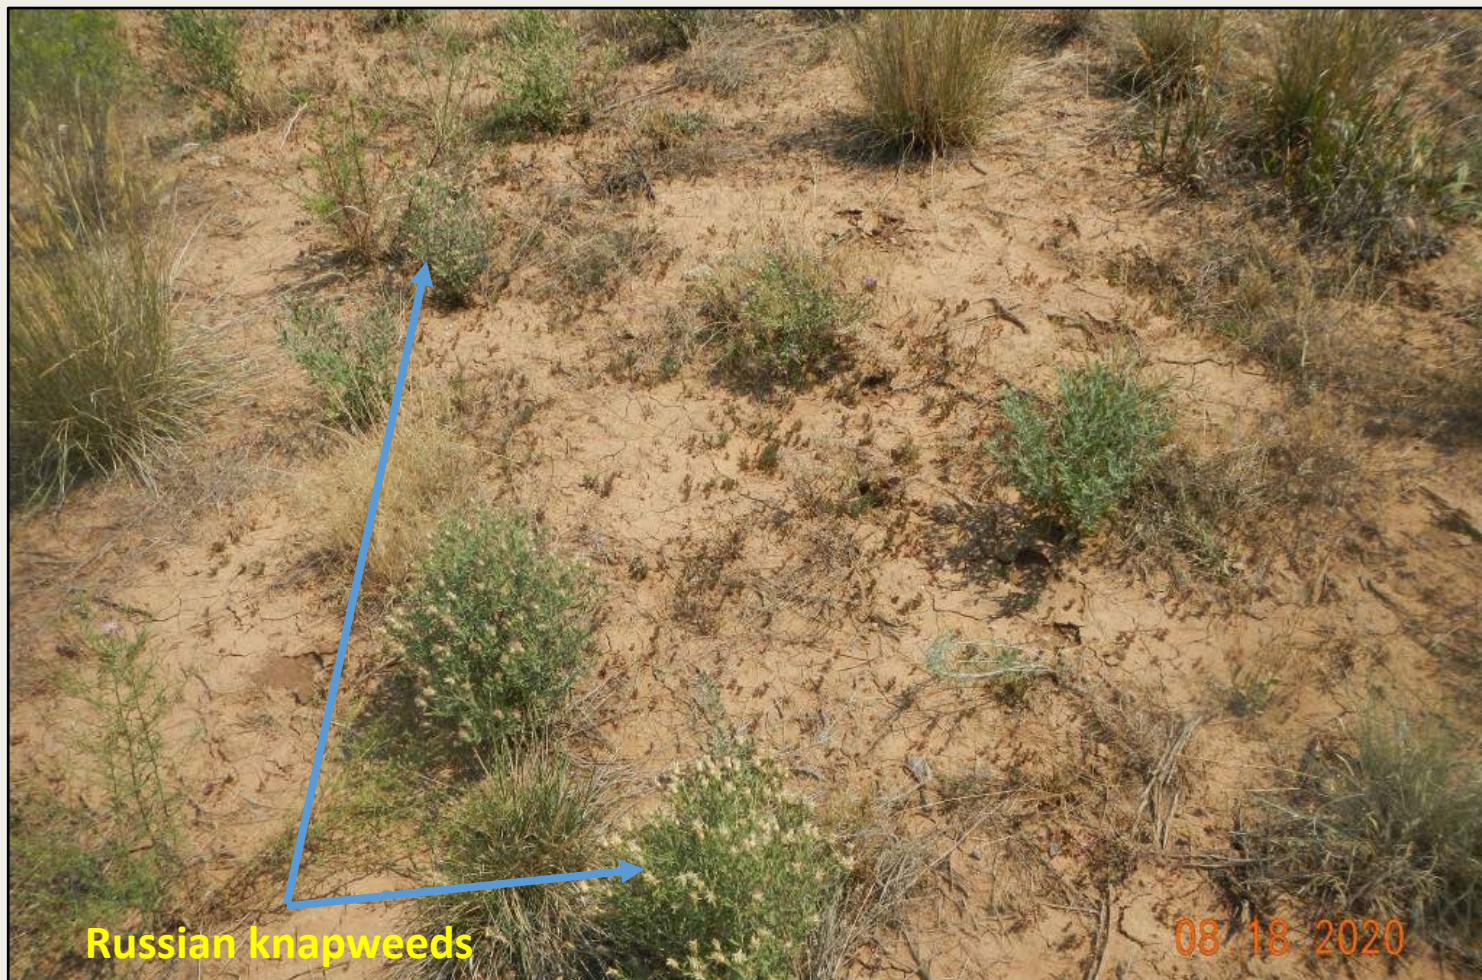
Photo 4. Another view of Russian knapweeds within the northern project area.

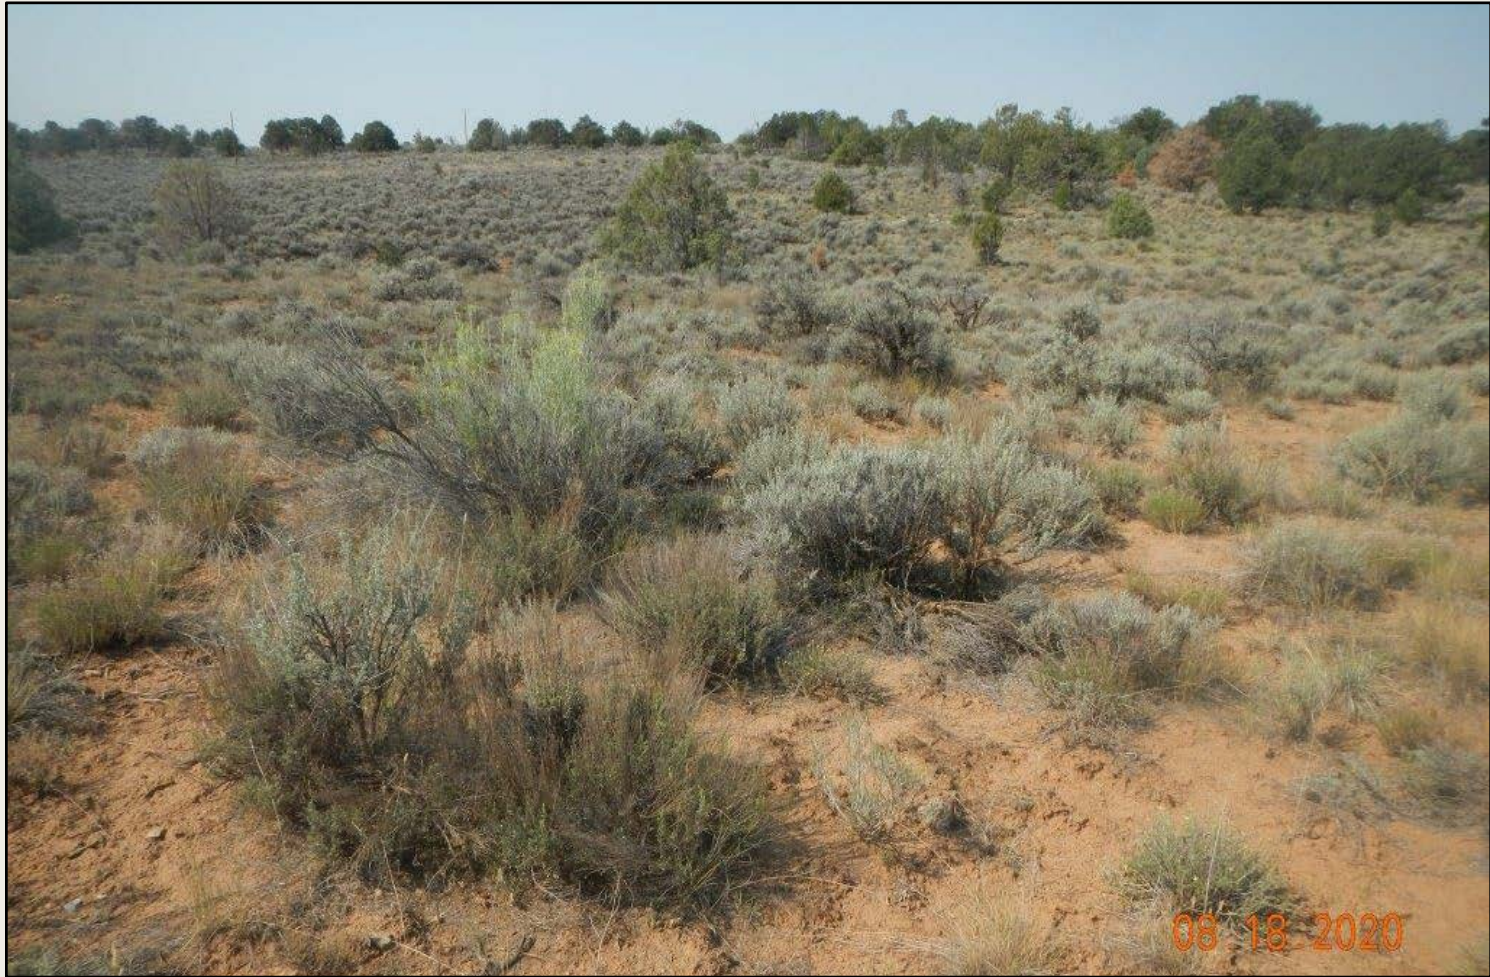
Photo 5. View of reference area comprised of sagebrush shrubland, with black sage and big sagebrush, scattered pinyon and ponderosa pine trees, with an understory of squirreltail, blue grama, purple three-awn, penstemons, and purple asters.
