Inspection Photos  
Operator: Hilcorp Energy  
API: 067-08737  
Date: 8/27/2020

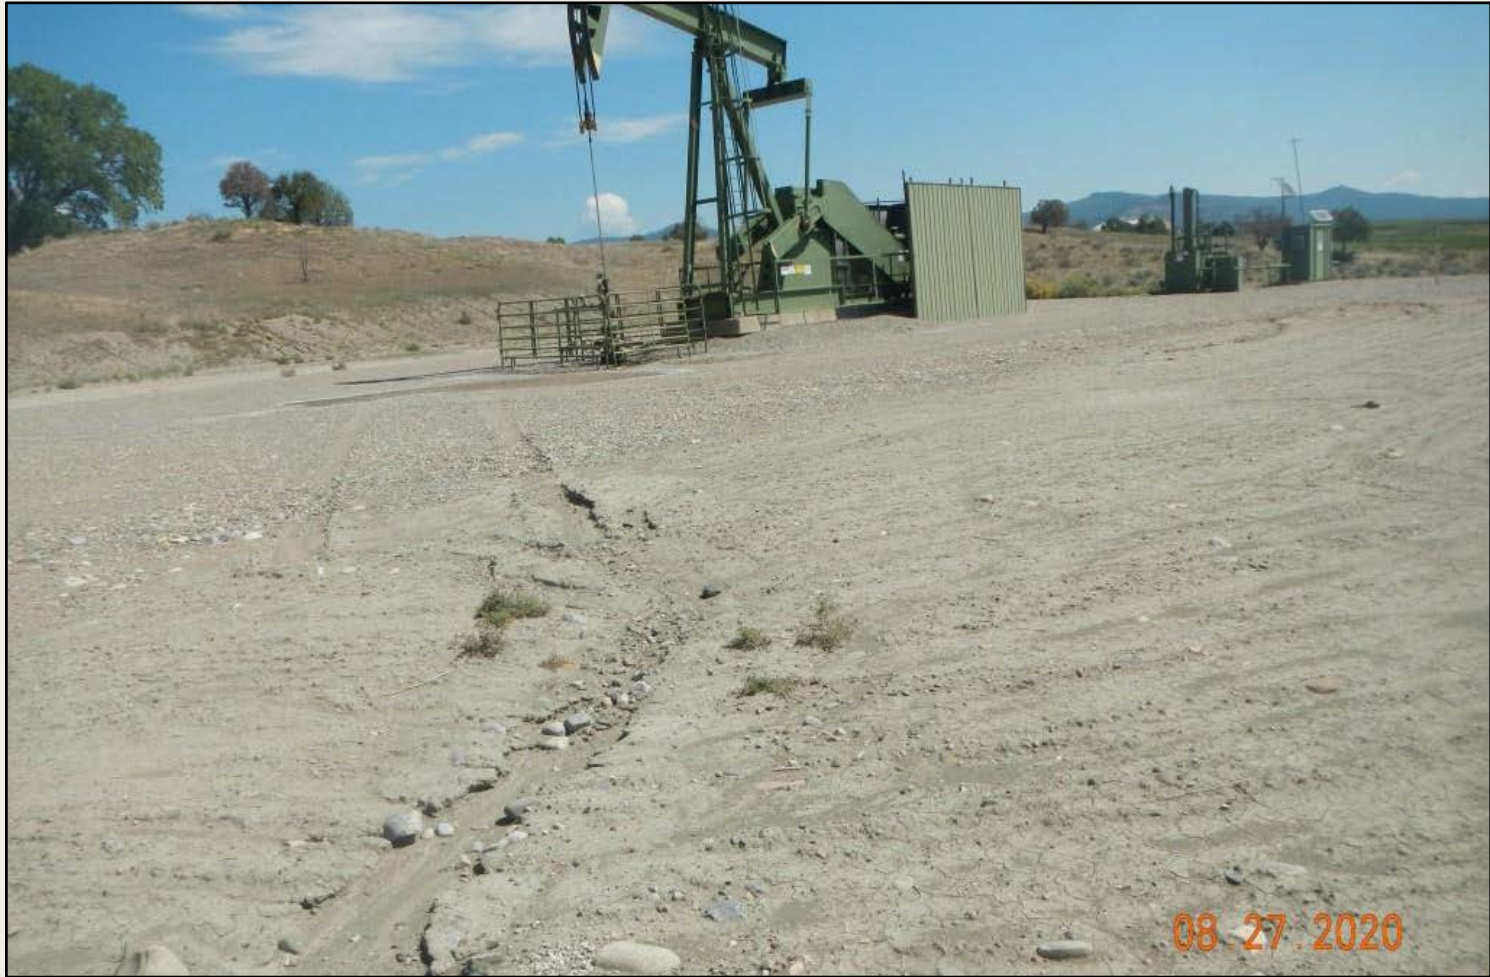
Photo 1. View of the project area from the southwestern edge facing center.

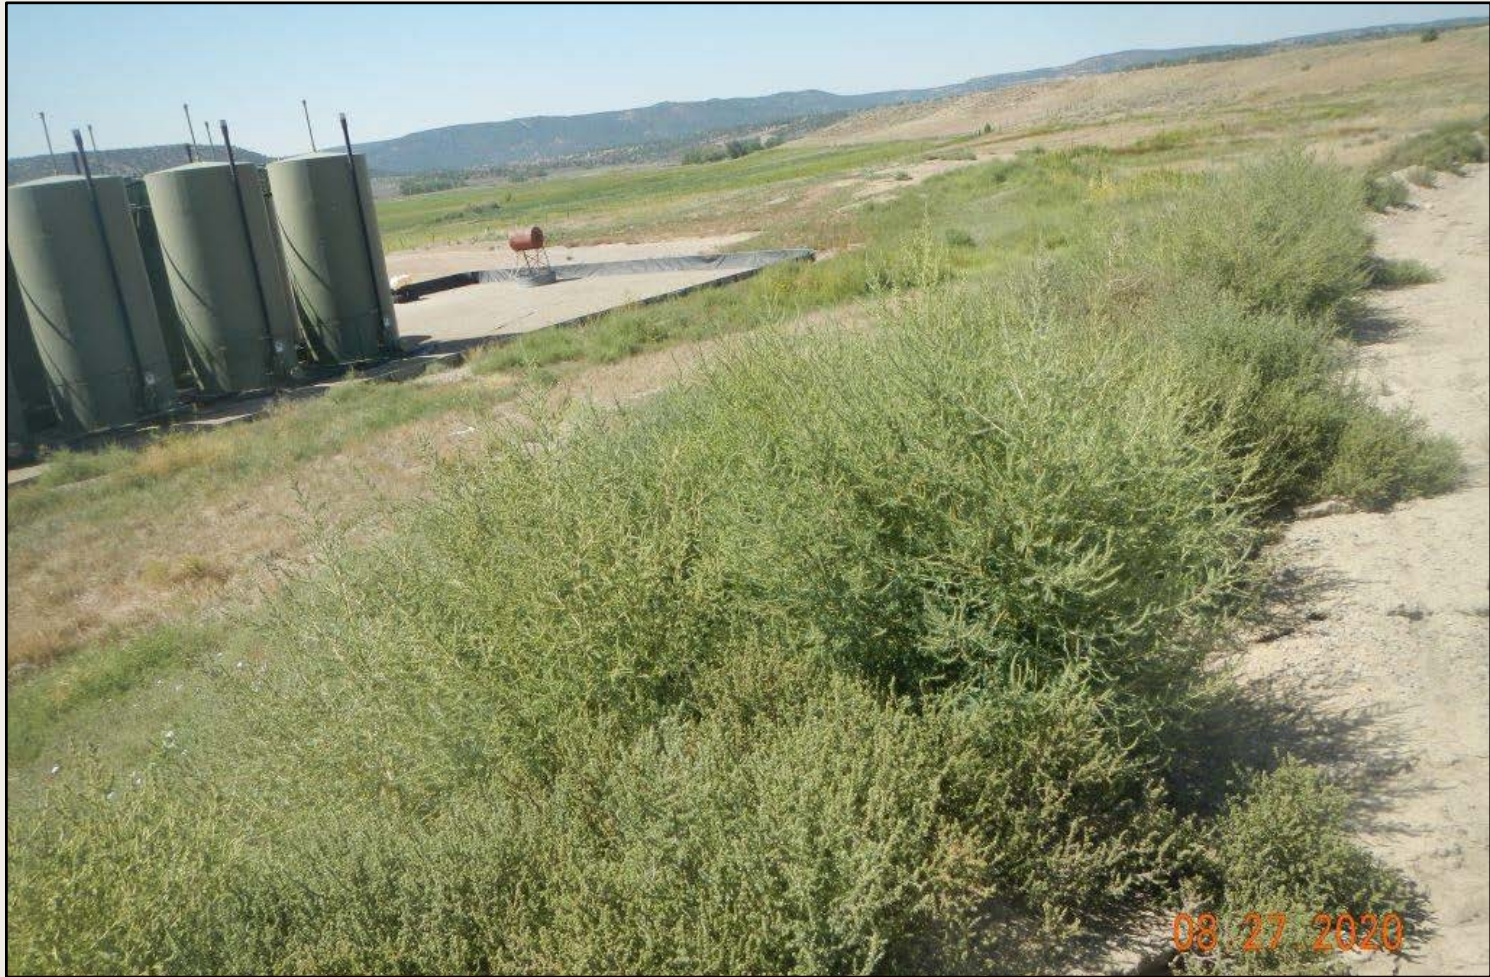
Photo 2. View of the southern fill slope facing westward. Dense Russian thistle and kochia growing up to 4-feet tall within the reclamation areas.

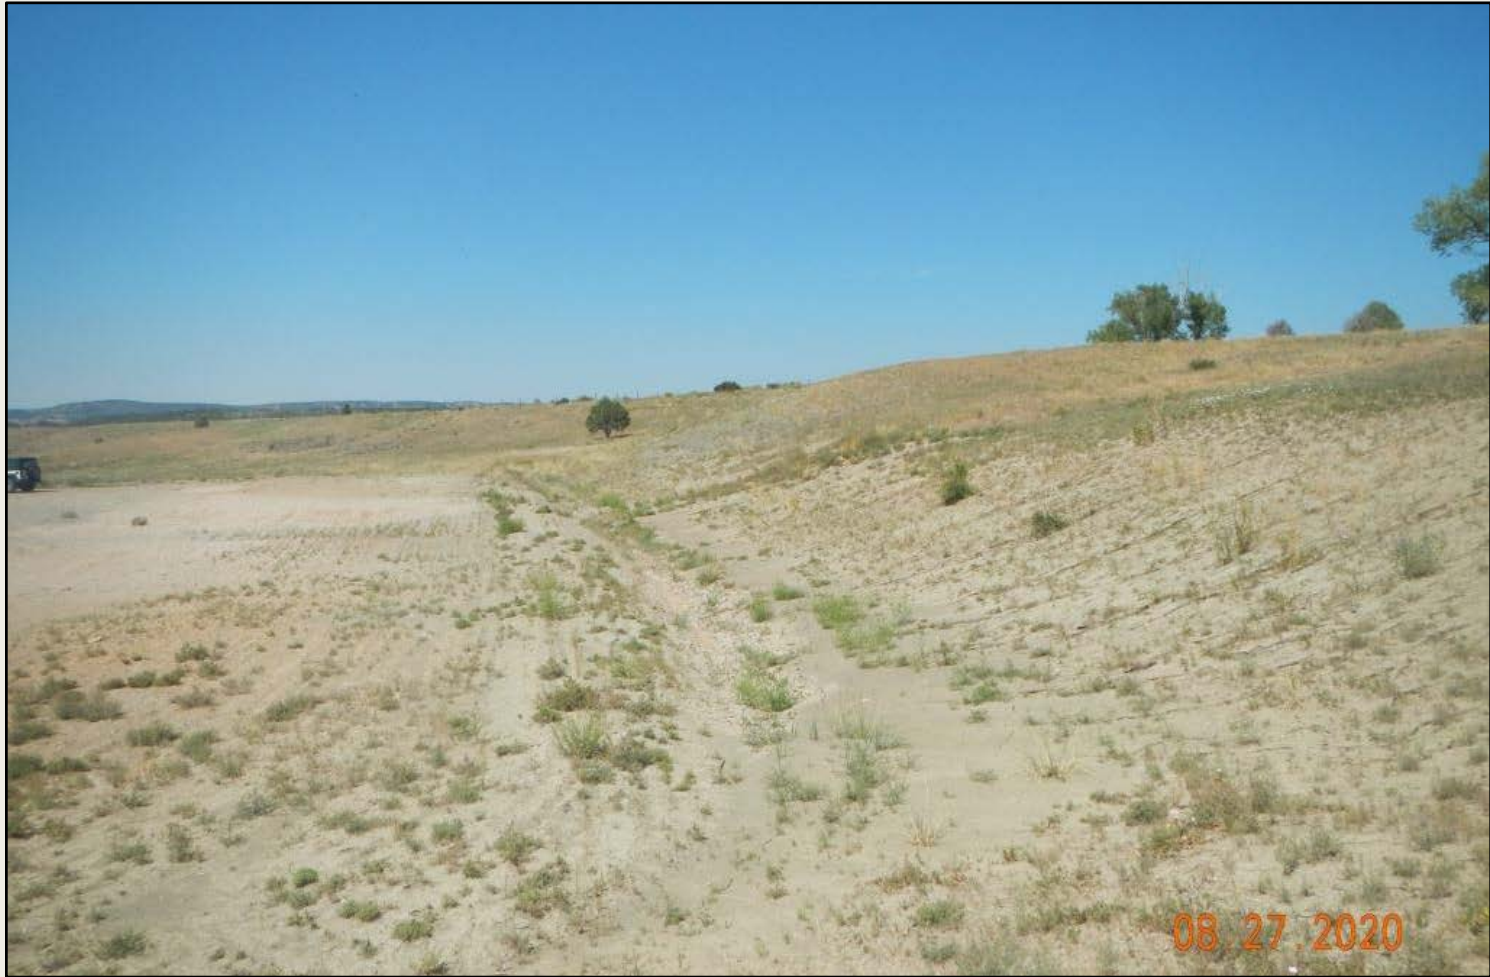
Photo 3. View of the northern cut-slope and revegetation areas. Some desirable vegetation becoming established, although many areas remain sparse/bare.

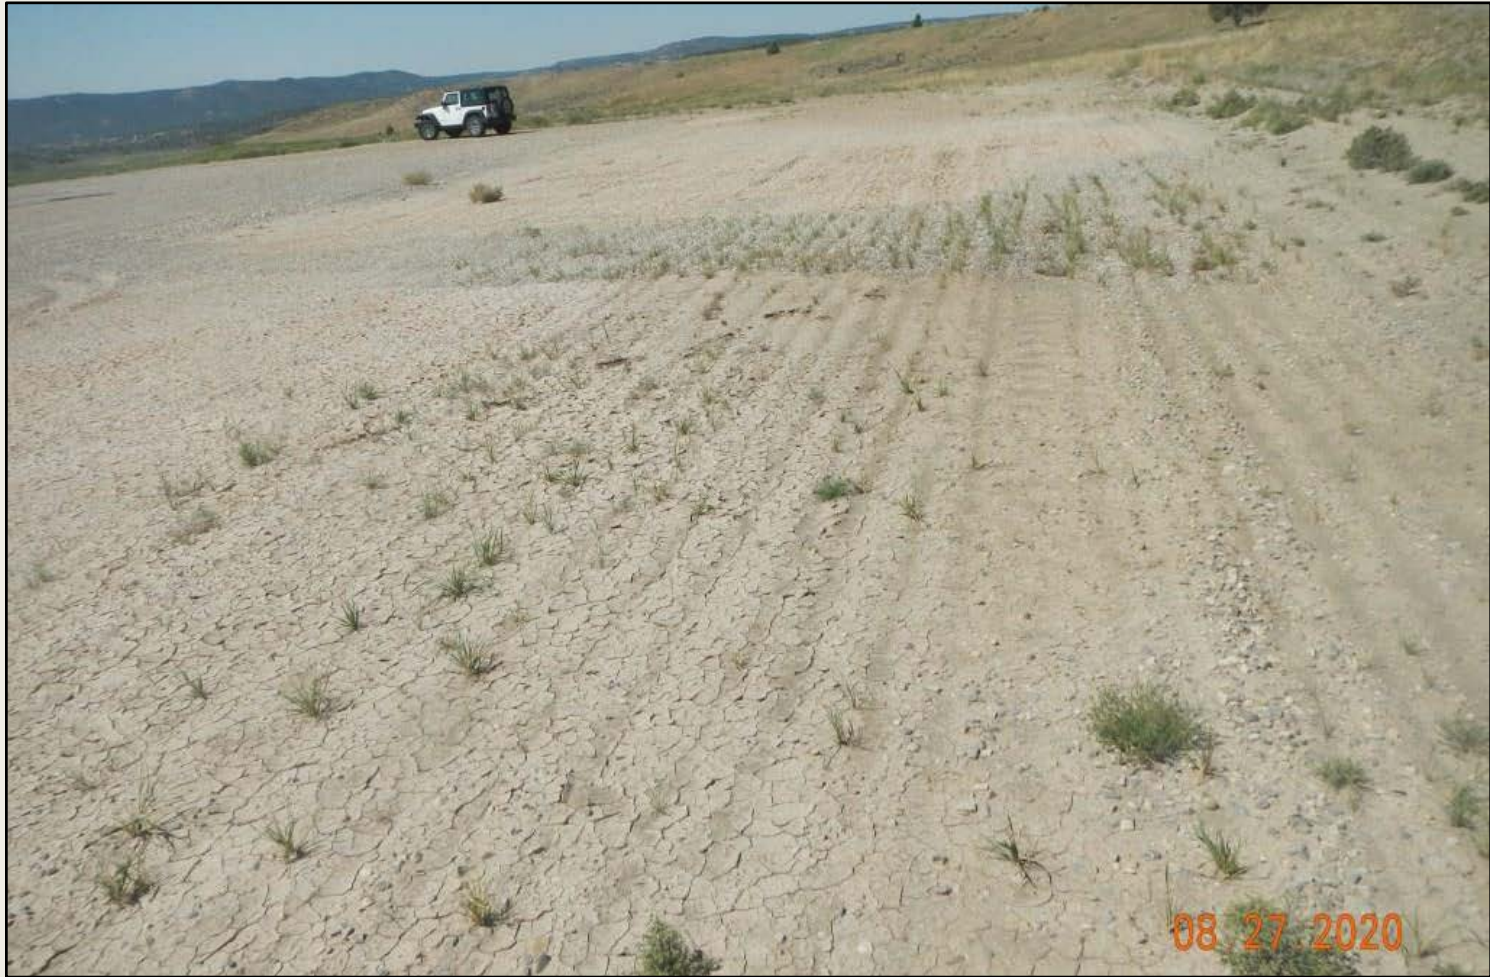
Photo 4. View of reclamation area in the northern project area. Scattered germination of desirable species observed, however significant portions of the area remain bare.

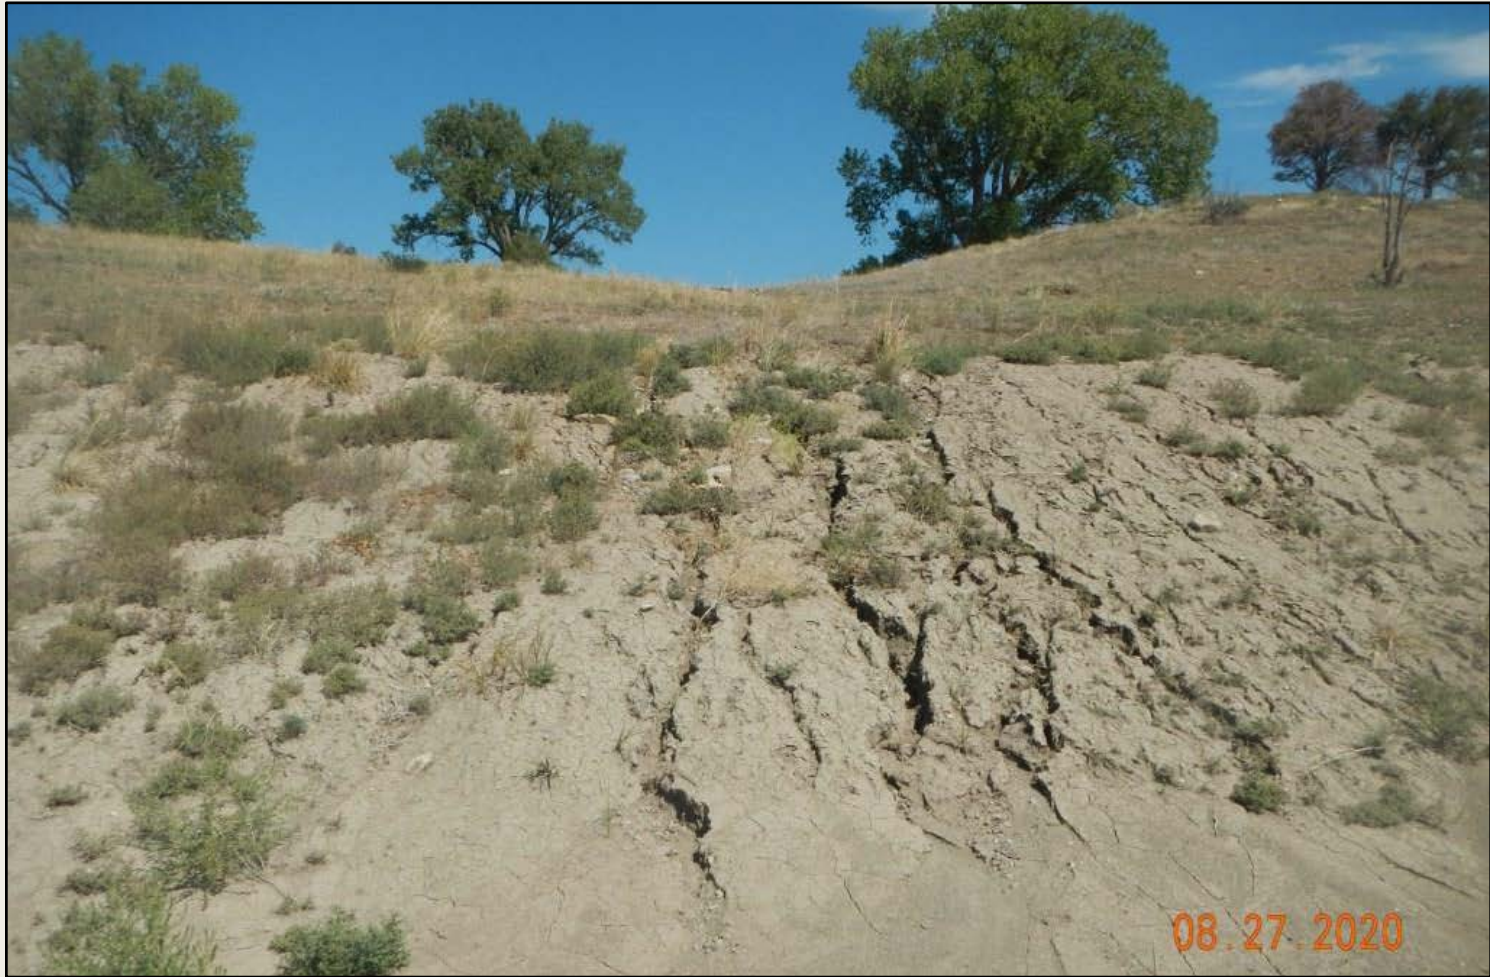
Photo 5. View of erosional rilling and sediment deposition that continues on the well pad cut-slopes.

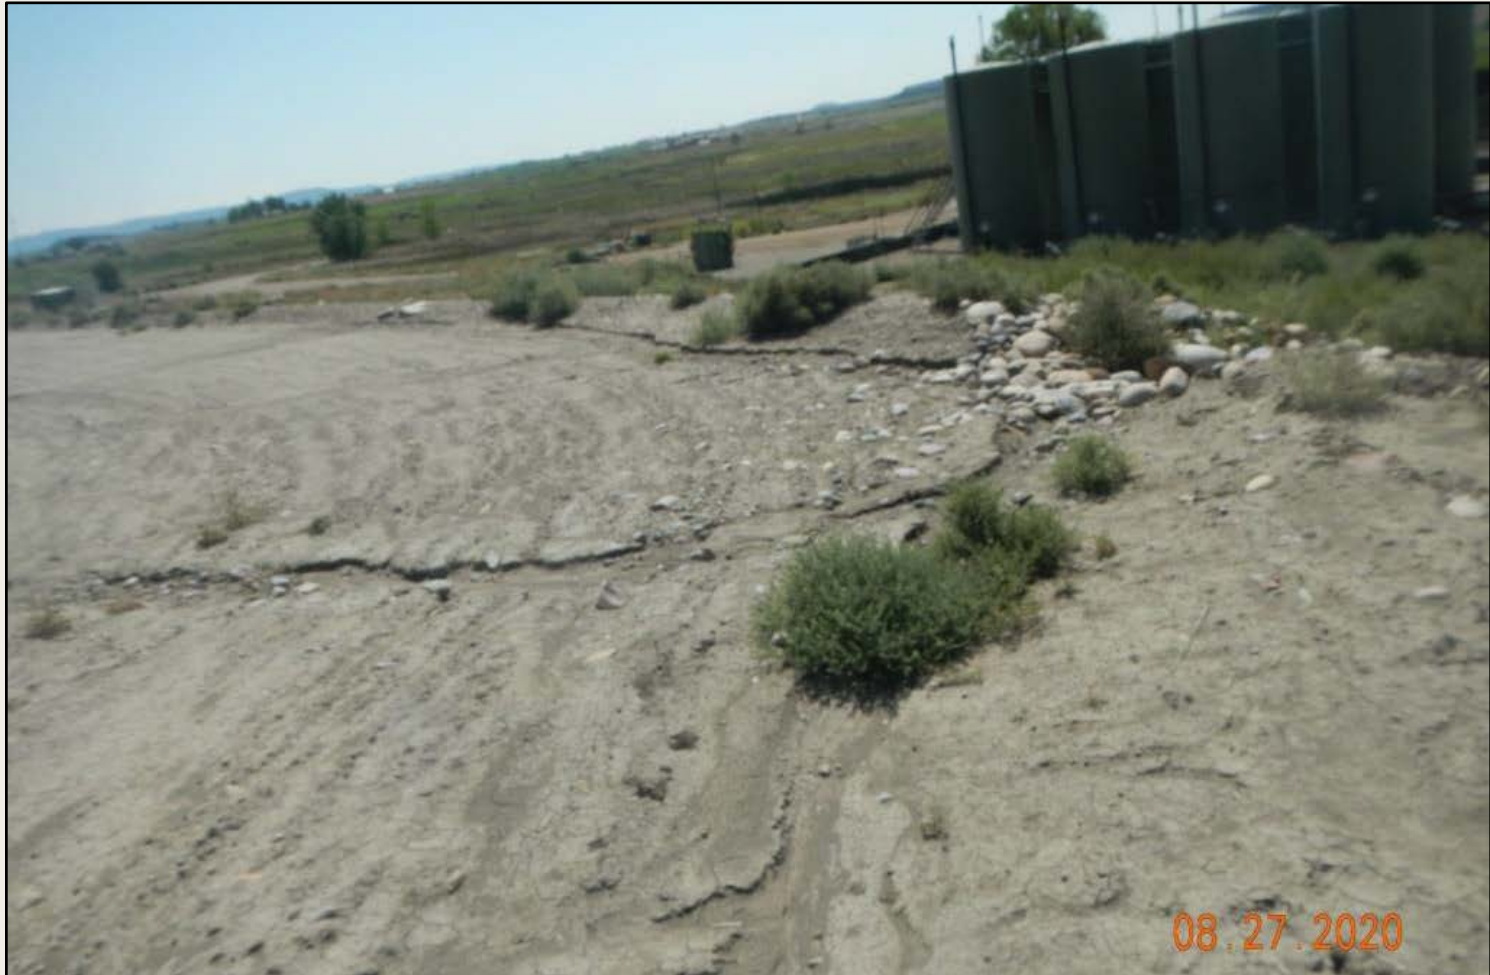
Photo 6. View of continued erosion occurring within the southwestern project area.

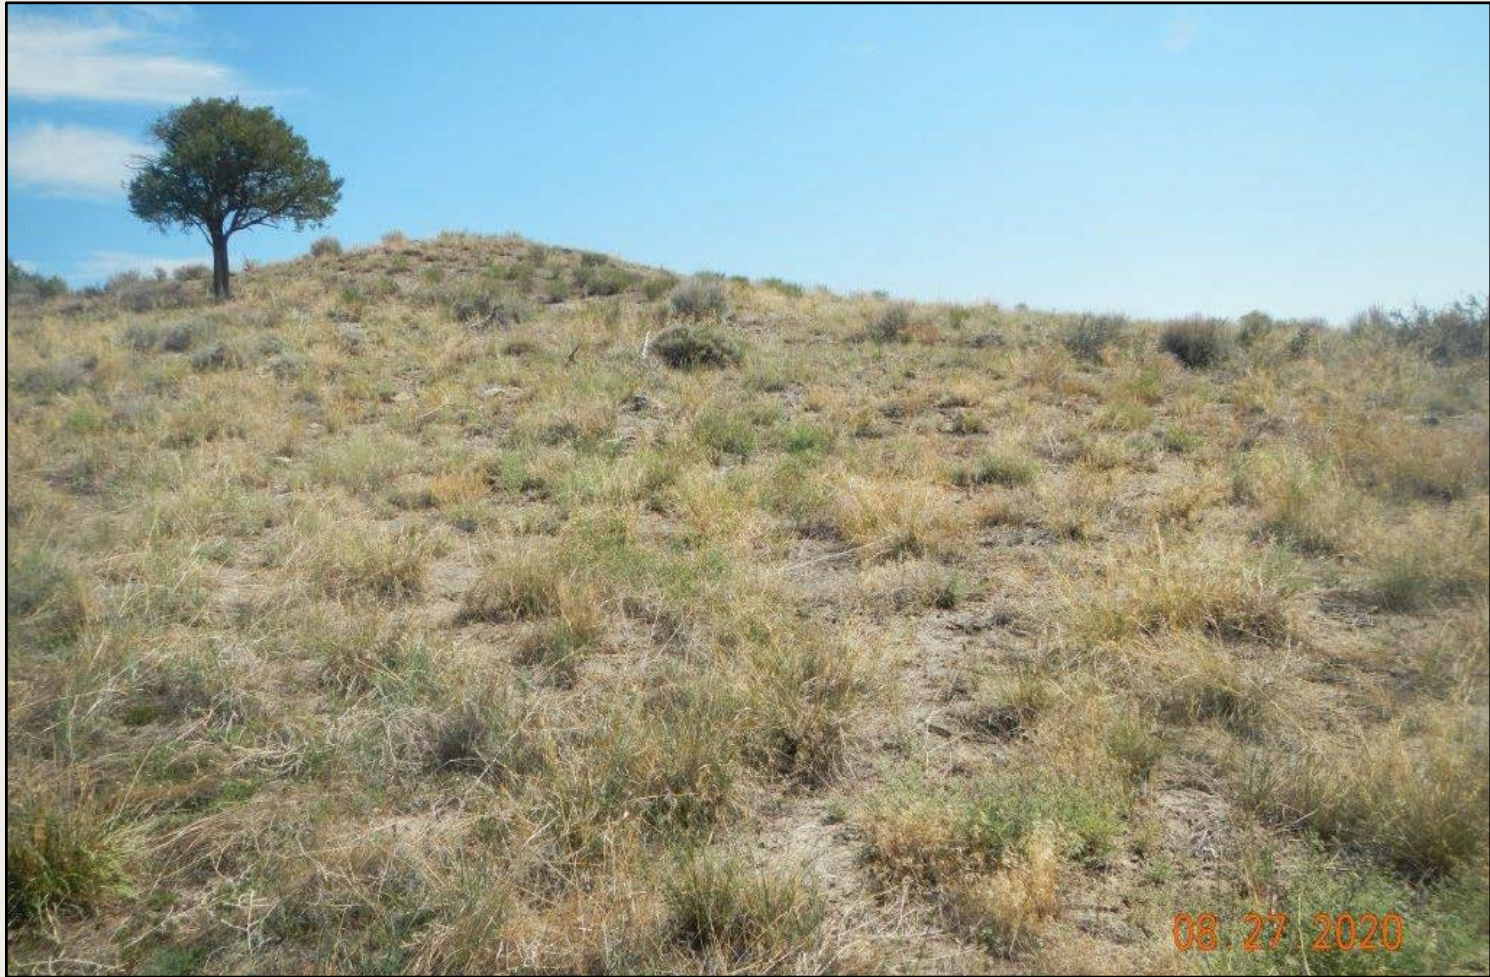
Photo 6. View of reference area vegetation comprised of black sagebrush shrubland with grasses and forbs such as Indian ricegrass, lanceleaf buckwheat, and needleandthread grass.
