Inspection Photos

API: 071-07186

Operator: TIMBER CREEK OPERATING

Inspection Date: 8/27/2020

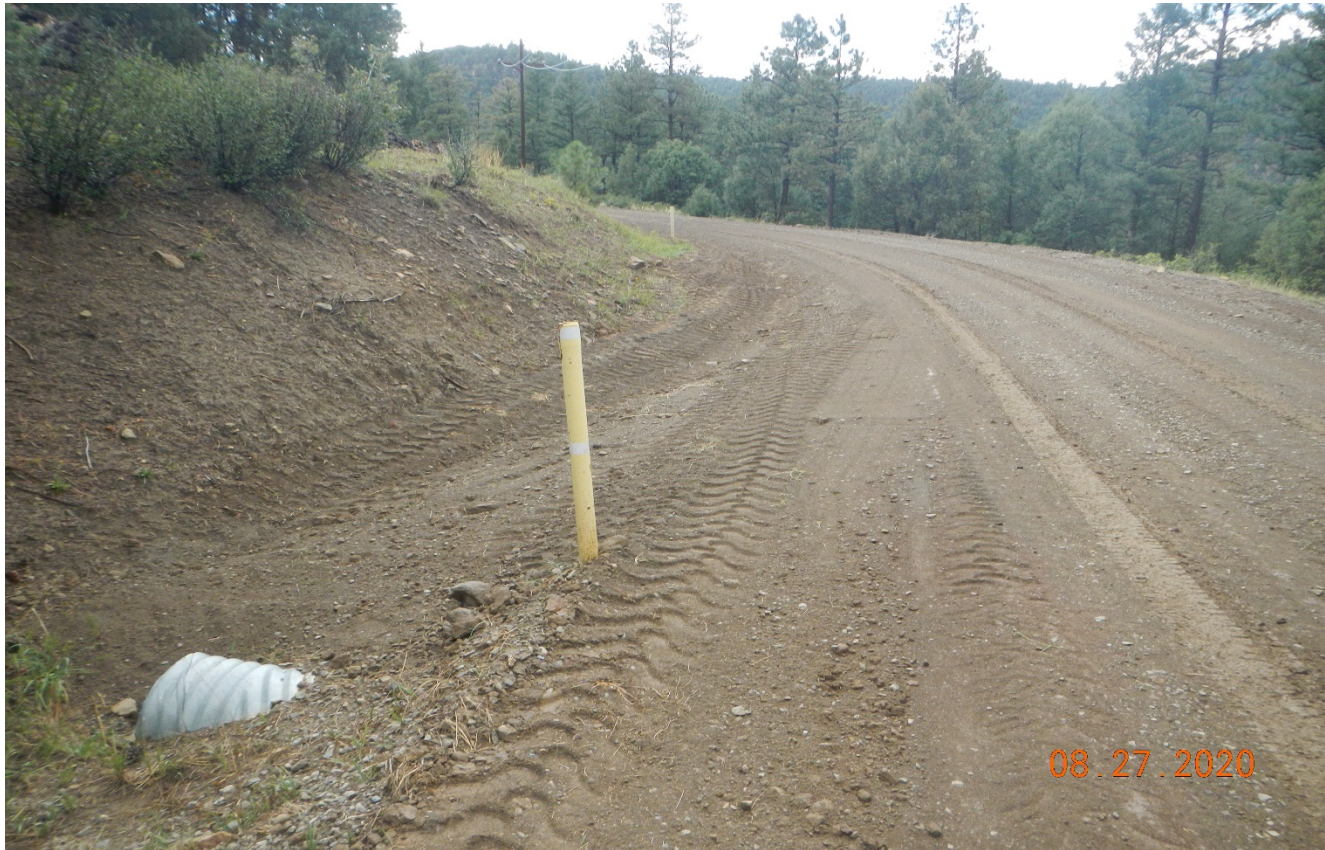
Photo 1. The road has been regraded near the location and the culvert is maintained.

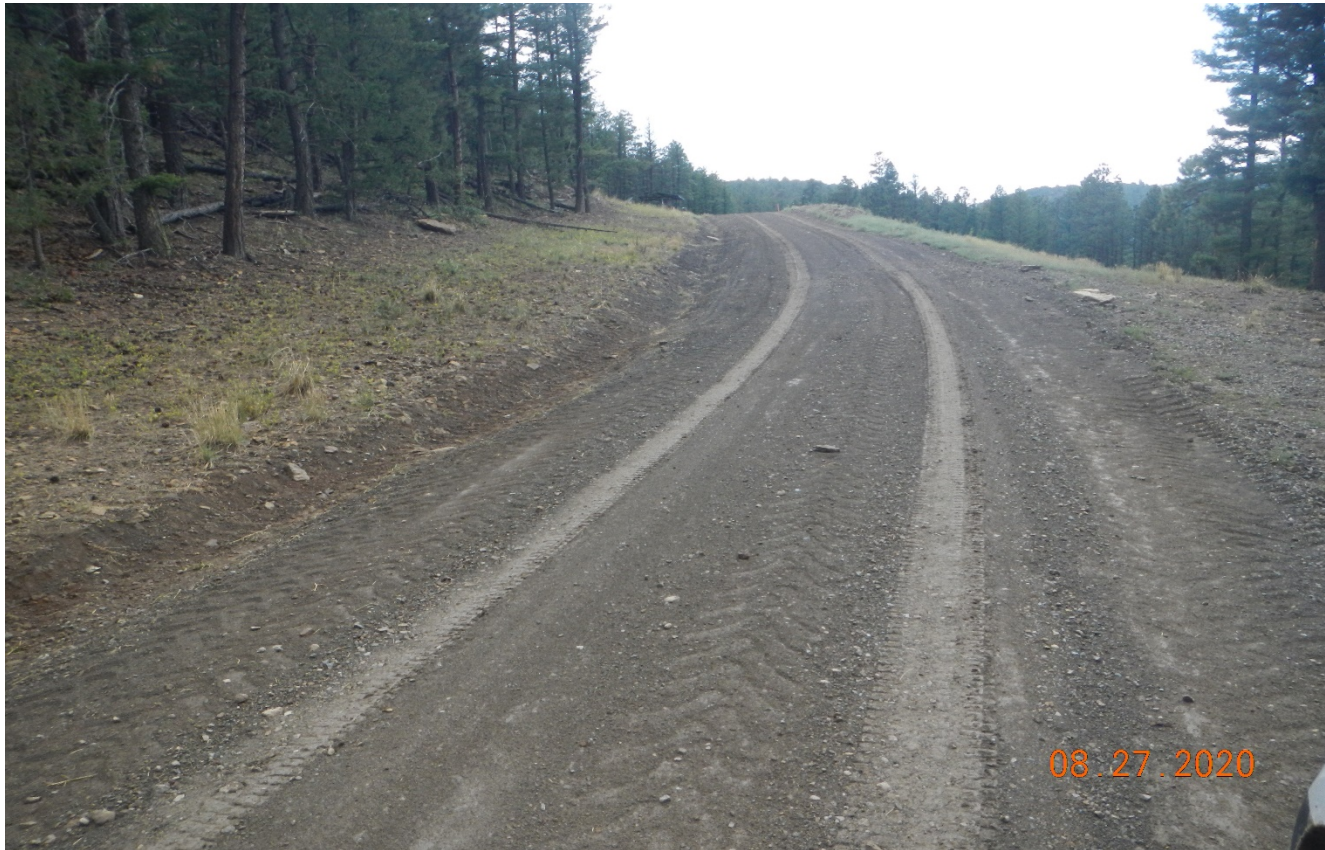
Photo 2. Facing west near the location. The erosion has been repaired and road regraded. BMP's may be needed along the road to dissipate stormwater flow.

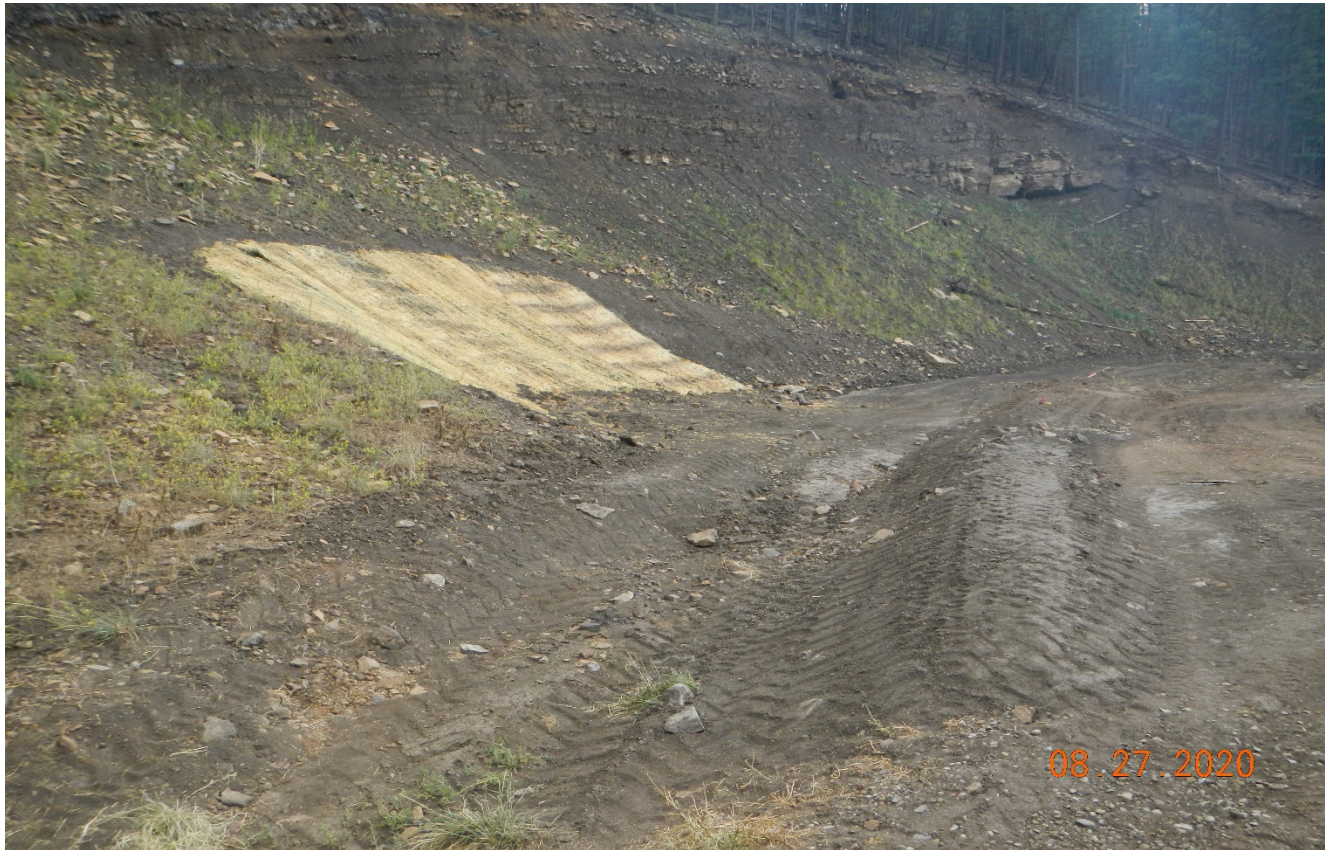
Photo 3. There is straw blanket installed along a portion of the cut slope.

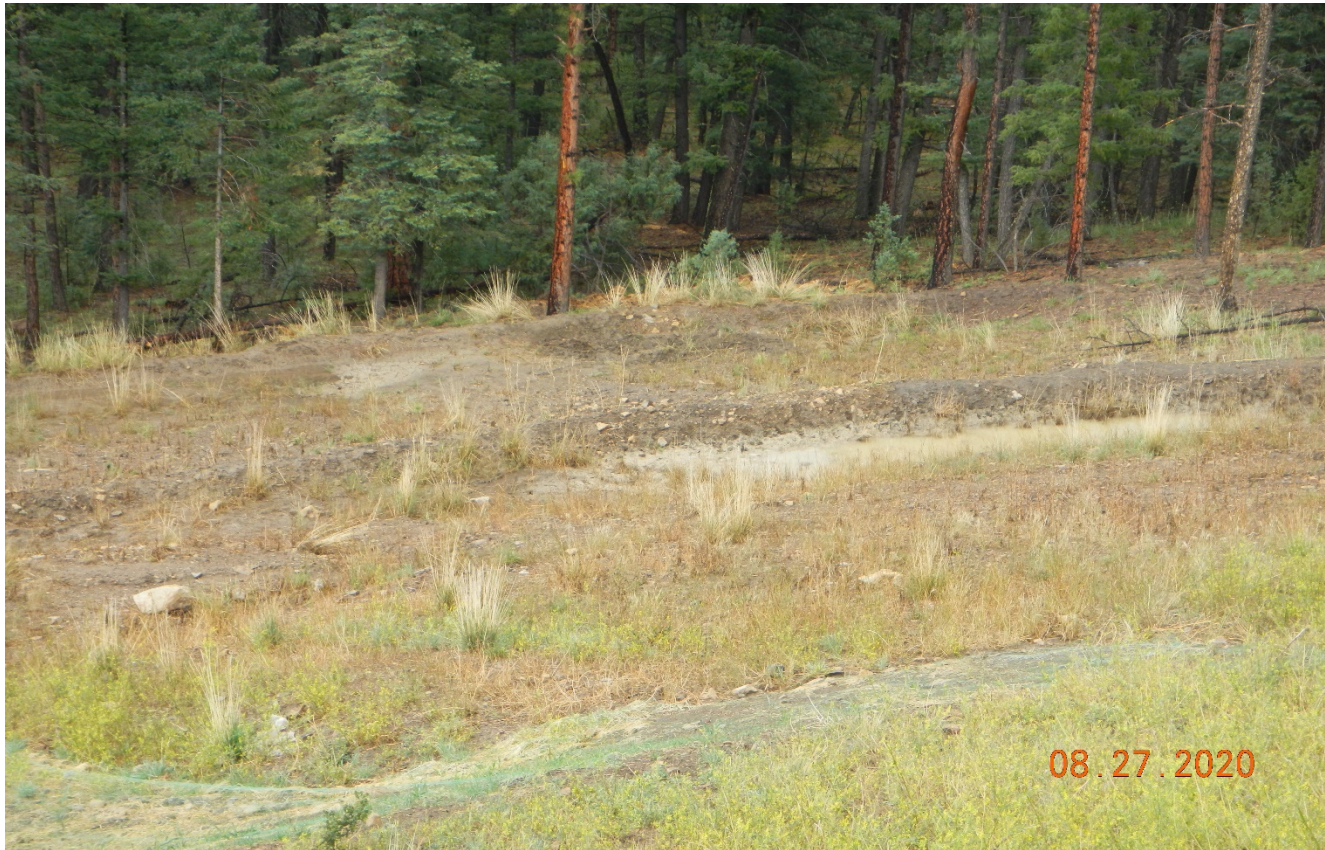
Photo 4. The berms along the bottom of the fill slope have been repaired.

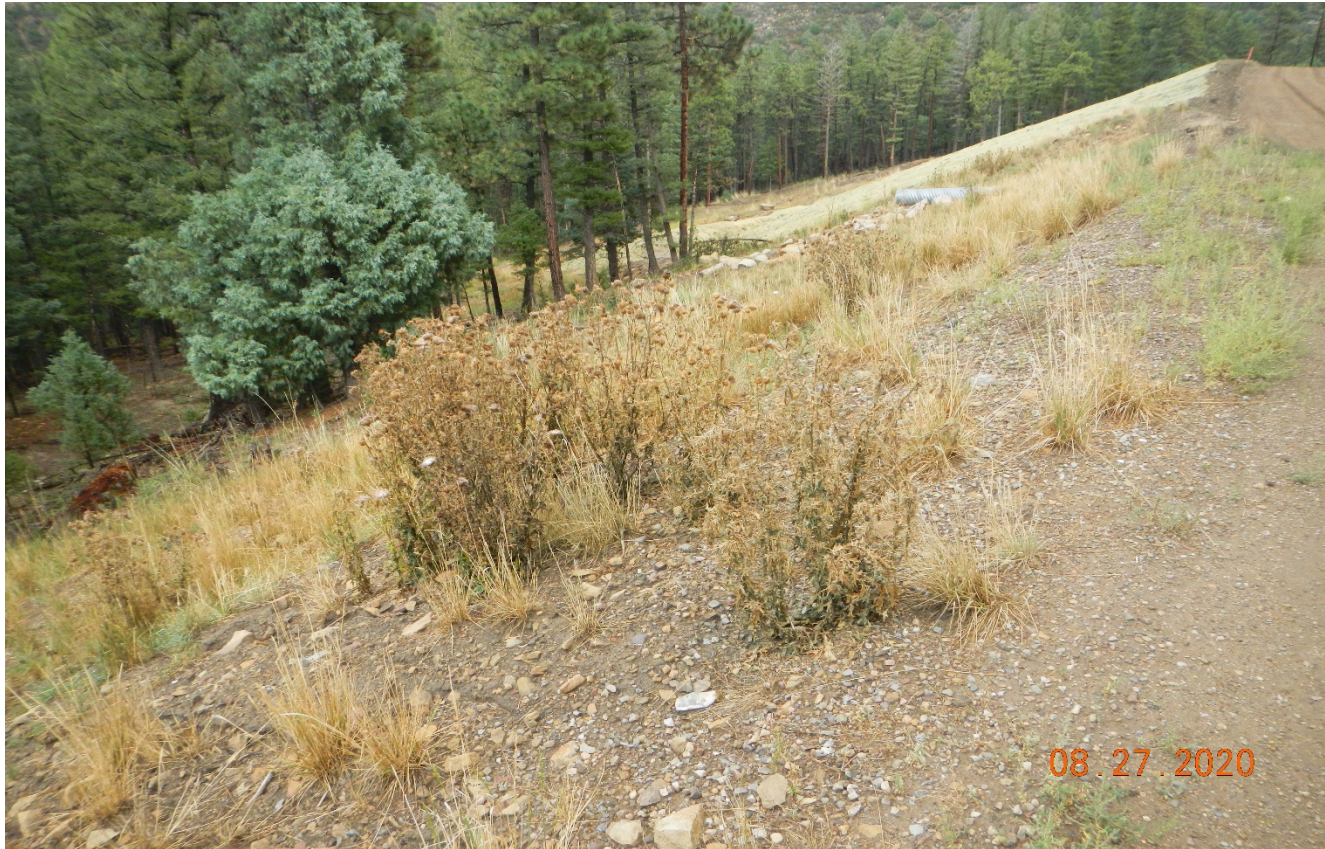
Photo 5. It appears noxious weeds are wilted from herbicide treatment.

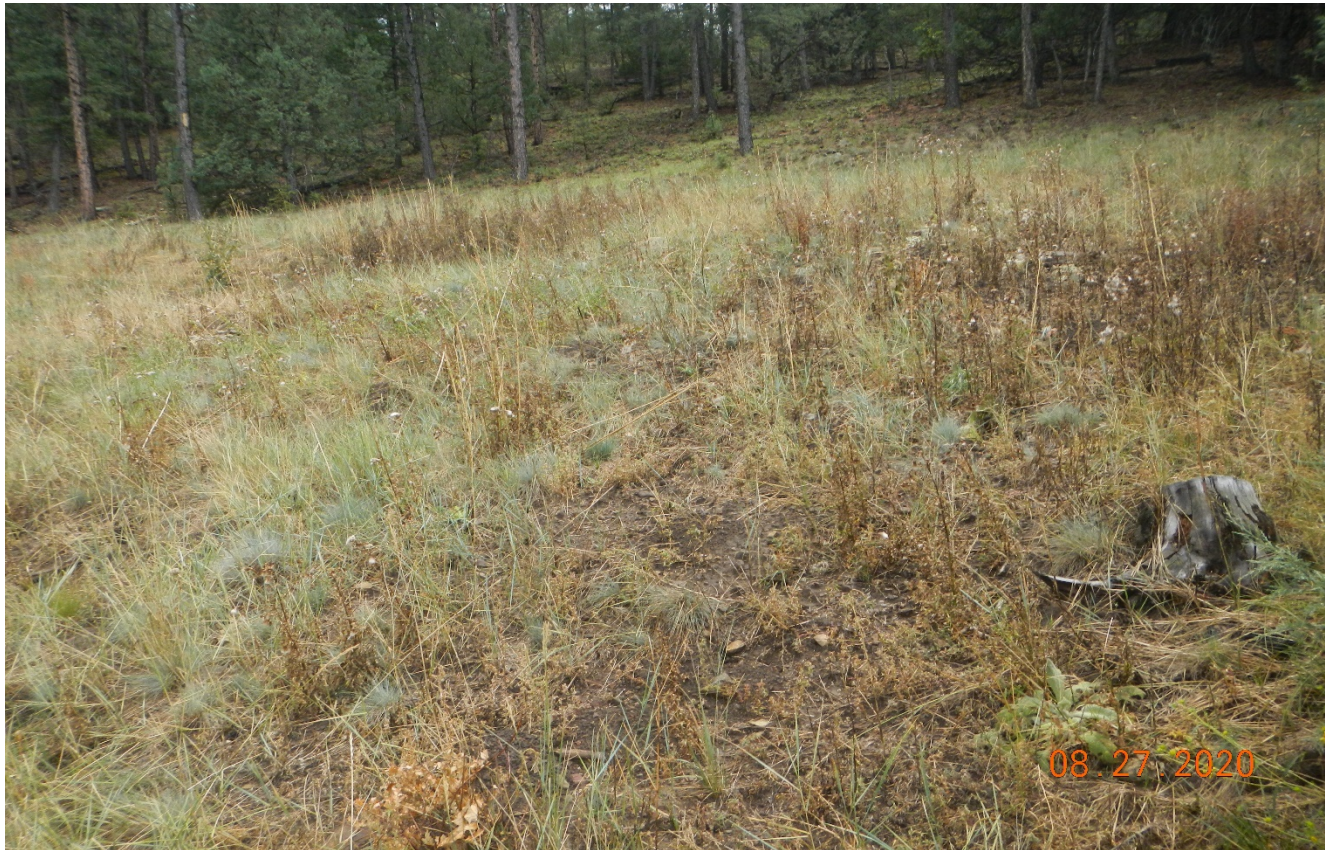
Photo 6. Further along the road noxious weeds appear to have been controlled however, the weeds have begun to produce and disperse seed.
