Construction and Stormwater Inspection

August 26, 2020

Operator: GULF EXPLORATION LLC- #10728

Location ID: 456859

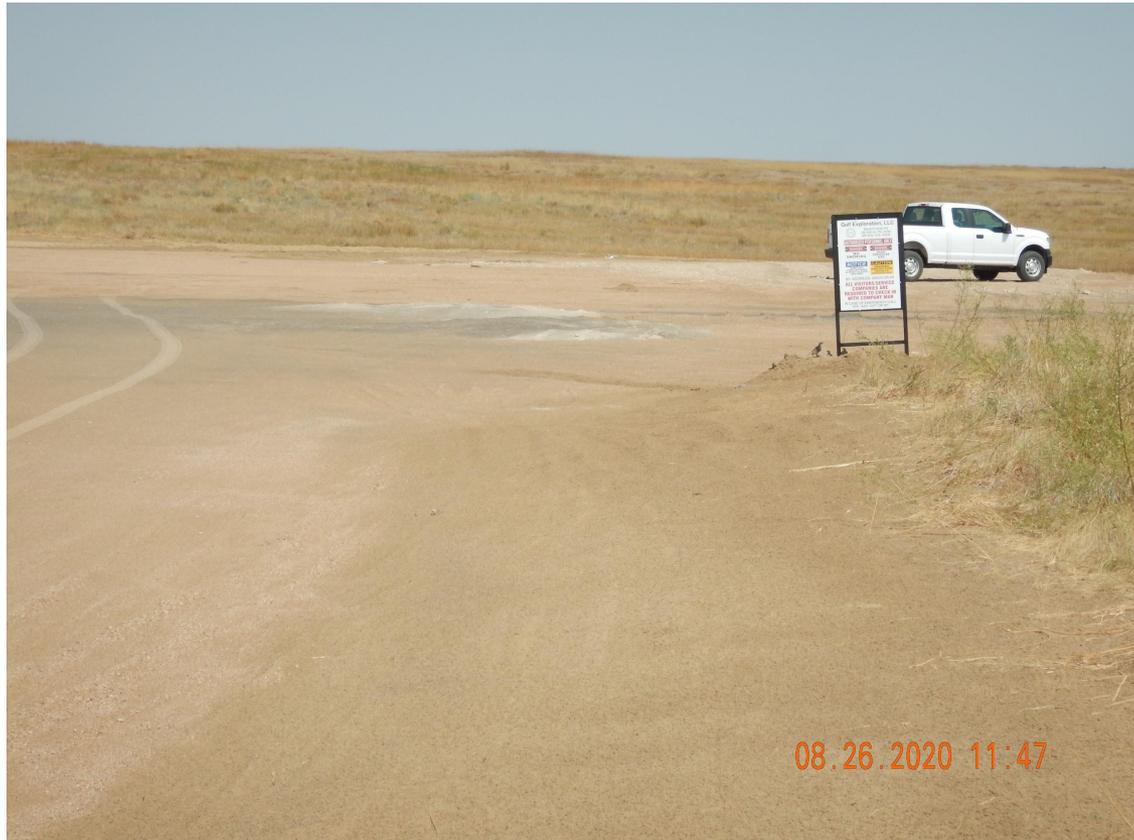
Photo 1. Photo taken from the access road, facing North. Photo illustrates the Operator sign at the entrance of location.

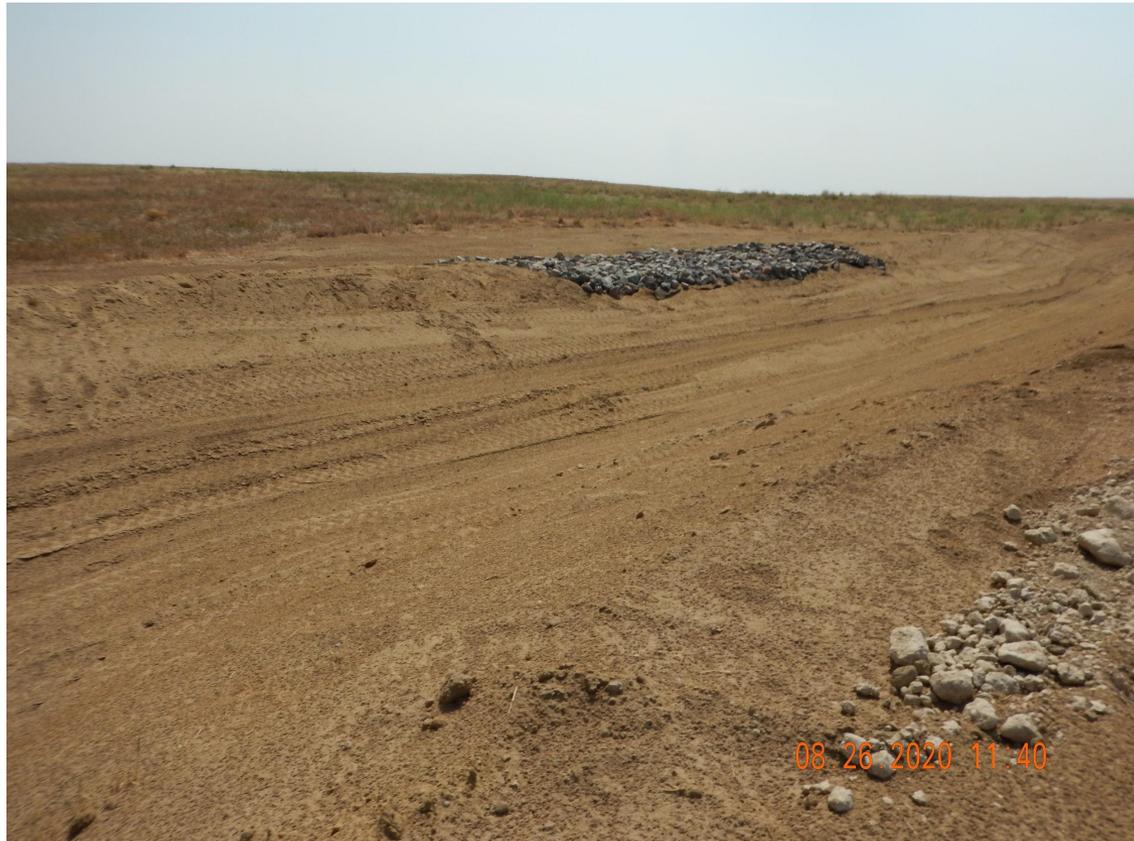
Photo 2. Photo taken from the northeastern location, facing Southeast. Photo illustrates stormwater BMPs- retention area, and a stabilized outlet. Stormwater BMP areas will likely need to be stabilized due to the sandy soil.

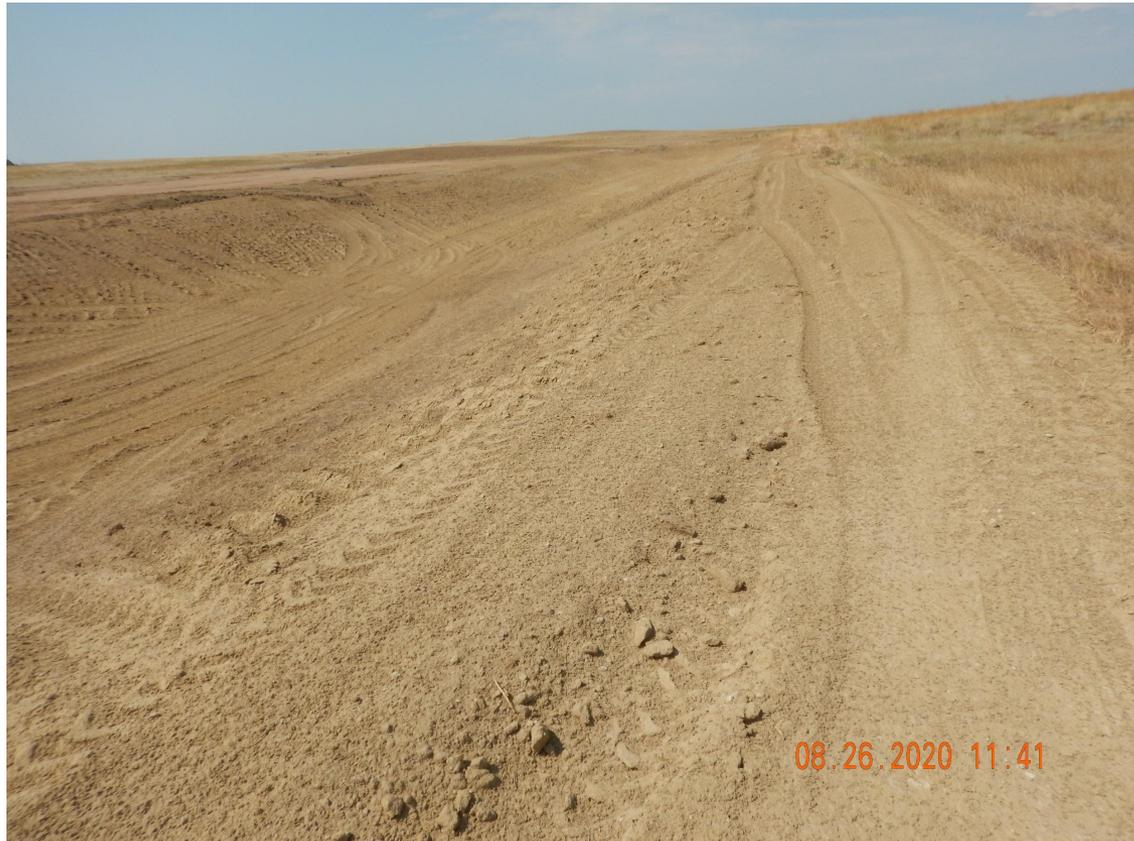
Photo 3. Photo taken from the northeastern location, facing West. See comments under Photo 2.

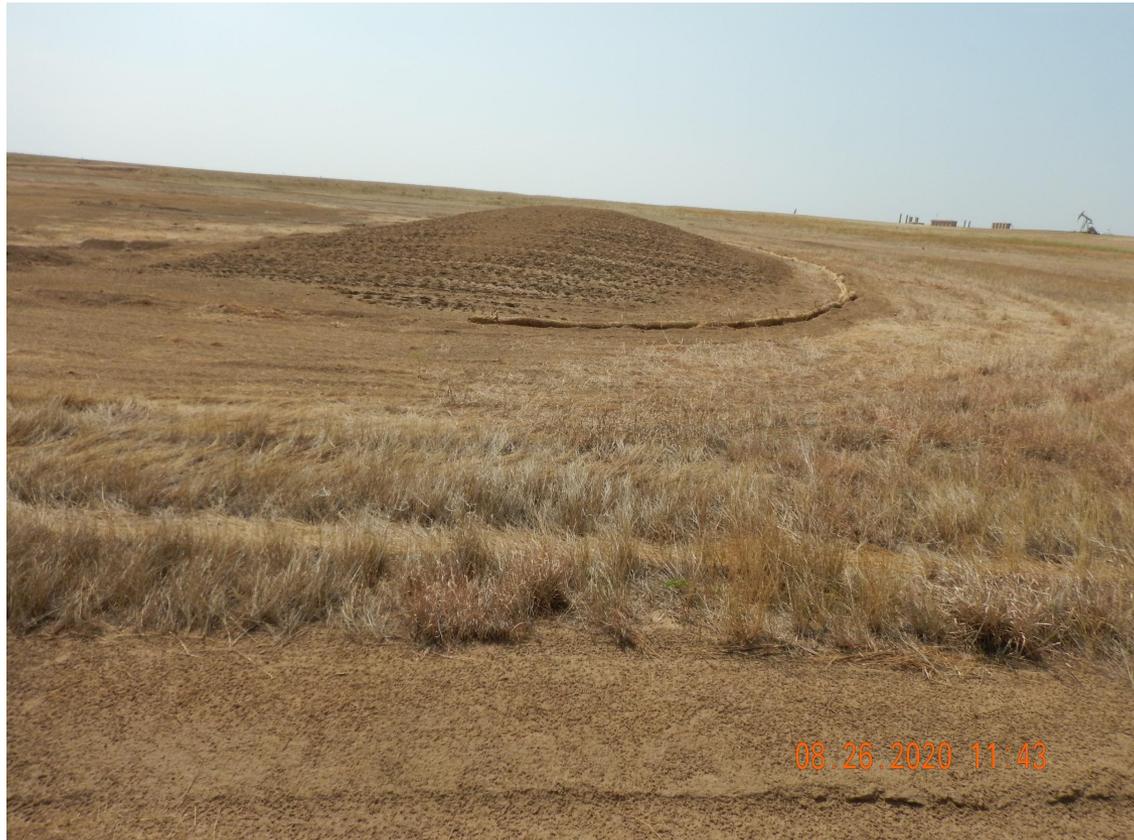
Photo 4. Photo taken from the northwestern location, facing South. Photo illustrates the topsoil stockpile which has been temporarily stabilized with equipment tracking. Wattle BMPs have been installed around the outer perimeter of the stockpile.

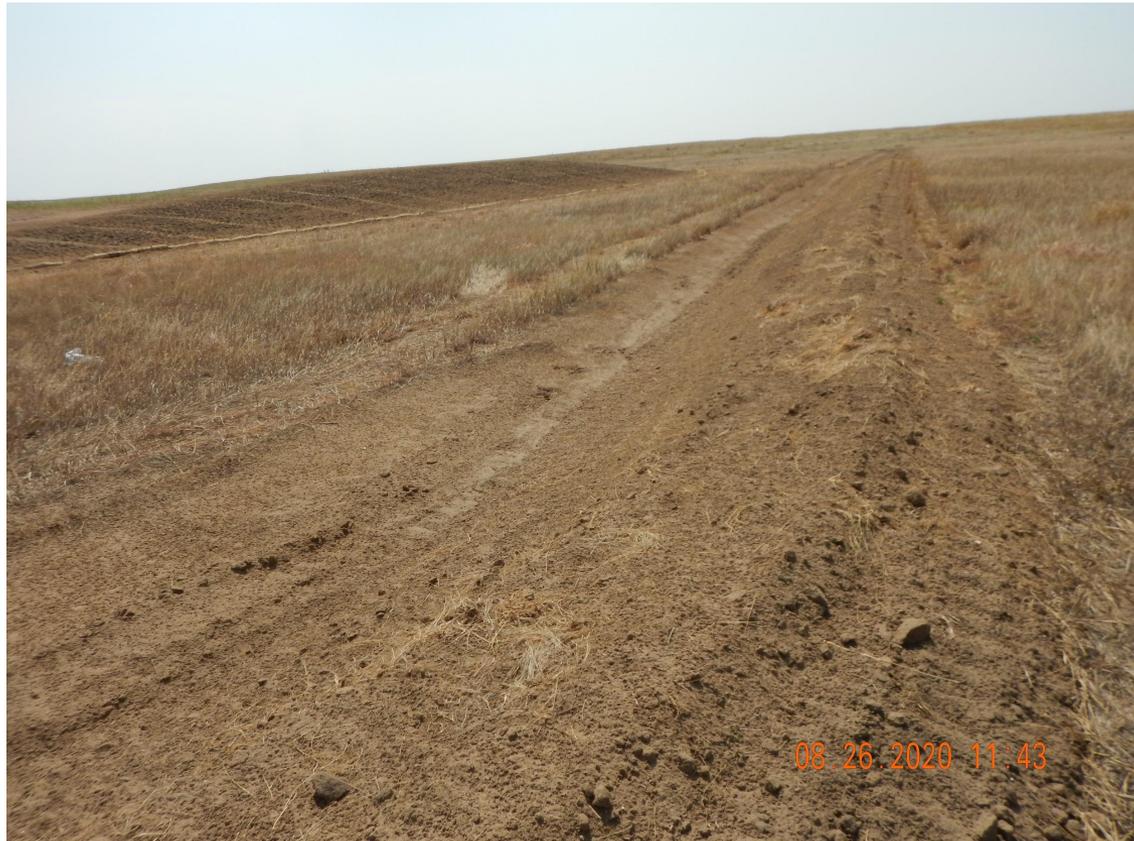
Photo 5. Photo taken from the northwestern location, facing South. See comments under Photo 2. Note: there is a vegetated buffer between the pad and the outer perimeter BMP.

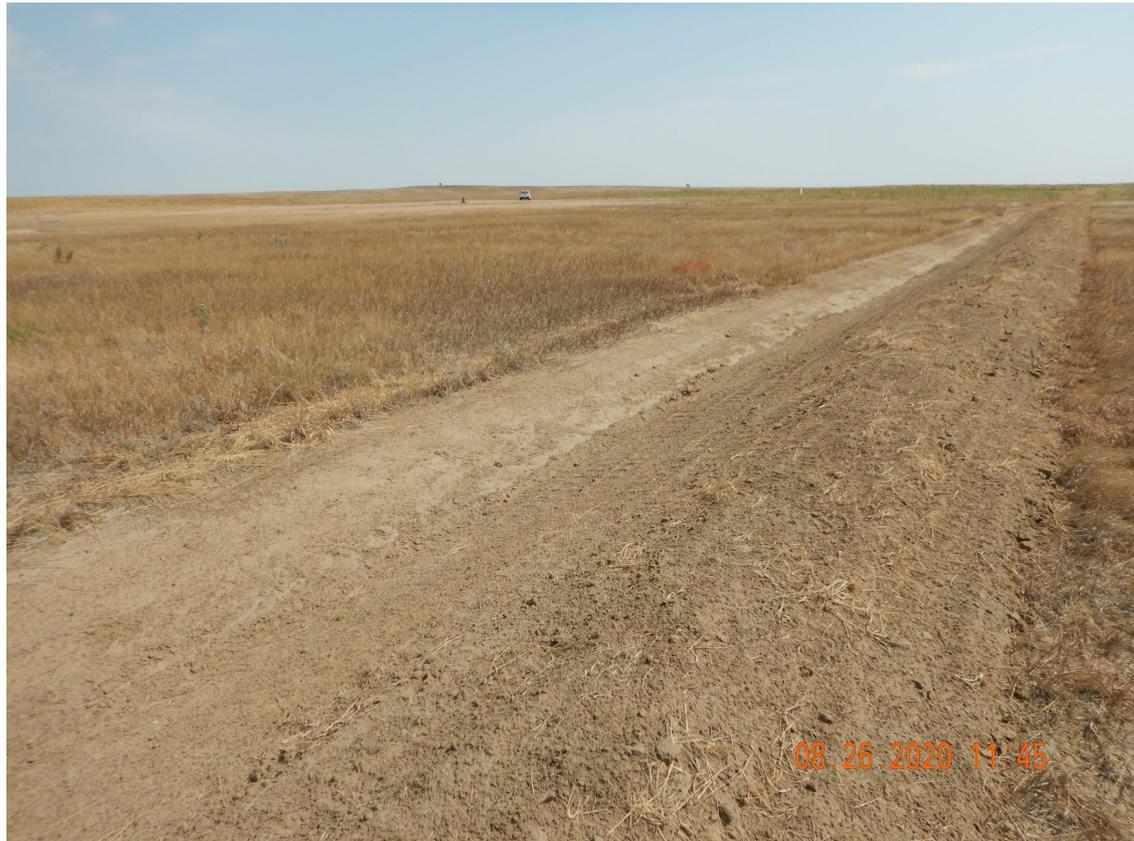
Photo 6. Photo taken from the southwestern location, facing East. See comments under Photo 5.

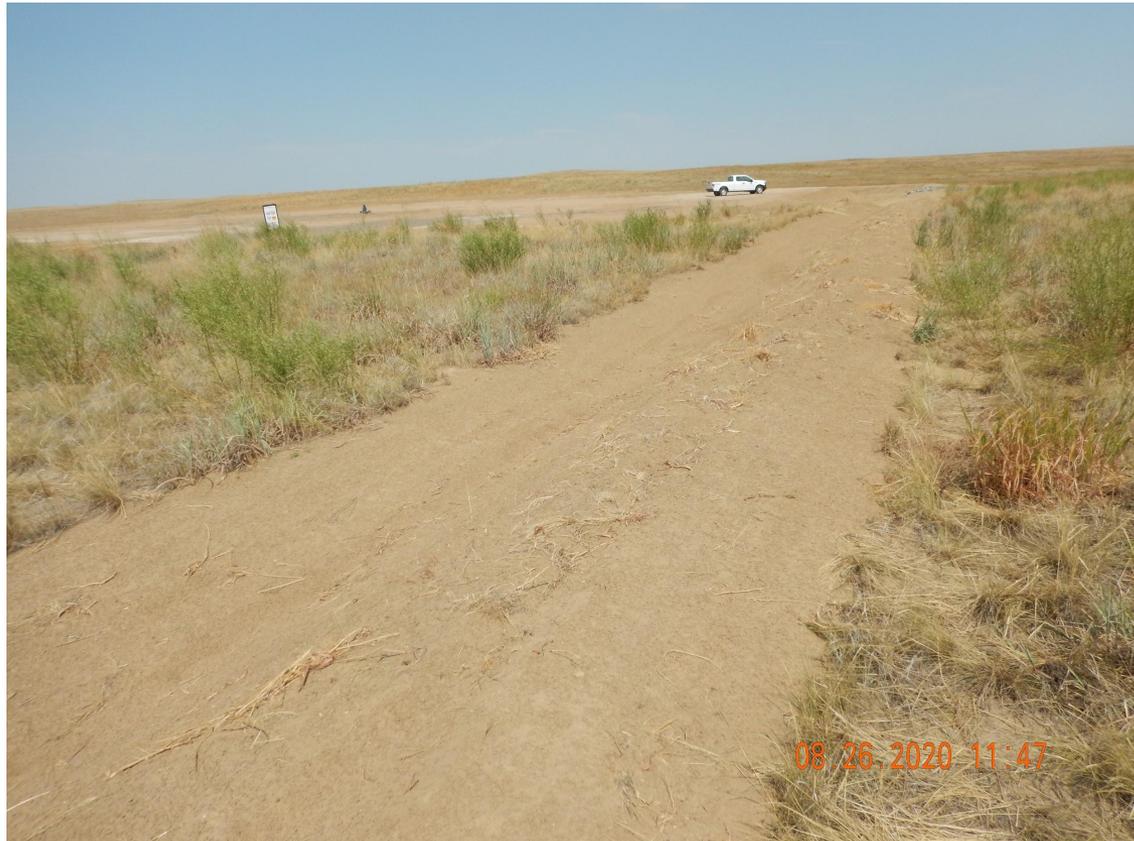
Photo 7. Photo taken from the southeastern location, facing North. See comments under Photo 5.
