Inspection Photos
Operator: Hilcorp Energy
API: 067-06933
Date: 8/27/2020

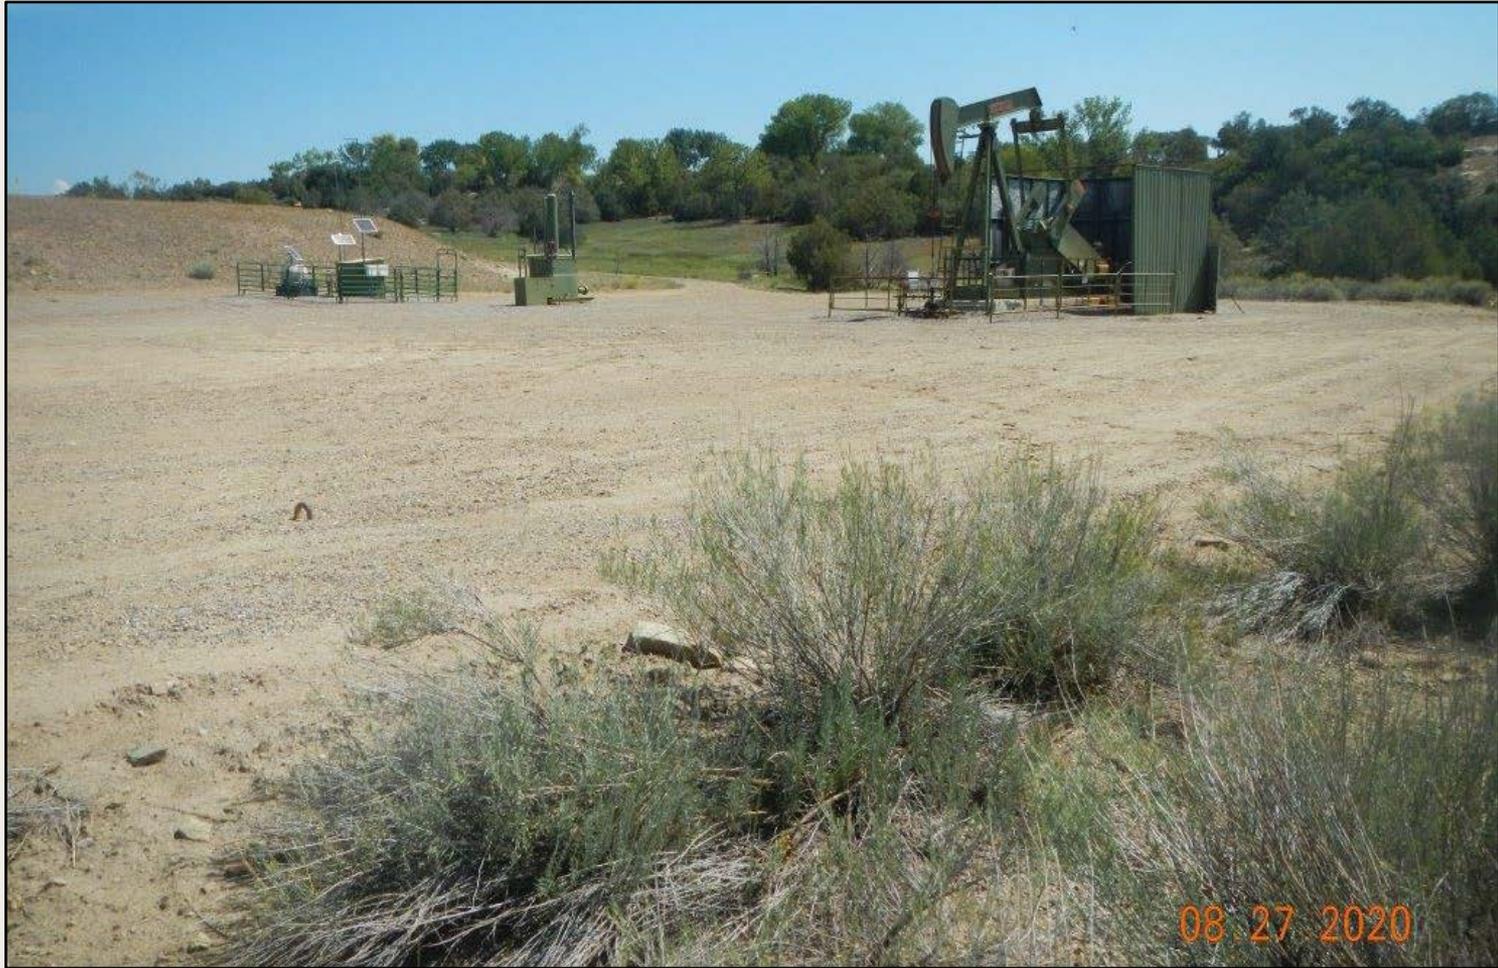
Photo 1. View of the project area from the southwestern edge facing center.

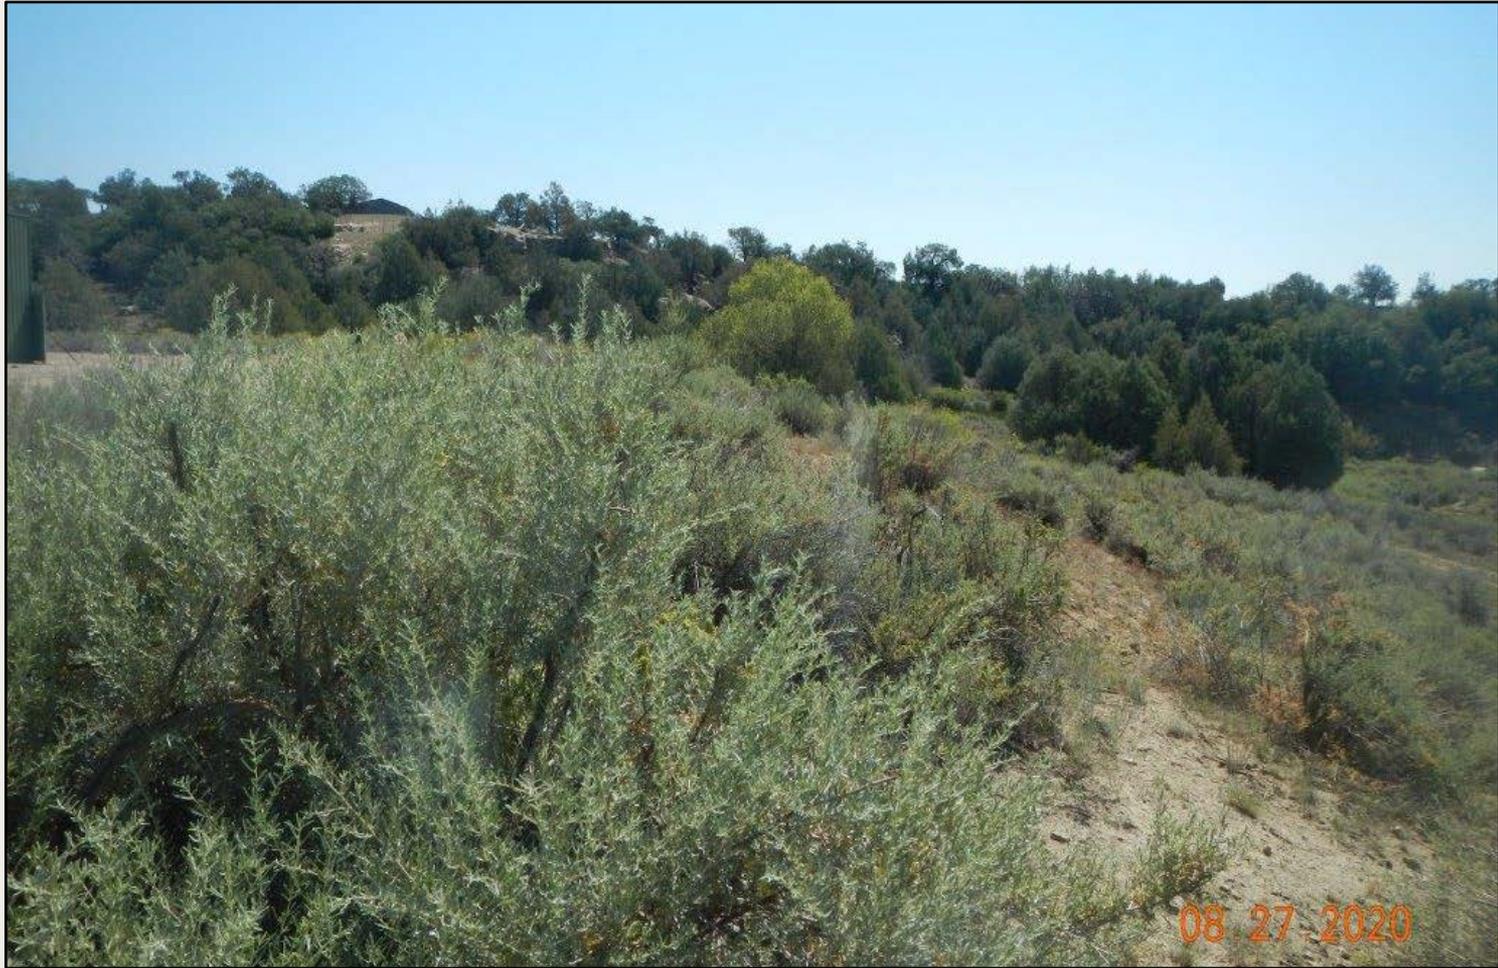
Photo 2. View of the southern fill slope facing westward. Vegetation is becoming established with fourwing saltbush, rubber rabbitbrush, and western wheatgrass.

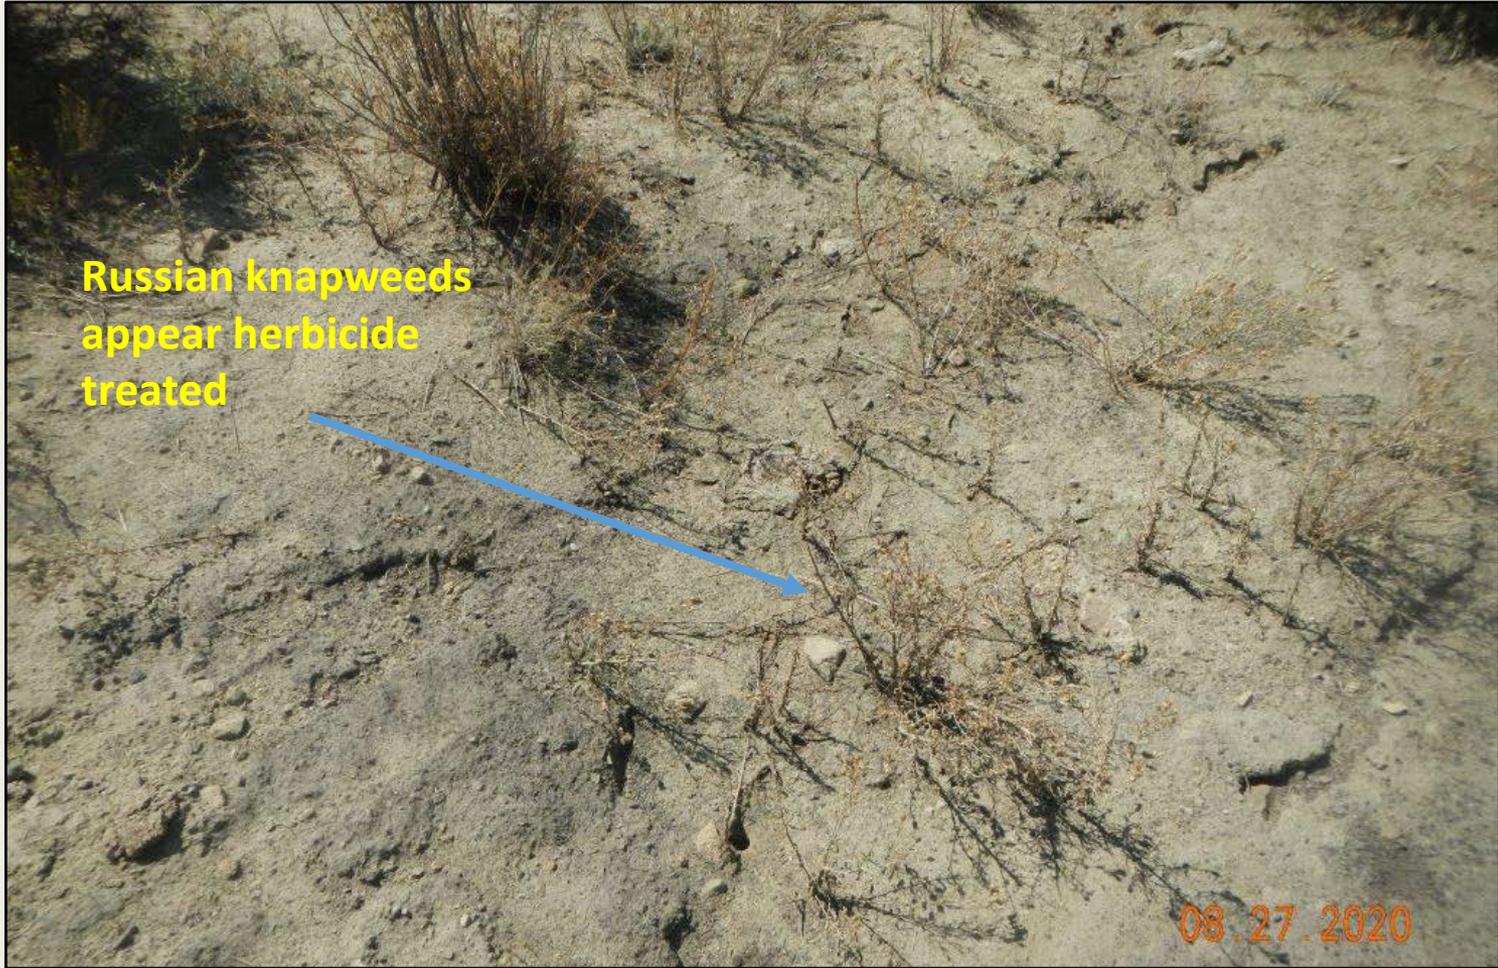
Photo 3. View of Russian knapweeds that appear to be herbicide treated within the project area.

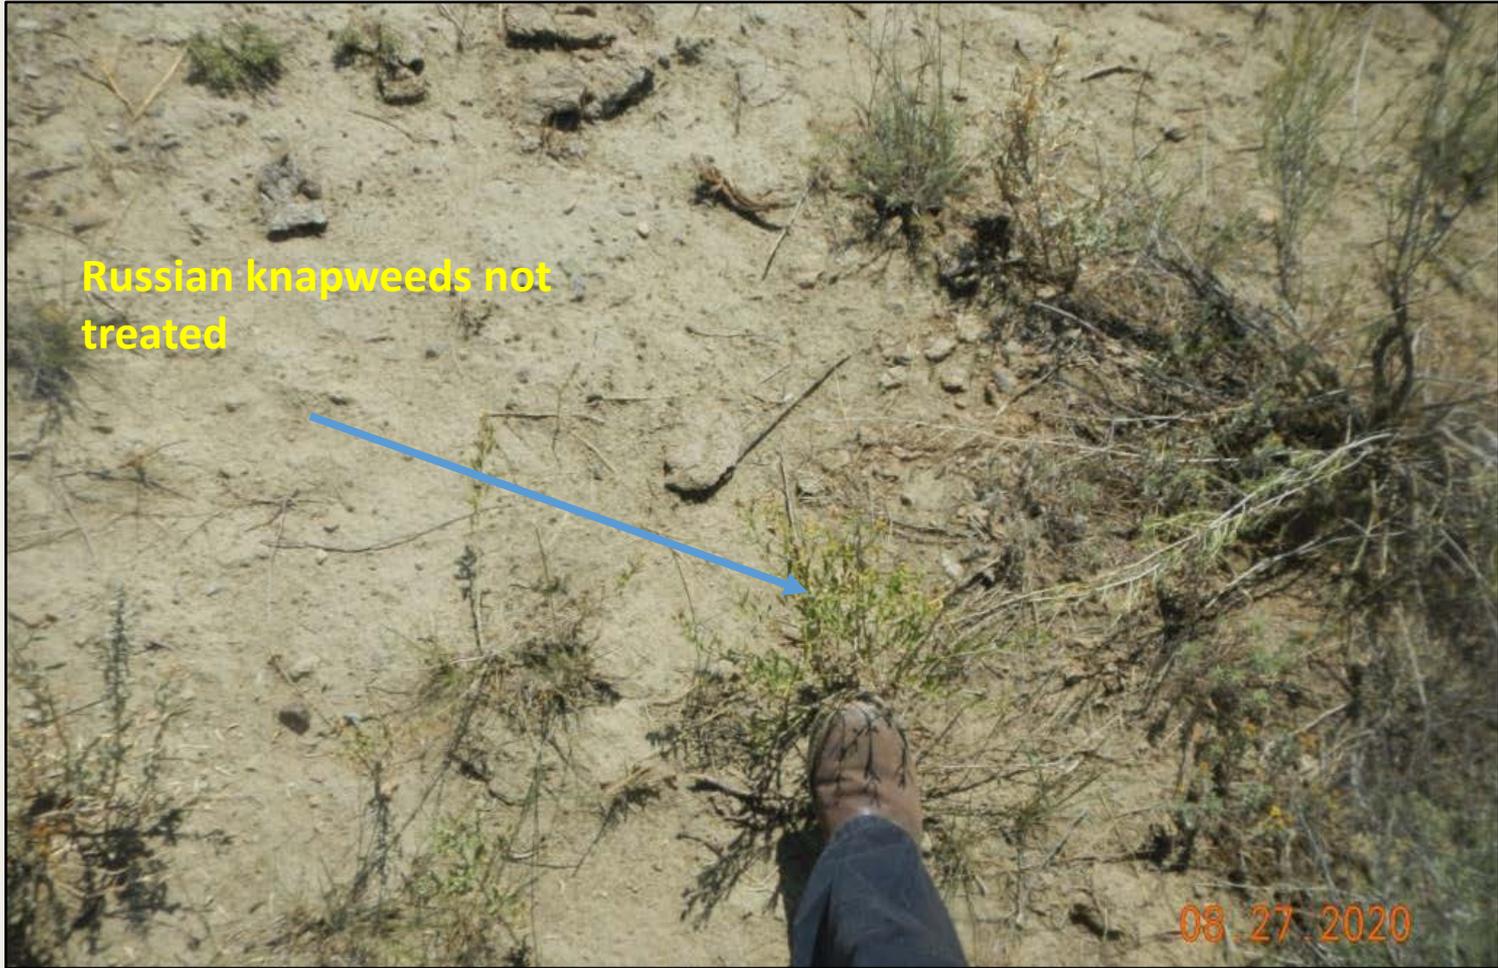
Photo 4. View of Russian knapweeds that do not appear to be herbicide treated within the project area.

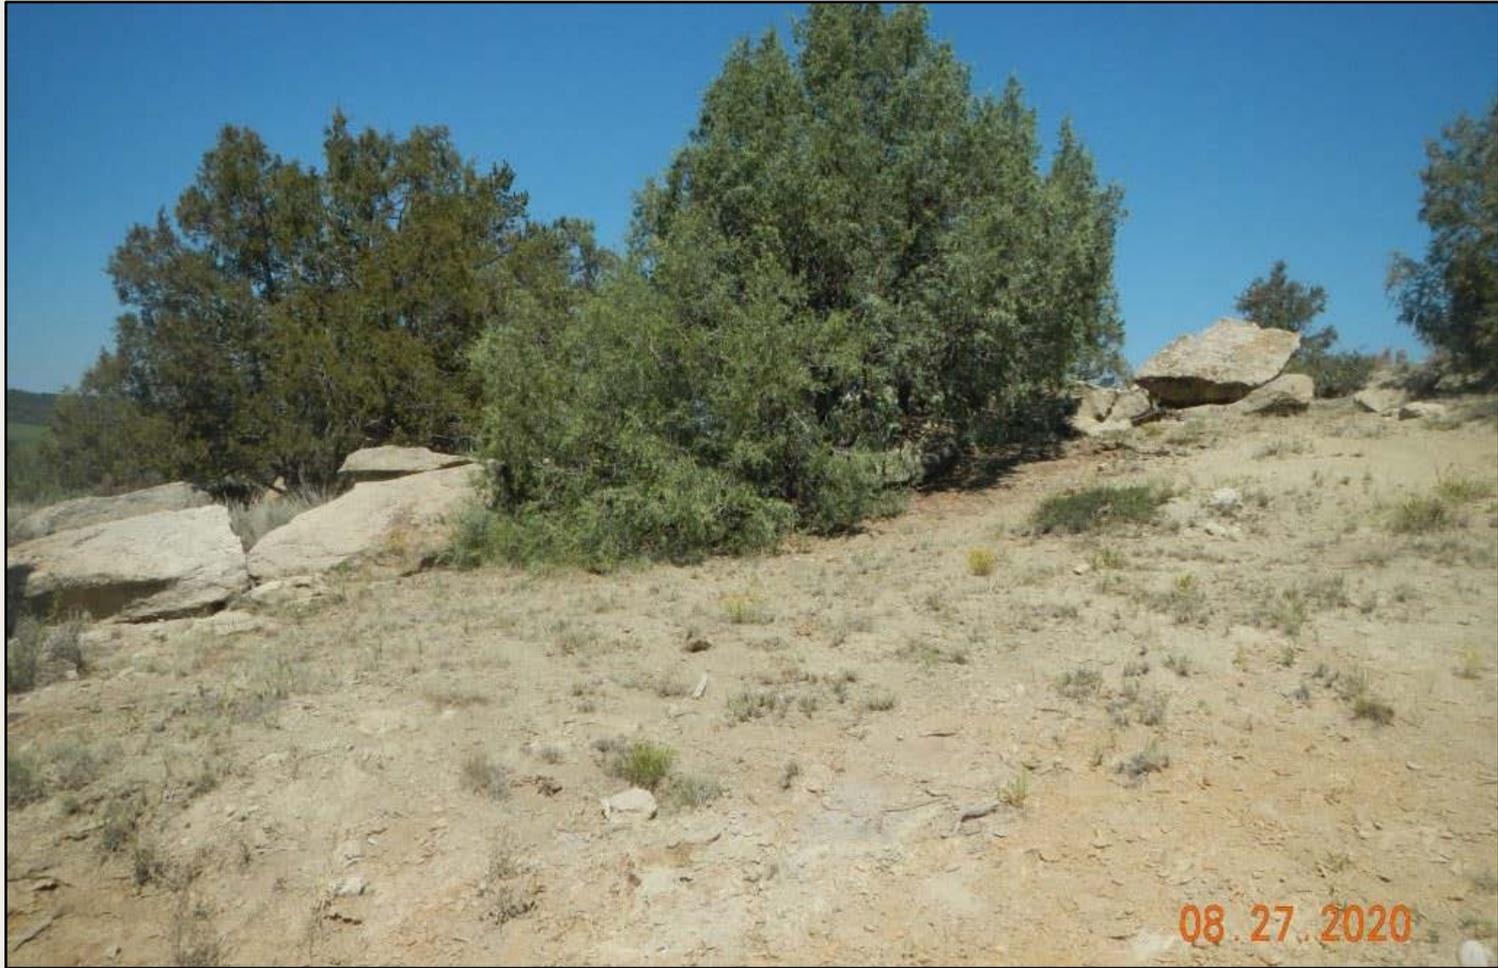
Photo 5. View of reference area vegetation comprised of pinyon juniper woodland with understory of big sagebrush, squirreltail, and antelope bitterbrush.
