Inspection Photos
Operator: Hilcorp Energy
API: 067-06512
Date: 8/27/2020

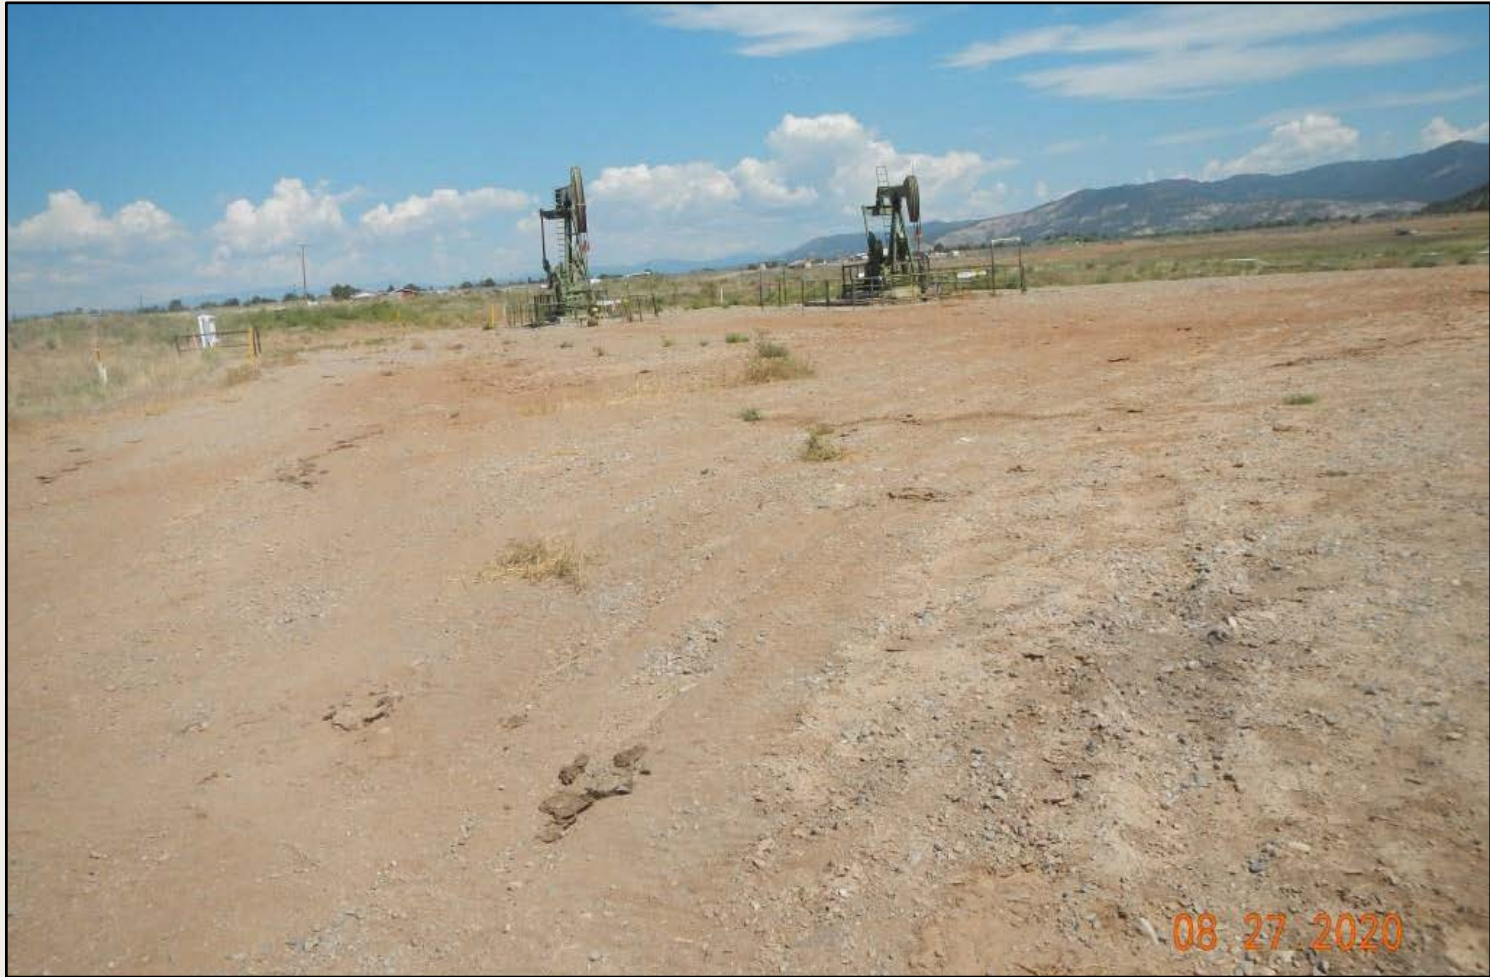
Photo 1. View of the project area from the well pad entrance facing center.

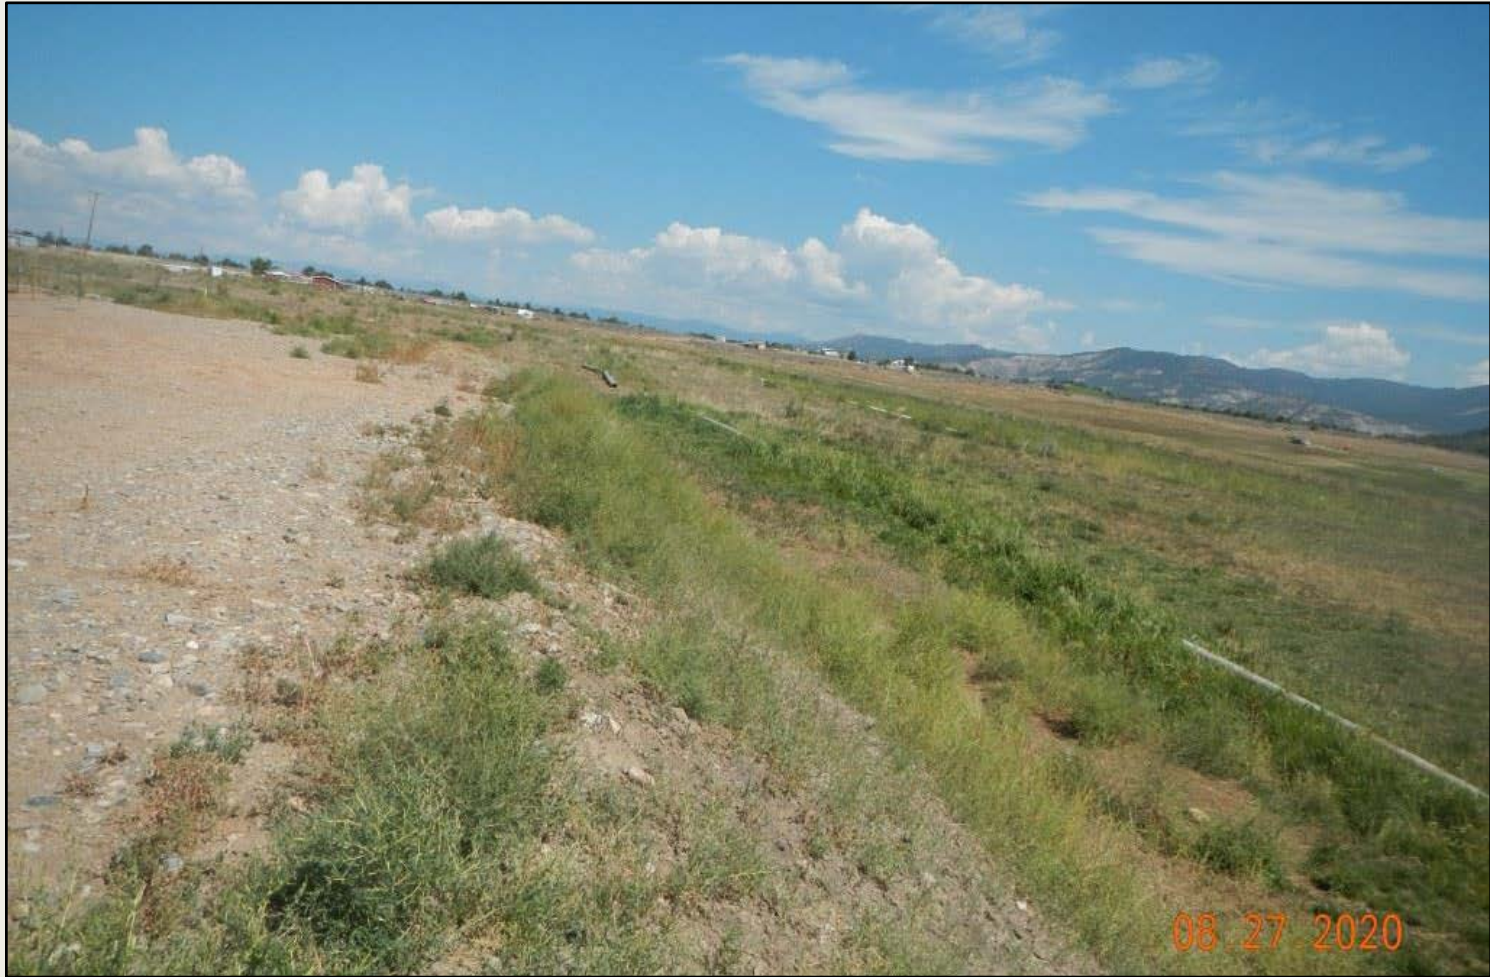
Photo 2. View of the eastern fill slope from the southeastern corner facing northward. Revegetation is progressing outside of irrigation alignment, with western wheatgrass and smooth brome.

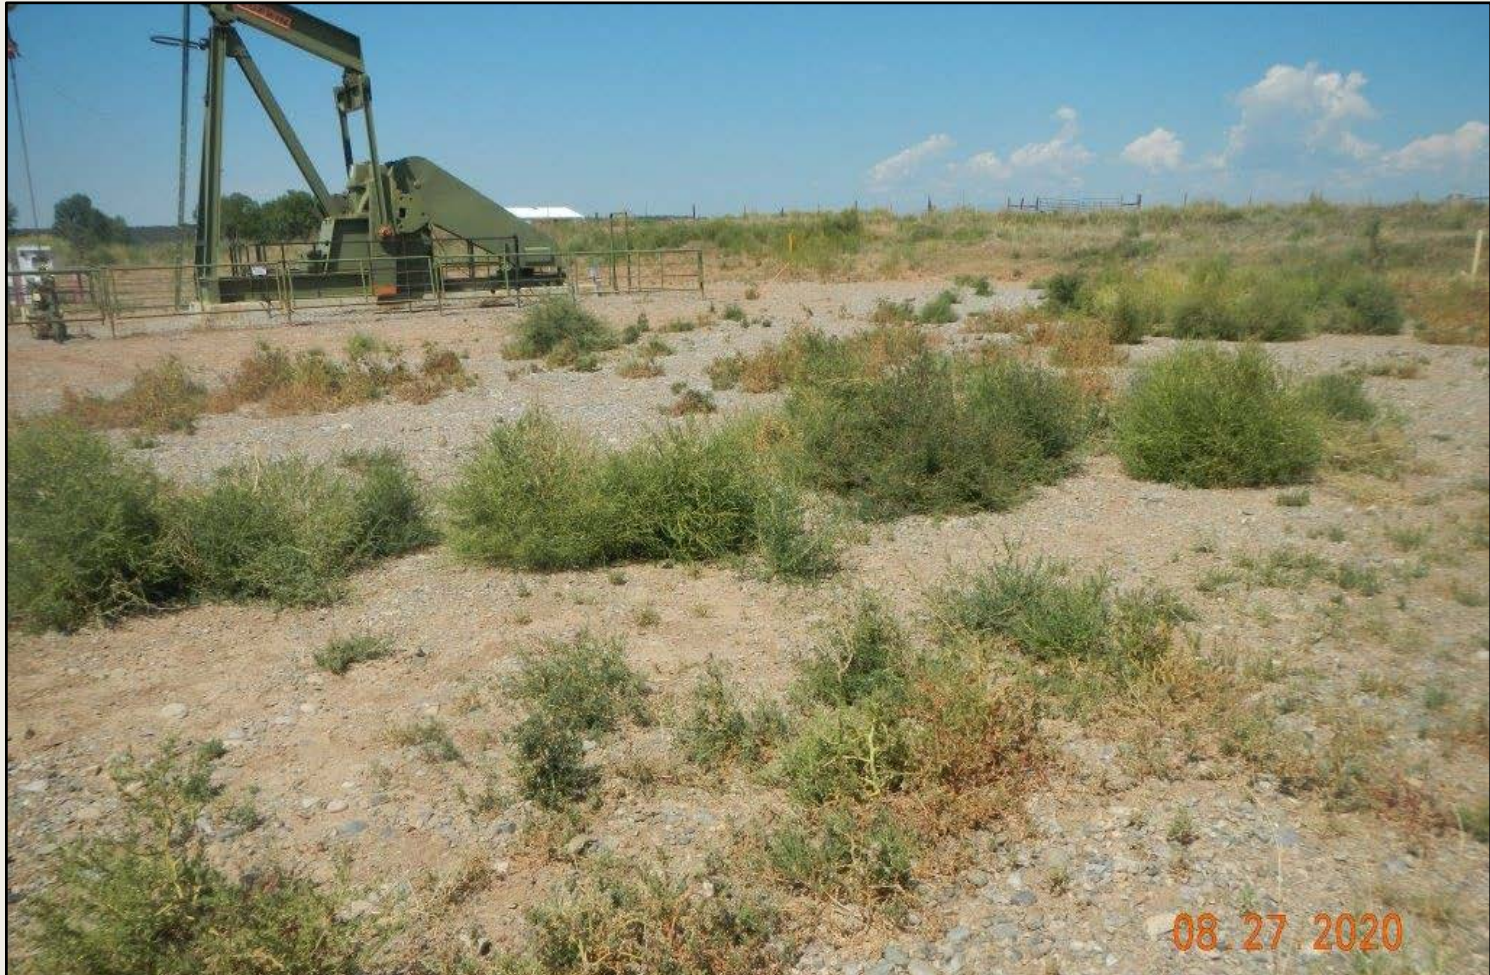
Photo 3. View of dense kochia debris, up to 3-feet tall, growing on the well pad, needs to be removed and properly disposed of.

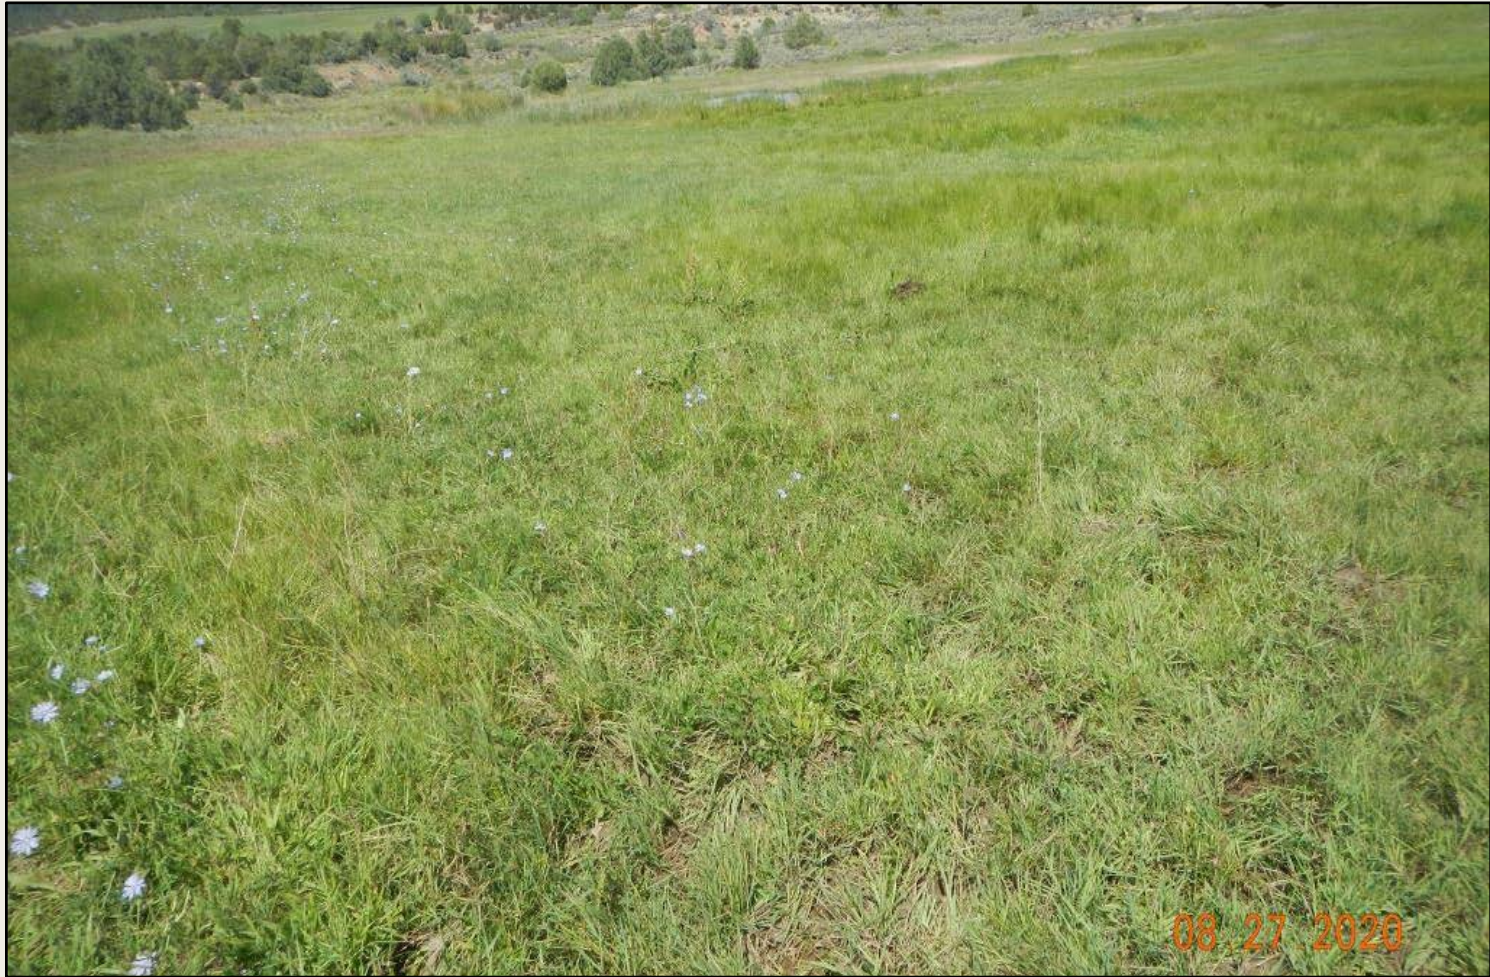
Photo 4. View of reference area vegetation comprised of irrigated grass field with grasses such as orchard grass as well as sedges and rushes such as Baltic rush.
