**Inspection Photos**  
**Location Name: HILL RANCH 35-14**  
**API#: 05-071-08252**  
**INSP. #: 695103244**

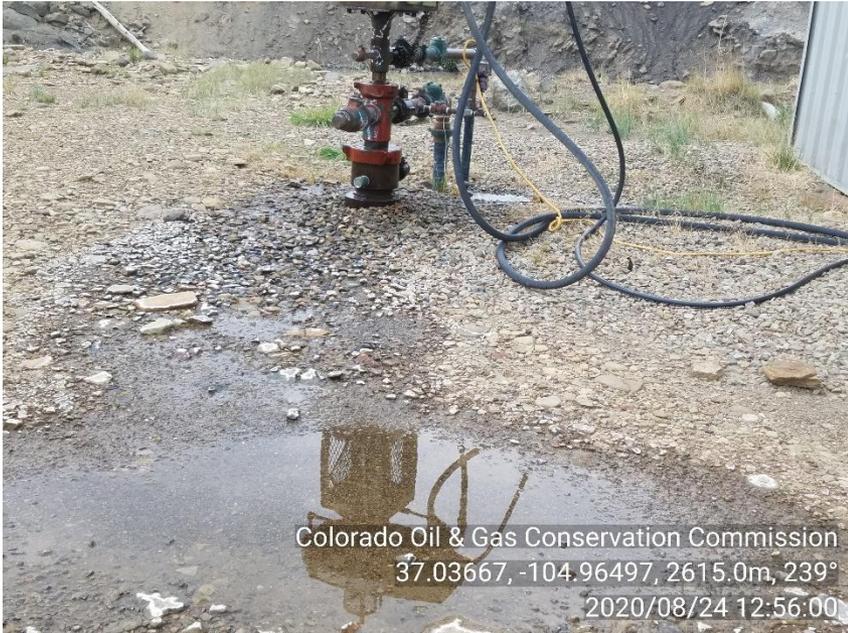
**PHOTO 3: TBG PACKING IS LEAKING PRODUCED WATER. REPAIR PACKING (THERE IS LITTLE TO NO STANDING FLUID ON THE GROUND), COMPLY WITH RULE 907.c. AND Securely fasten all valves, pipes, and fittings to ensure good mechanical condition, inspect at regular intervals and maintain in good mechanical condition per Rule 605.d. CA DATE 8-25-20.**

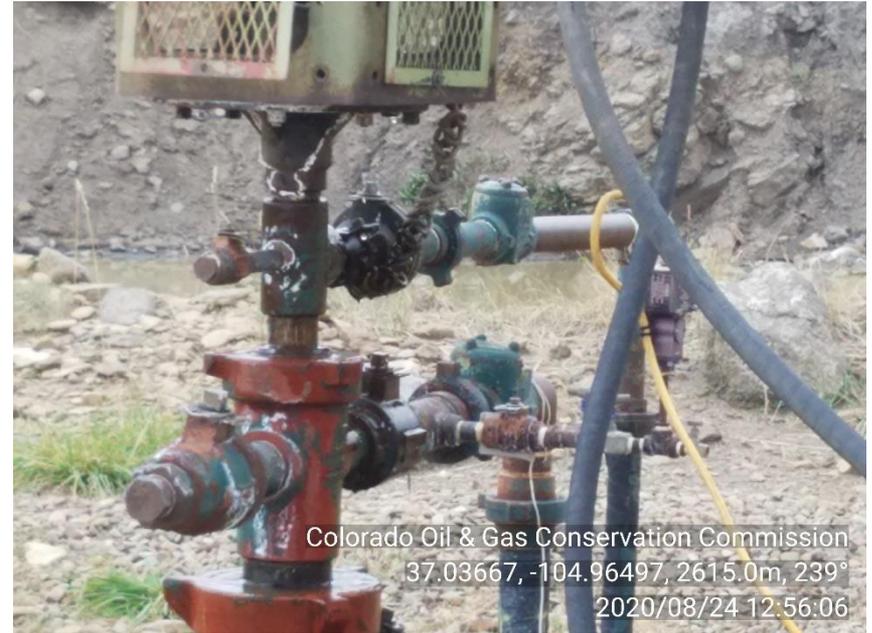
**PHOTO 4: CLOSER IMAGE OF PACKING LEAK, FOLLOW GUIDANCE GIVEN ON PHOTO 3.**
