Stormwater Inspection Report

Operator:	Laramie Energy, LLC
Project:	North Vega
Location:	Gunderson 20-03 Pad
Date:	Wednesday, June 10, 2020
Weather:	Mostly Clear, Breezy, High 77° Lo 42°

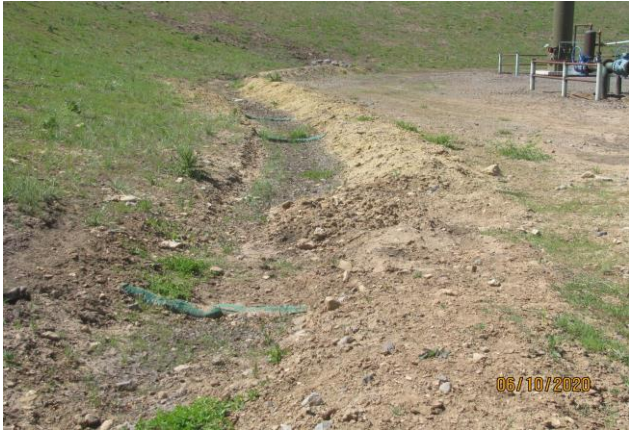
Photo 1

Berm Material within the Dewatering Channel on the Gunderson 20-03 Pad

Comments / Descriptions / Explanations
<p>COGCC corrective actions were completed today for the Gunderson 20-03 pad. Berm material pushed into the dewatering channel in the NE corner of the pad was removed and replaced back onto the berm. The berm was repaired and then maintenance was completed for the inlet areas around the culvert inlet. Maintenance was also completed for the sediment trap inlet area in the NW corner of the pad. The pad was swept for garbage and a handful of noxious weeds were hand removed from around the BMP locations.</p>

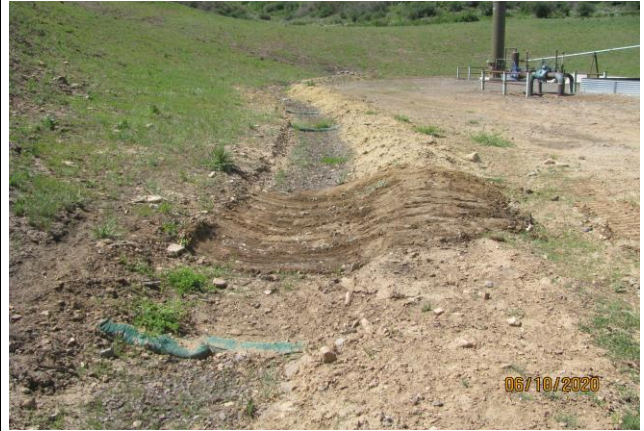
Photo 2

Berm Repaired on the Gunderson 20-03 Pad
