Inspection Photos

API: 071-06488

Operator: EVERGREEN NATURAL RESOURCES

Inspection Date: 8/31/2020

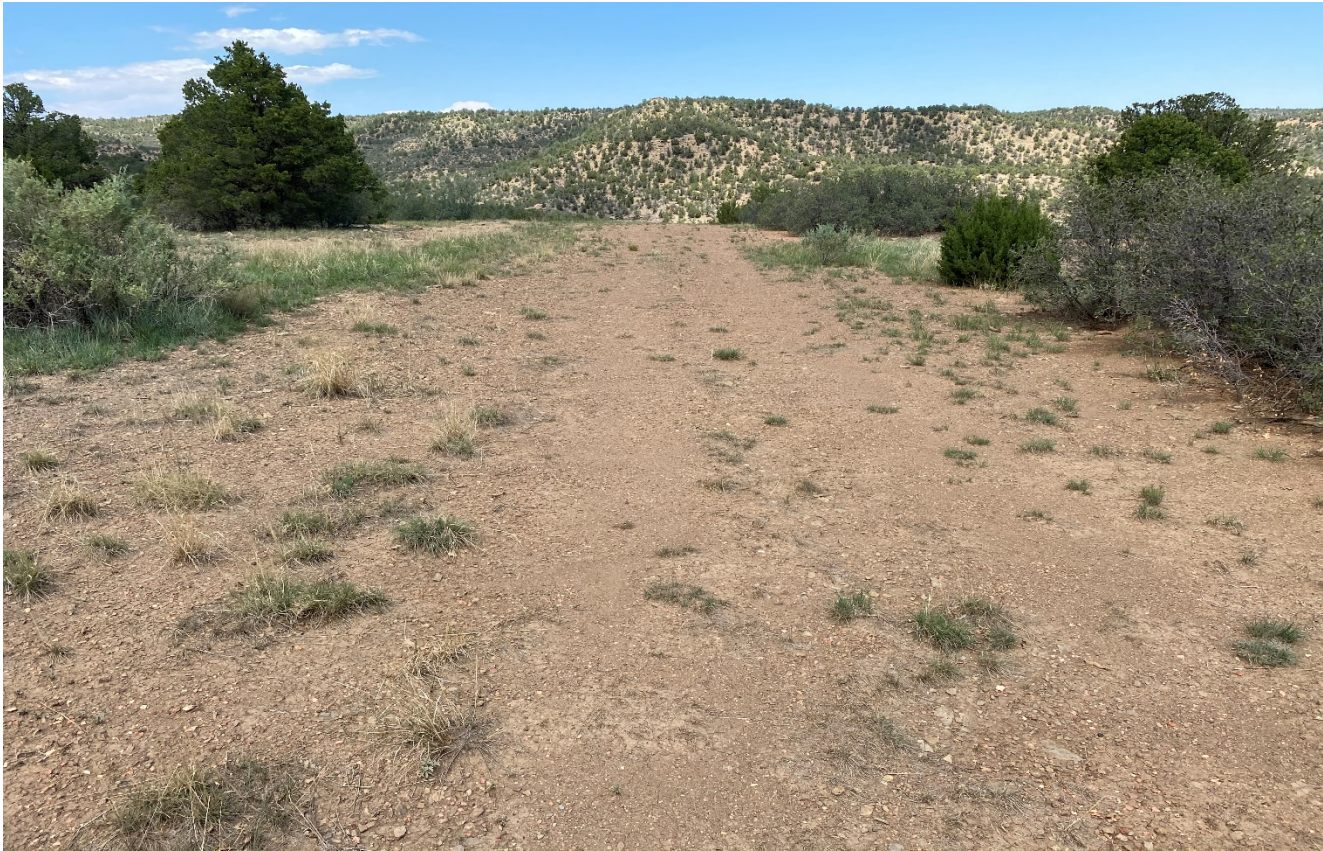
Photo 1. Facing north along the access road. Vegetation has not adequately established along the road. Soils may be compacted in this area.

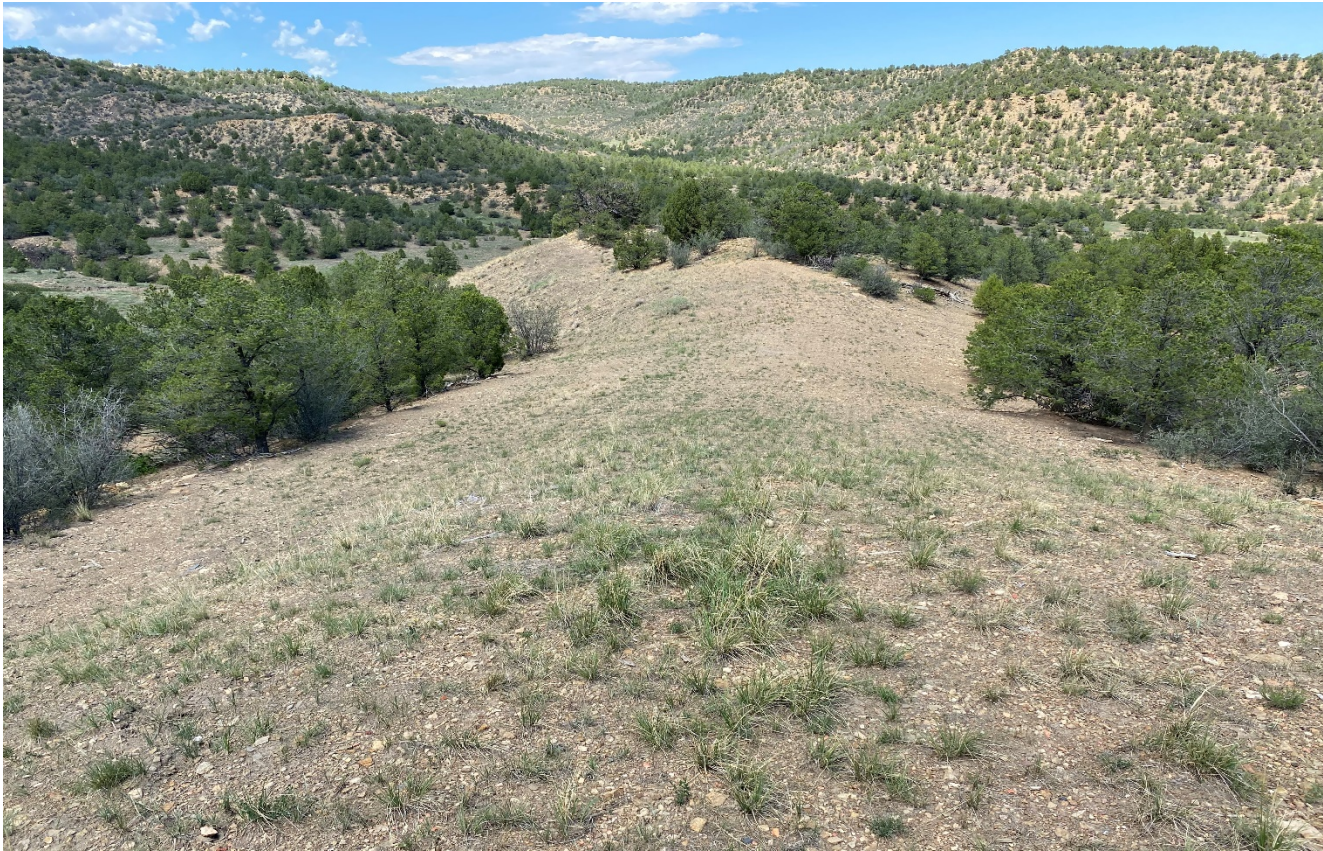
Photo 2. Facing north along the access road.

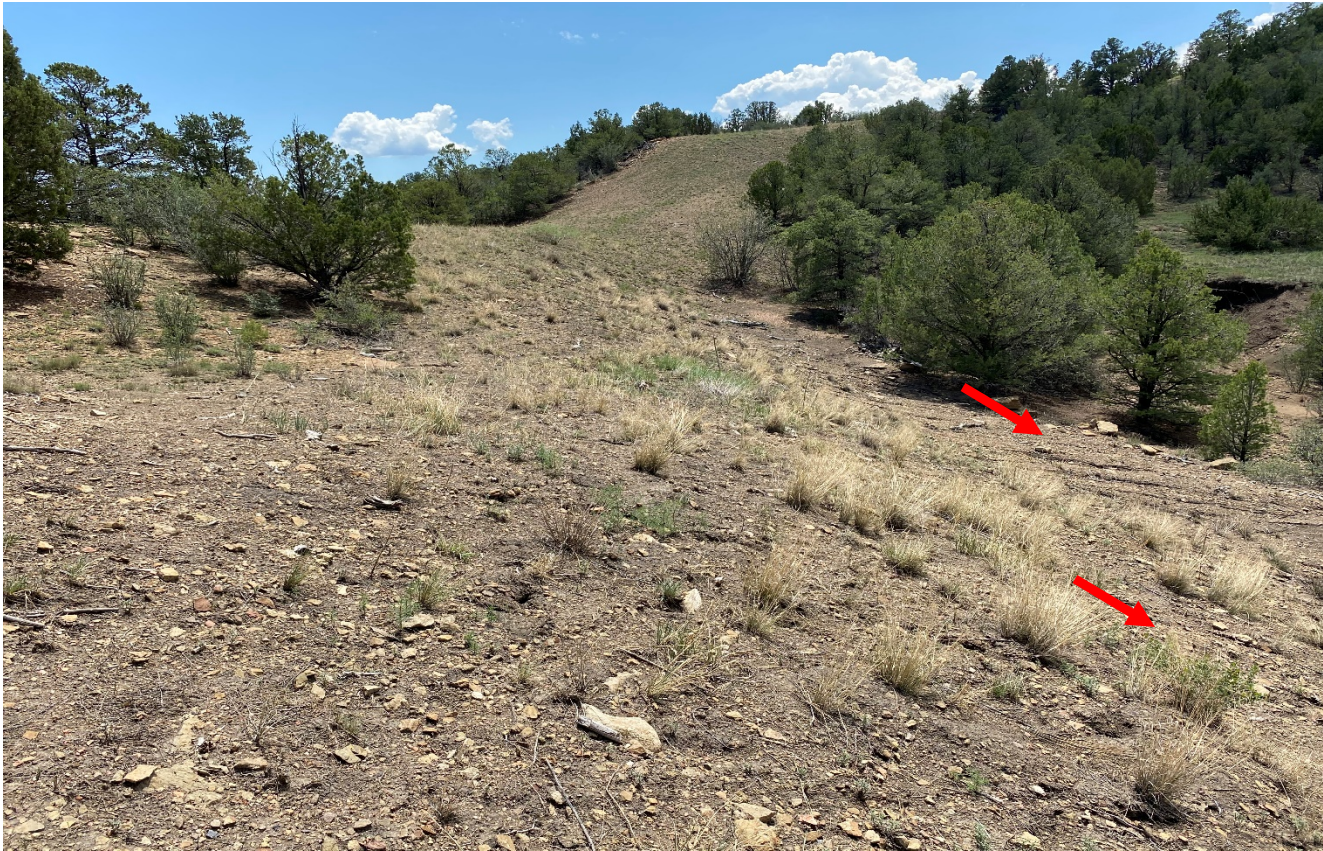
Photo 3. Facing back to the south along the access road. There is some riling occurring in this area.

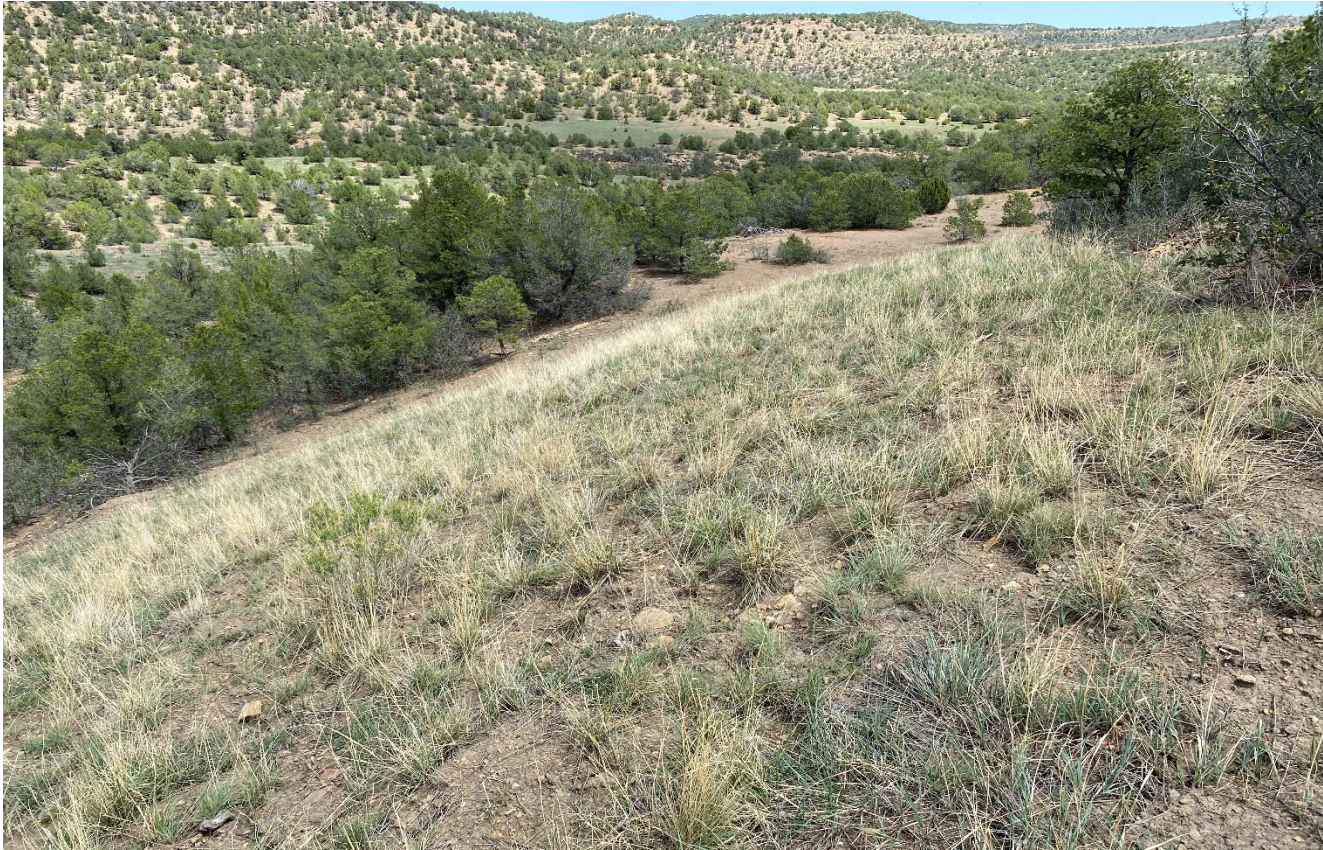
Photo 4. Facing northeast along the reclaimed access road. Vegetation is well established along this portion of the road.

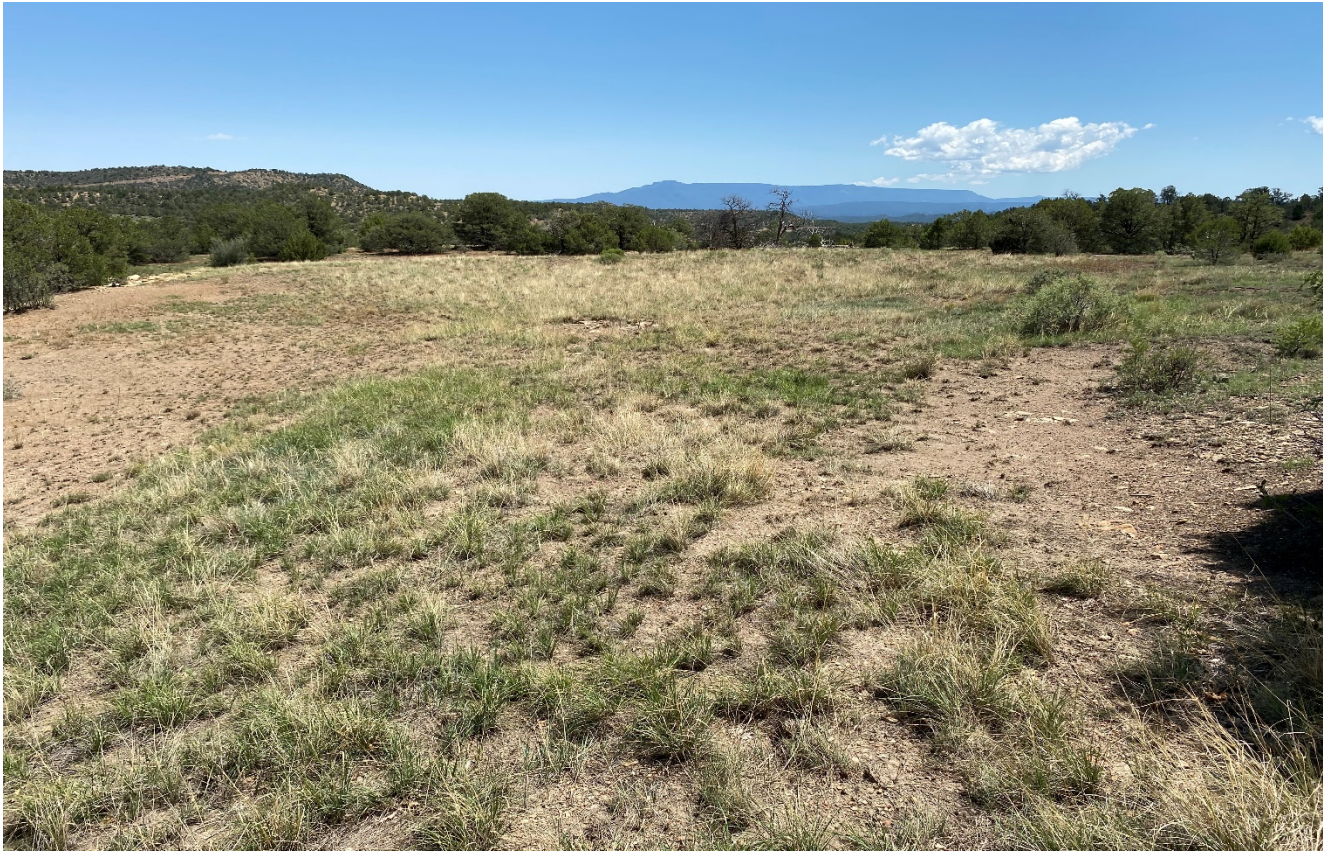
Photo 5. Facing east toward the location. Vegetation is well established at the location.

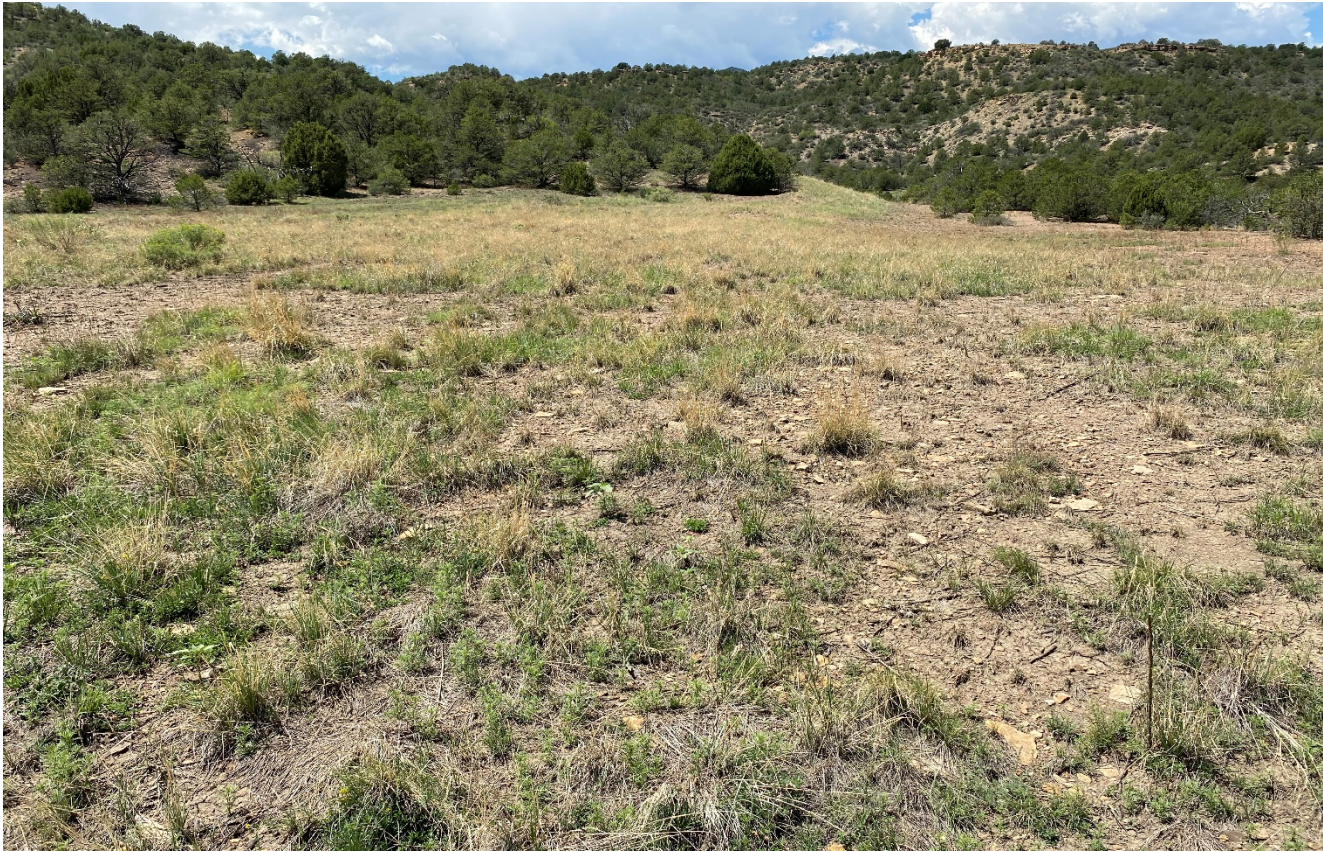
Photo 6. Facing west toward the location. Vegetation is well established at the location.

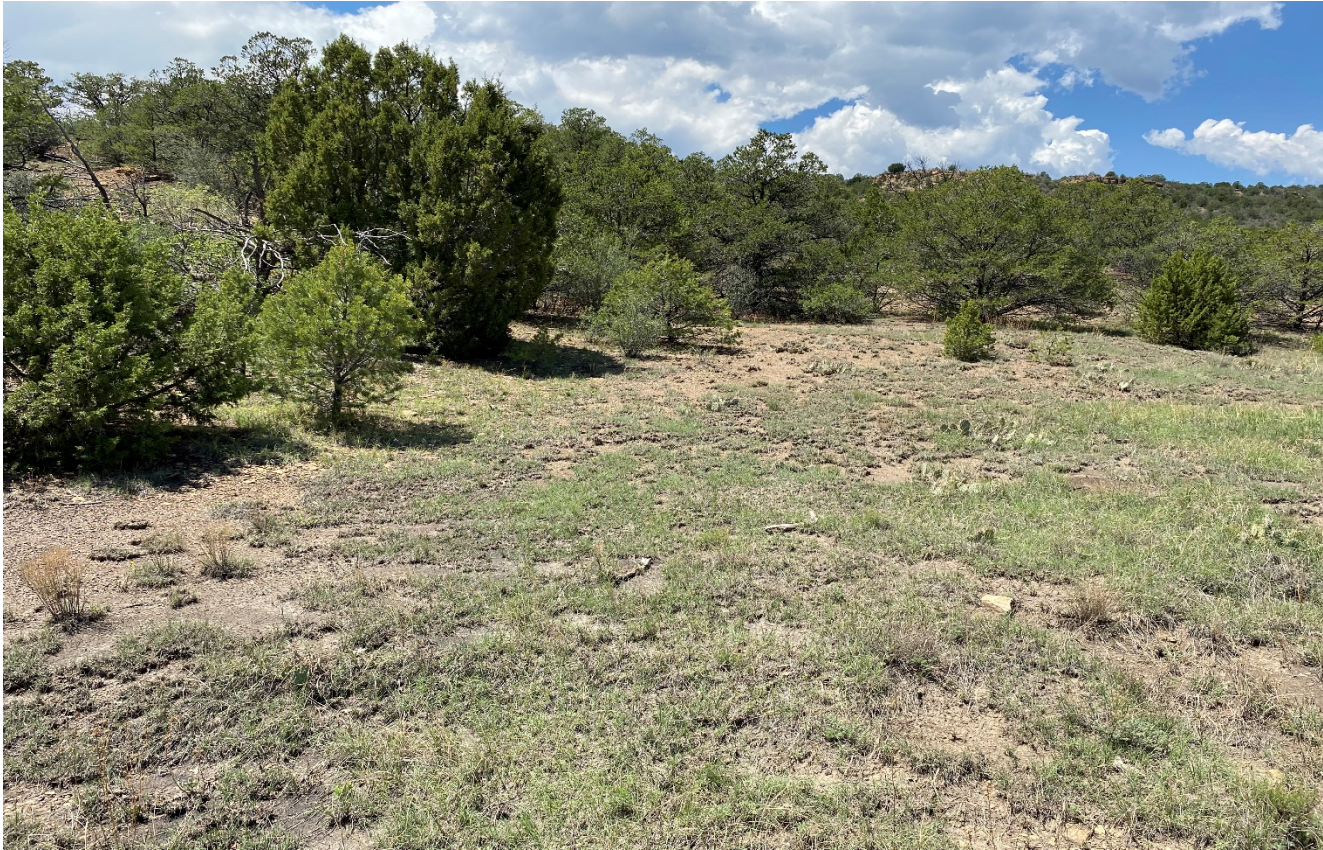
Photo 7. Facing southwest adjacent to the access road at the undisturbed vegetation reference area.
