Inspection Photos

Loc#418843

Insp#: 692402482

Inspection Photos: GRMR Durham Loc#418843

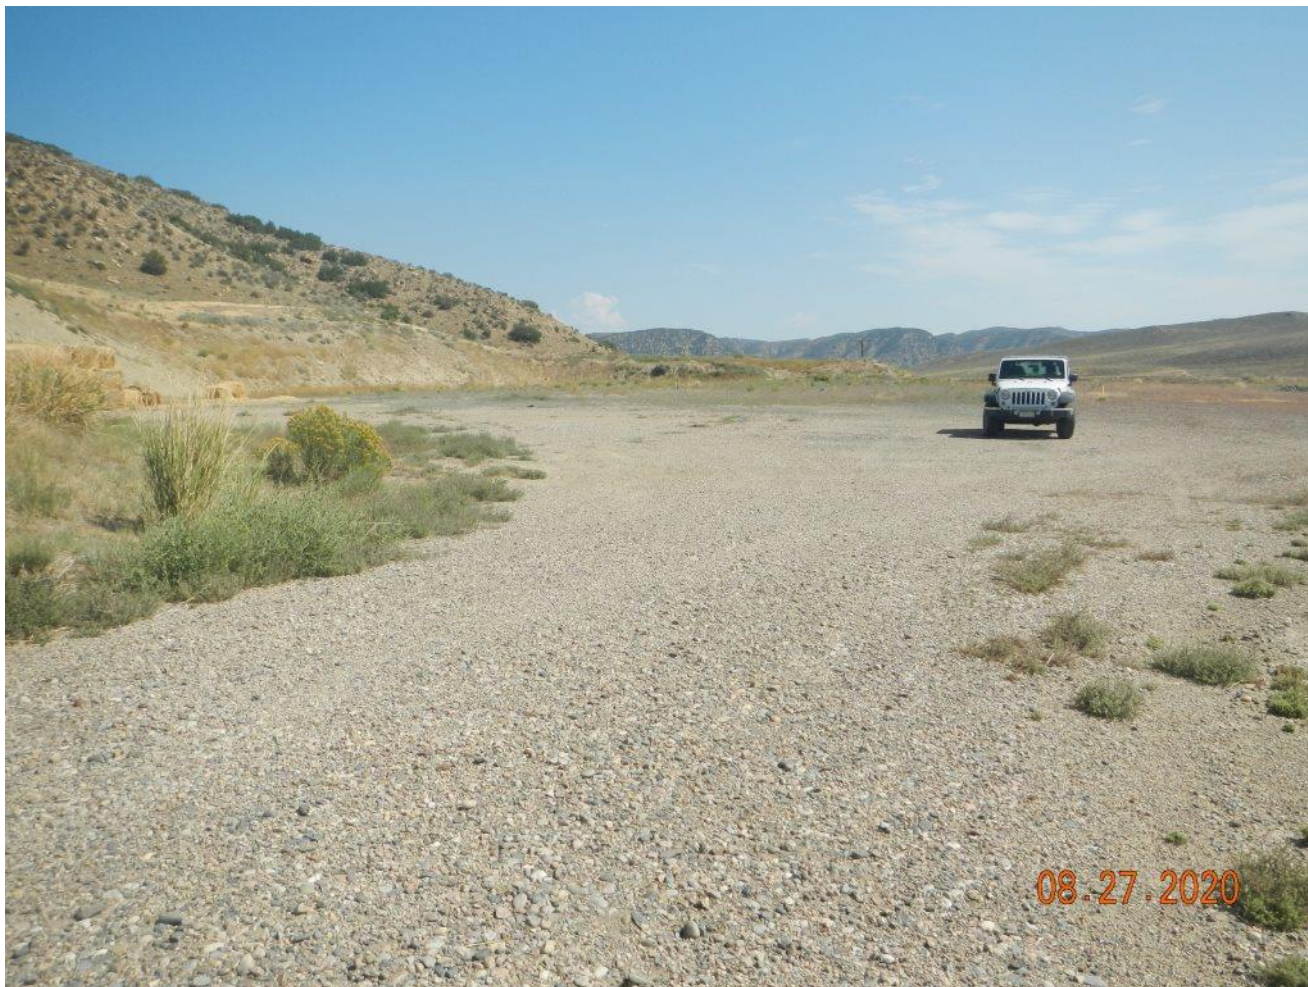
Photo#1:
Overview of Location from entry to North.

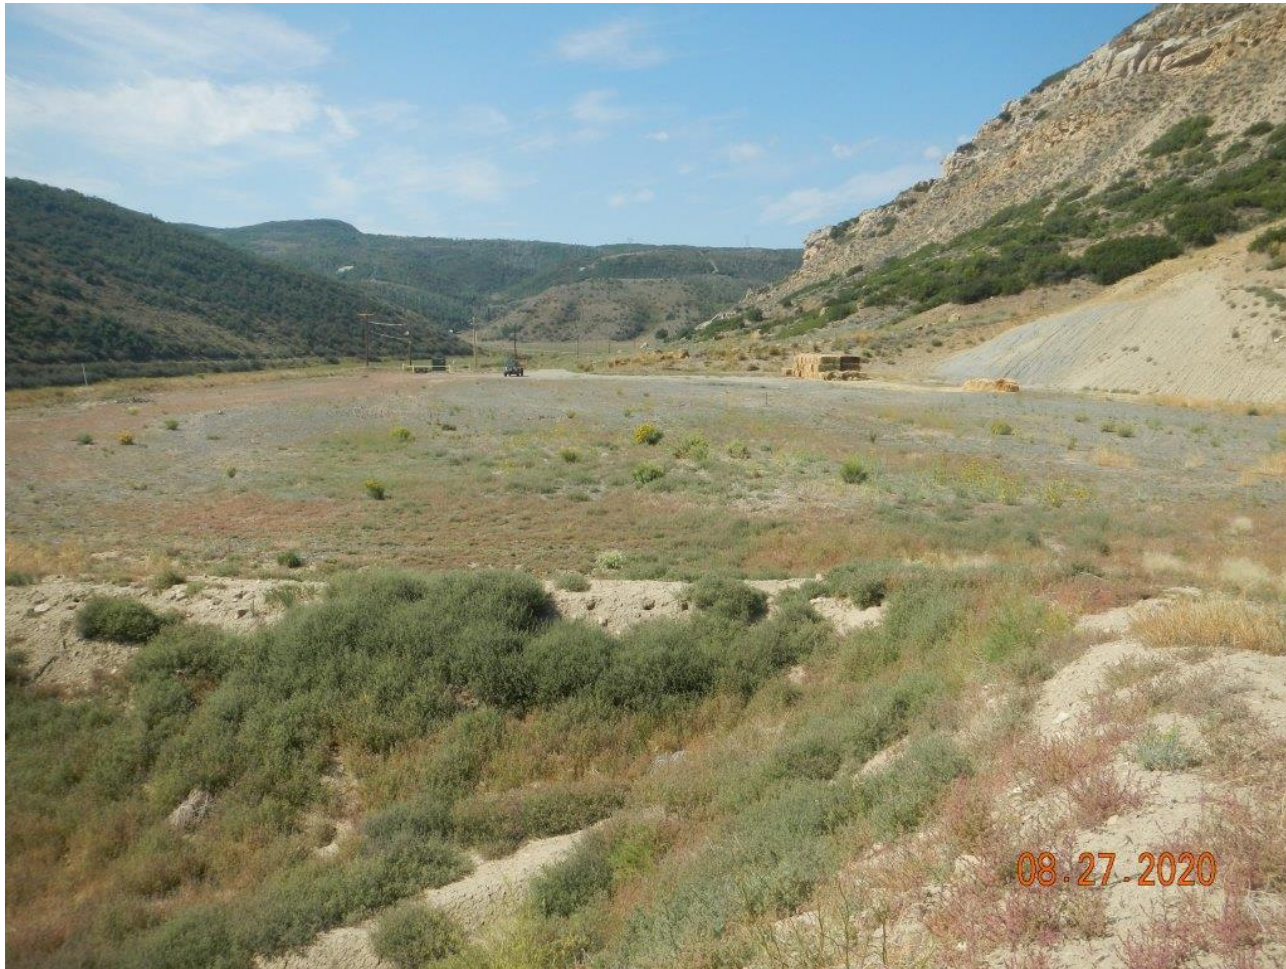
Photo#2:
Overview of Location to South.

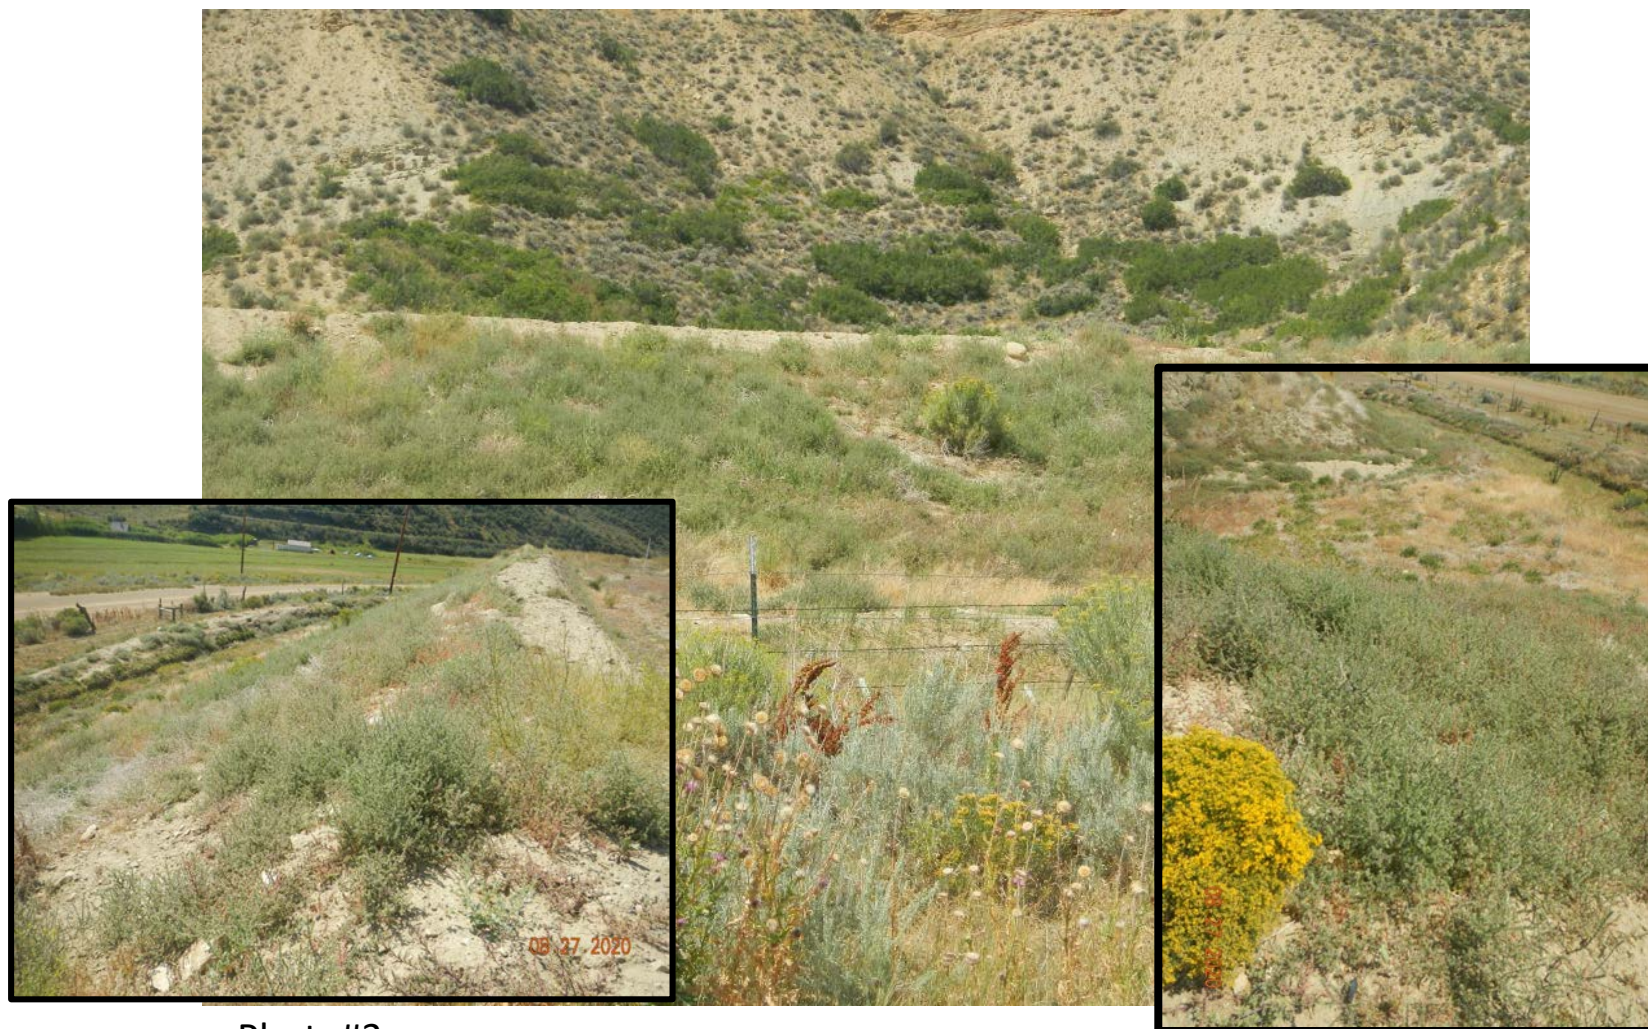
Photo#3:
Views of fill slope and weed establishment ; Russian thistle predominate.

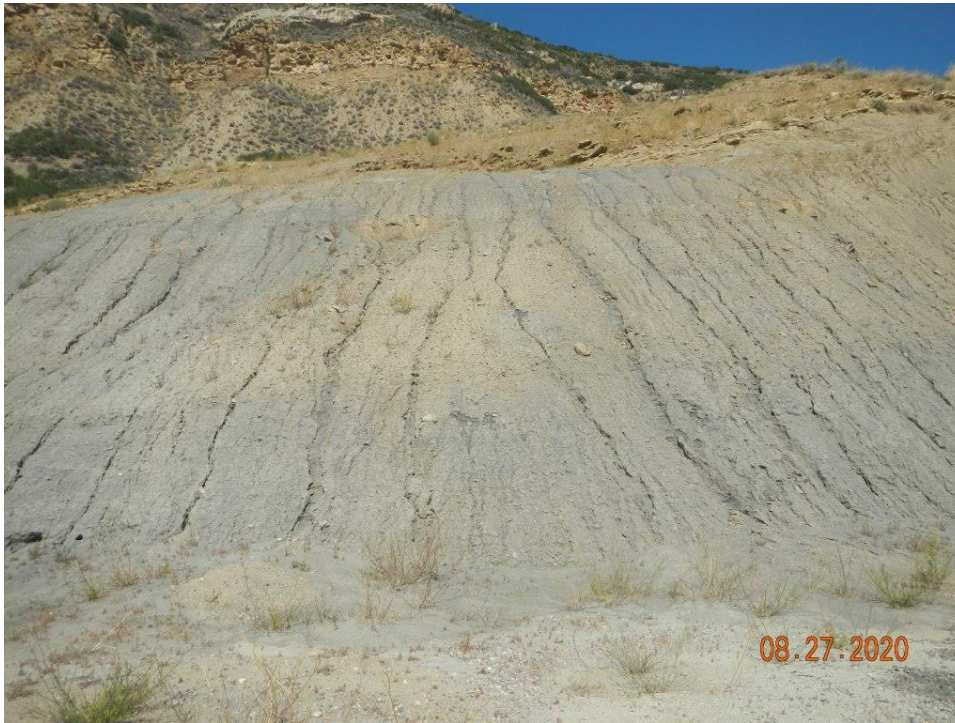
Photo#4:
Cut slope erosion and sediment run on.

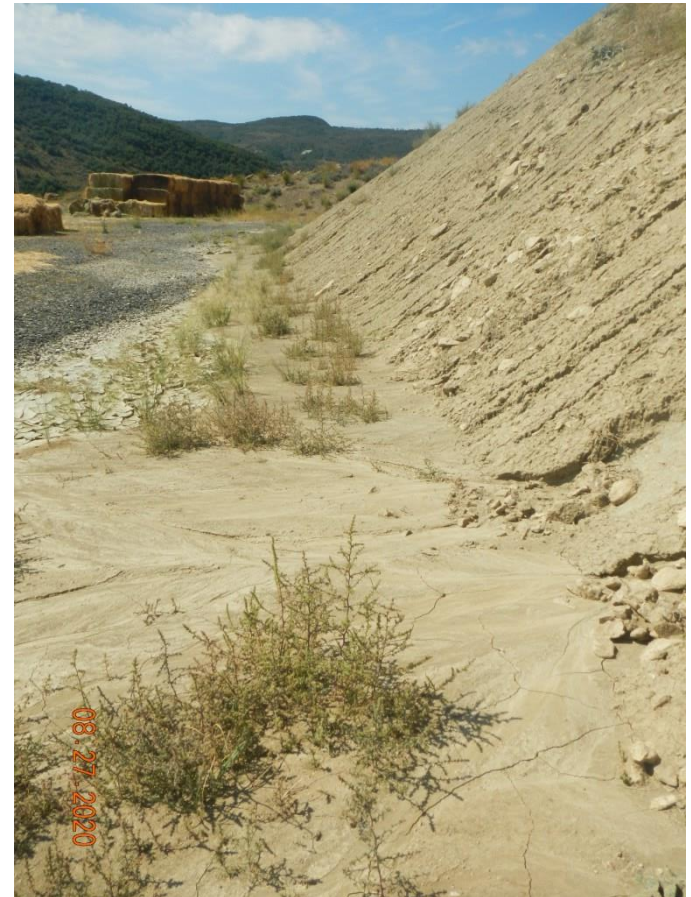
Photo#5:
Cut slope erosion and sediment run on.

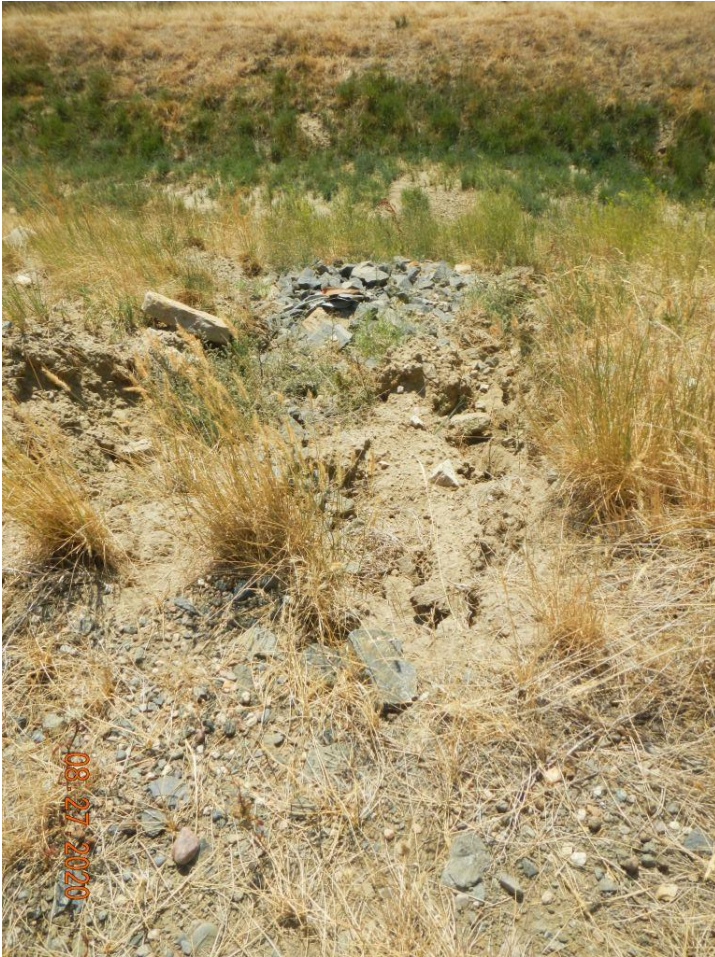
Photo#6:
Erosion at pad edge; view down fill slope.

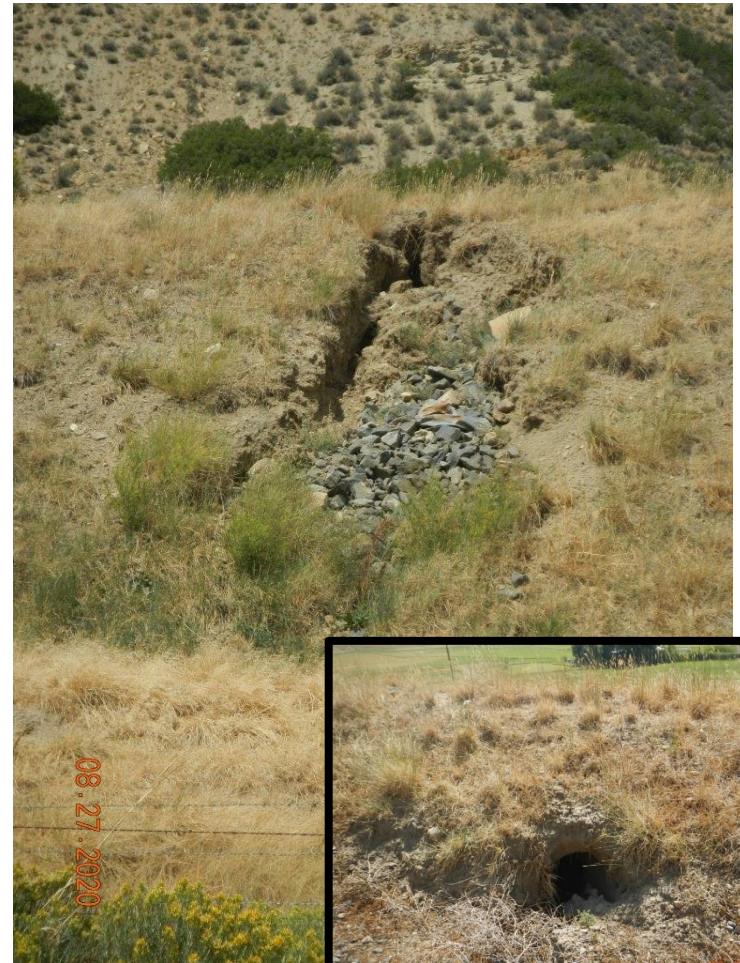
Photo#7:
Washout; view from base of fill. Insert of top of slope
and believed tunnel/wormhole origination.

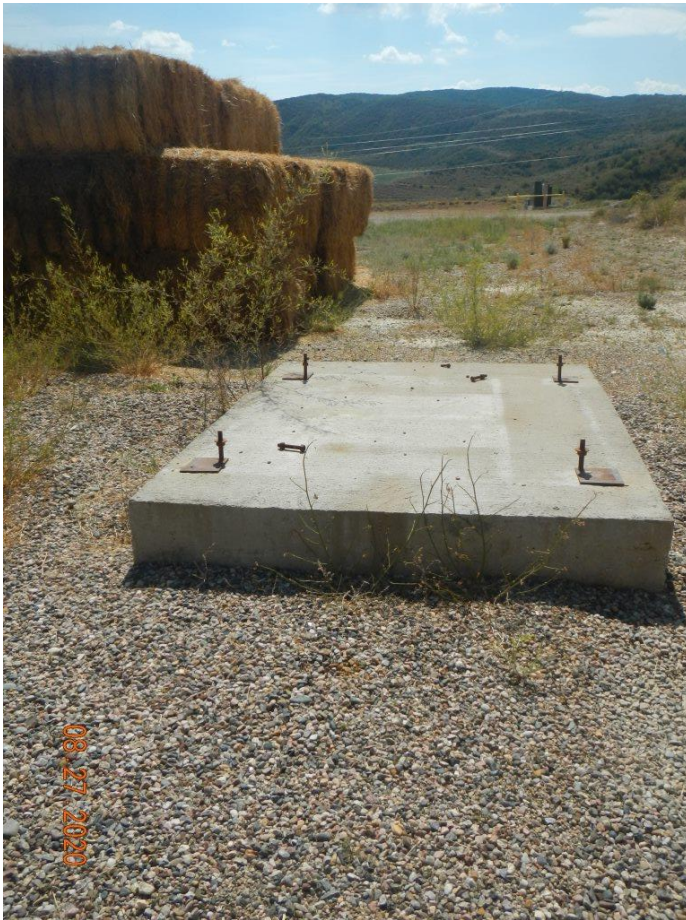
Photo#8:
Concrete equipment base remains on site.

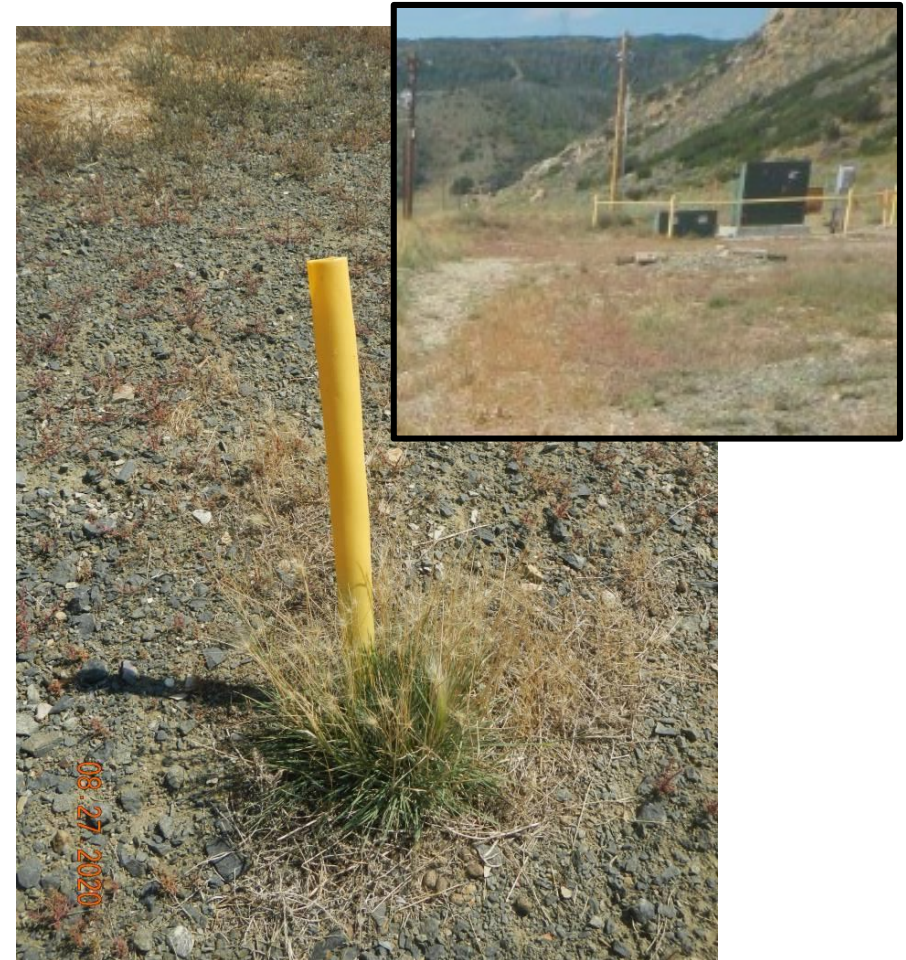
Photo#9:
Anchors, electrical unit remain on site.
