Inspection Photos

Operator: BP America
API: 067-07246
Date: 9/2/2020

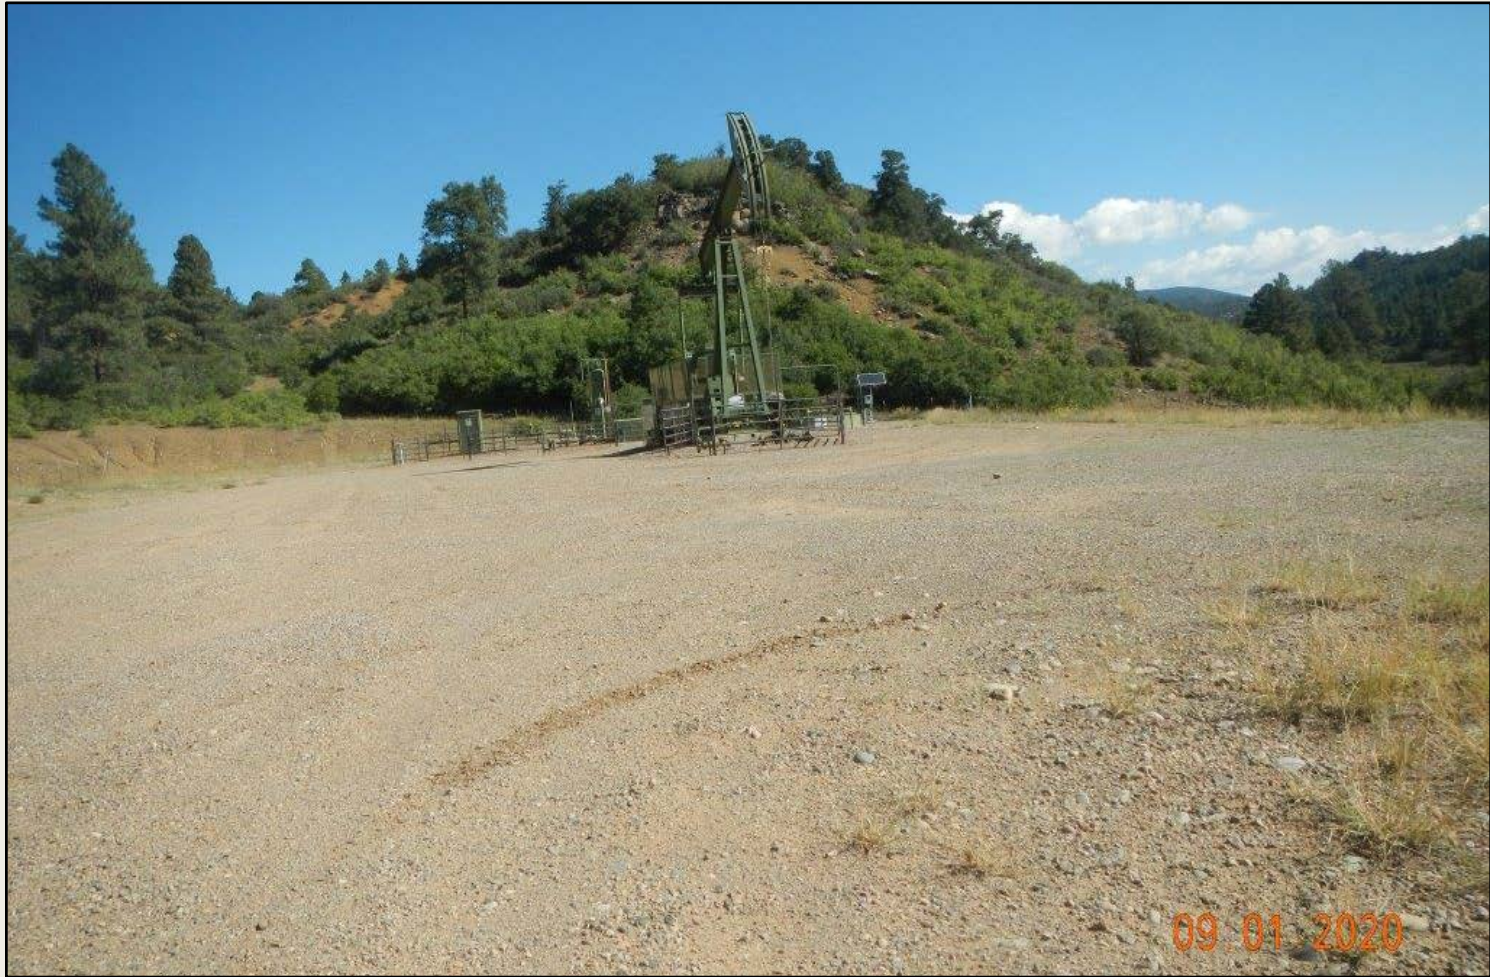
Photo 1. View of the project area from the well pad entrance facing center.

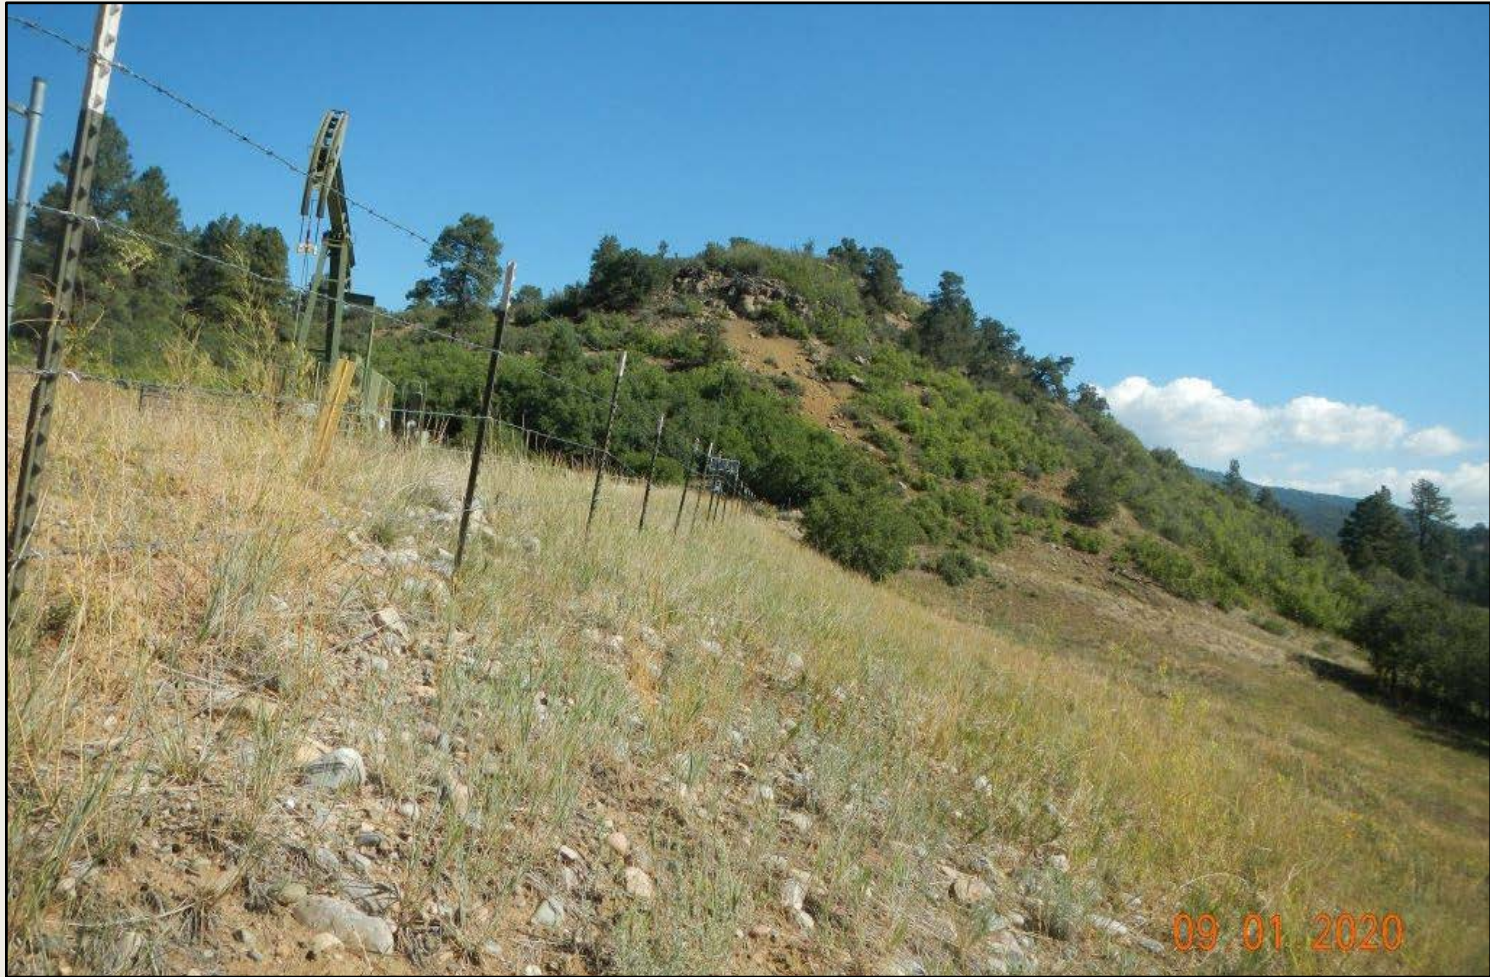
Photo 2. View of the eastern project area from the southeastern corner facing northward. Revegetation is progressing here with western wheatgrass and smooth brome facing northward.

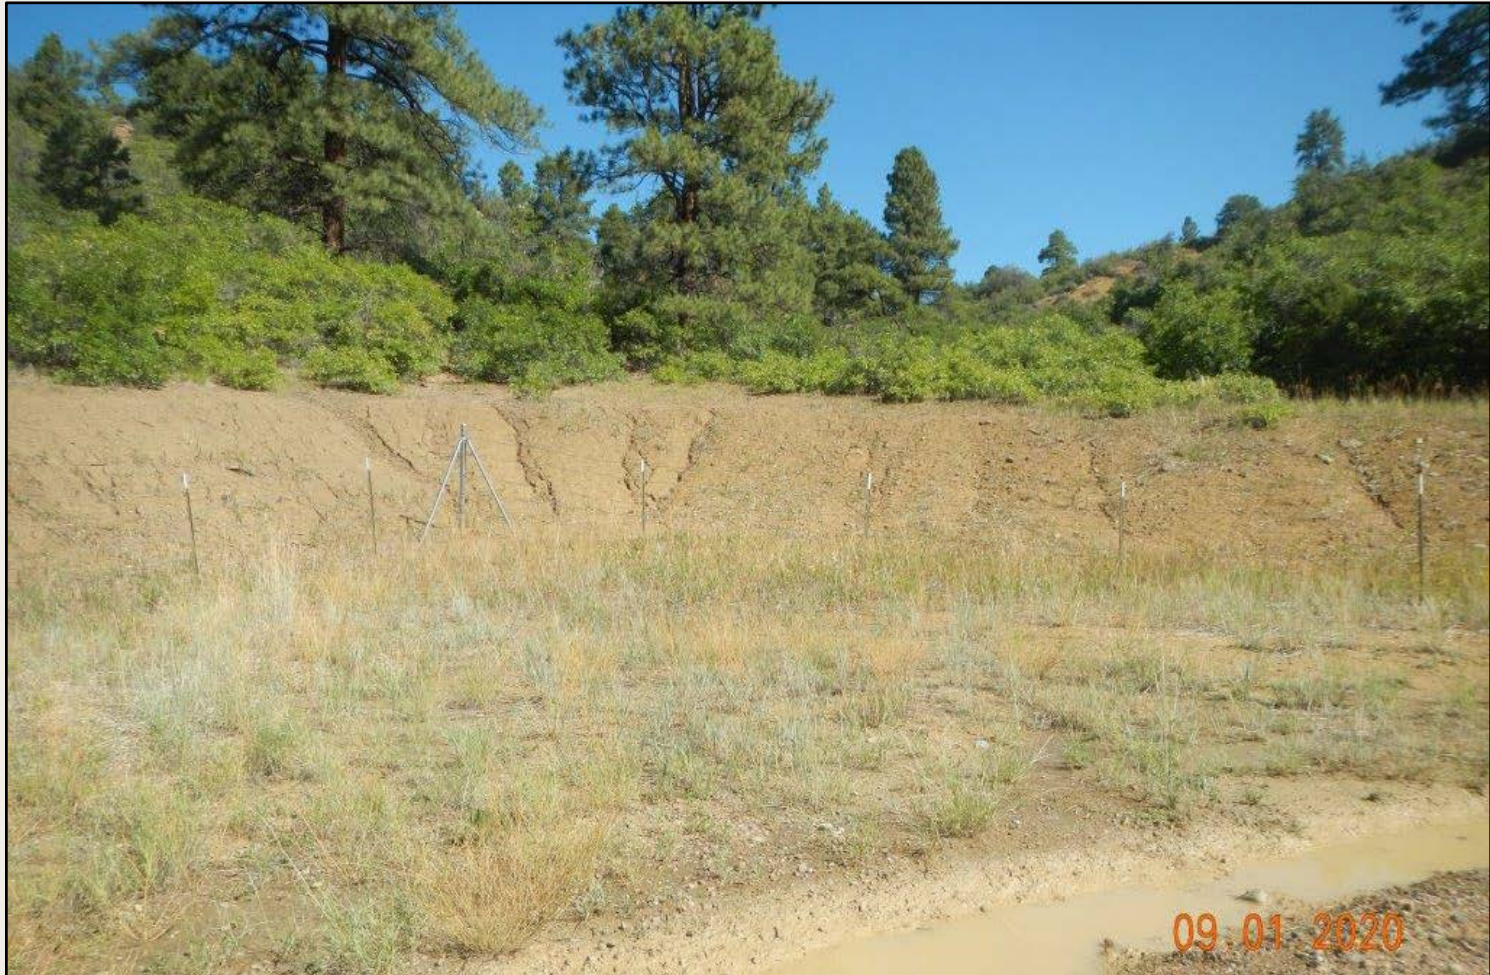
Photo 3. View of the northwestern project area. Bare soils need stabilization.

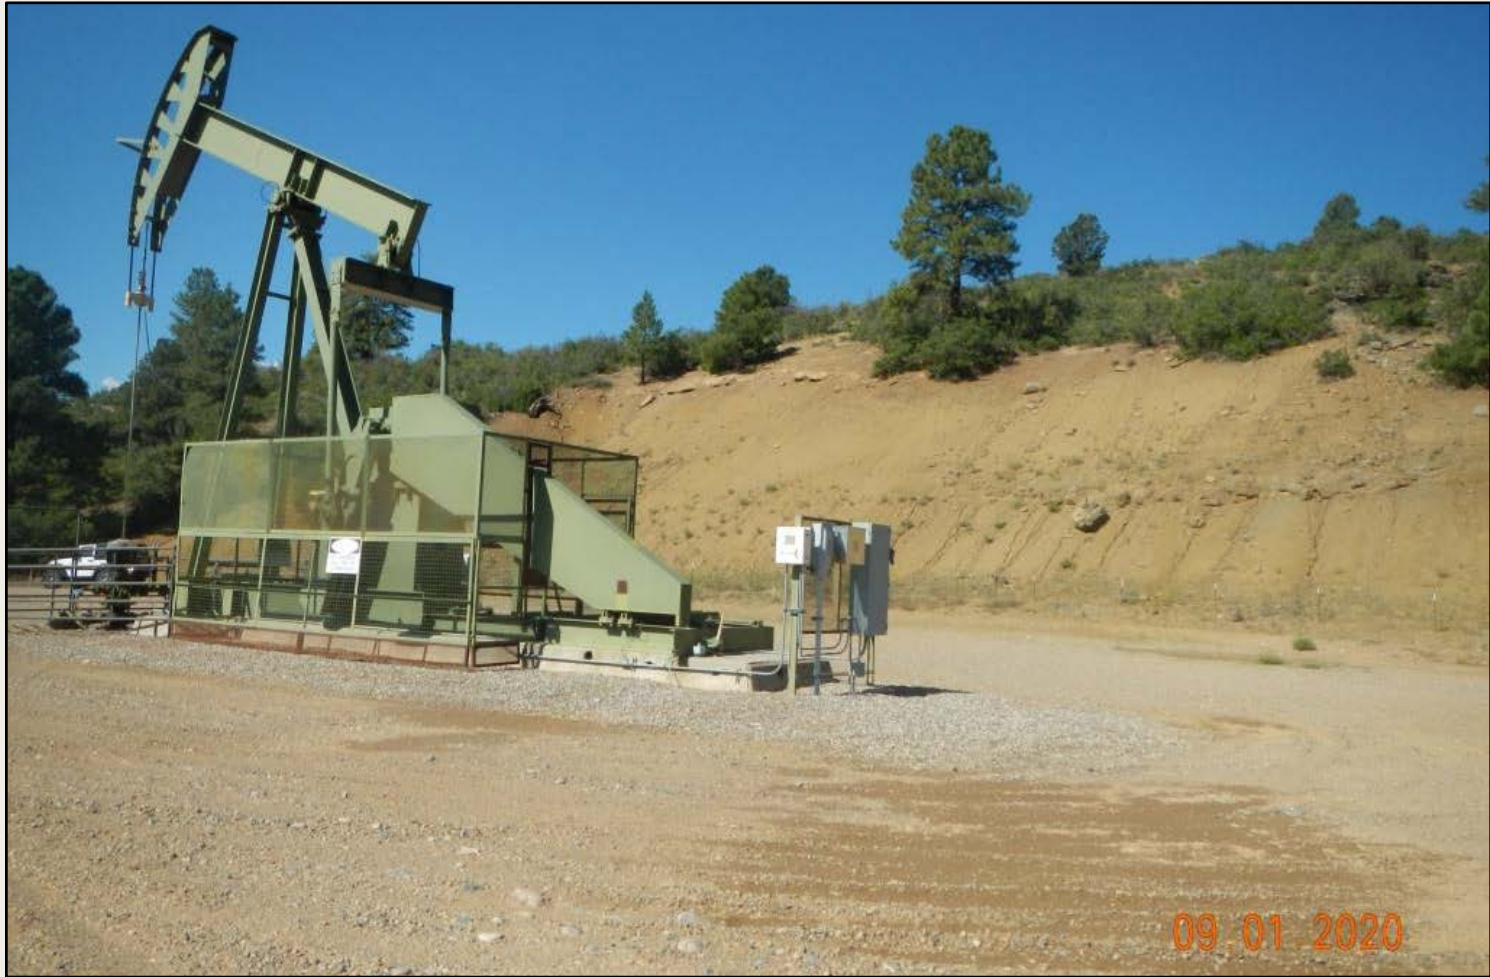
Photo 4. View of the well pad cut-slope. Additional stabilization measures are needed to stabilize bare soils.
