**Inspection Photos**  
**Operator: Hilcorp Energy**  
**API: 067-07593**  
**Date: 9/1/2020**

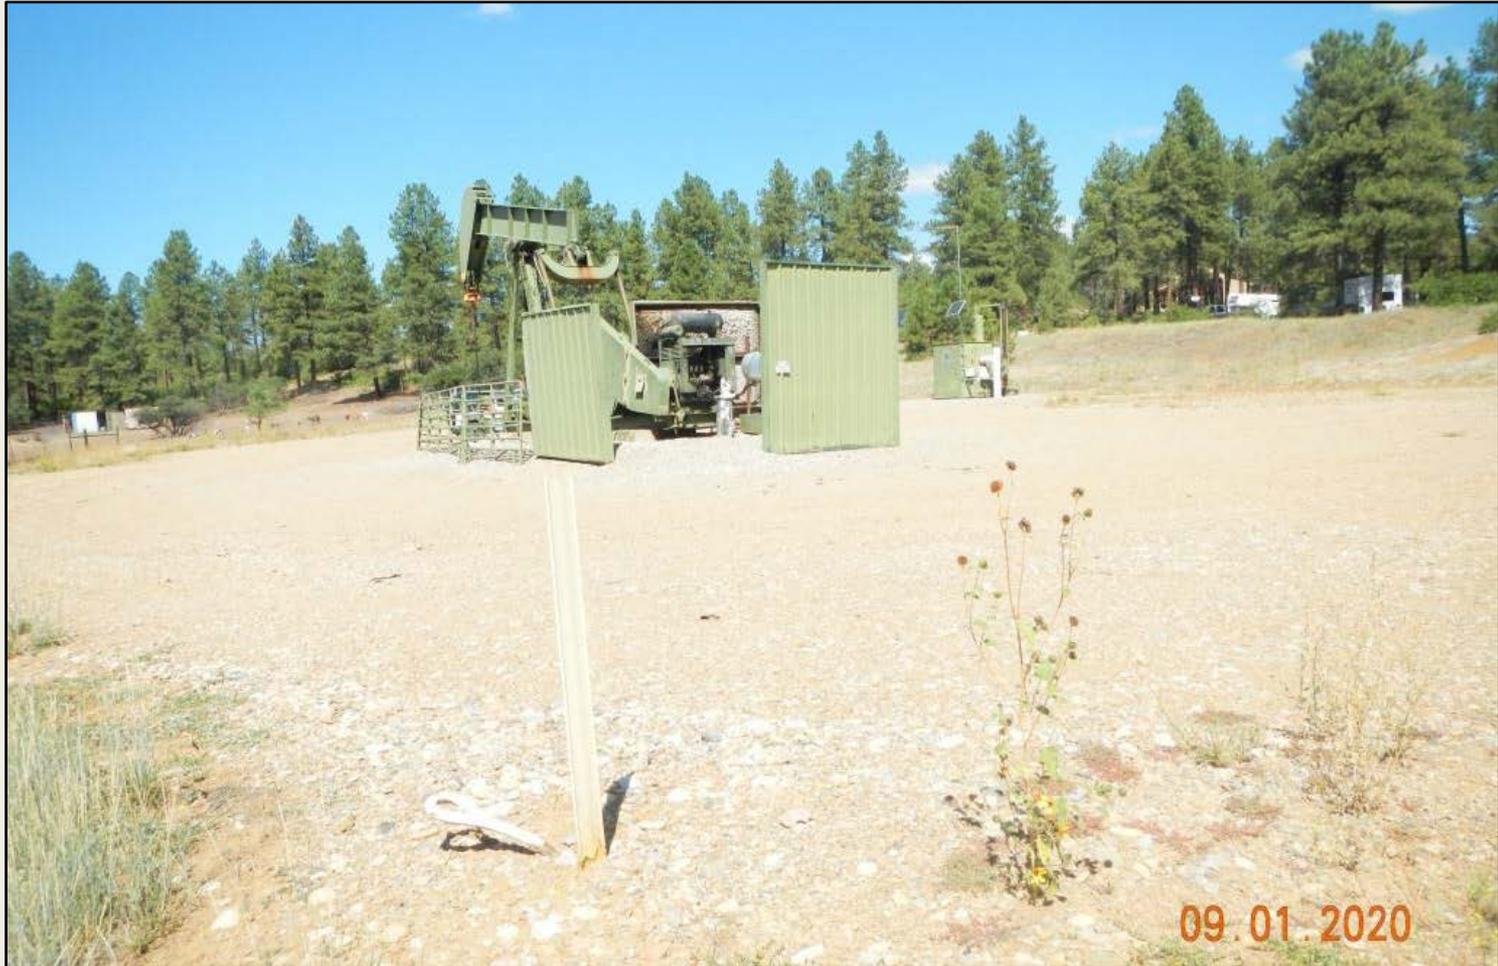
Photo 1. View of the project area from the southeastern corner facing center.

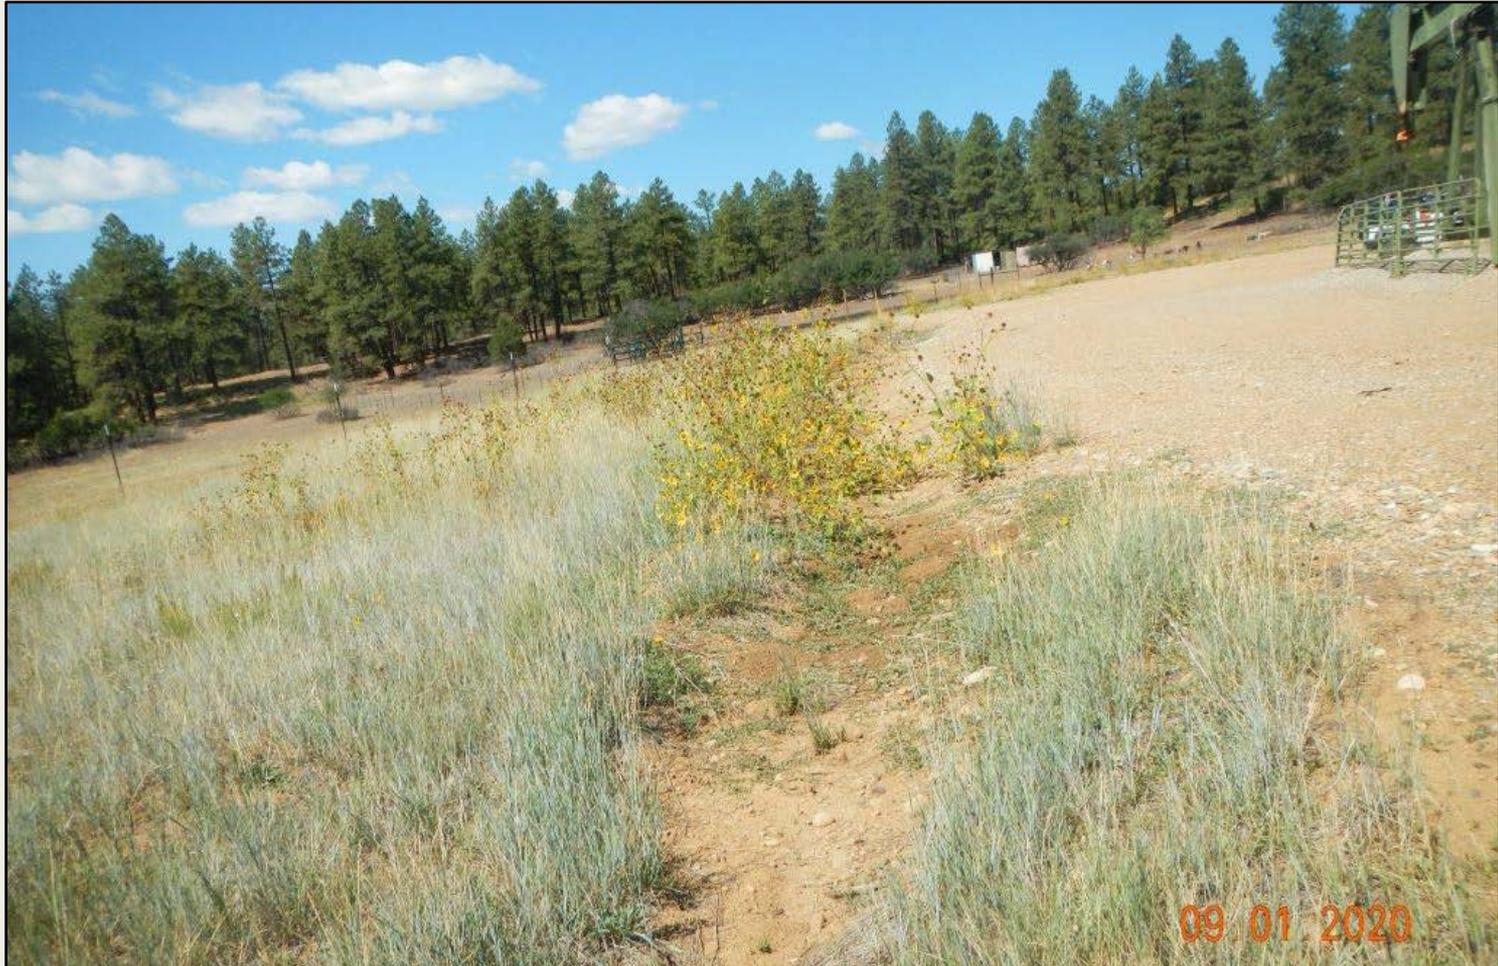
Photo 2. View of the southern fill slope from the southeastern corner facing westward. Revegetation is progressing, largely with western wheatgrass and sunflowers.

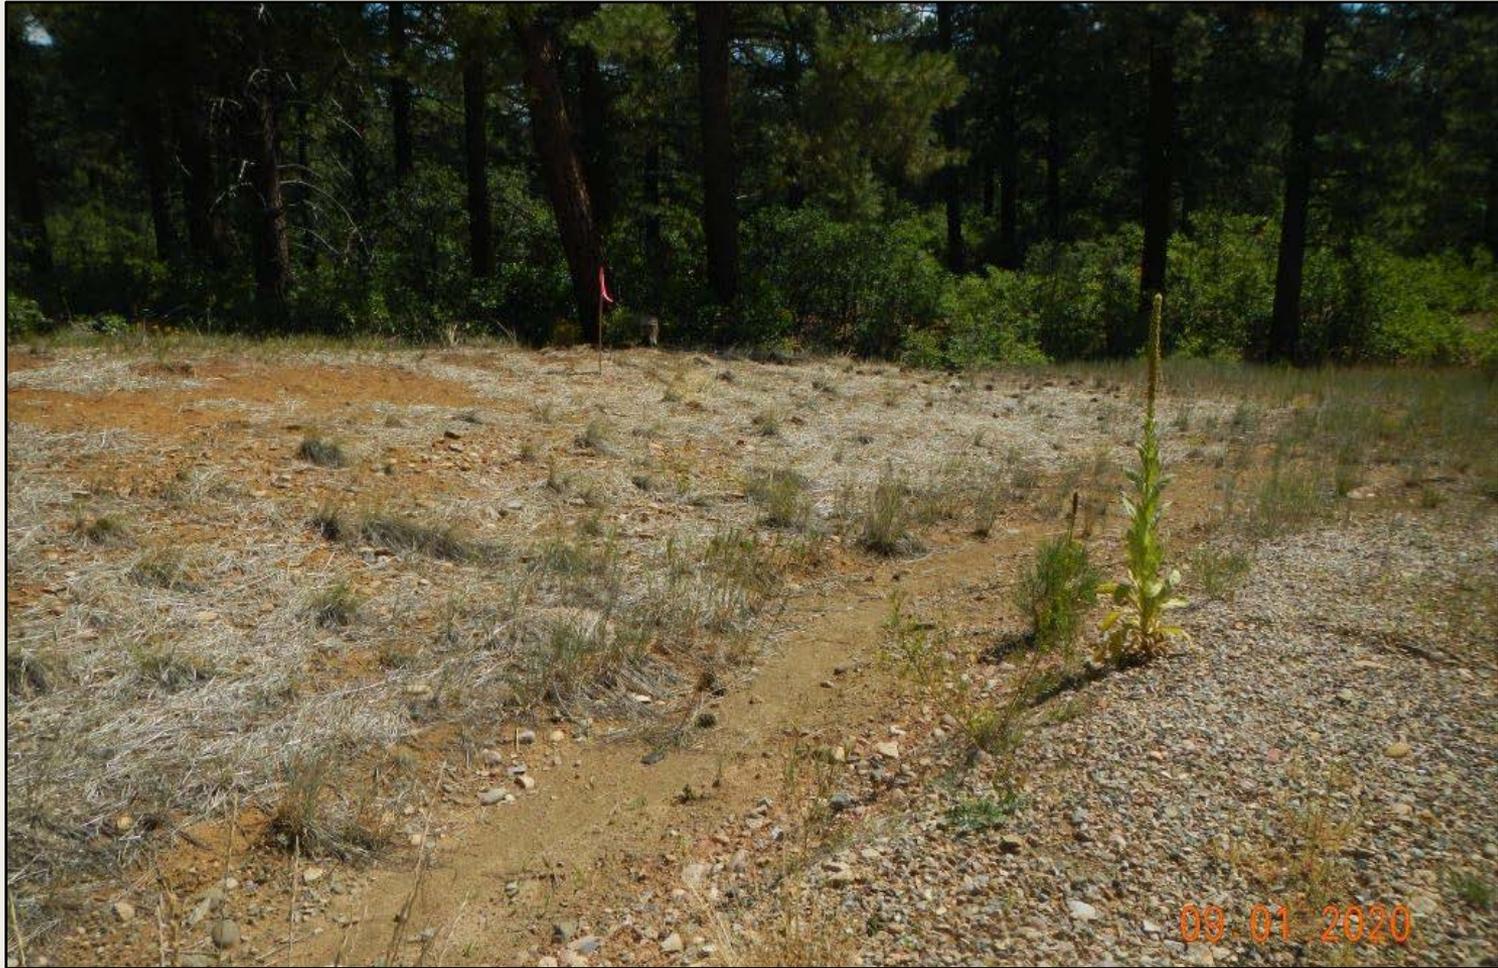
Photo 3. View of the northeastern cut-slope. It appears revegetation was conducted here as straw mulch is present. Grasses are becoming established.

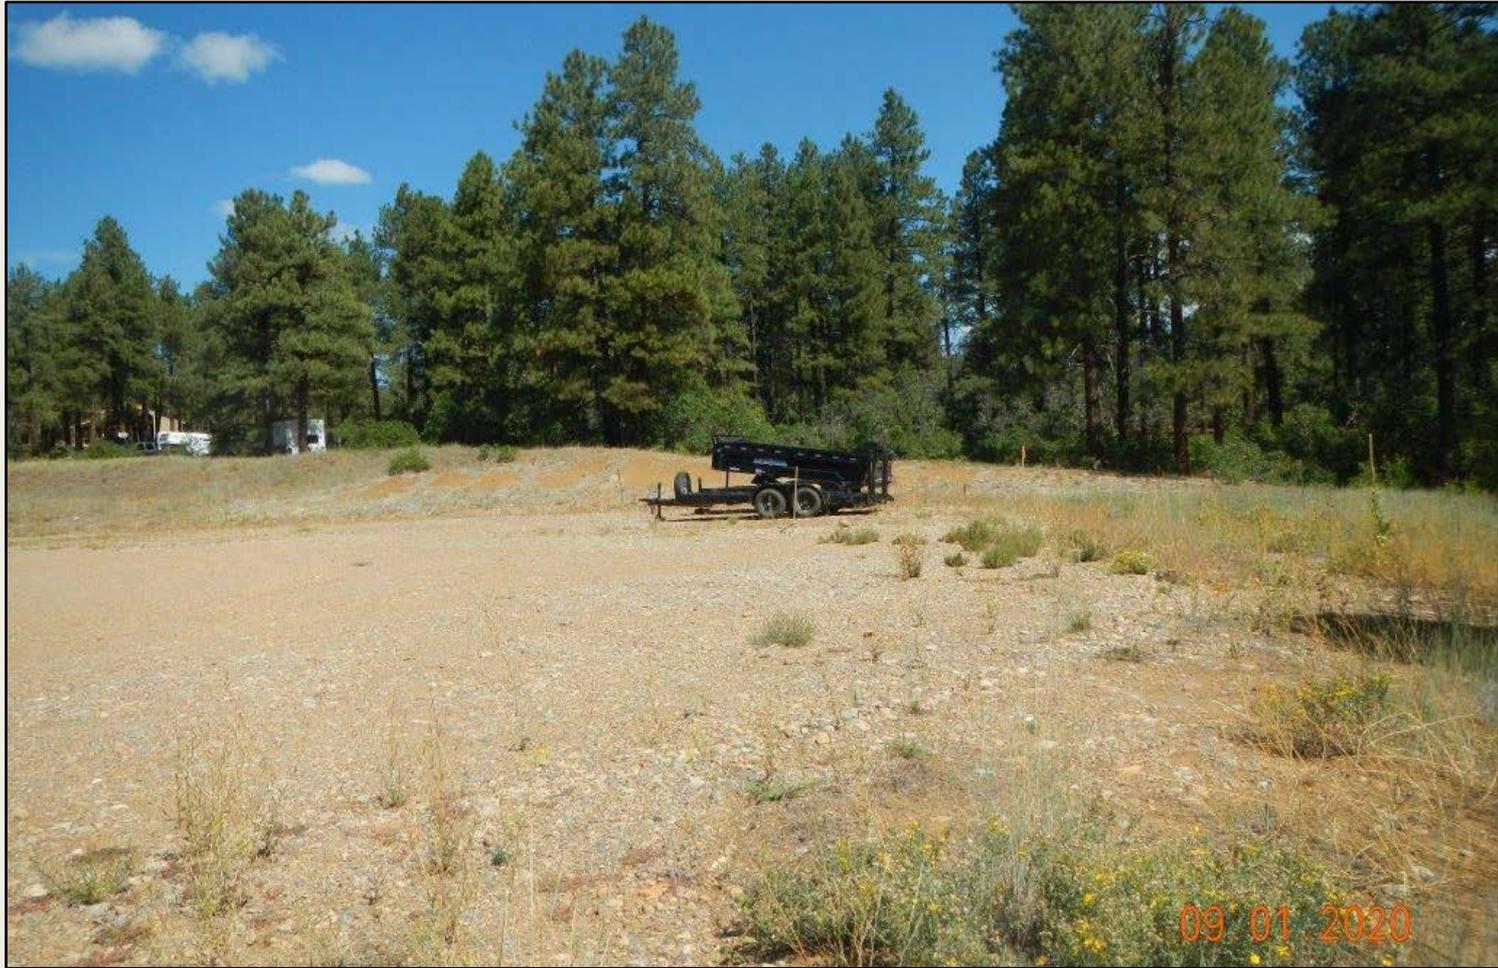
Photo 4. View of the eastern project area from the southeastern corner facing northward. Unused equipment (trailers) parked on the well pad. If portions of the project area are not needed for production operations, then interim reclamation needs to be conducted.

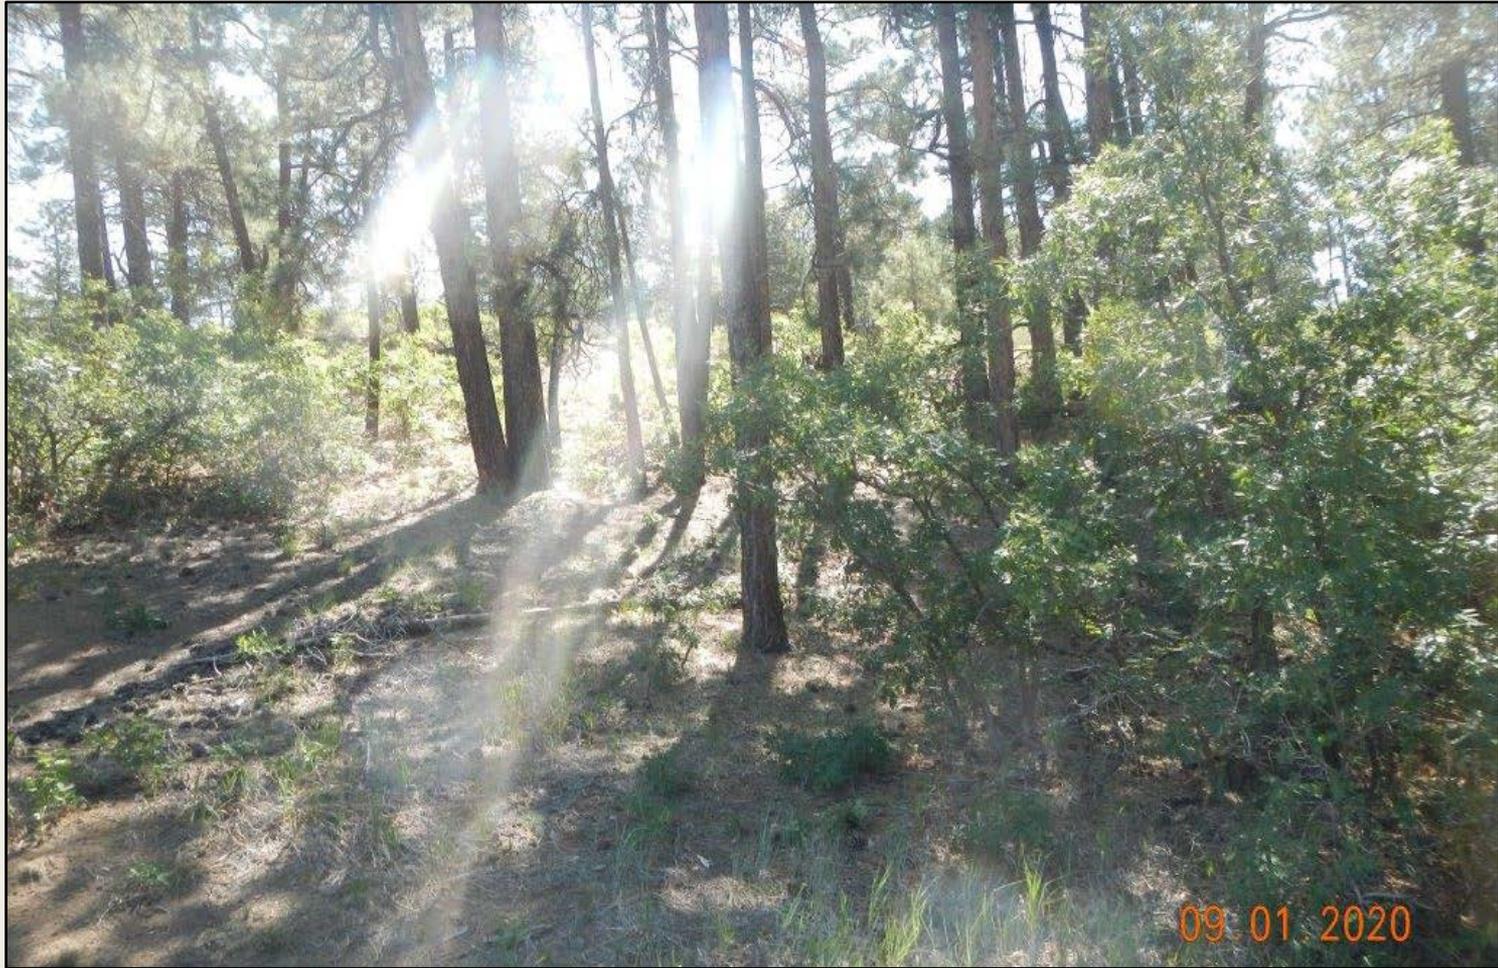
Photo 5. View of reference area vegetation comprised of ponderosa pine forest with an understory of gambel oaks, Oregon grape, and Sandberg bluegrass.
