Inspection Photos

Location Name: MARALEX RESOURCES INC FEDERAL-68S97W /29SWNW

Location ID: 312424

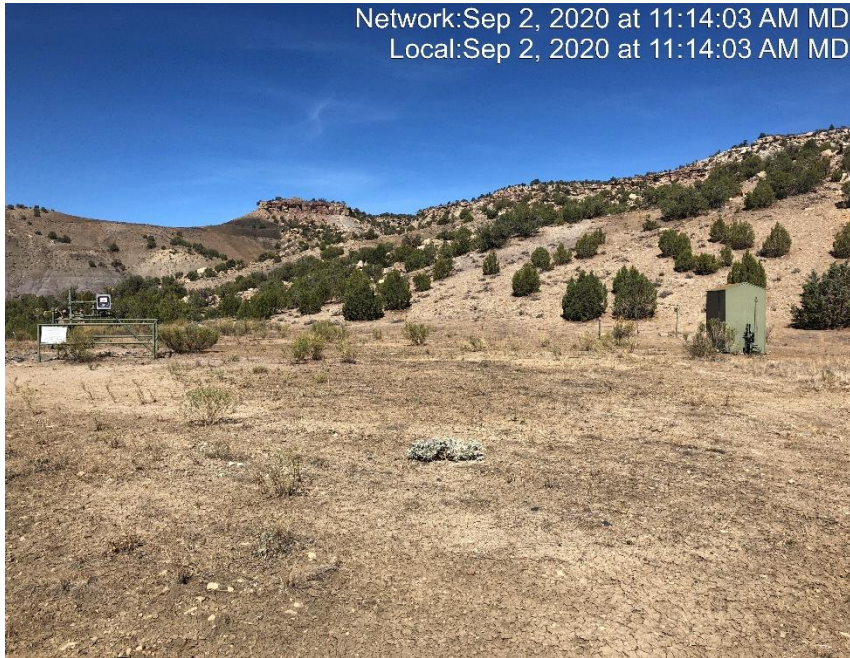
Photo #1826 from entrance to location

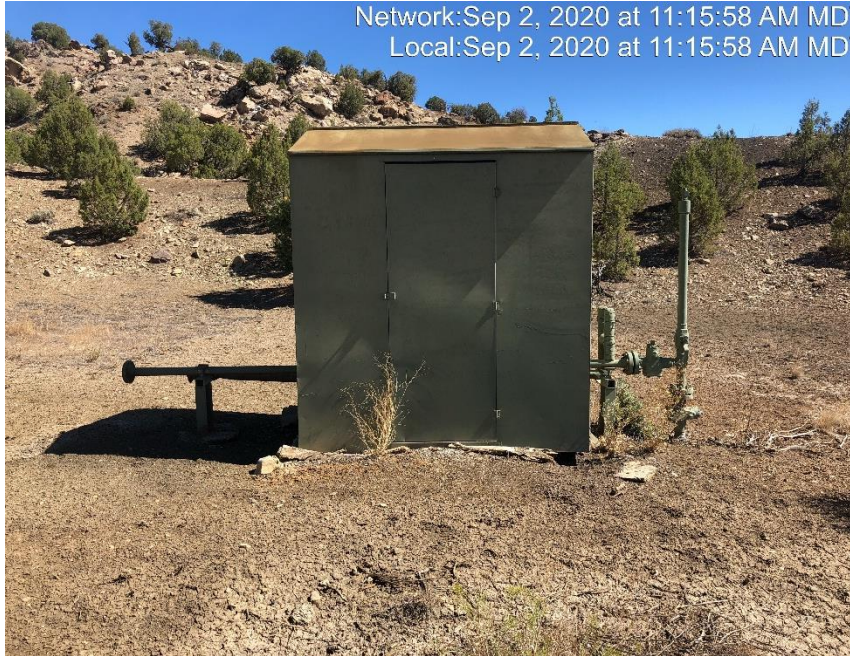
Photo #1827 Unused meter run.

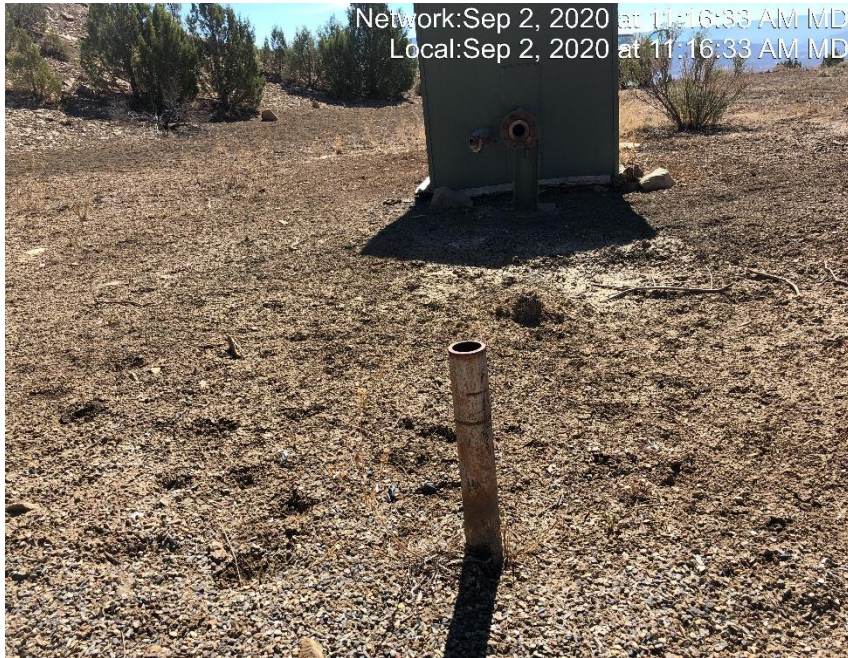
Photo #1828 Flow line riser not LO/TO.

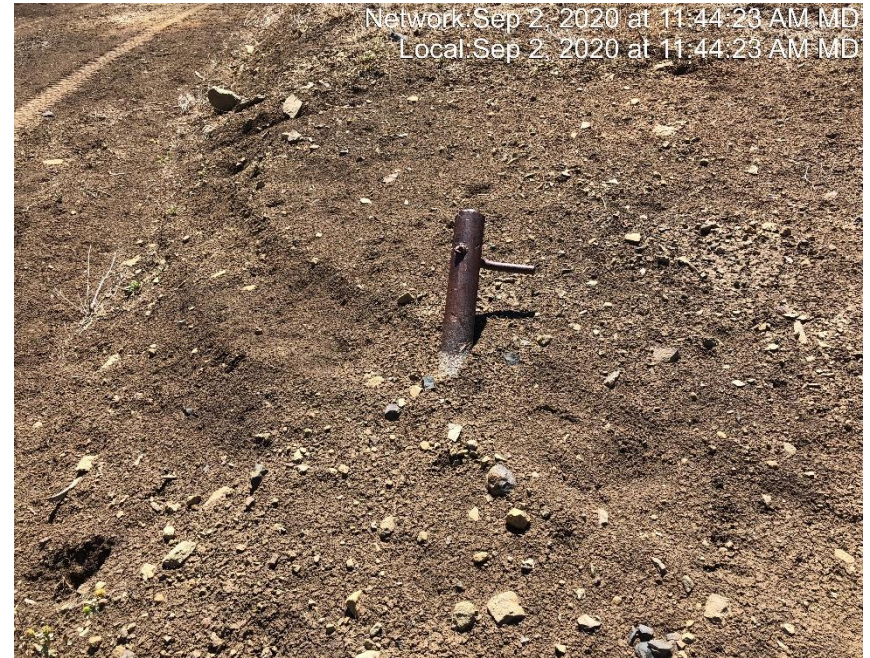
Photo #1830 Multiple unmarked deadman.
