## Inspection Photos

Location Name: MARALEX RESOURCES INC FEDERAL-68S97W /30SWSW

Location ID: 312424

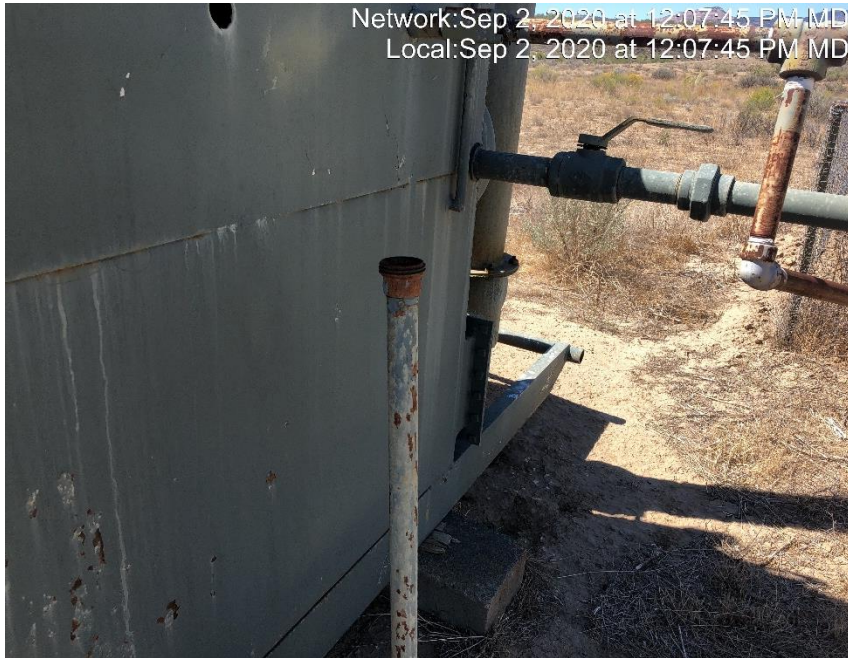
Photo #1832 Flow line risers not LO/TO.

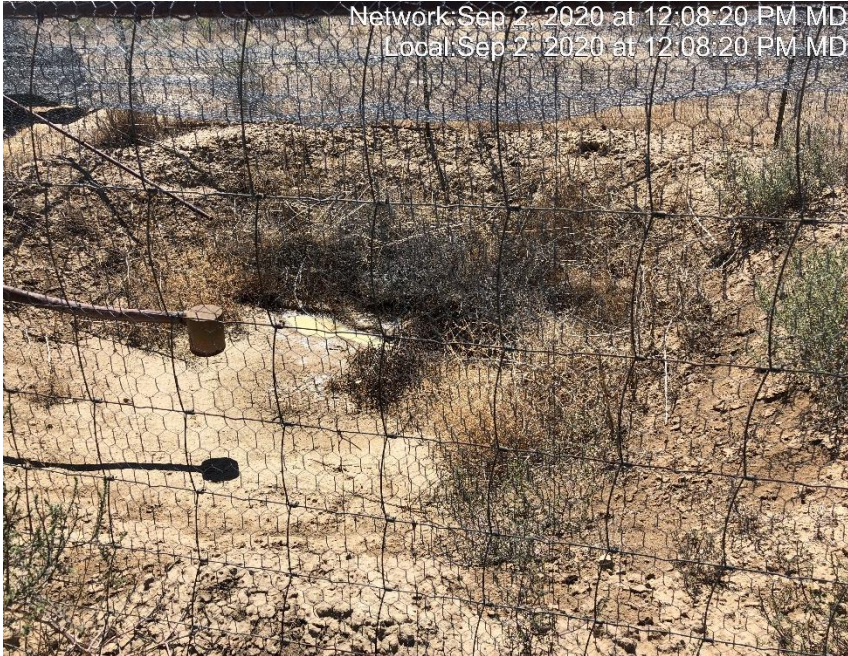
**Photo #1833 Debris inside pit.**
