## Inspection Photos

Location Name: MARALEX RESOURCES INC FEDERAL-68S98W /25NWSE

Location ID: 312424

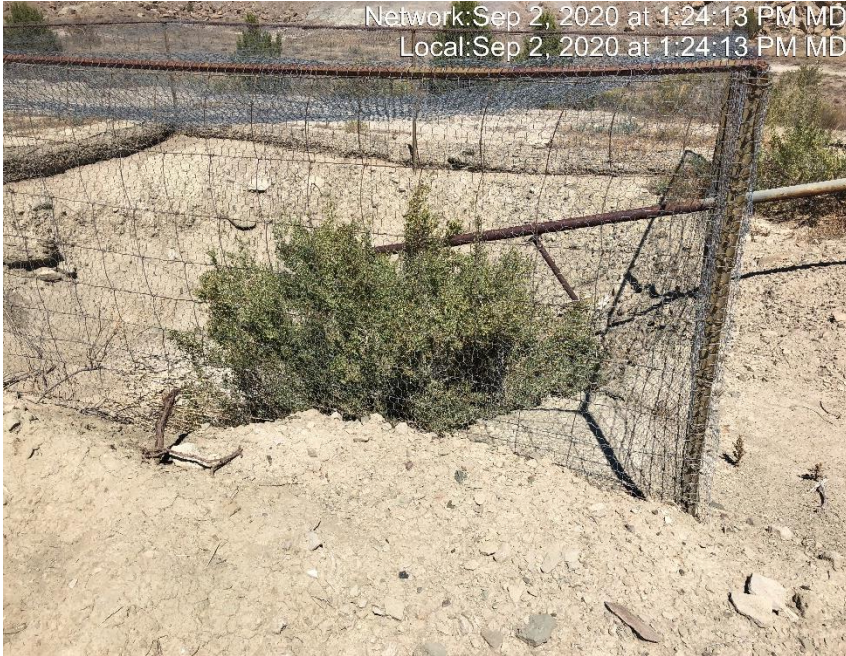
**Photo #1836 Debris inside pit.**

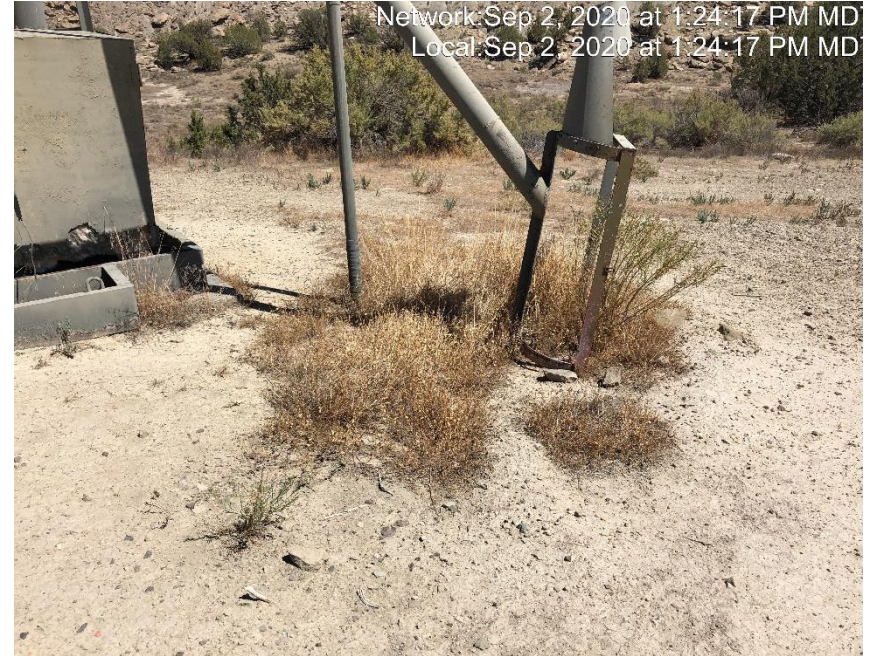
**Photo #1837 Debris around equipment.**
