Inspection Photos

Location Name: MARALEX RESOURCES INC FEDERAL-68S98W /35SENW

Location ID: 312511

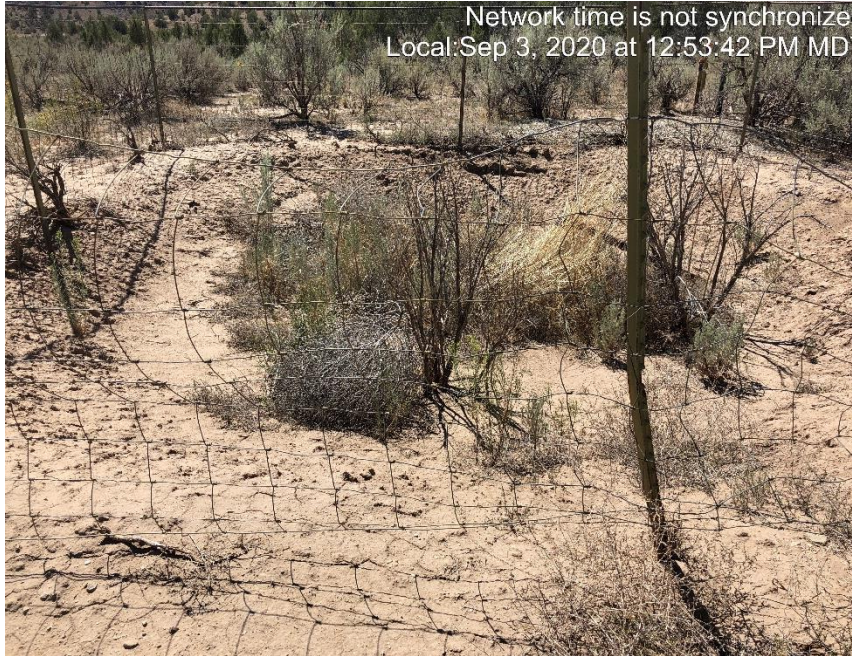
Photo #1842 Debris inside both pits

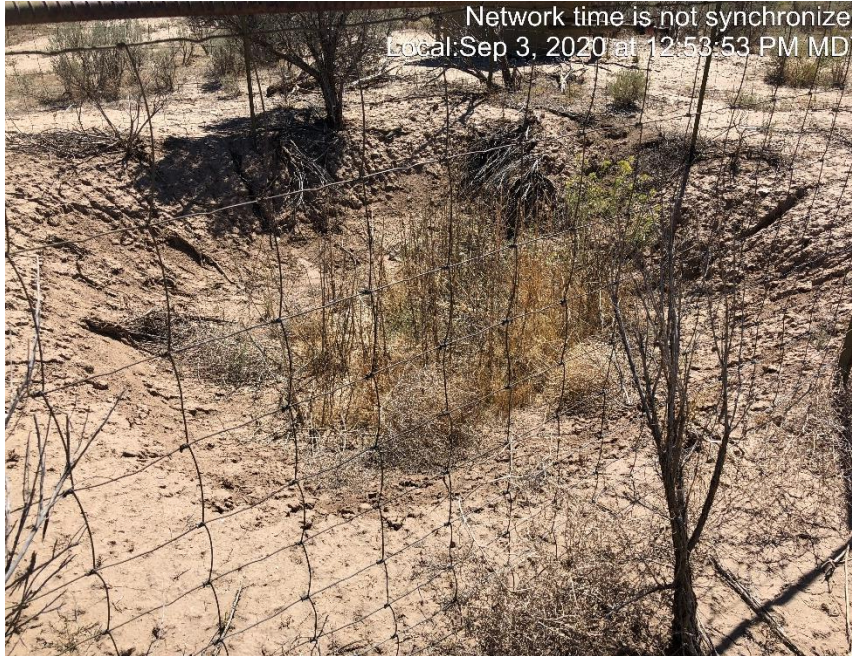
Photo #1843 Debris inside both pits

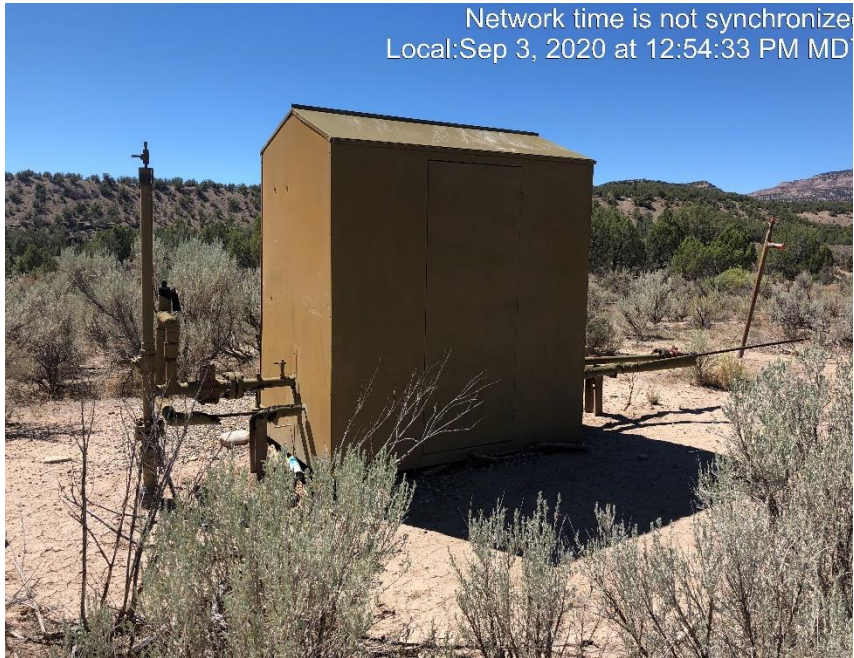
Photo #1844 Unused meter run.
