## **Response to August 5, 2020 Inspection Document Number 697501850**

Name: Centralized Land Treatment Facility

Location ID: 287848

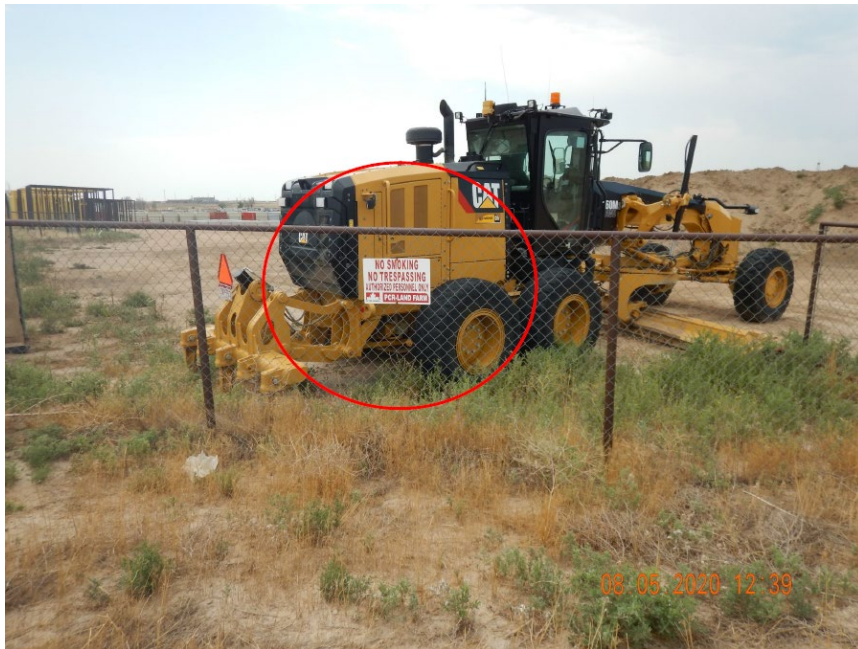
1. Signs/Marker: Inaccurate Operator signs were observed. Refer to the attached inspection photos. Install/remove signs to comply with Rule 210.c.

Photo 2. Photo taken from the main point of access to the facility, facing South. Photo illustrates an inaccurate sign. Other inaccurate signs were observed.

Response: Noble removed inaccurate operator signs and installed correct signage.

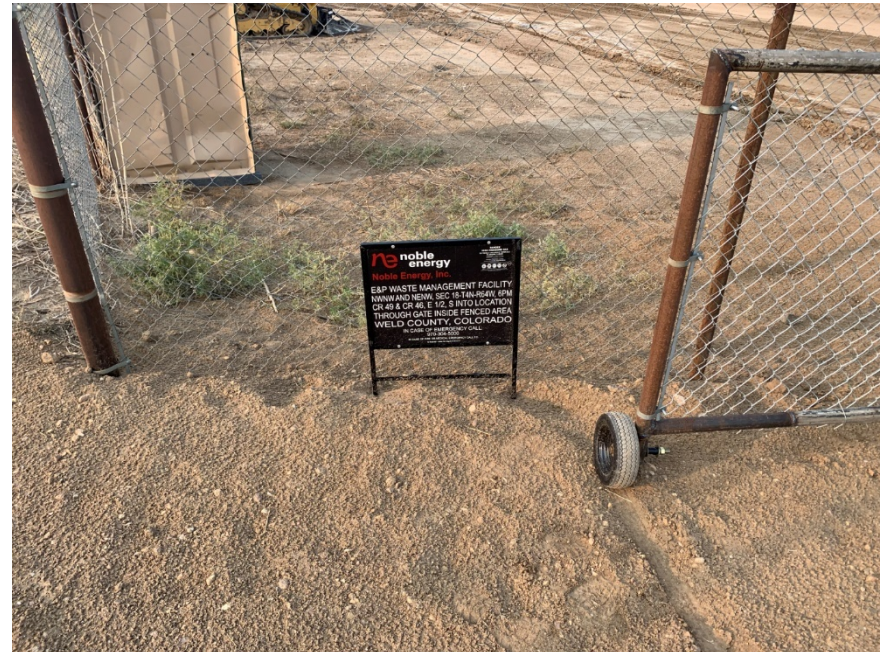
Photo NBL1. Inaccurate signage removed and proper signage installed, facing South.

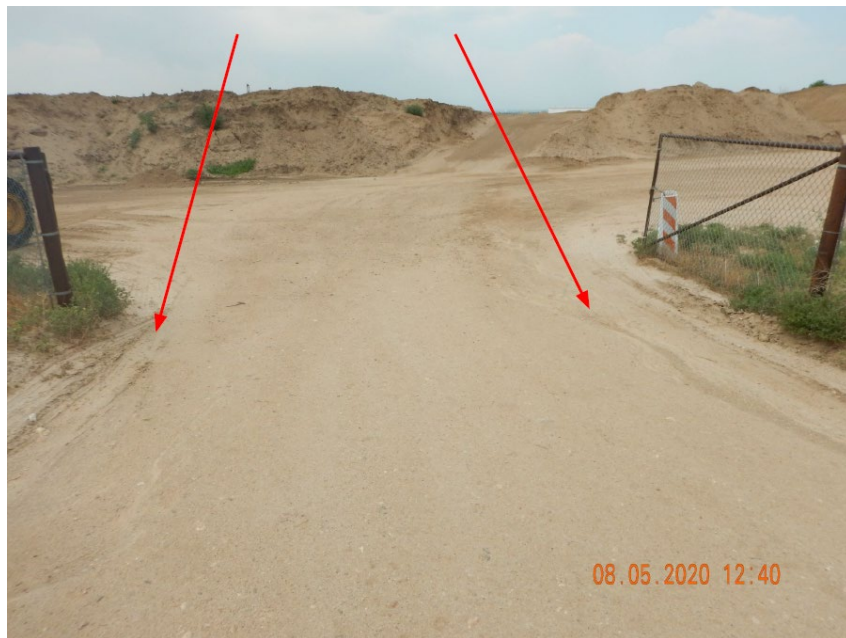
4. Storm Water: Unmanaged stormwater run-on was observed at the main point of access to the facility and unmanaged stormwater run-off was observed along the southern facility. Comply with Rule 908.b.(5)E and Rule 1002.f.(2)C.

Photo 3. Photo taken from the main point of access to the facility, facing West. Photo illustrates unmanaged stormwater run-on onto the facility. Note: There was stormwater run-off from the southern facility.

Response: Noble installed a cattle guard with riprap on the endpoints at the main point of access for the facility. Additionally, Noble re-cut and increased location ditch size to restore stormwater control.

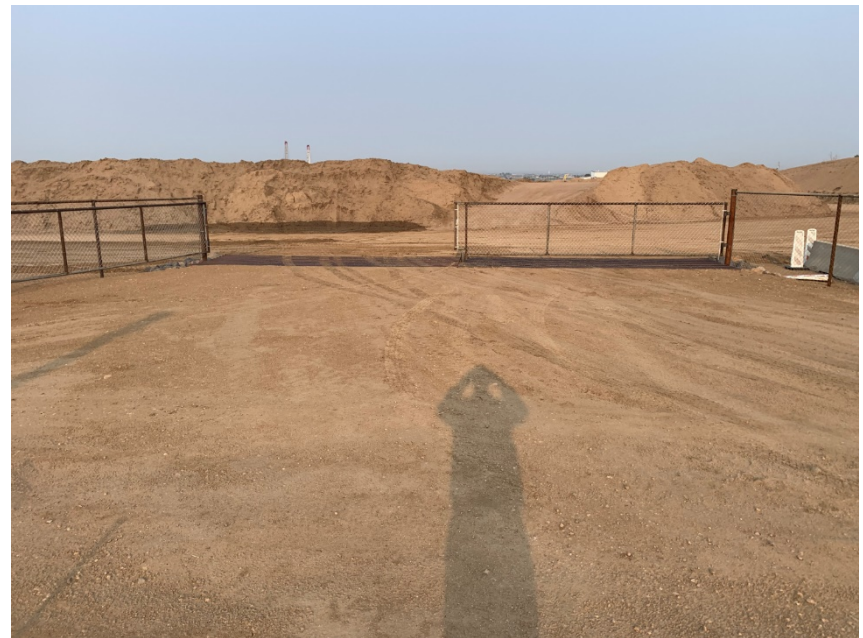
Photo NBL2. Main point of access to the facility, facing West, shown with lock, cattle guard, and riprap on endpoints of cattle guard.

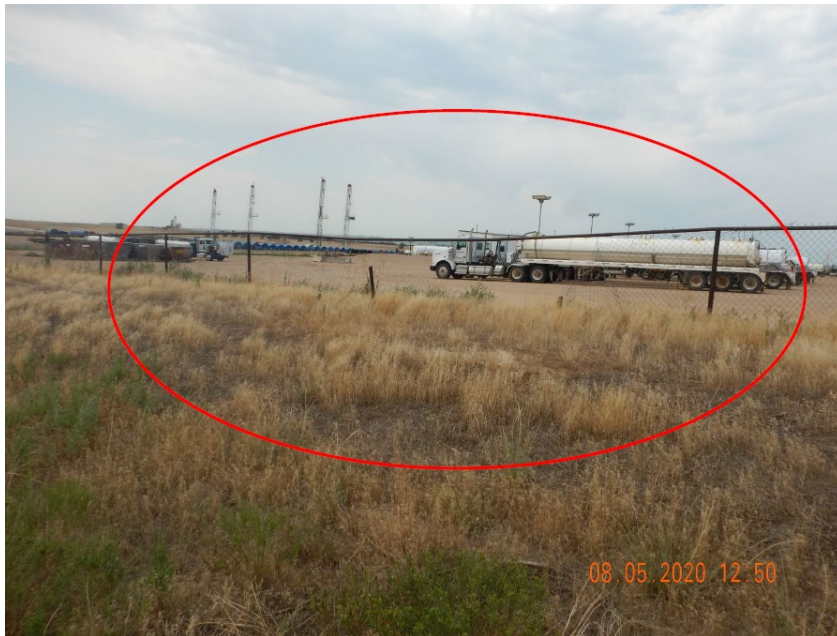
2. Good Housekeeping: A portion of the western perimeter fence has a breach and an open gate entry which is not controlling public access. Per Rule 908.b.(5)C., the facility shall be designed to control public access, prevent unauthorized vehicular traffic, provide for site security both during and after operating hours, and prevent illegal dumping of wastes. Appropriate measures shall also be implemented to prevent access to the centralized facility by wildlife or domestic animals. Comply with Rule 908.b.(5)C.

Photo 4. Photo taken from the western facility, facing West. Photo illustrates the perimeter fence has a breach to control public access.

Response: Noble repaired the breach in the western perimeter fence and installed a chain link and lock on the gate to control public access.

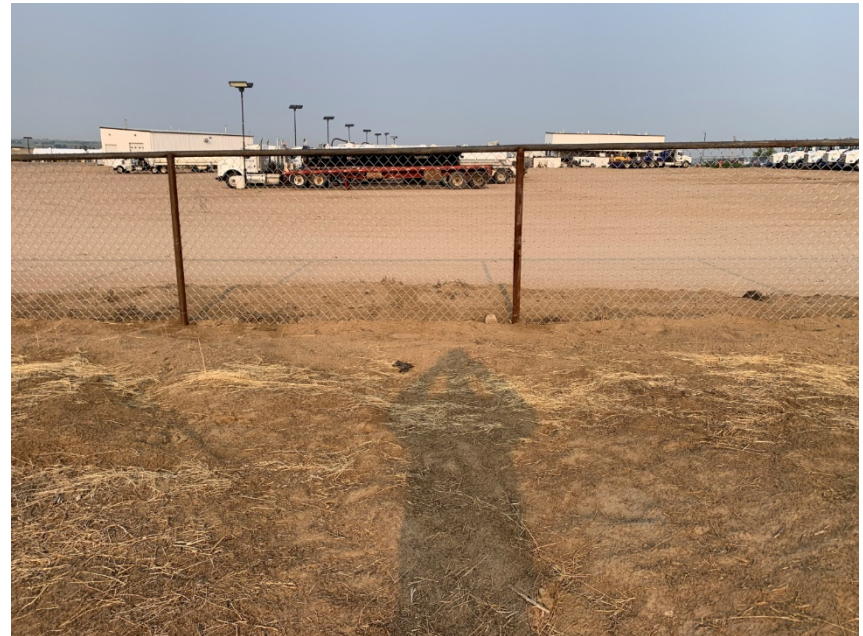
Photo NBL3. Breach in perimeter fence has been repaired to control public access, facing West.

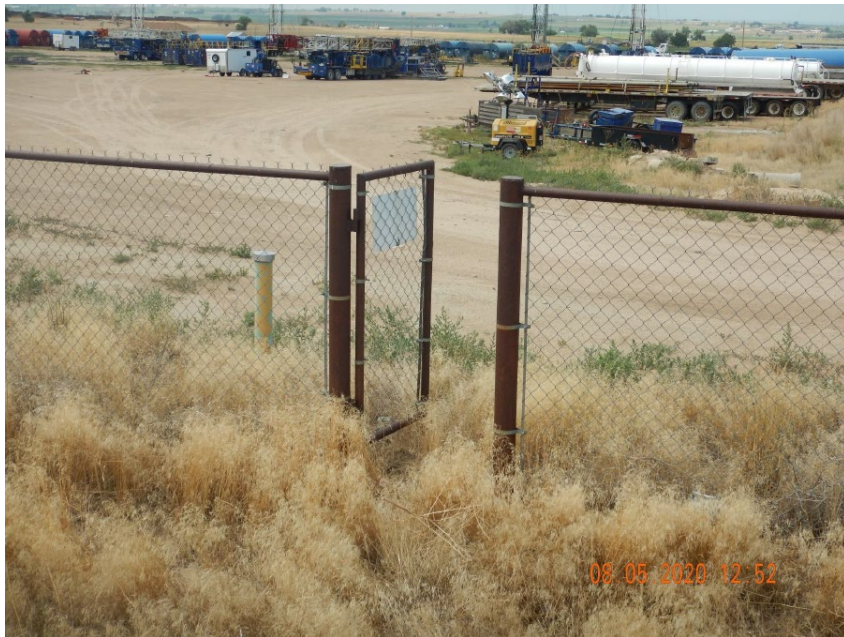
Photo 5. Photo taken from the western facility, facing West. Photo illustrates the perimeter fence entry is open.

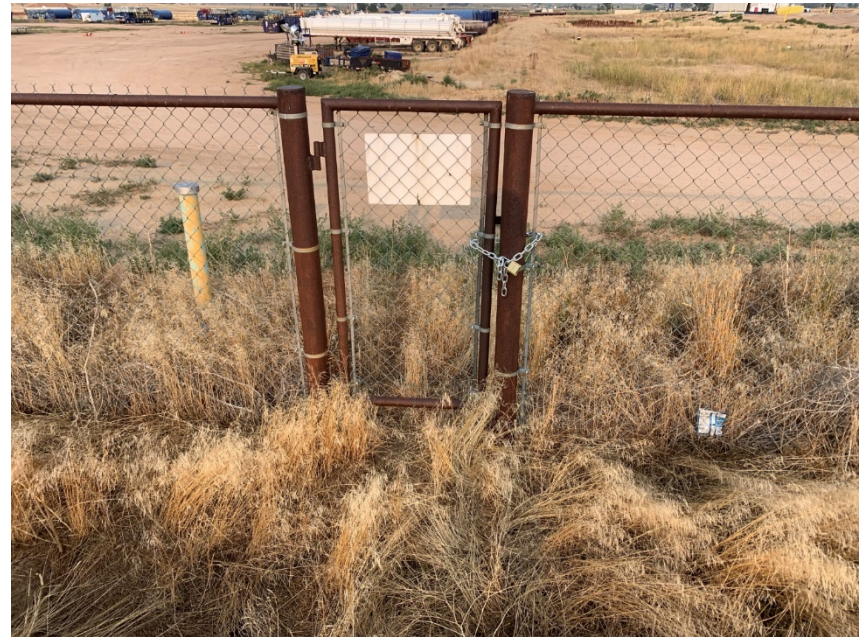
Photo NBL4. Perimeter fence chain linked and locked to control public access, facing West.

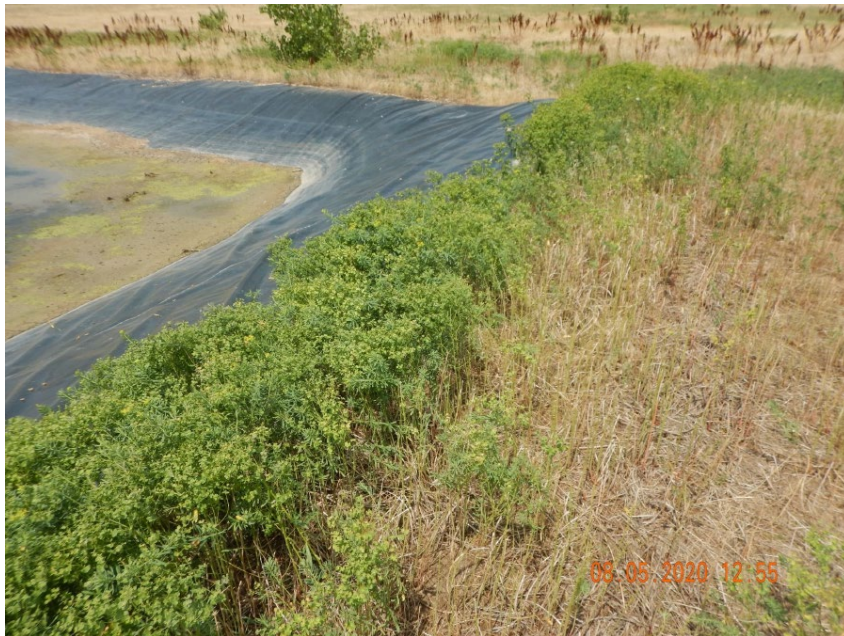
3. Interim Reclamation: At the time of this inspection, the facility is not in compliance with noxious weed management. Three (3) observed List B Colorado noxious weed species were observed- Leafy spurge, Scotch thistle and Musk thistle. Scotch and Musk thistle have already flowered. Seeds start to propagate two weeks after flowering. Operator shall use BMPs to properly remove all the senescent thistles. Mowing would not be considered a proper BMP as that would likely aid in the dispersal of seeds. Leafy spurge appears to be nearing the seed set growth stage. Note: Operator will have to conduct additional reclamation activities the next favorable season, as a weedy, annual List C noxious weed, cheatgrass, dominates the majority of the vegetated facility. Comply with Rule 1003.f.

Photo 6. Photo taken from the northeastern detention pond located along the western boundary of the facility, facing North. Photo illustrates a List B Colorado noxious weed, Leafy spurge.

Response: Noble sprayed the facility to manage the noxious weeds. Additional reclamation activities have been proposed to be scheduled for the next favorable season.

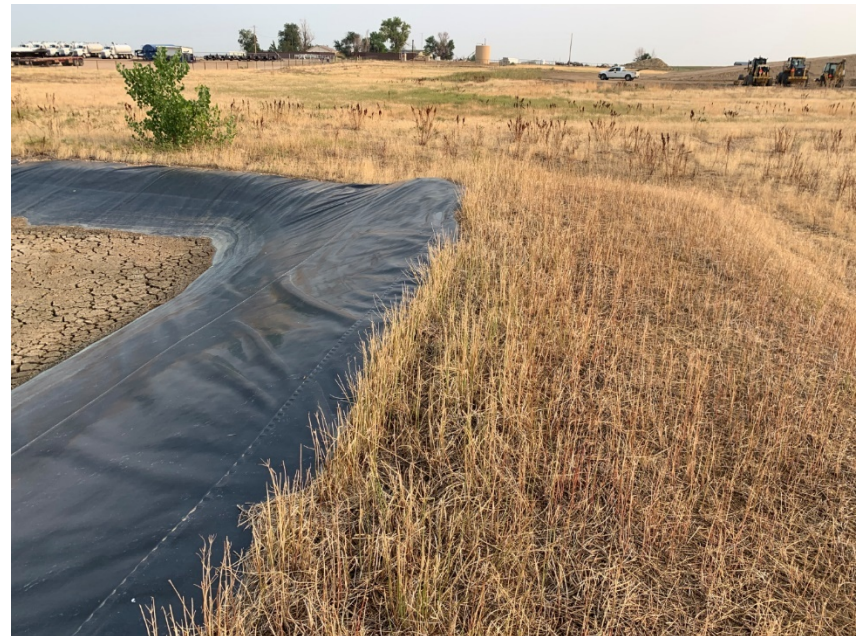
Photo NBL5. The northeastern detention pond along the western boundary of the facility, facing North, shown with noxious weeds that have been sprayed/killed.
