# Inspection Photos

Operator: BP America  
API: 067-06357  
Date: 9/1/2020

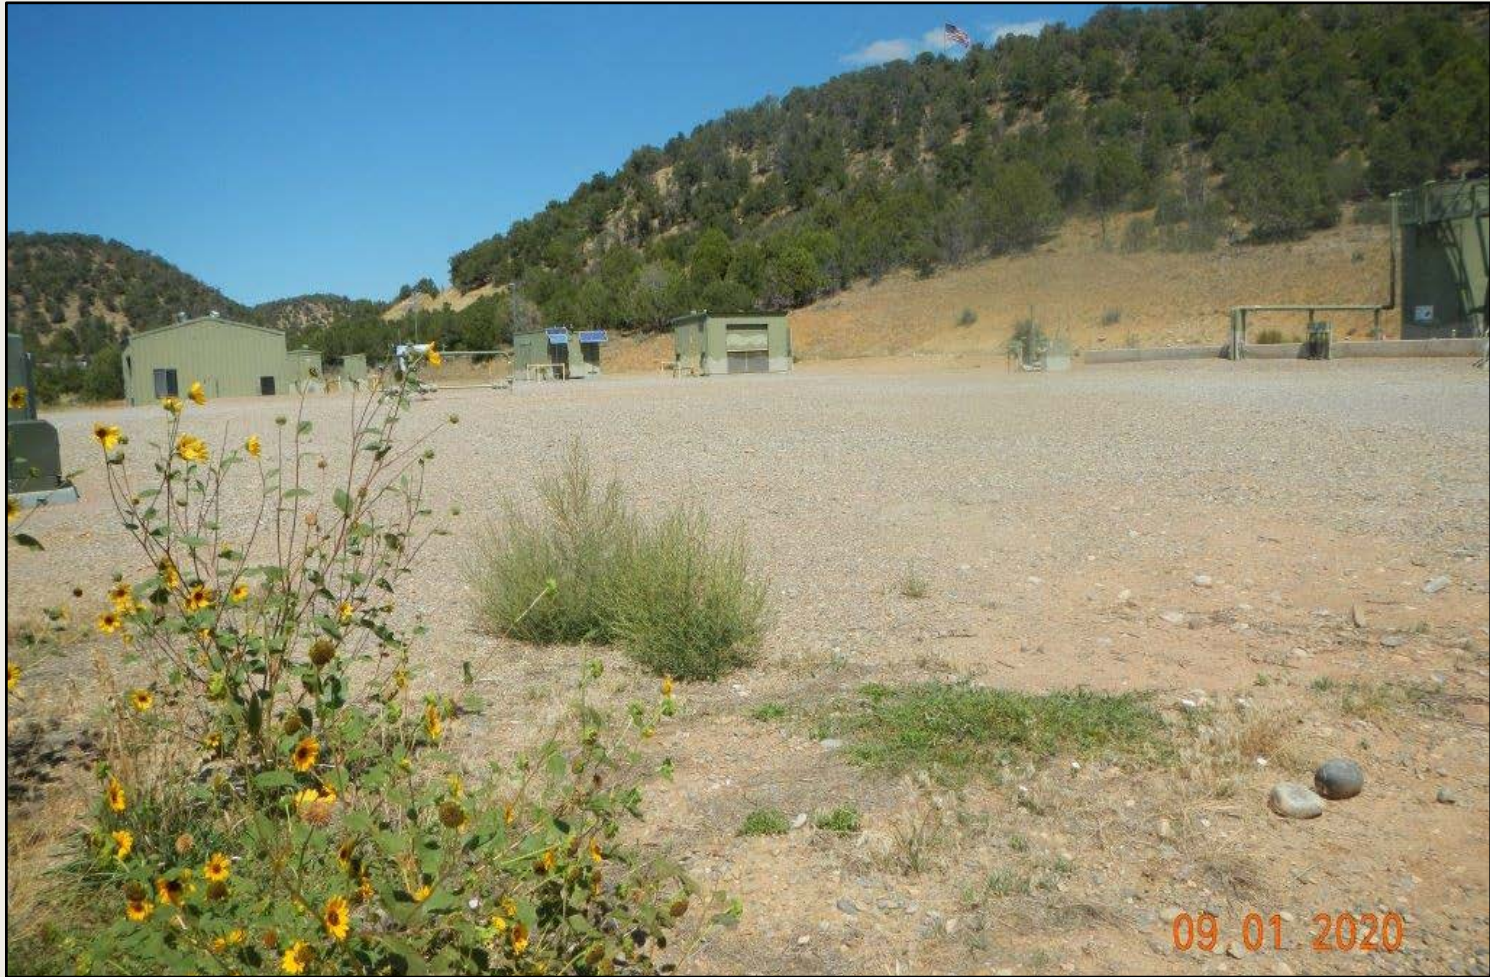
Photo 1. View of the project area from the southwestern corner facing center.

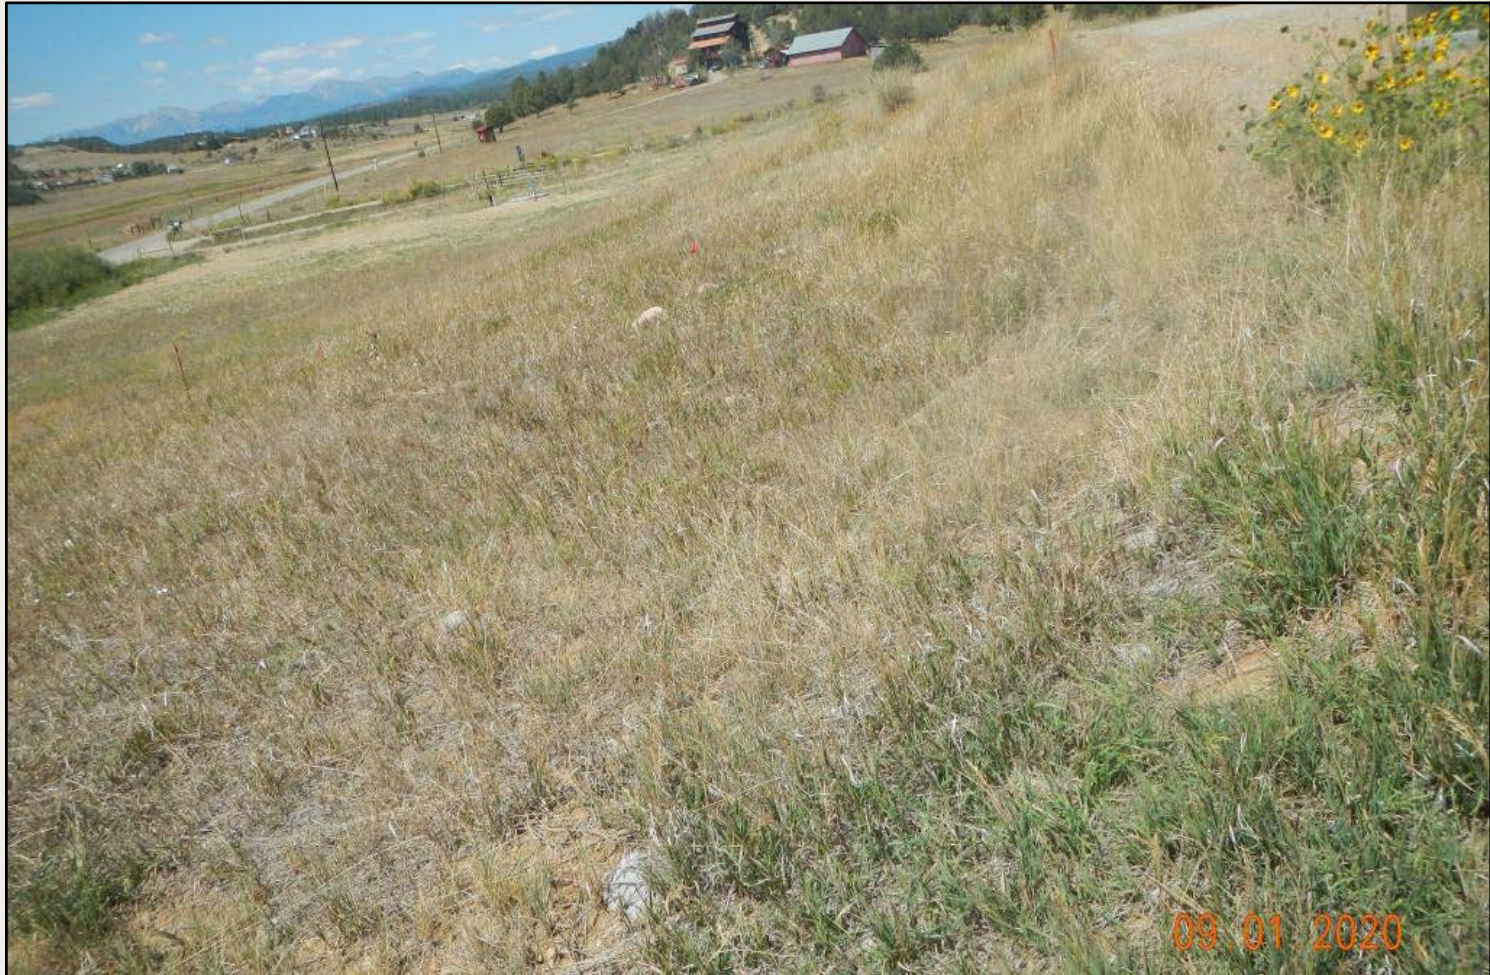
Photo 2. View of the western project area from the southwestern corner facing northward. Revegetation is progressing with grasses such as smooth brome and western wheatgrass.

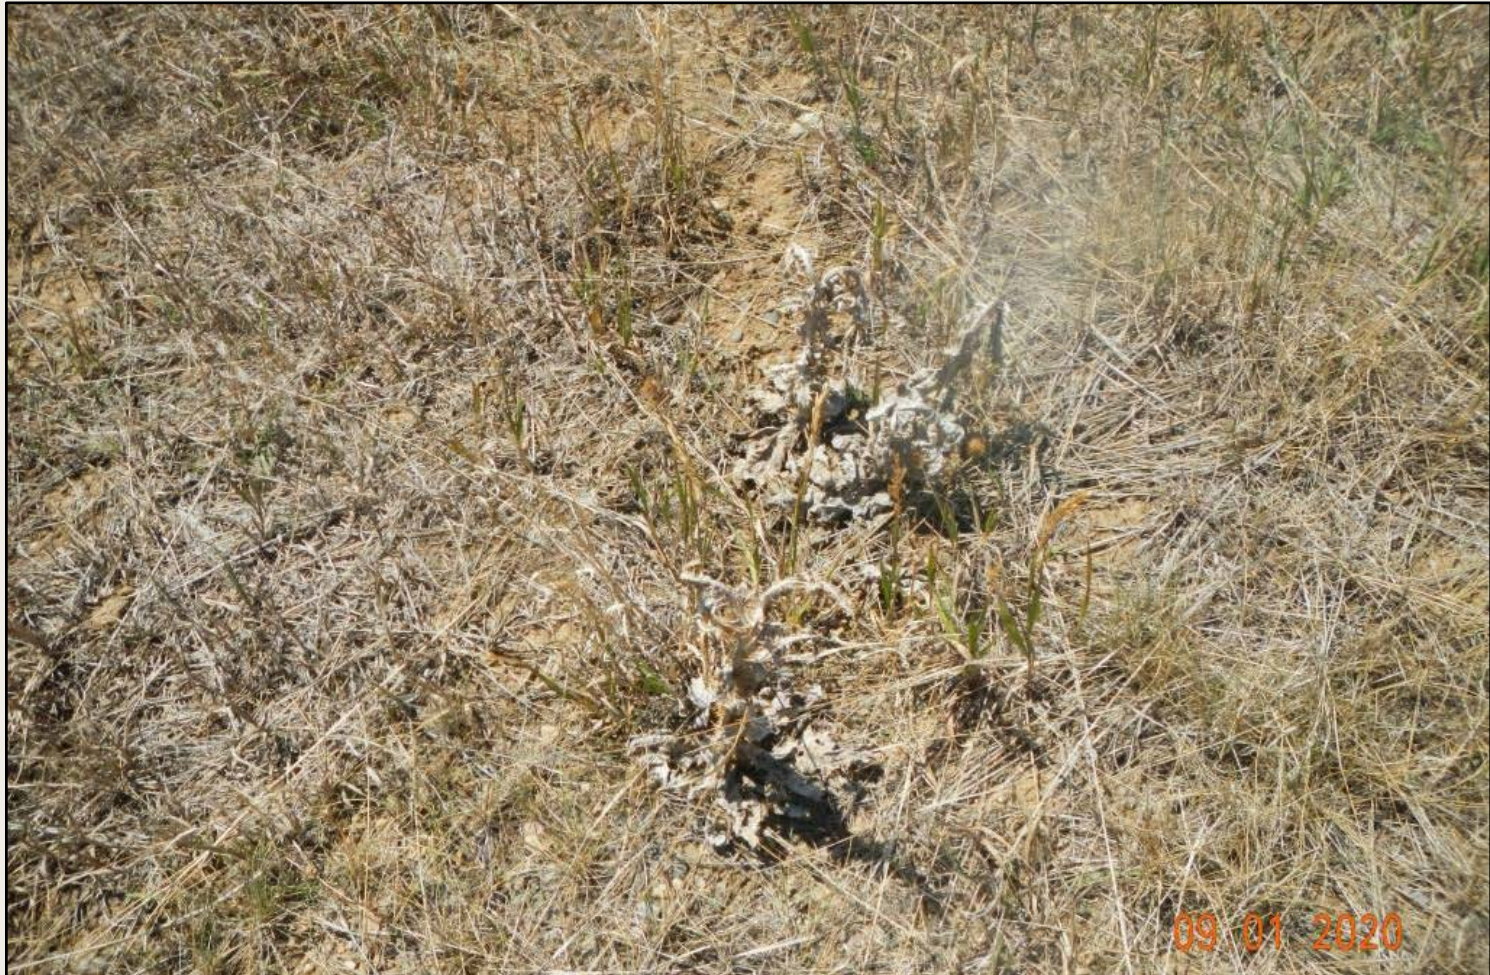
Photo 3. View of Scotch thistles that appear to be herbicide-treated within the project area. Approximately 200 herbicide-treated individuals observed.
