Inspection Photos

API: 071-09244

Operator: EVERGREEN NATURAL RESOURCES

Inspection Date: 9/2/2020

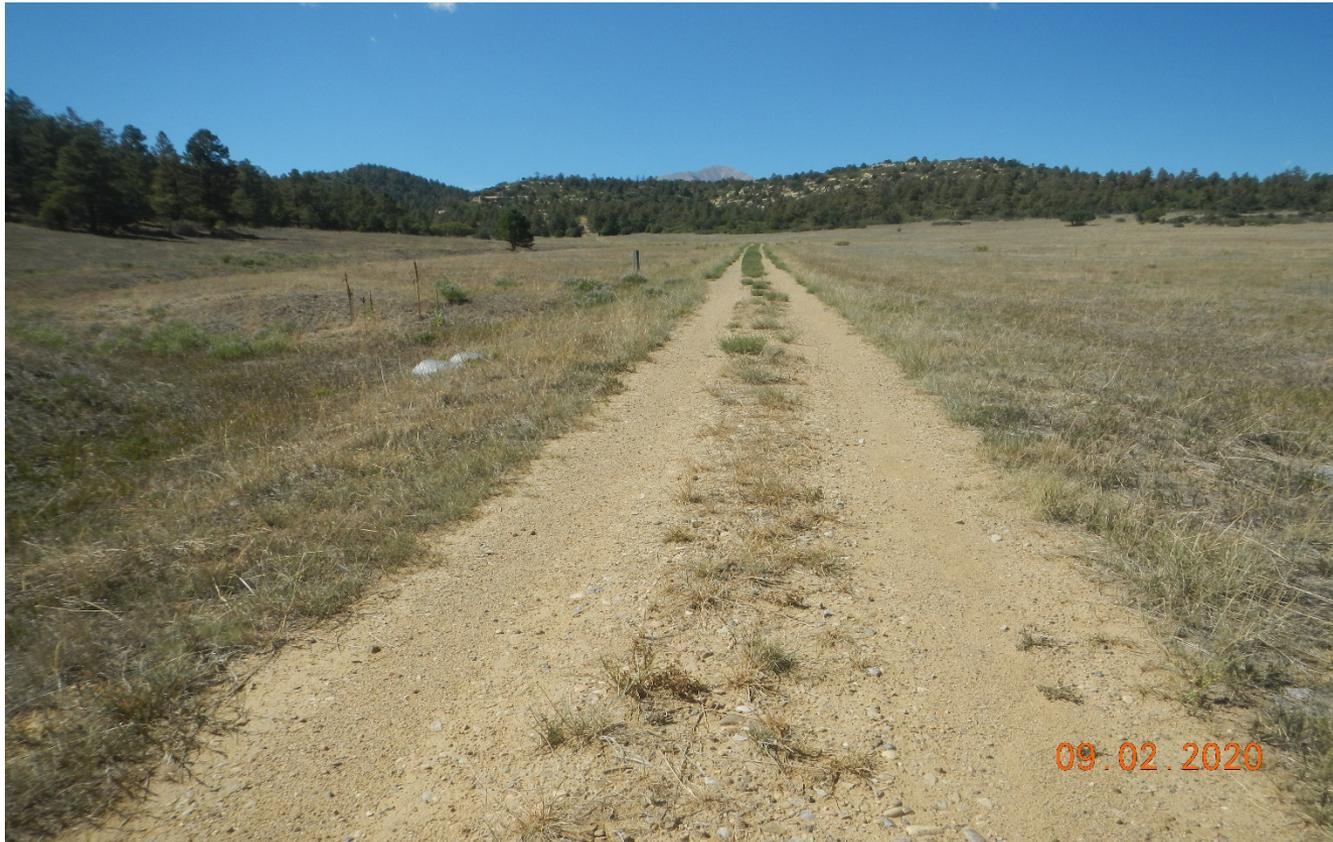
Photo 1. Facing northwest along the access road which has not been reclaimed.

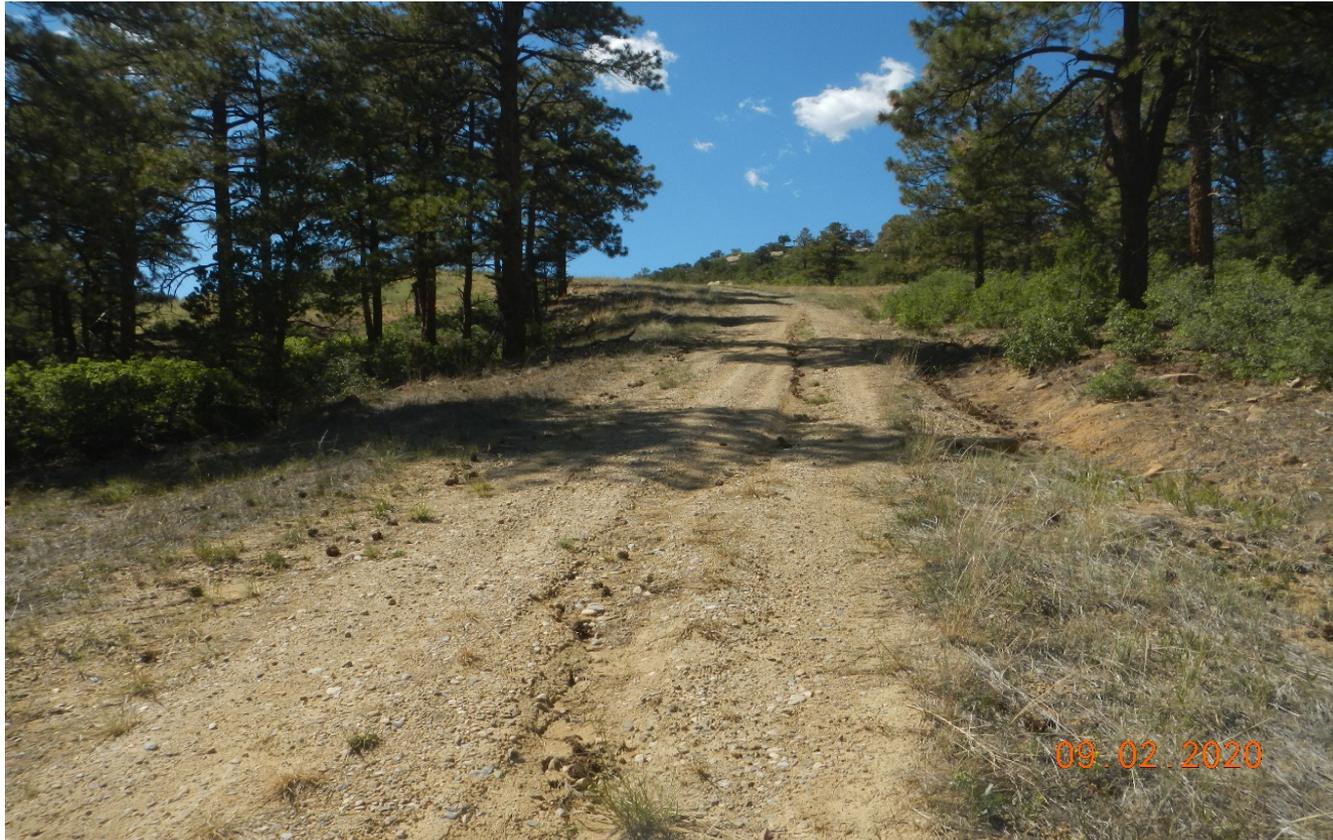
Photo 2. Facing northwest along the access road which has not been reclaimed. There is signs of erosion as the road ascends to the location.

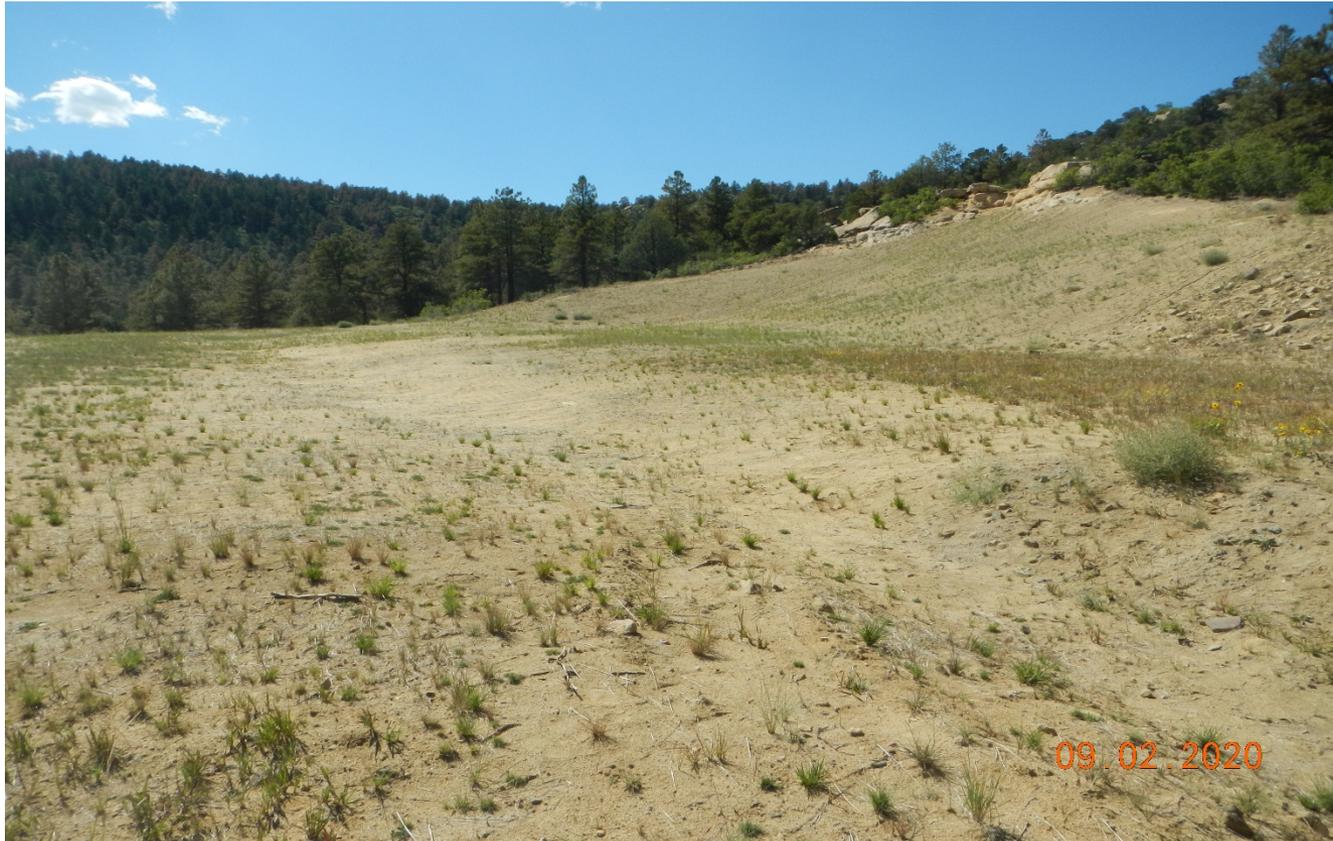
Photo 3. Facing west toward the location. The location has not been recontoured and reclaimed.

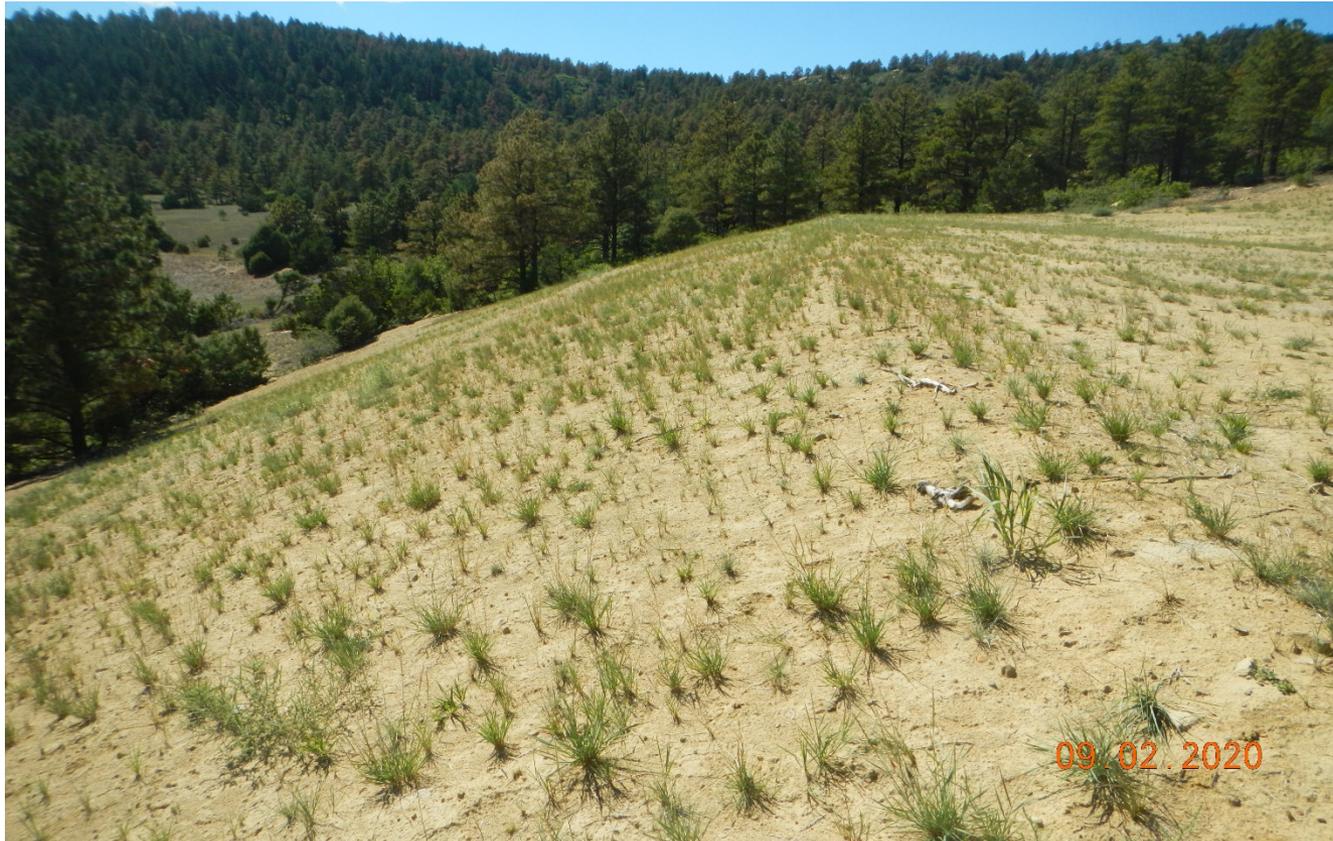
Photo 4. Facing west toward the fill slope.

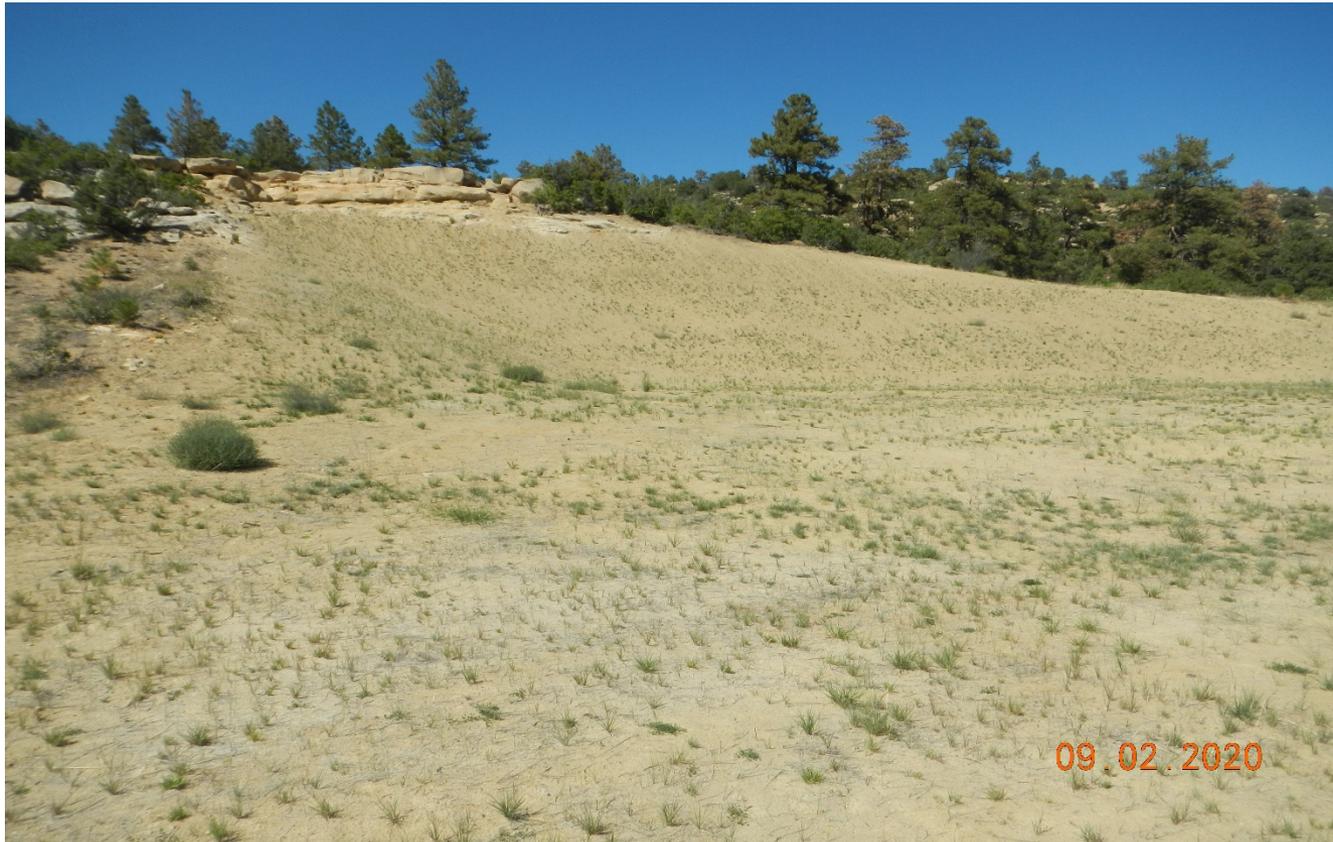
Photo 5. Facing north toward the cut slope.

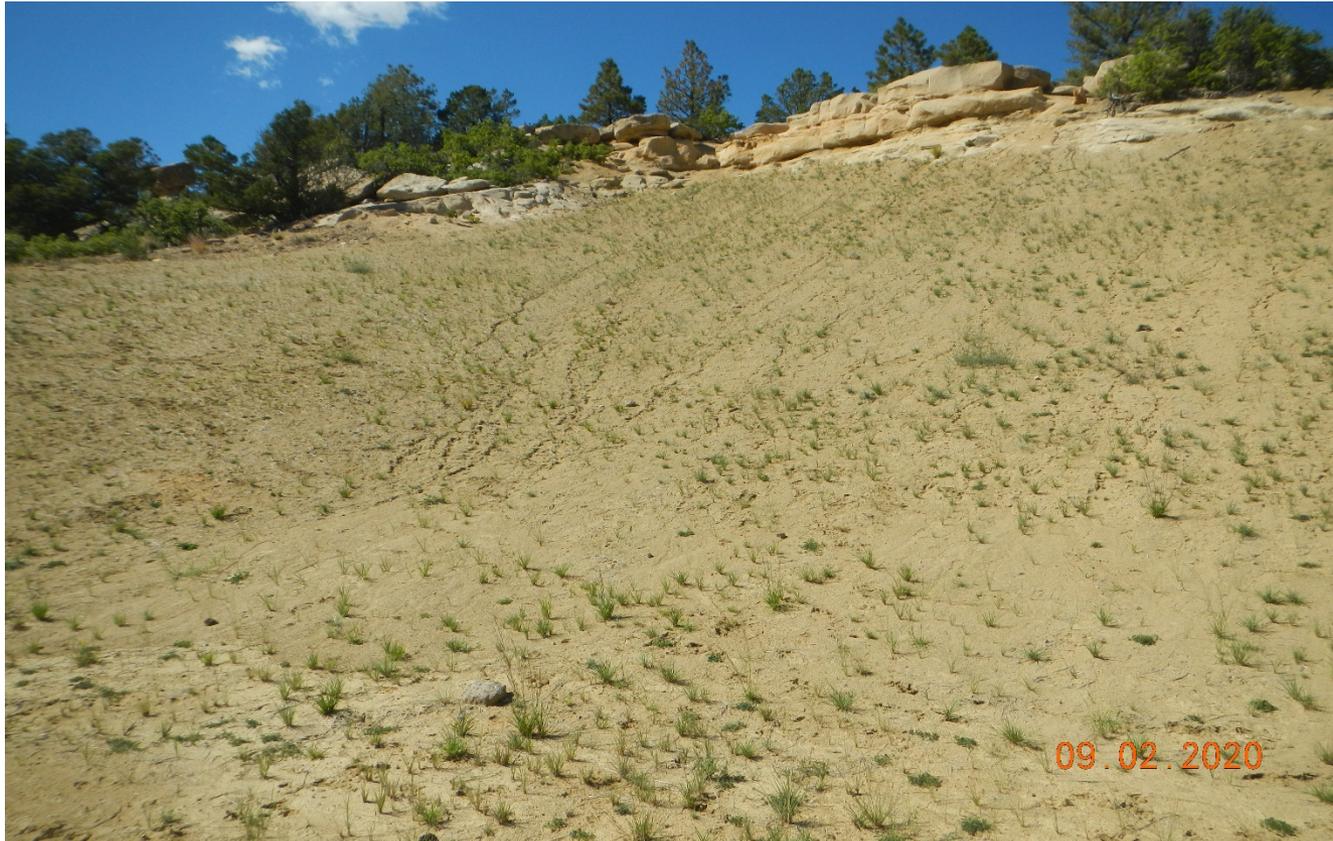
Photo 6. The cut slope is not stabilized and there is signs of erosion.

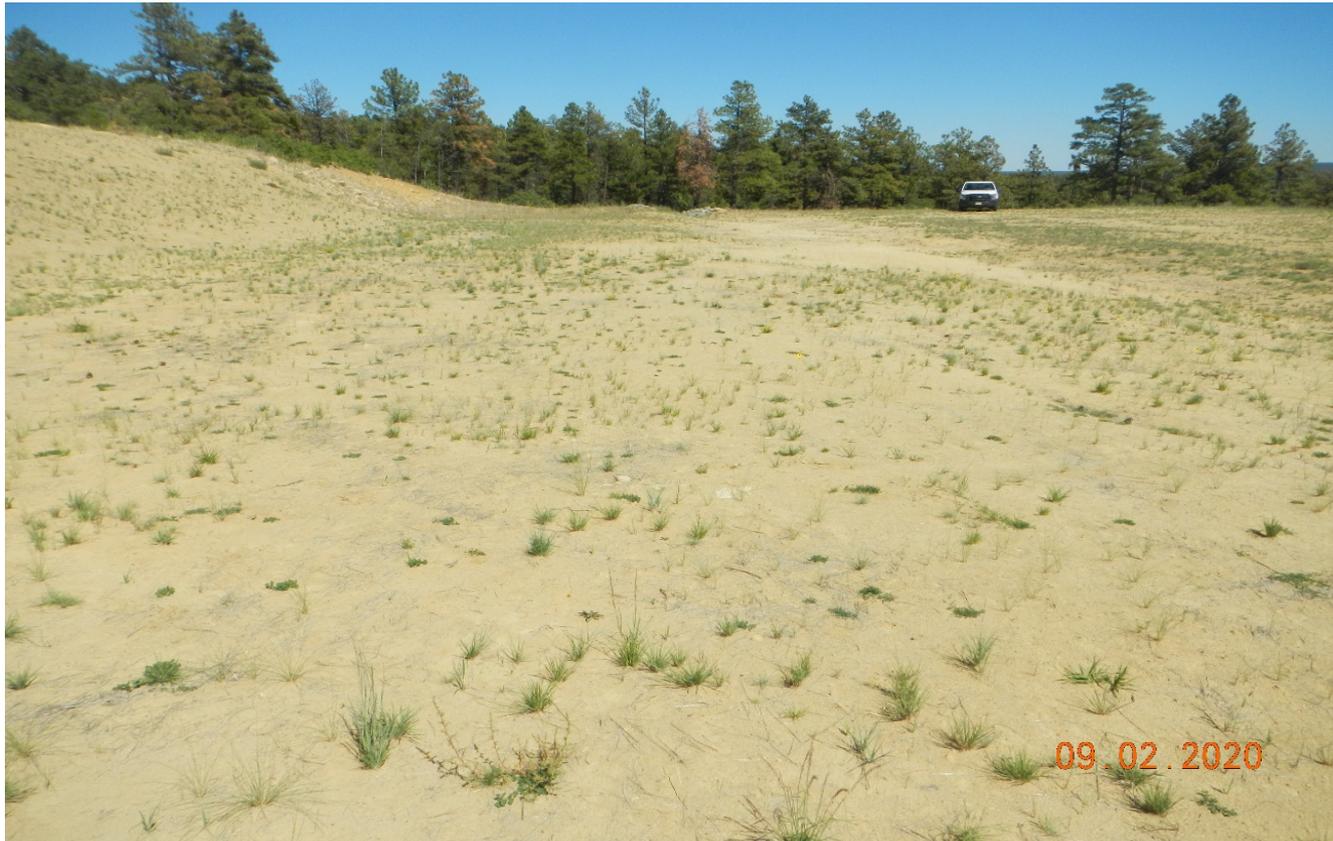
Photo 7. Facing east toward the location.
