Inspection Photos

API: 071-08562

Operator: EVERGREEN NATURAL RESOURCES

Inspection Date: 9/2/2020

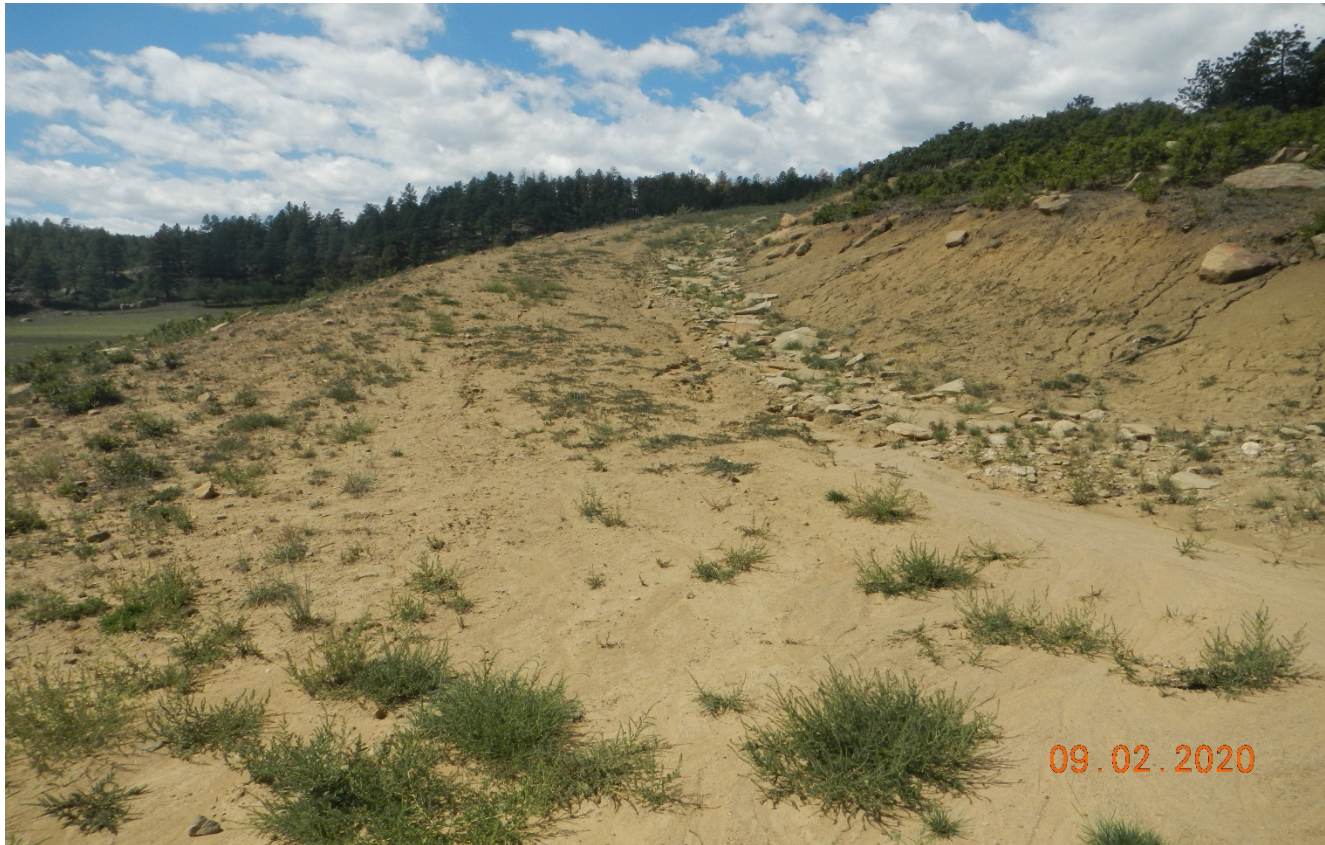
Photo 1. Facing west toward the beginning of the access road. The access road has not been recontoured and reclaimed and there is erosion occurring.

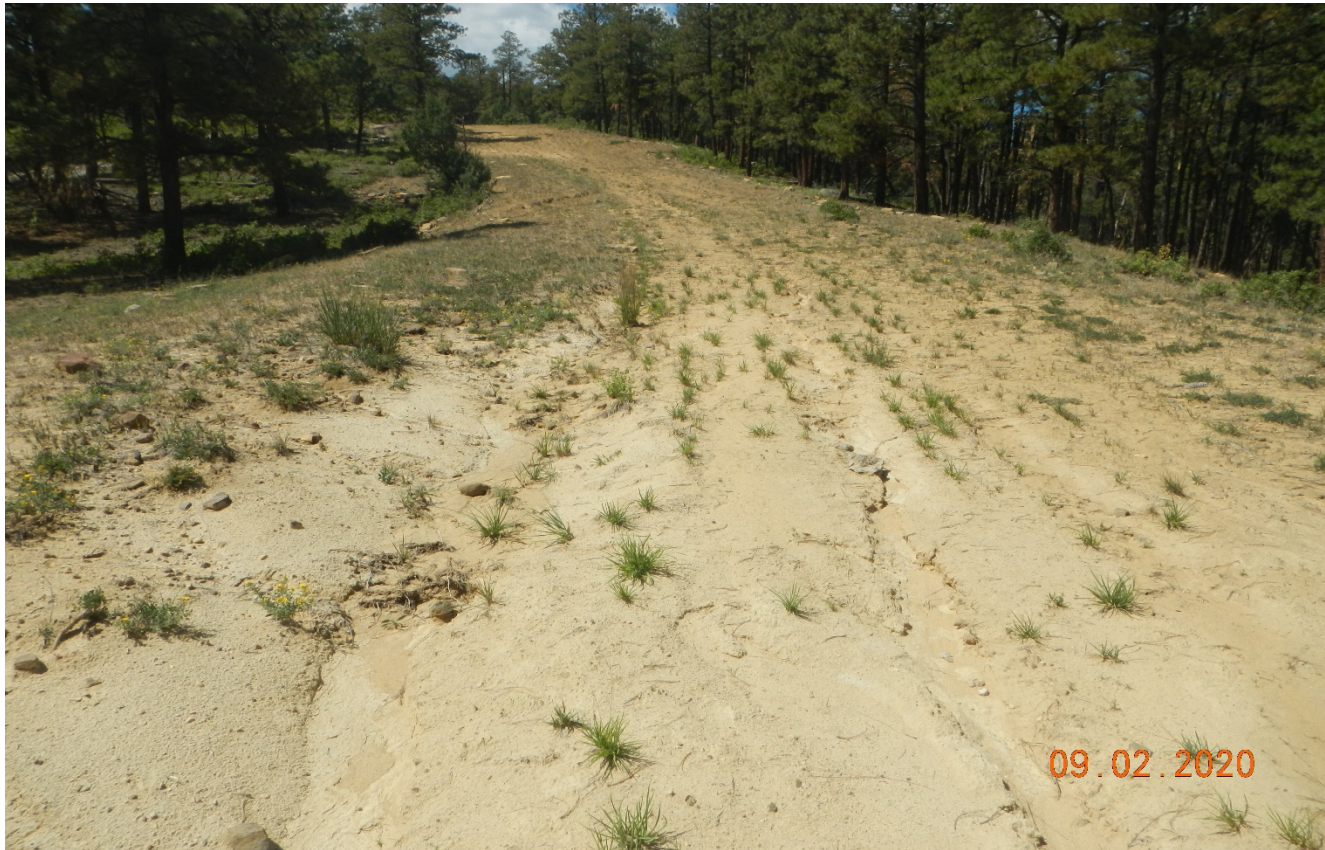
Photo 2. Facing west along the access road which has not been reclaimed.

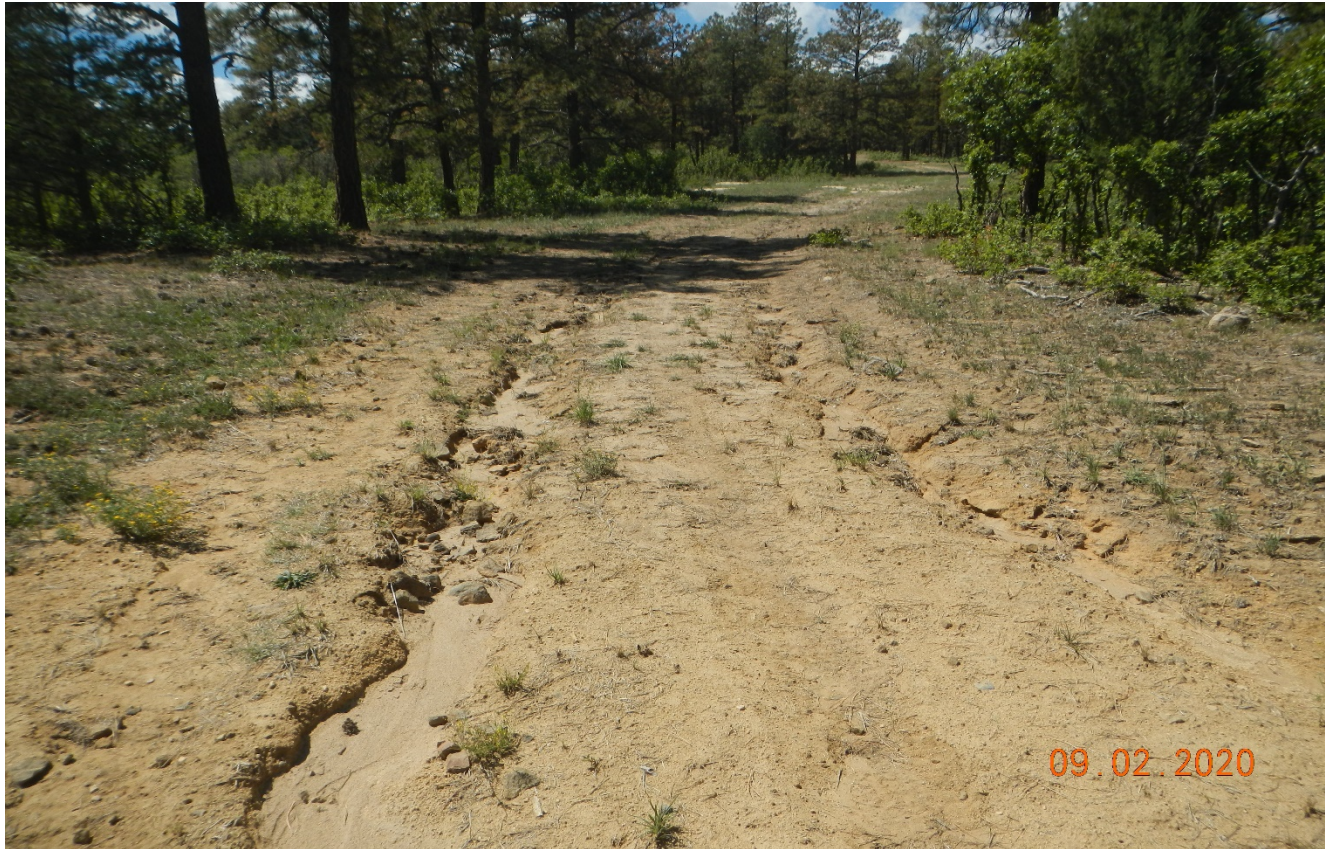
Photo 3. There is erosion occurring along the access road which is not stabilized.

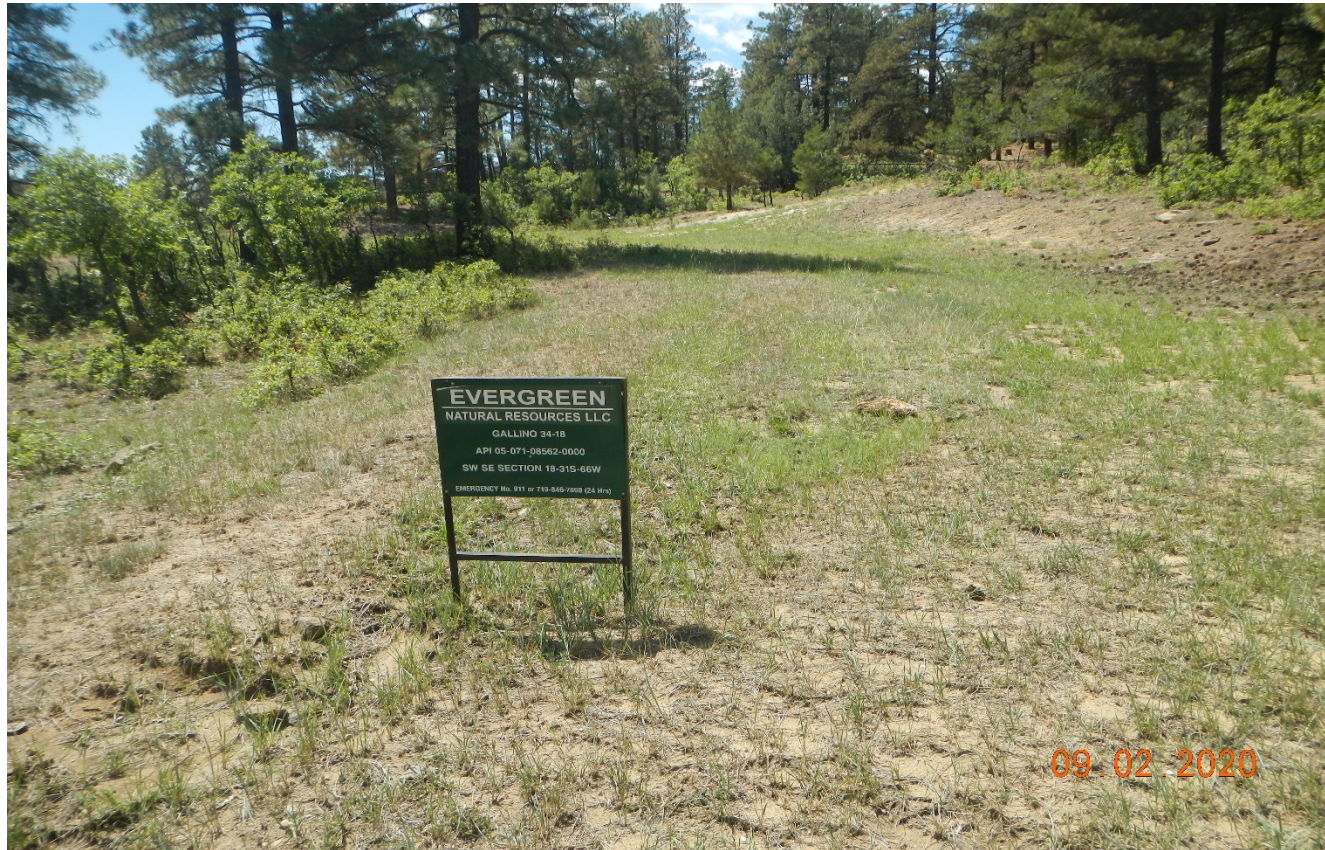
Photo 4. Facing southwest along the access road near the location.

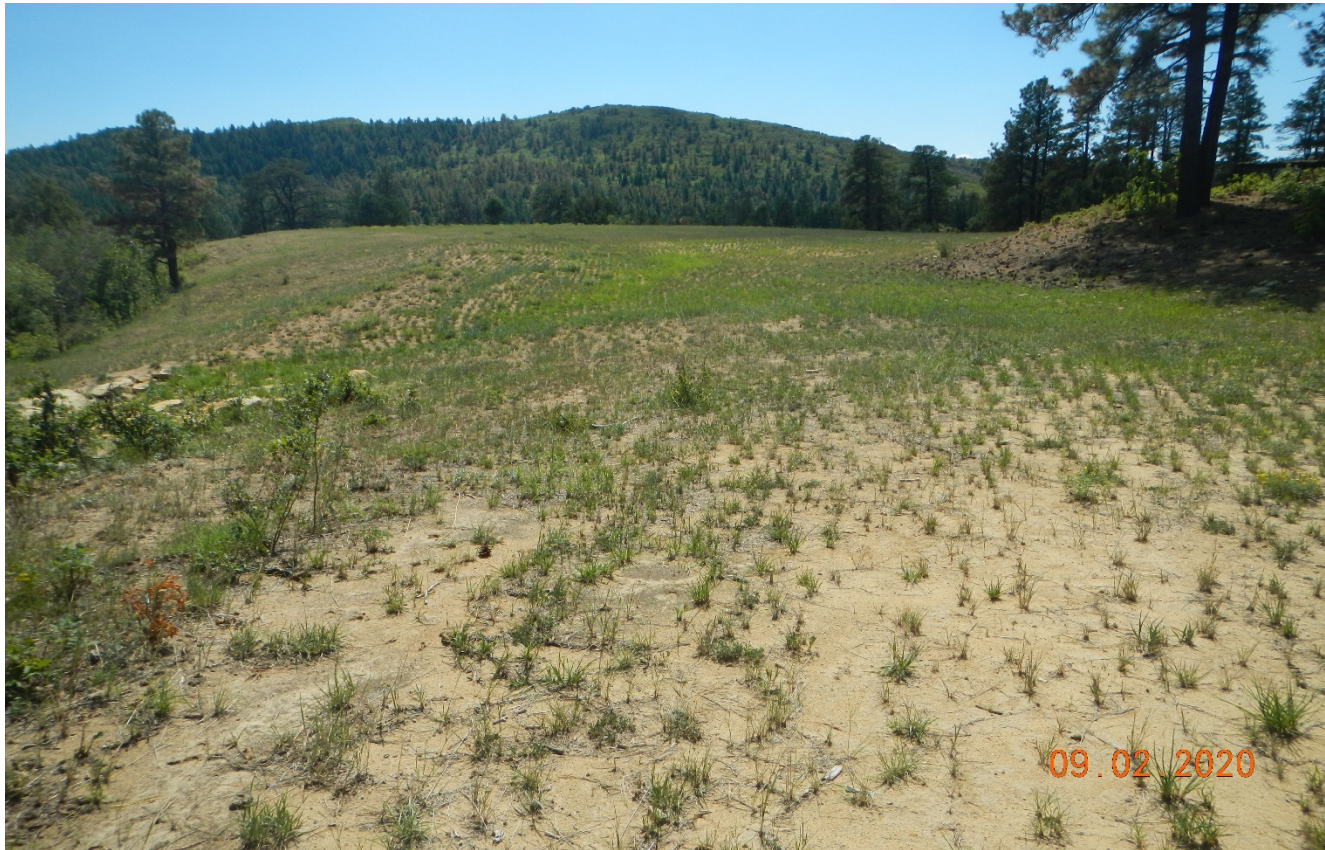
Photo 5. Facing southeast toward the location.

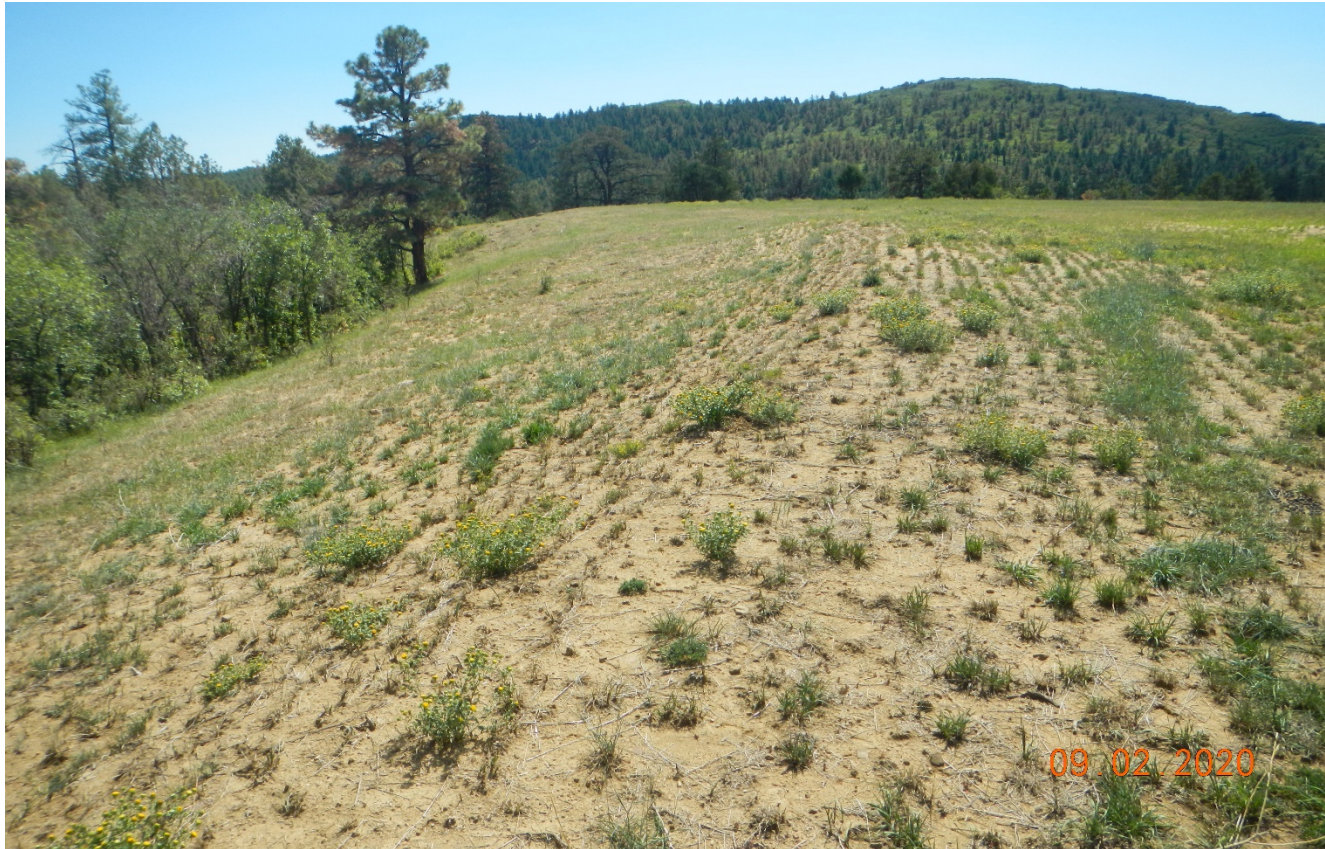
Photo 6. Facing southeast along the fill slope which has not been recontoured.

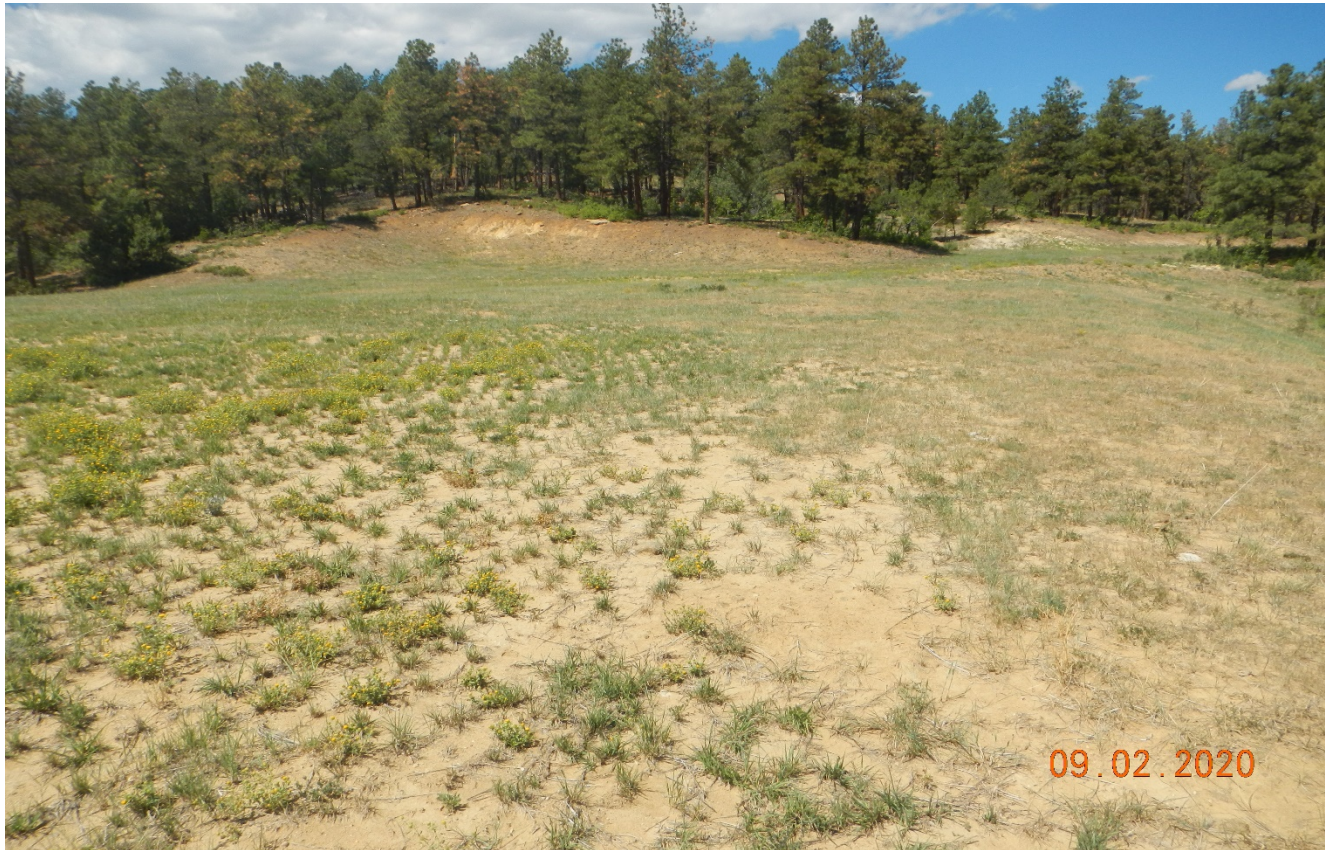
Photo 7. Facing northwest toward the location.

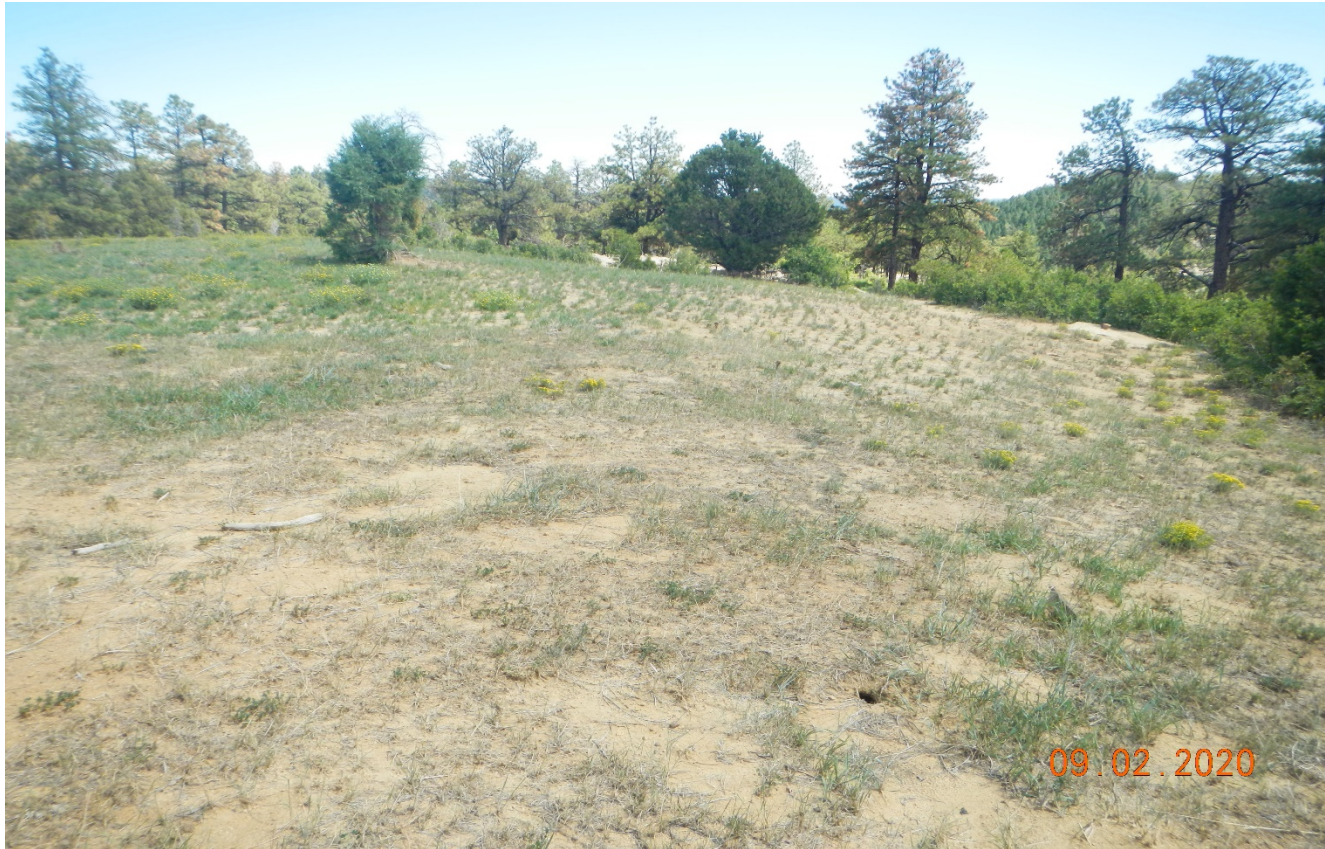
Photo 8. Facing east at the south side of the location. This area matches the contours. The south side of the location would likely not require recontouring.

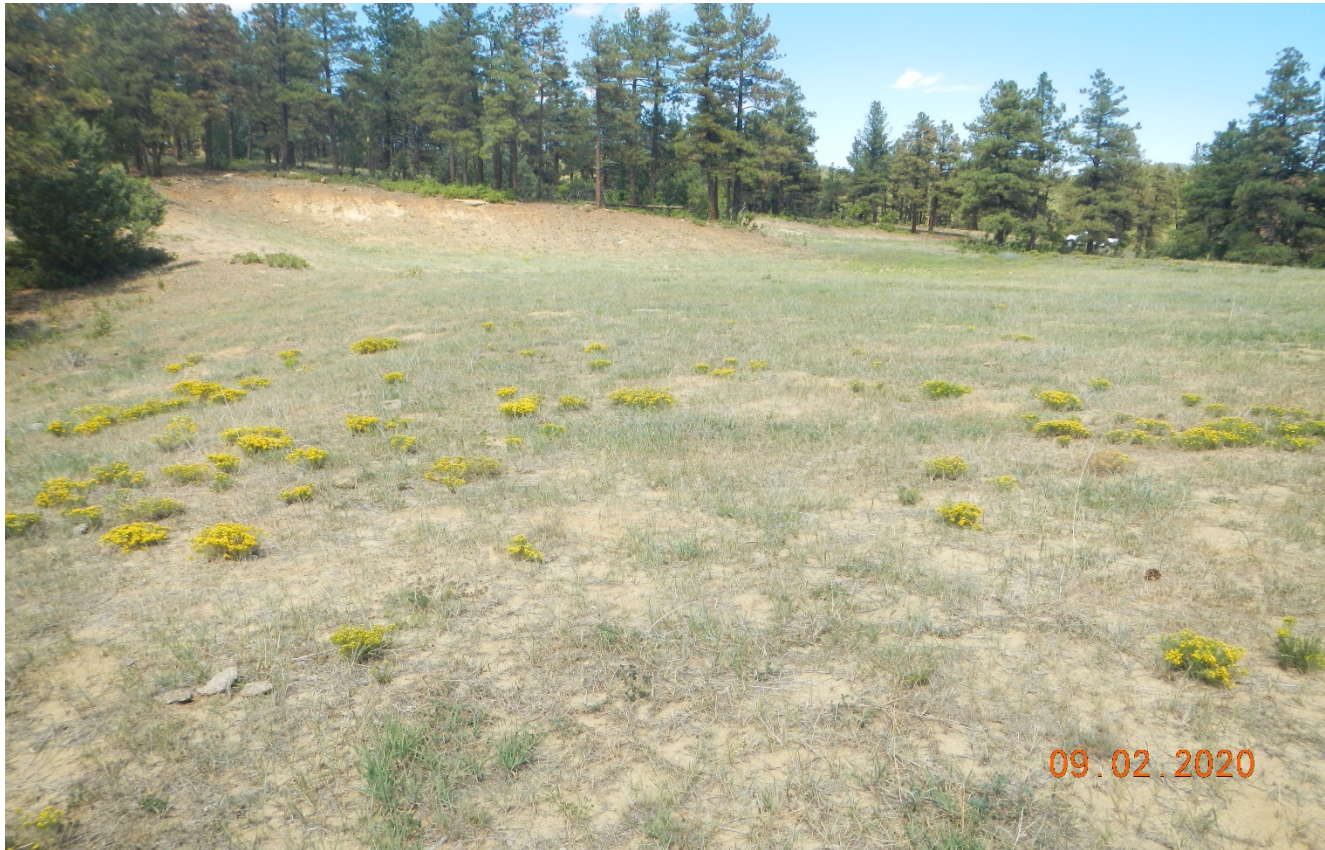
Photo 9. Facing northwest toward the location. The cut slope has not been recontoured to the approximate contours.

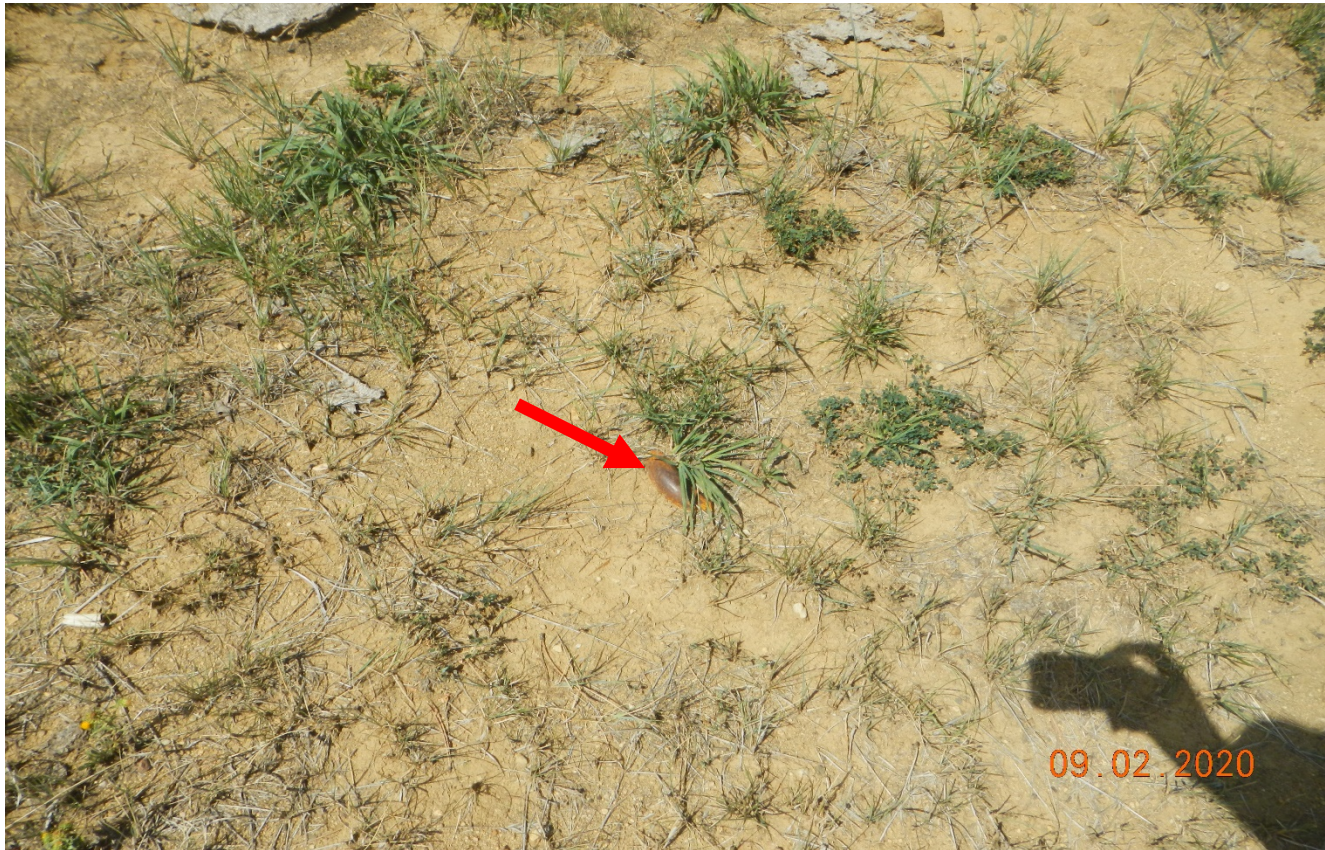
Photo 10. There is a guy line anchor found at the flat portion of the location.

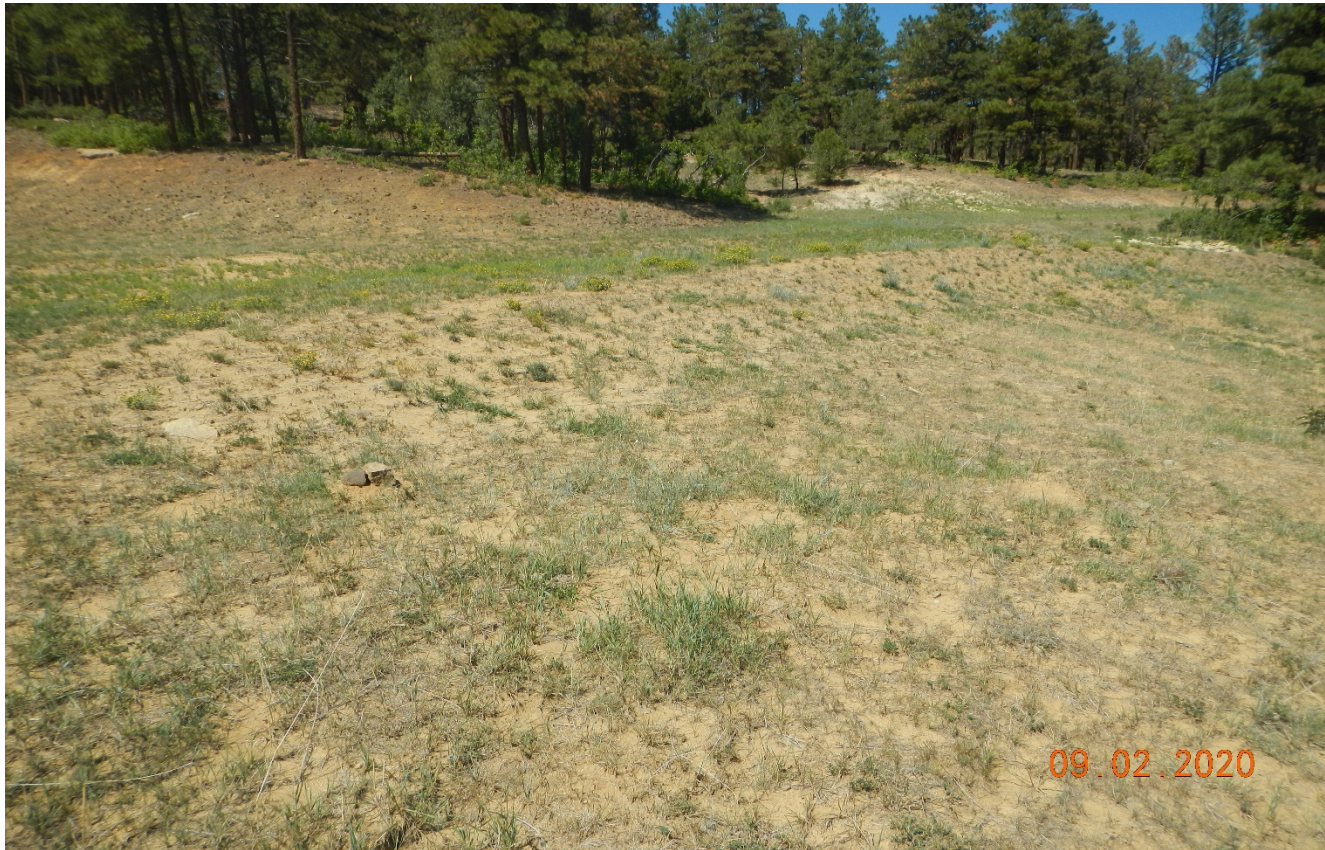
Photo 11. Facing northwest at the northern portion of the location. This fill slope area should be pushed back into the cut slope to match the approximate contours.
