Inspection Photos
Location Name: Fitzhugh #6
API: 05-007-05038

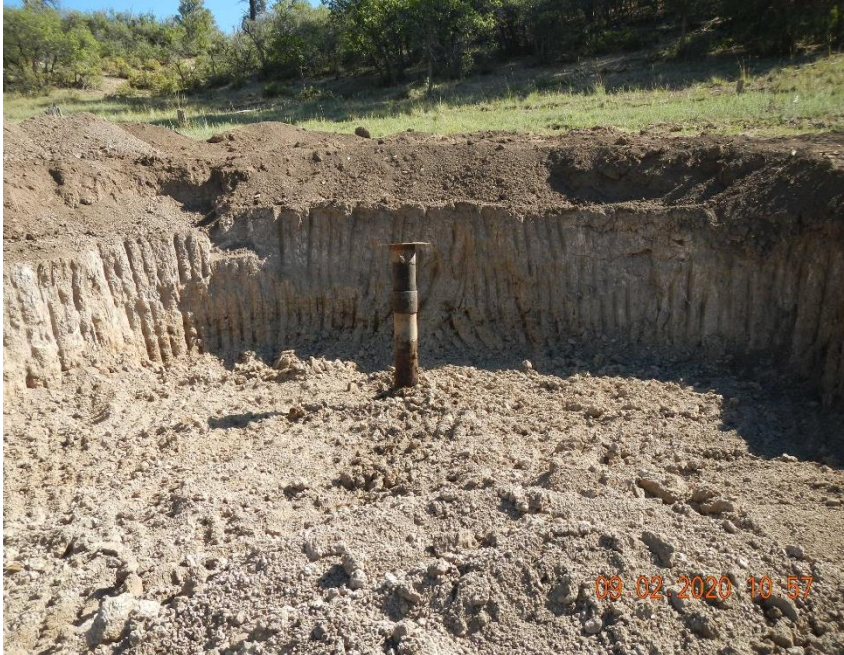
Excavation around Fitzhugh #7 well head.

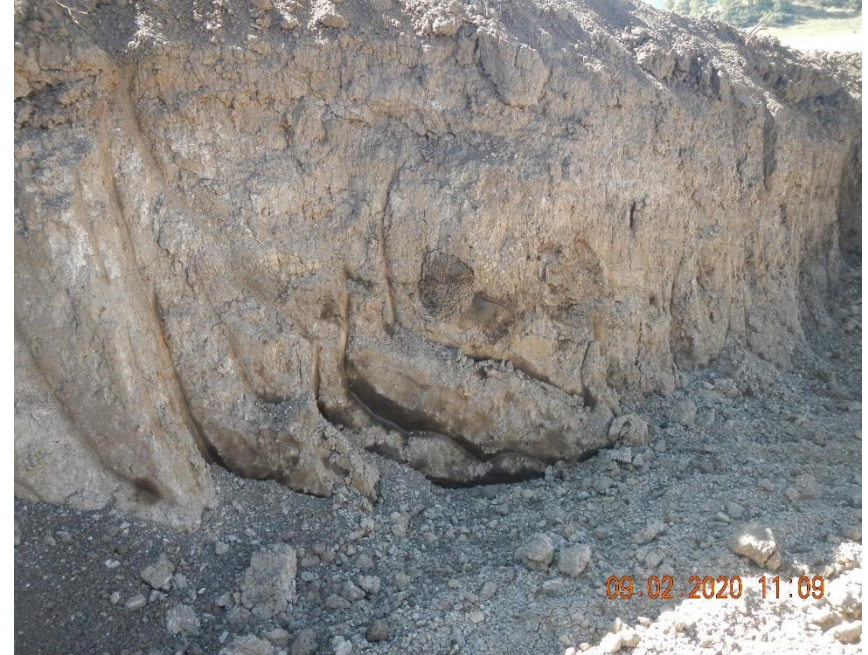
Impacted material in sidewall of excavation.

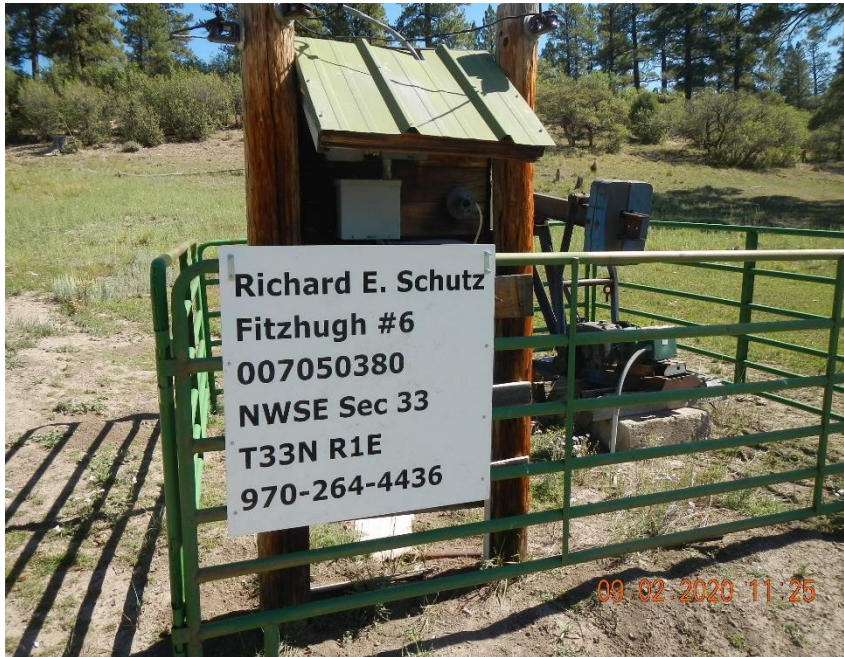
Fitzhugh #6.

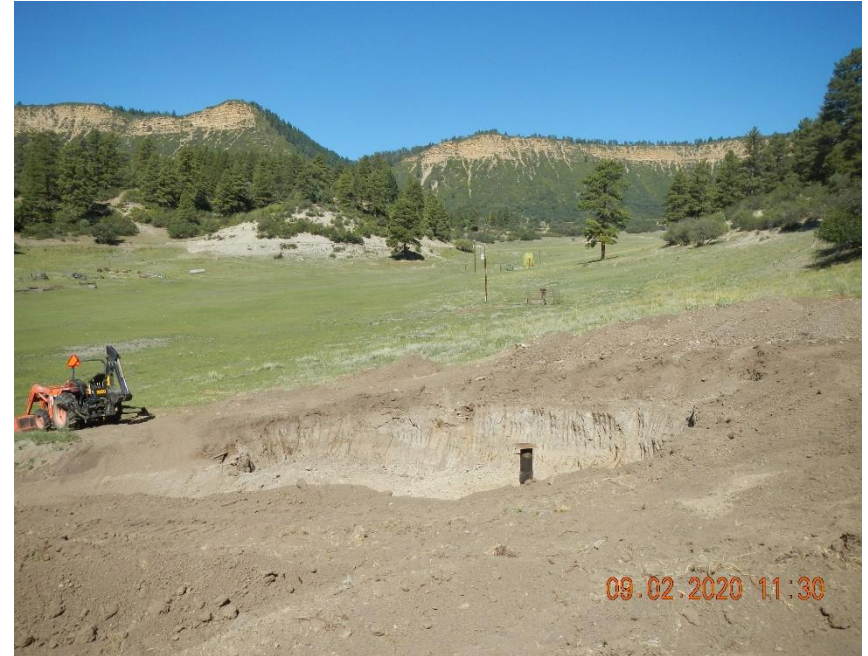
Excavation near Fitzhugh #7.

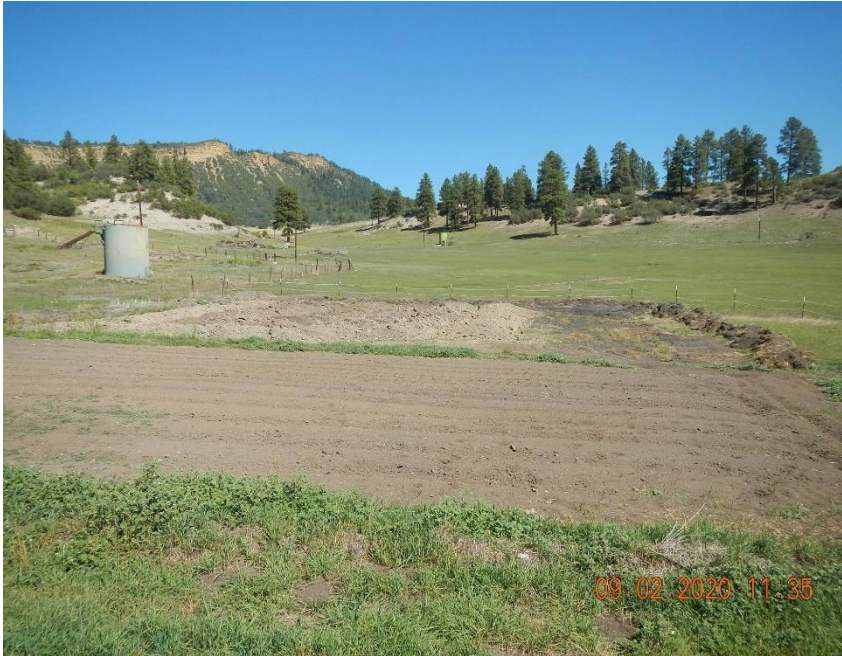
Second land farm treatment cell to the north of the first.

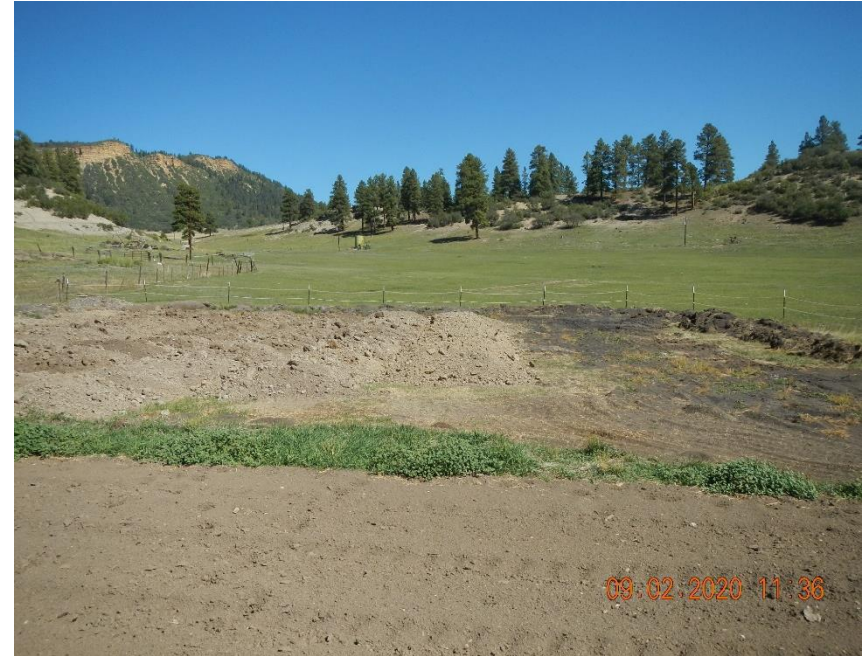
Impacted material from excavation near the Fitzhugh #7 in newly created land farm treatment area.

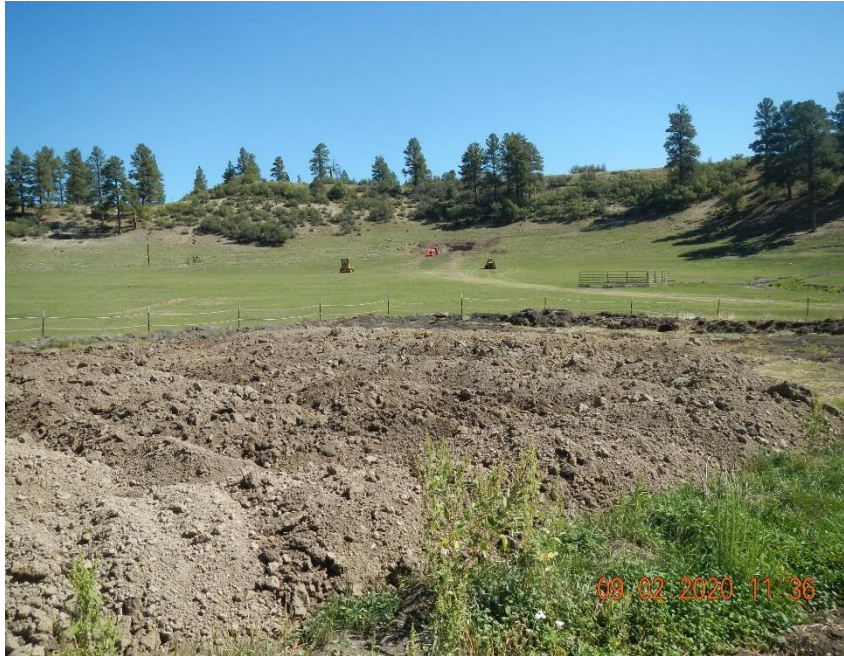
View of north treatment cell with excavation near Fitzhugh #7 in background.

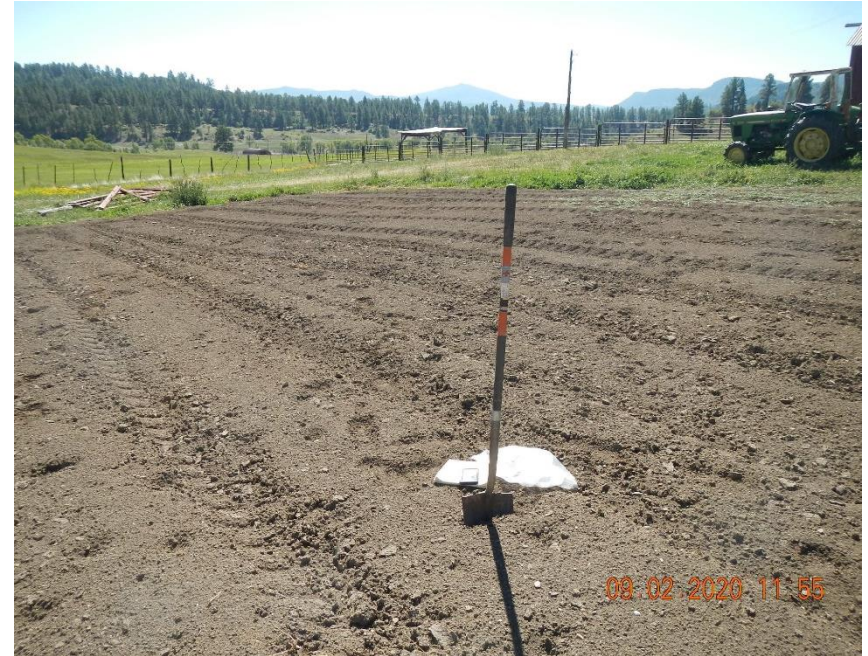
Sample location in southern treatment cell.
