Inspection Photos
Location Name: Chavez #1
API: 05-007-06120

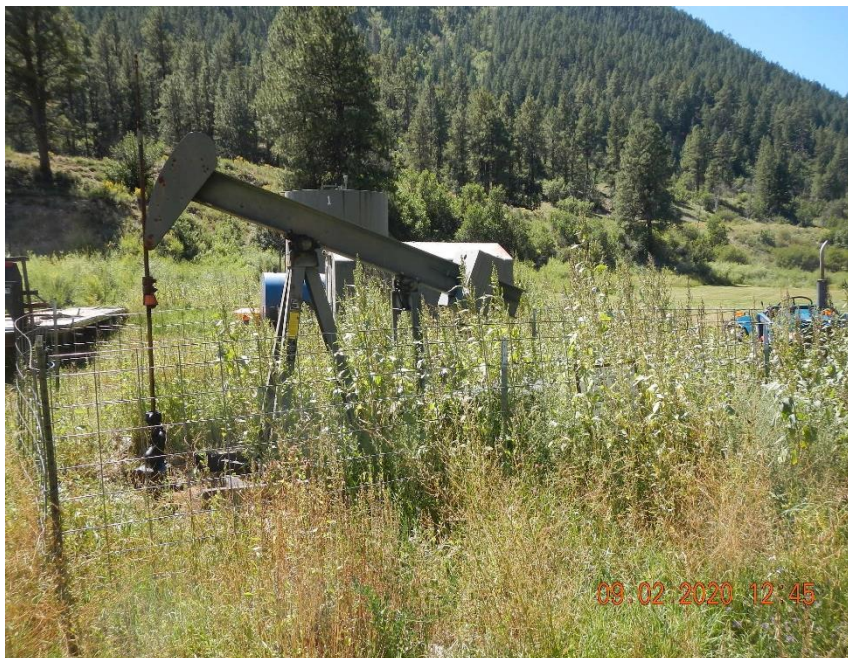
Weeds present near pump jack and within secondary containment for AST.

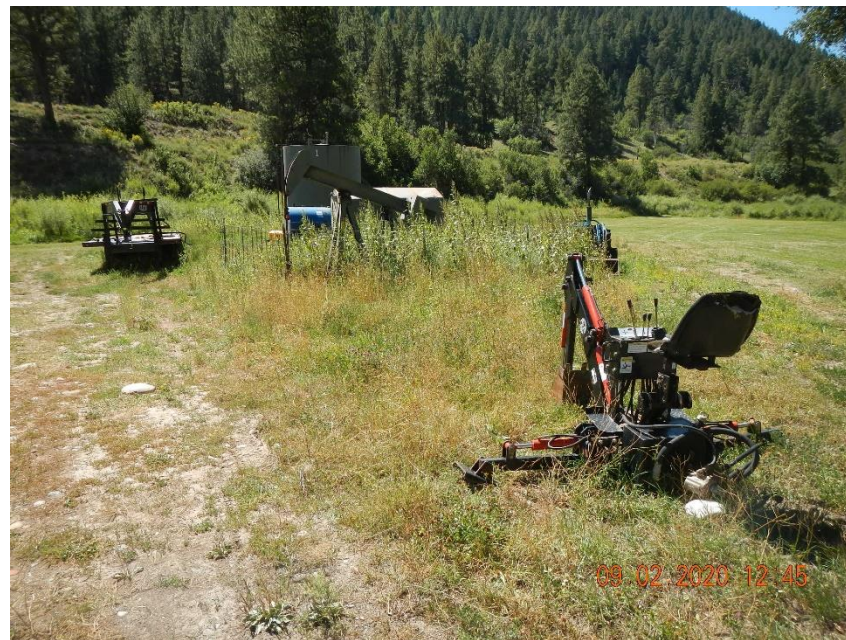
Equipment and trailers stored on site.

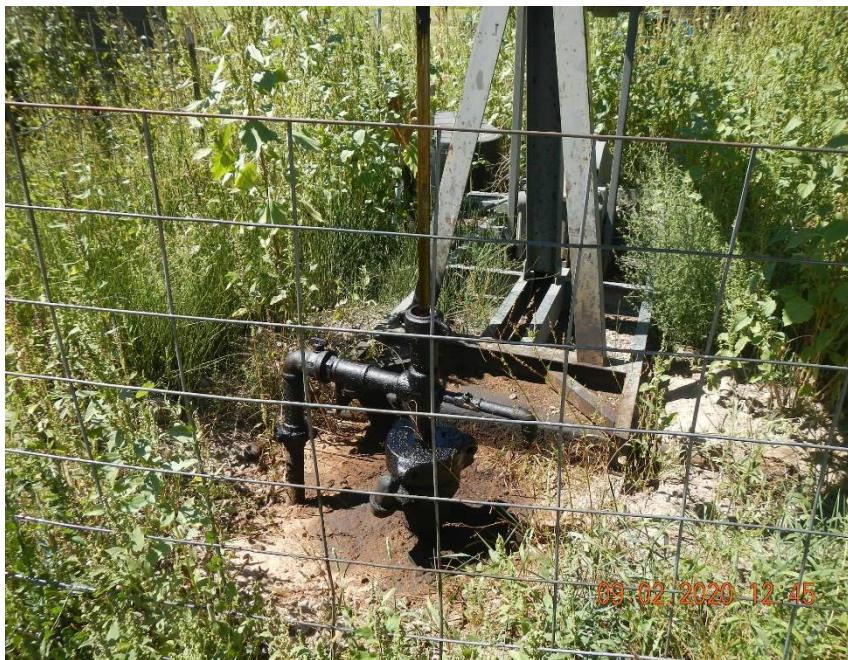
Well head is stained and wet.

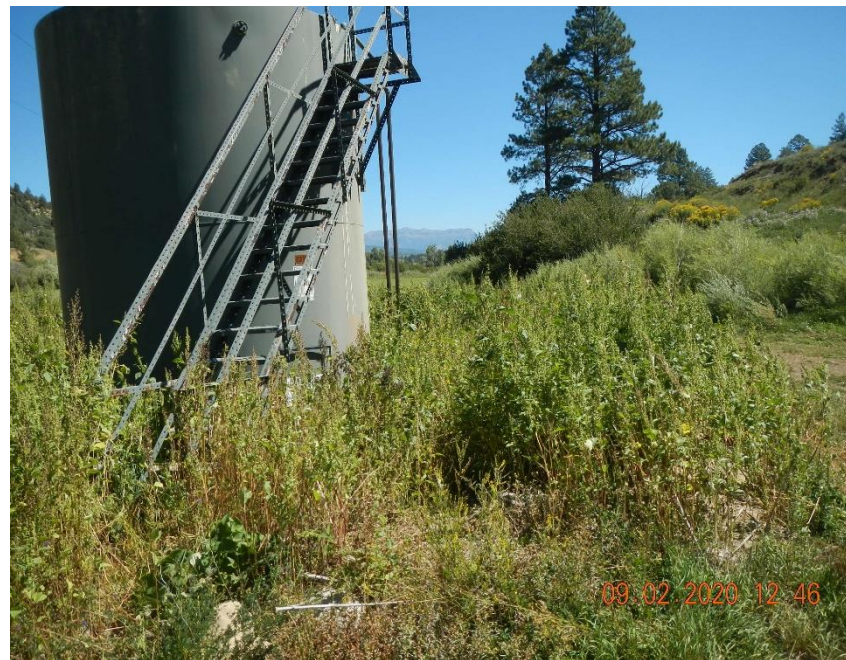
Weeds present within secondary containment
