Construction and Stormwater Inspection

Operator: MALLARD EXPLORATION LLC- #10670

Location ID: 455576

Inspection Photos
Location Name: Harlequin North /Pad
Location ID: 455576

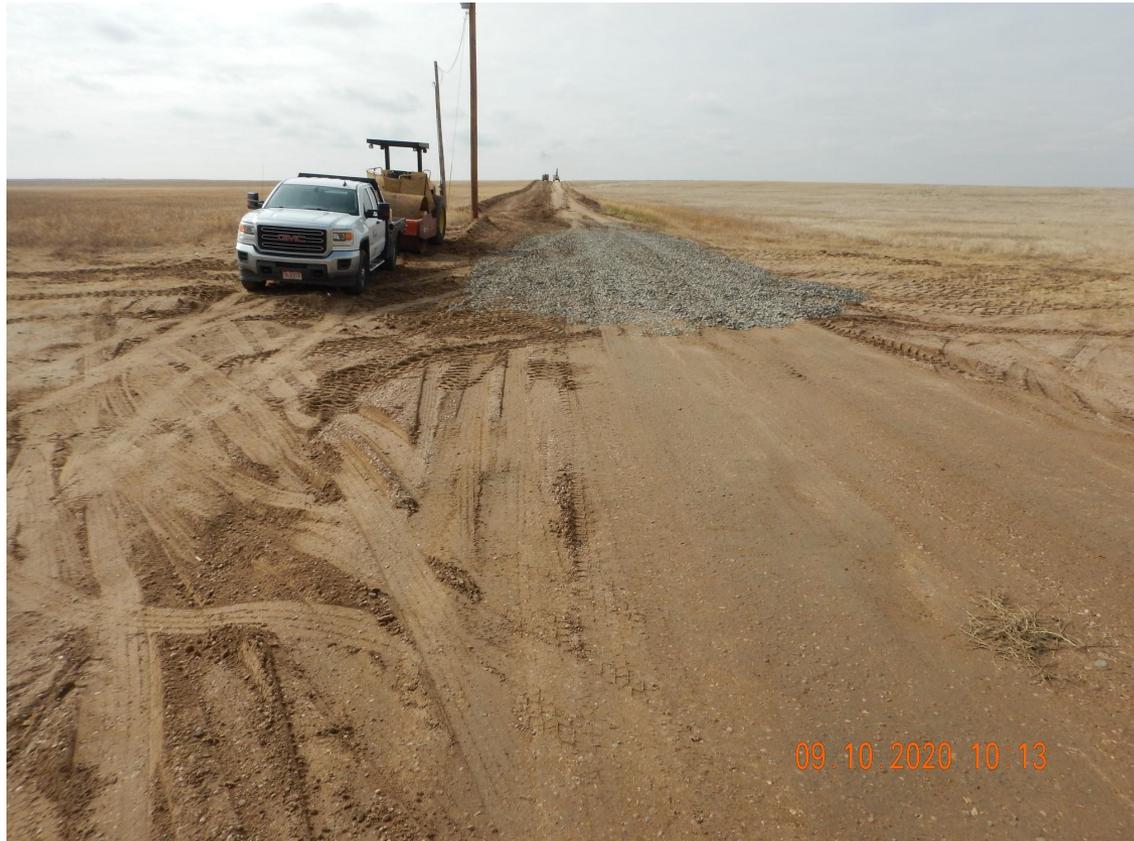
Photo 1. Photo taken from the entrance of the location off Hwy 14, facing South. Photo illustrates a tracking device BMP. At the time of this inspection, there were no track out issues observed.

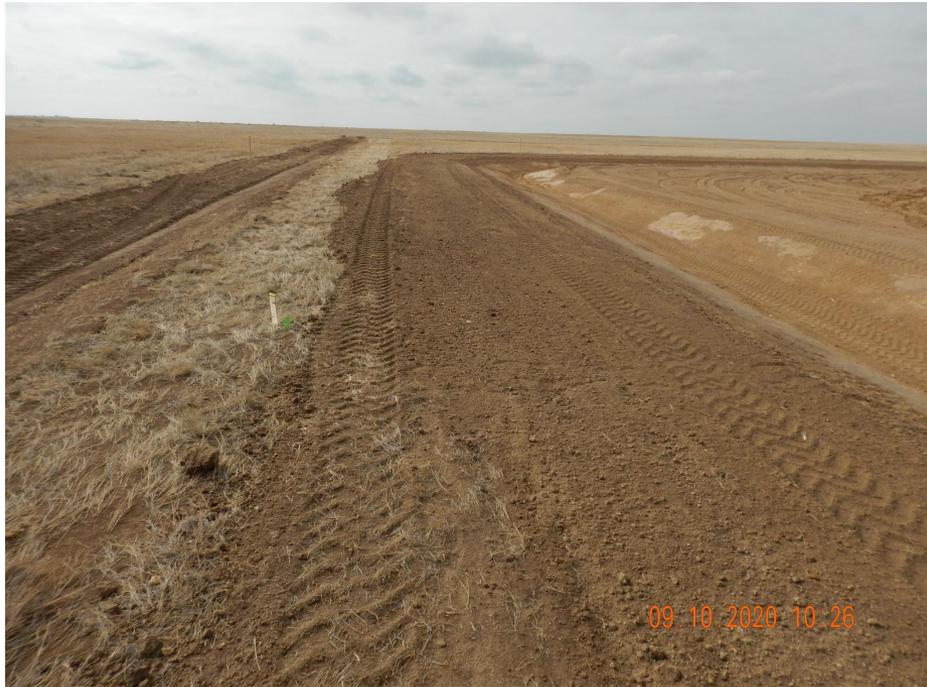
Photo 2. Photo taken from the eastern location, facing South. Photo illustrates two sets of ditch BMPs. The inner ditch BMP is directed to the northeastern retention area, while the outer ditch BMP appeared to be installed at the start of construction operations, controlling stormwater runoff and runon.

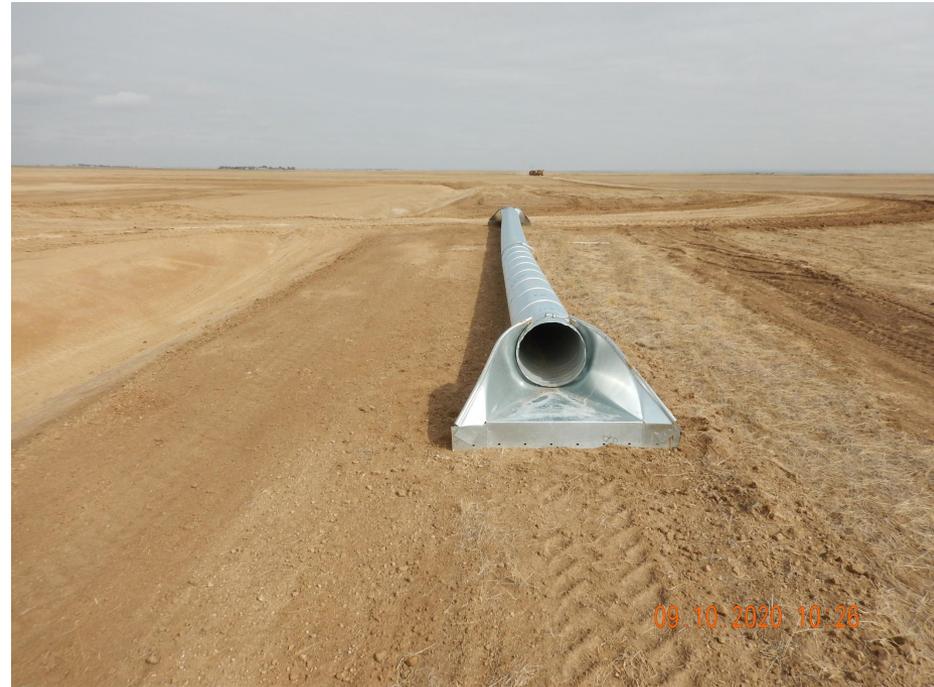
Photo 3. Photo taken from the eastern location, facing North. See comments under Photo 2. This photo also illustrates a culvert scheduled to be installed.

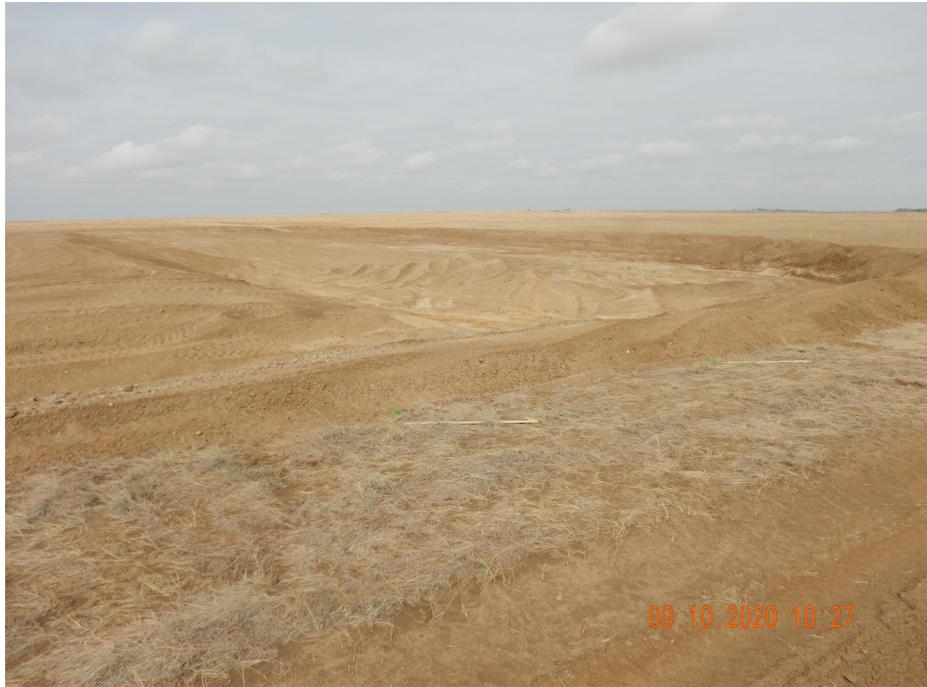
Photo 4. Photo taken from the northeastern location, facing Northwest. See comments under Photo 2.

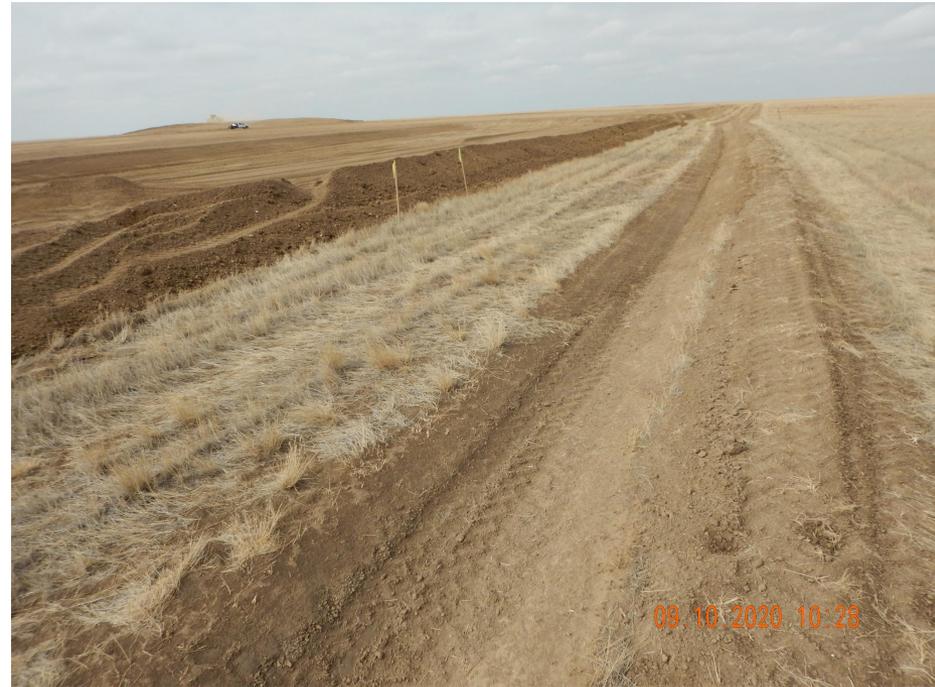
Photo 5. Photo taken from the northeastern location, facing West. See comments under Photo 2.

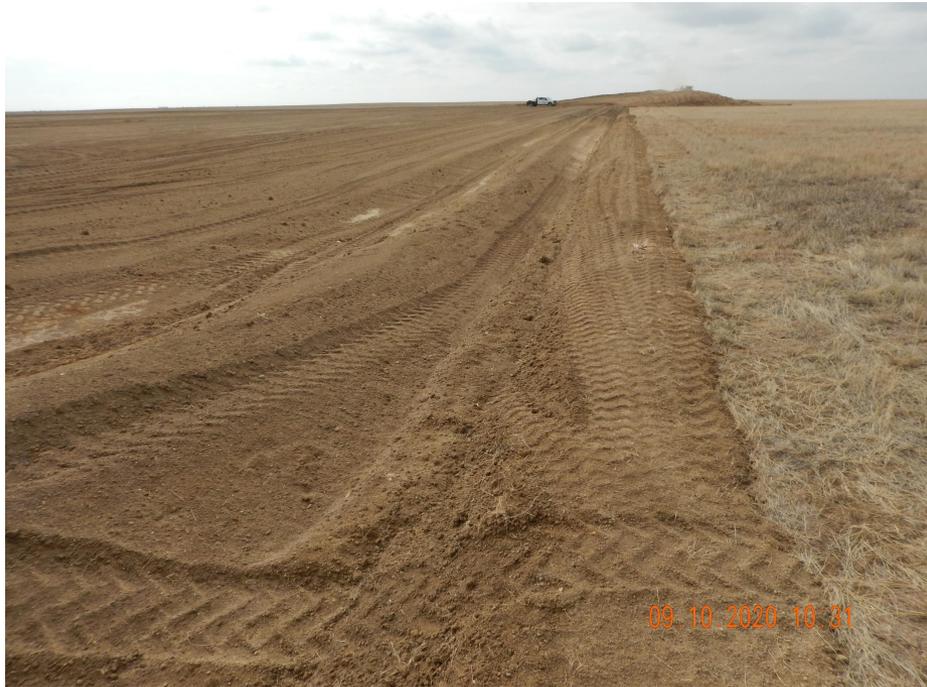
Photo 6. Photo taken from the northwestern location, facing South. See comments under Photo 2.

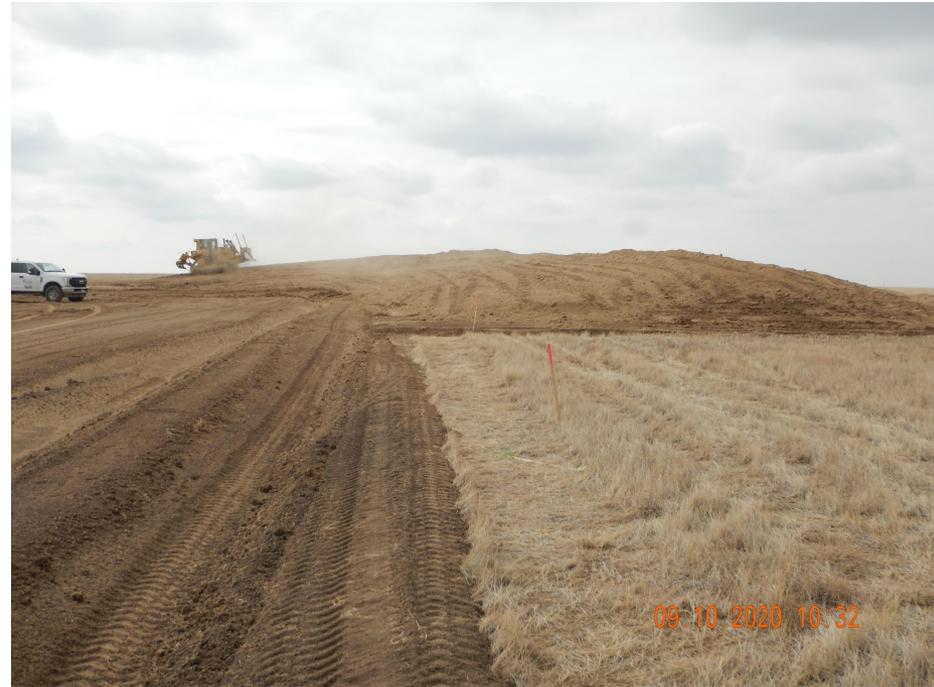
Photo 7. Photo taken from the western location, facing South. See comments under Photo 2. This photo also illustrates the topsoil stockpile along the southwestern location. At the time of this inspection, Operator was temporarily stabilizing the stockpile via equipment tracking.

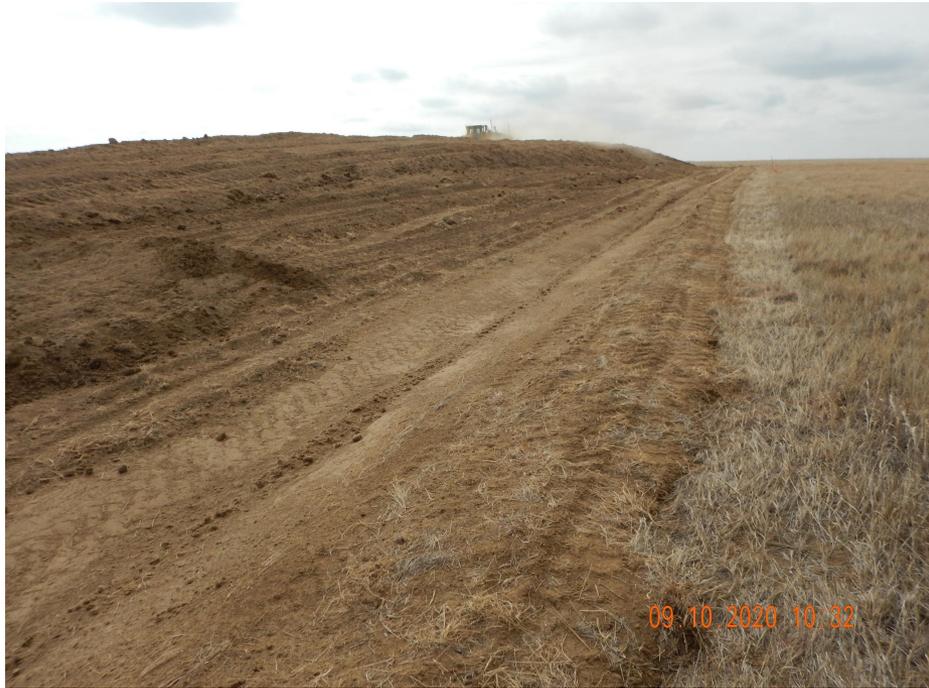
Photo 8. Photo taken from the southwestern location, facing South. See comments under Photo 2 and 7.

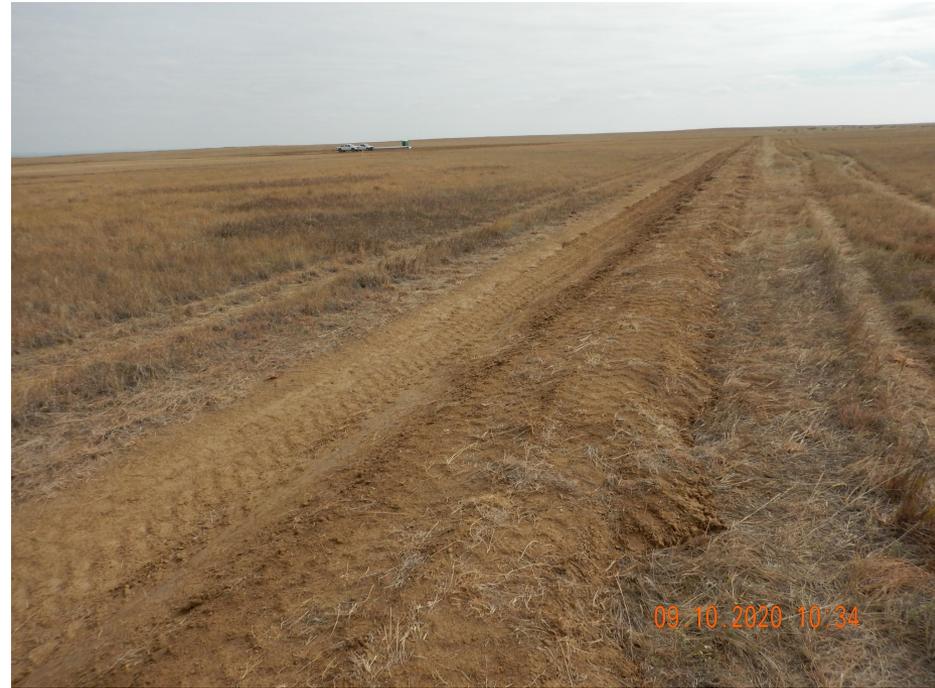
Photo 9. Photo taken from the southwestern location, facing East. See comments under Photo 2.

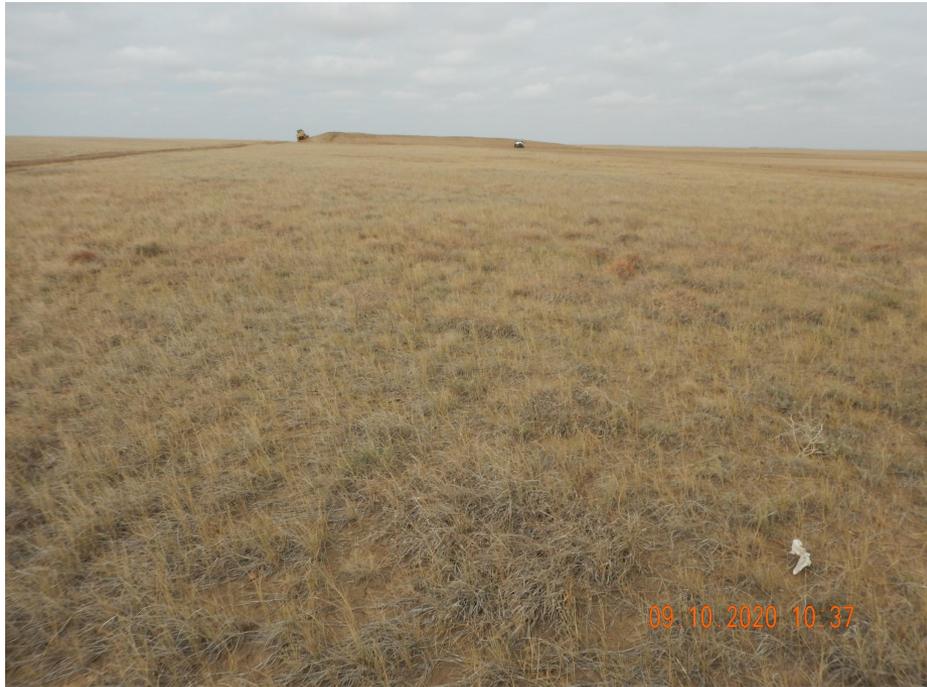
Photo 10. Photo taken from the southeastern location, facing West. Photo illustrates a vegetative buffer along the entire southern well pad and the outer perimeter ditch BMP.

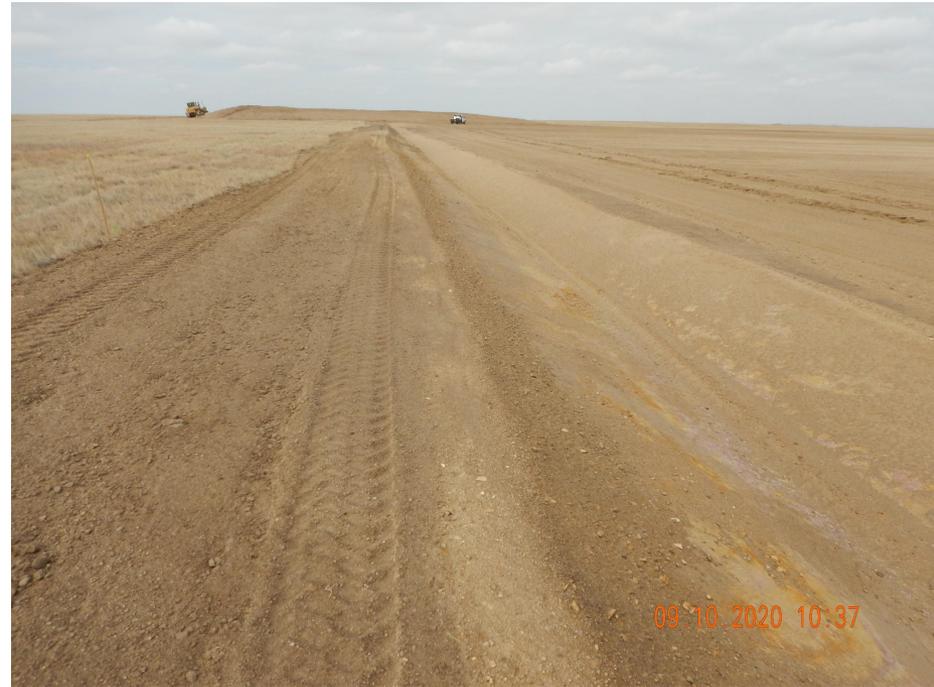
Photo 11. Photo taken from the southeastern well pad, facing West. See comments under Photo 10.
