Inspection Photos

API: 071-08734

Operator: TIMBER CREEK OPERATING LLC

Inspection Date: 9/11/2020

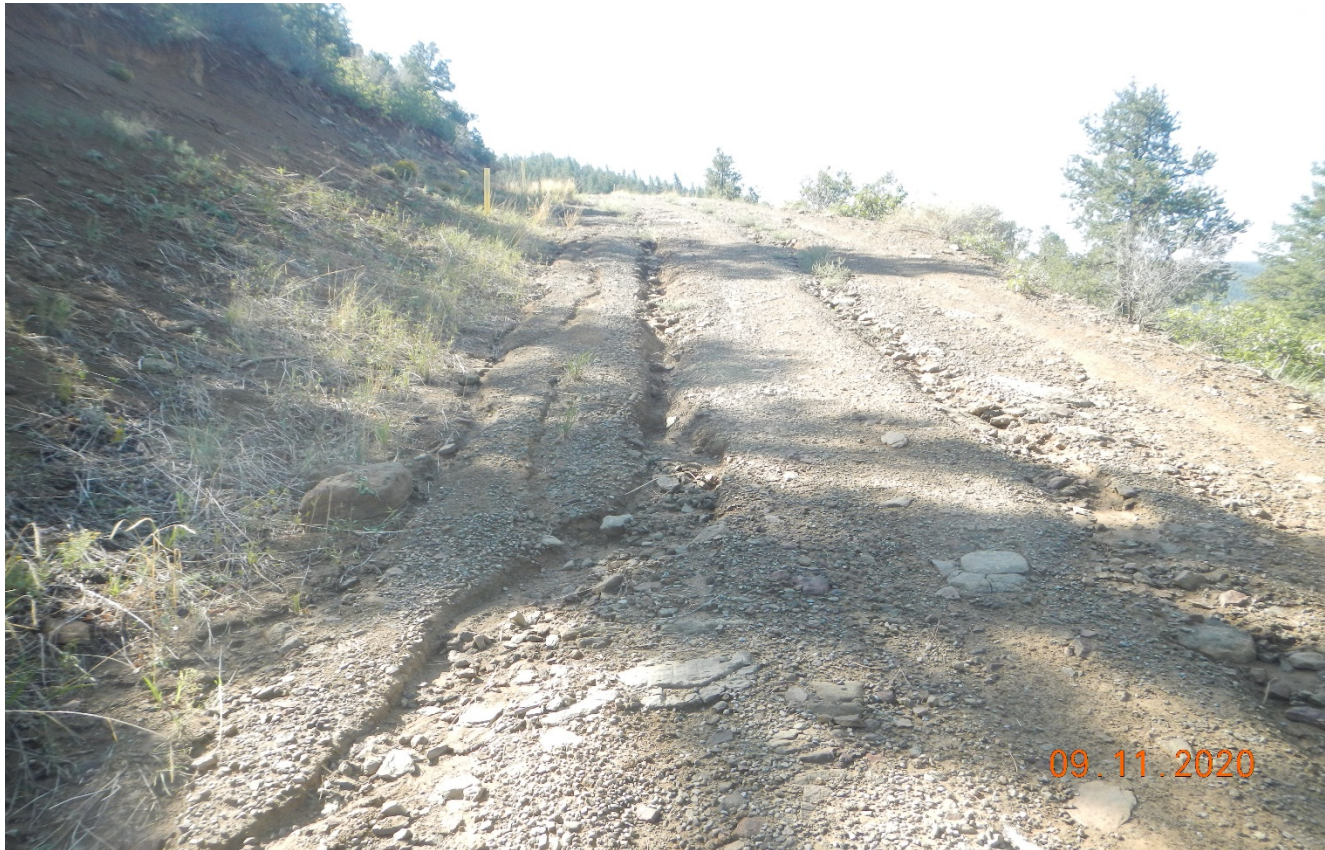
Photo 1. Facing south along the access road ascending the hillside. There is erosion occurring down the road and stormwater is not properly diverted toward the culvert.

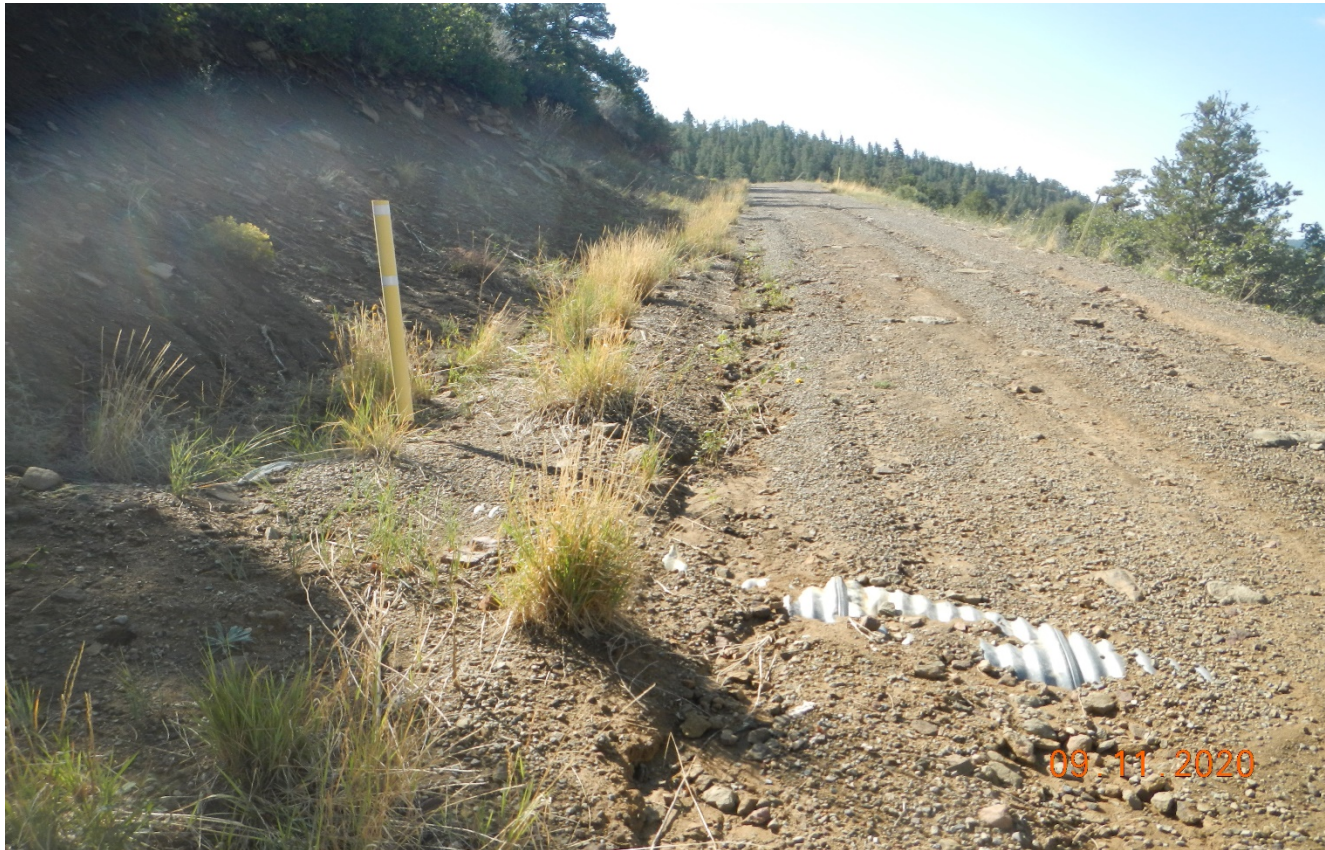
Photo 2. Stormwater is not properly diverted toward the culvert which is causing erosion of the road shown in previous photo.

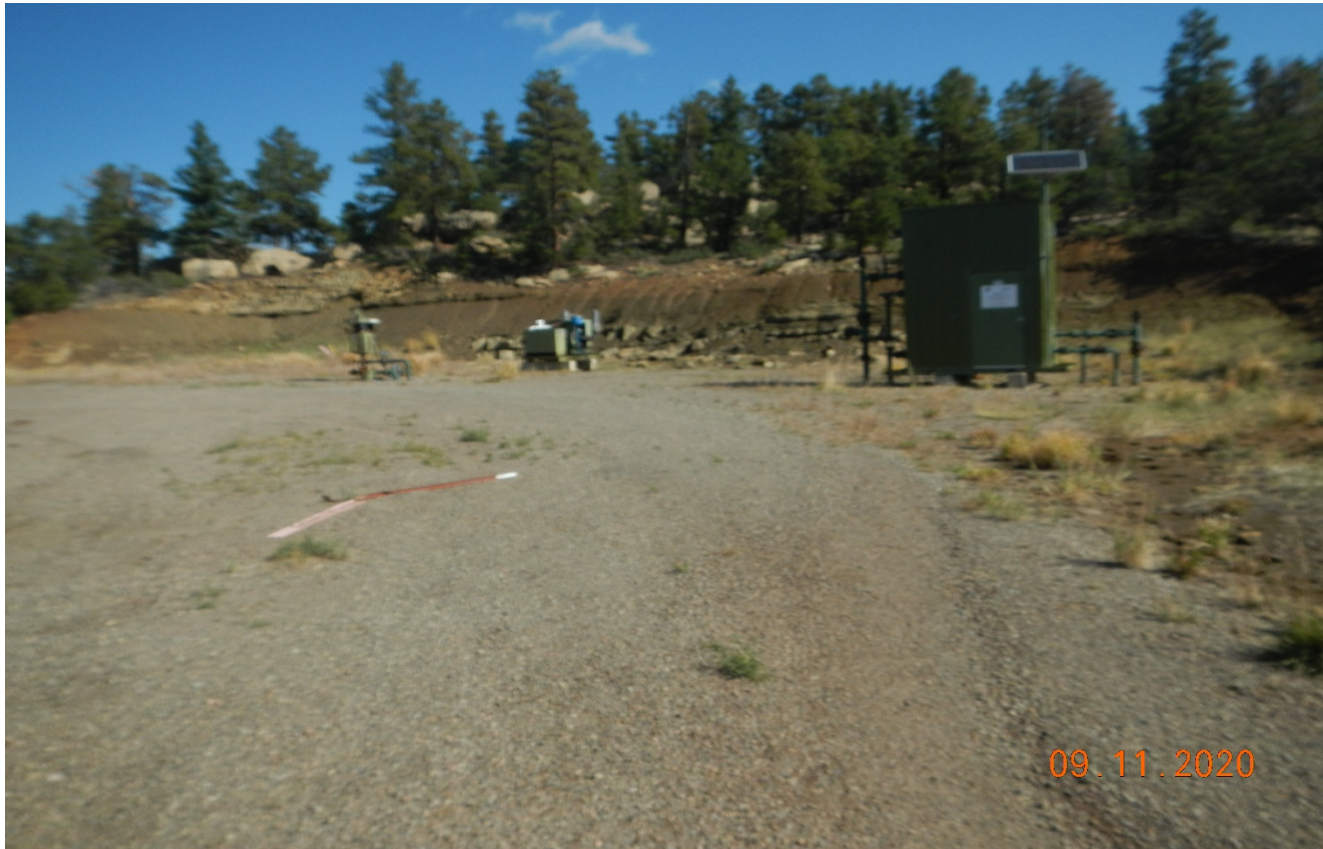
Photo 3. Facing north toward the location.
