# Inspection Photos

API: 071-07778

Operator: TIMBER CREEK OPERATING LLC

Inspection Date: 9/11/2020

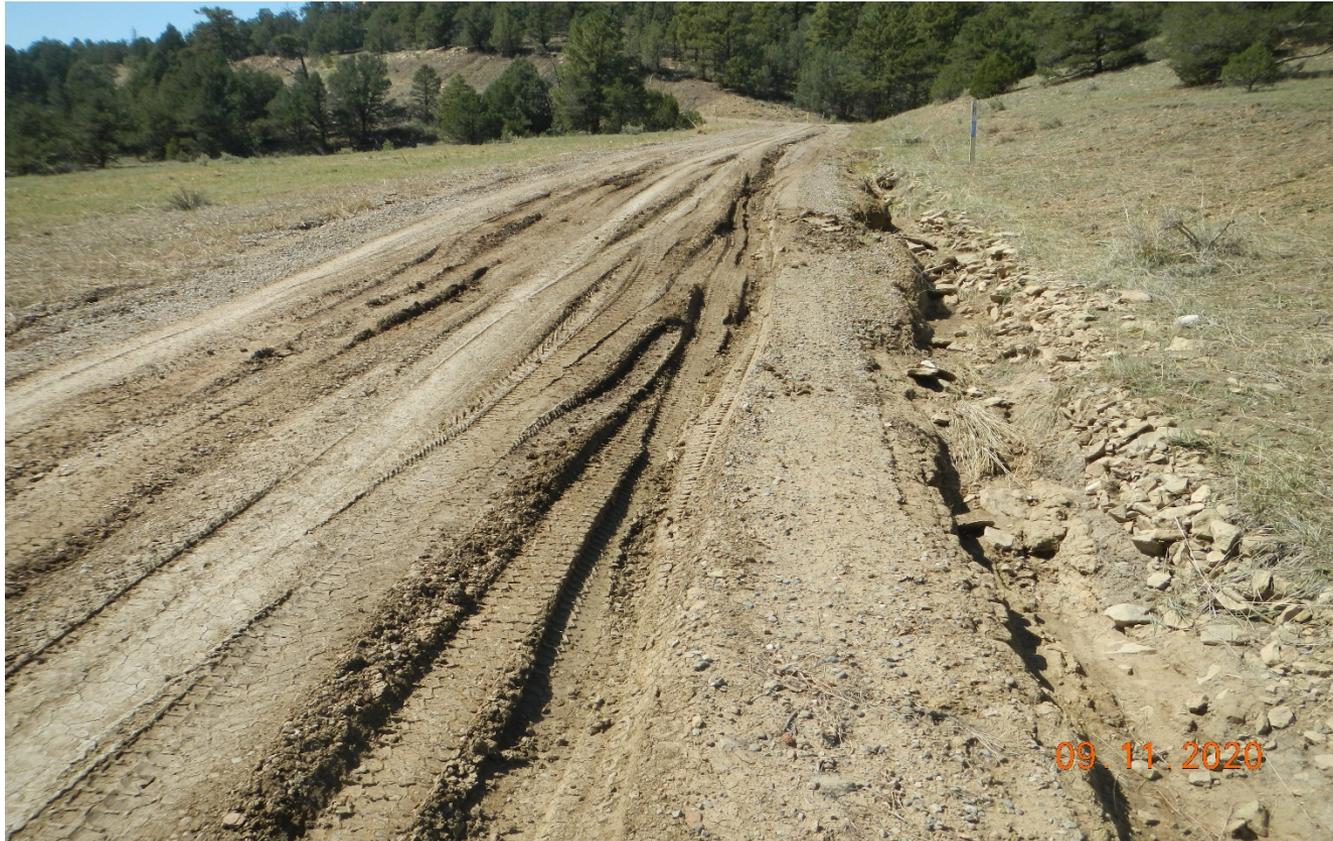
**Photo 1.** Facing southwest along the access road ascending the hillside. There is erosion occurring down the road and stormwater is not properly diverted toward the culvert up the road..

**Photo 3.** Facing back down the road where stormwater is flowing down the road causing the erosion shown in photo 1.

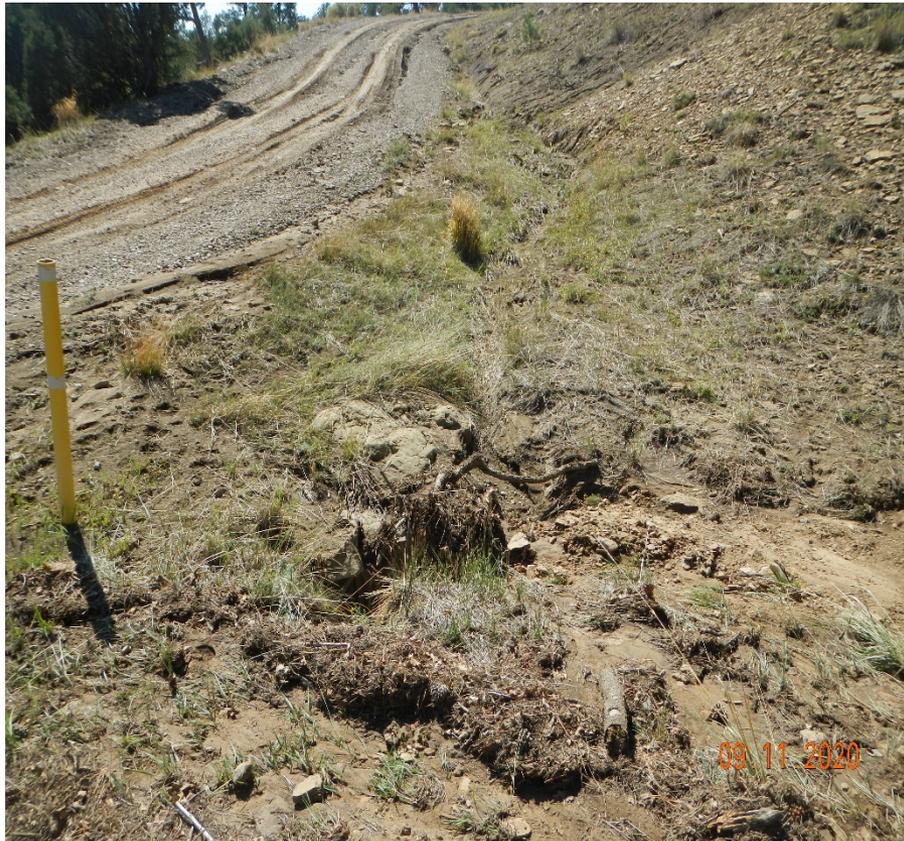
**Photo 2.** The culvert along the road has filled in with sediment causing stormwater to flow down the road.

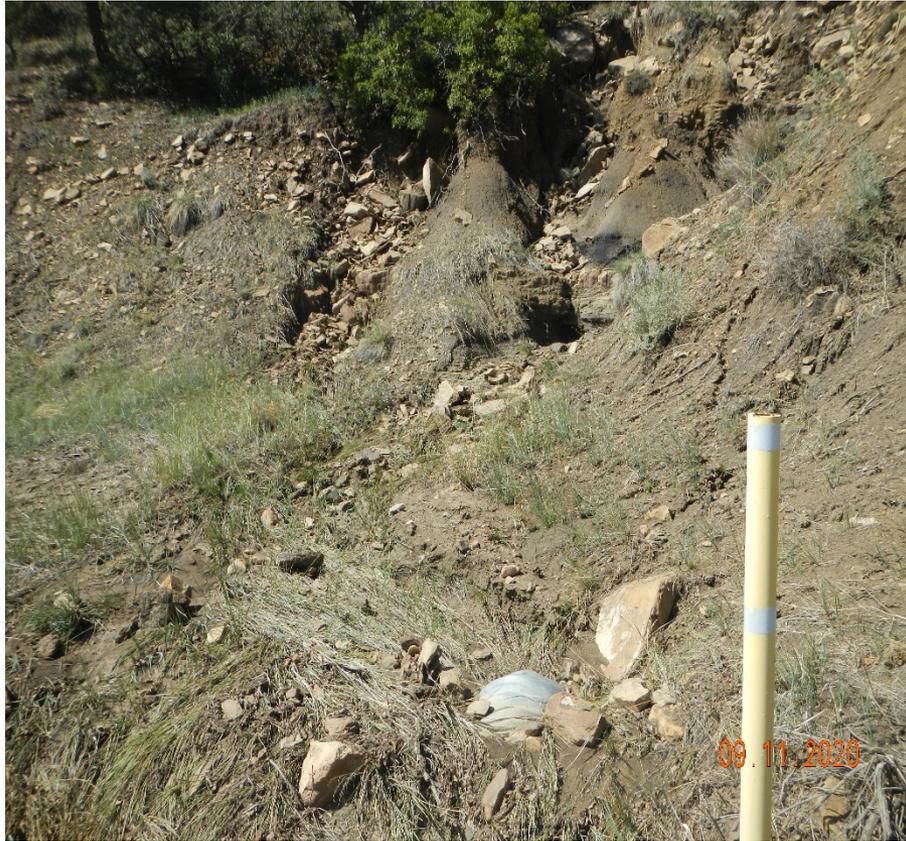
**Photo 4.** Another culvert further along the road is partially filled with sediment.

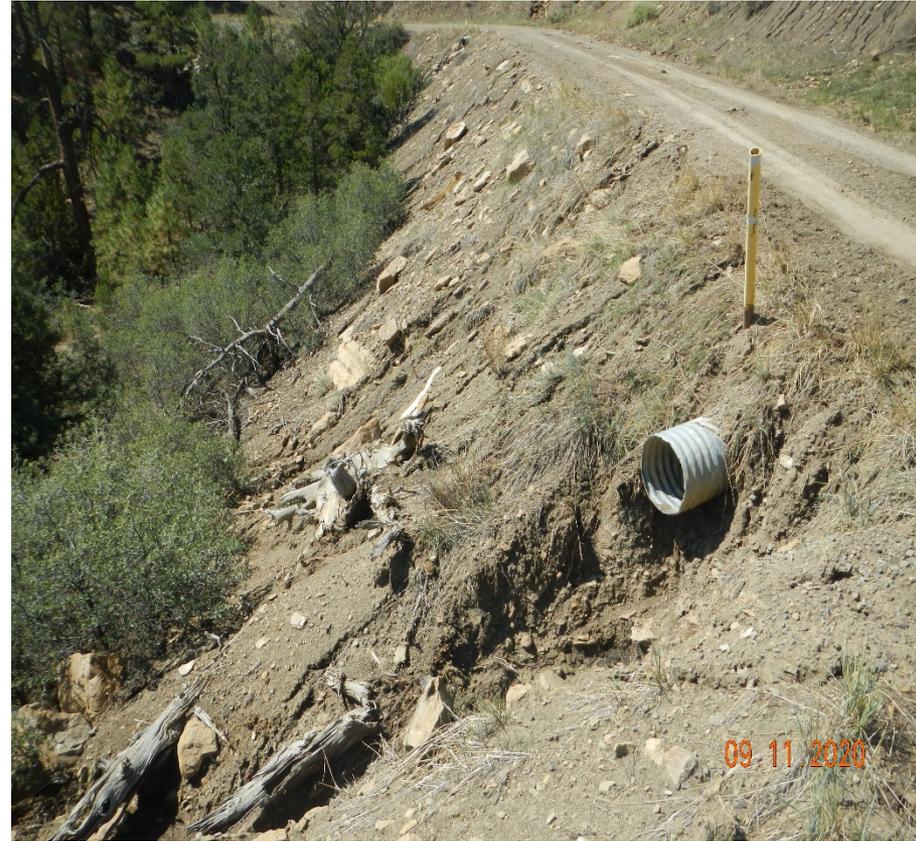
**Photo 5.** There is no culvert outlet protection which is causing erosion.
