# Inspection Photos

API: 071-09485

Operator: TIMBER CREEK OPERATING LLC

Inspection Date: 9/11/2020

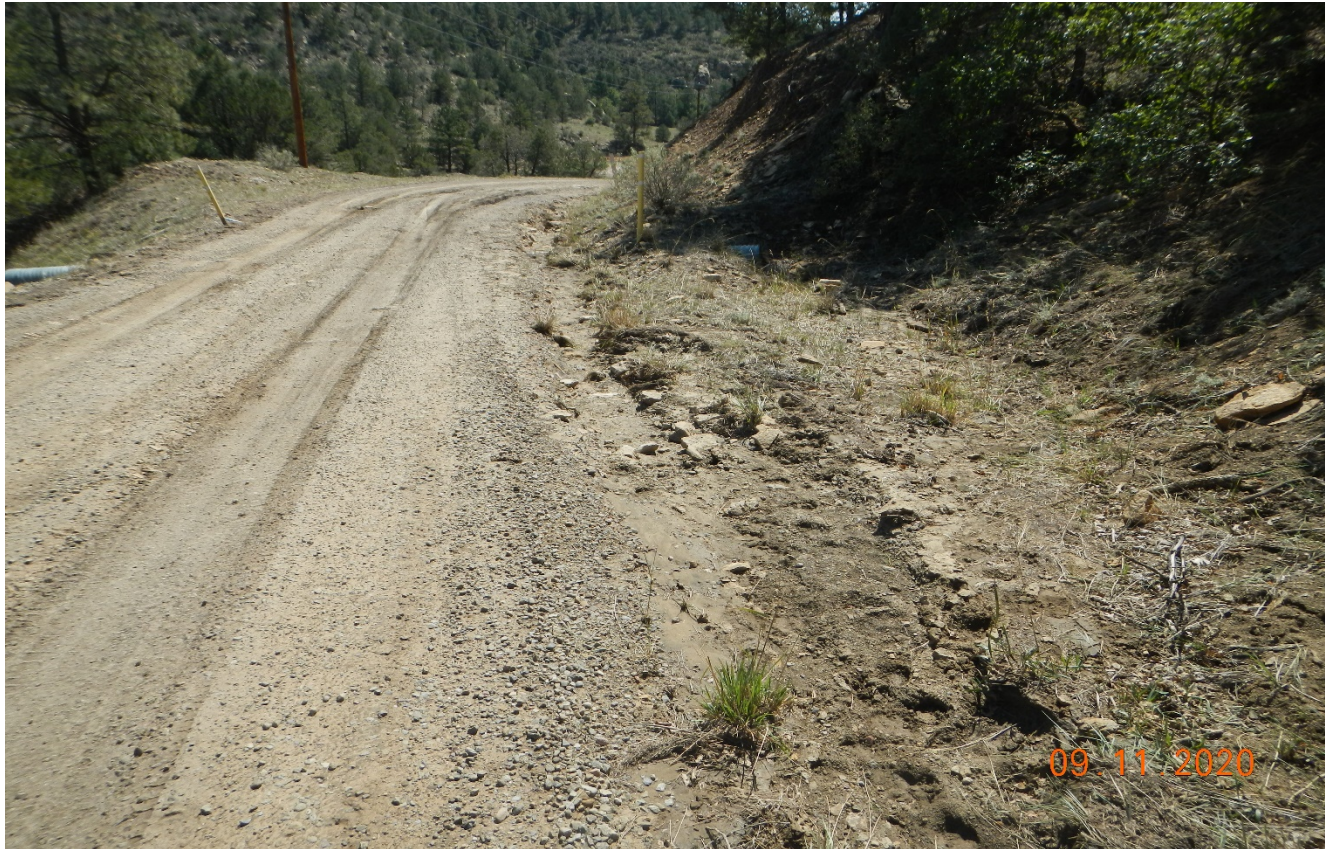
**Photo 1.** Facing southeast along the access road. Stormwater is not properly diverted toward the culvert in this area. Lat/Long:37.14697,-104.88575.

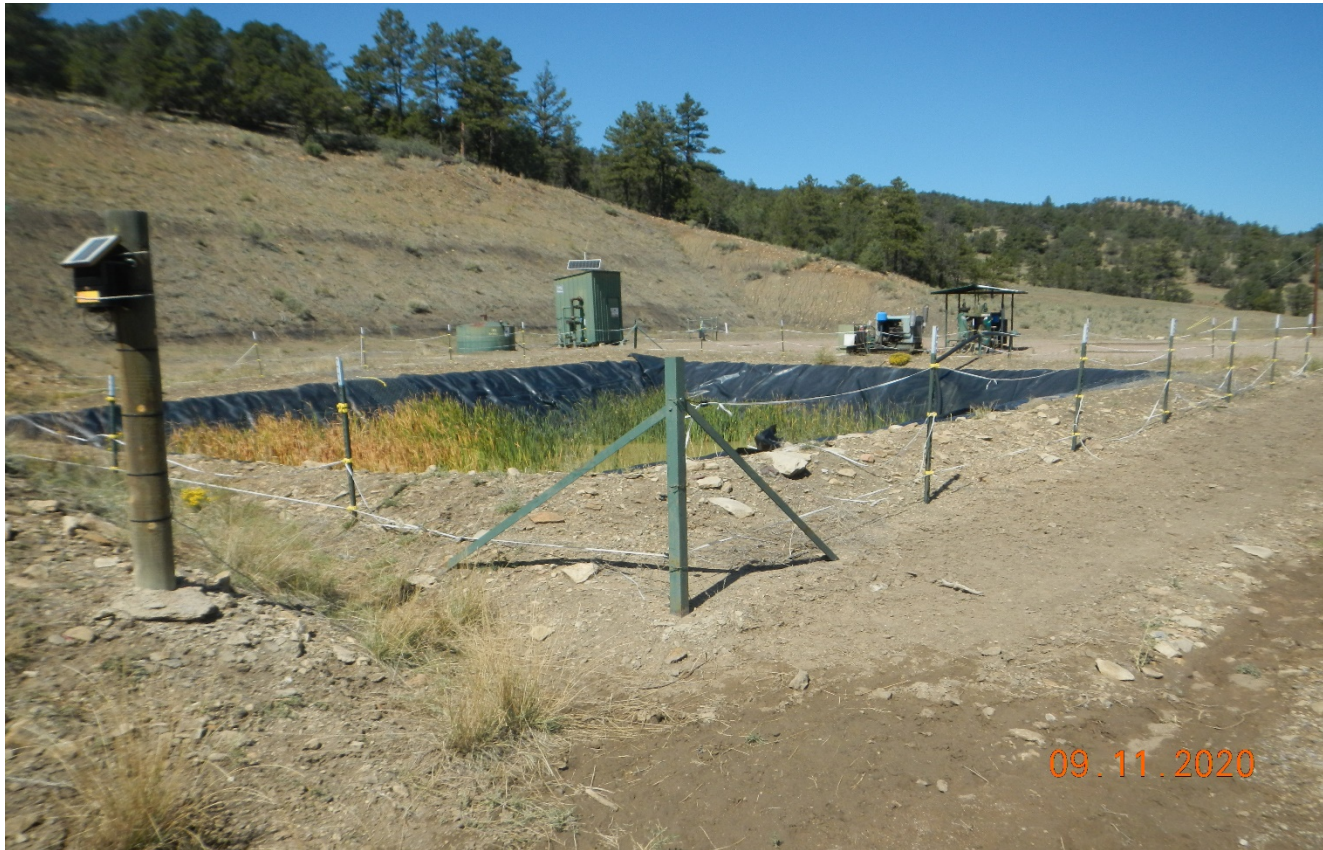
**Photo 2.** Facing northwest toward the location. The electric fence is in disrepair and needs maintenance.
