# Inspection Photos

API: 071-07680

Operator: TIMBER CREEK OPERATING LLC

Inspection Date: 9/11/2020

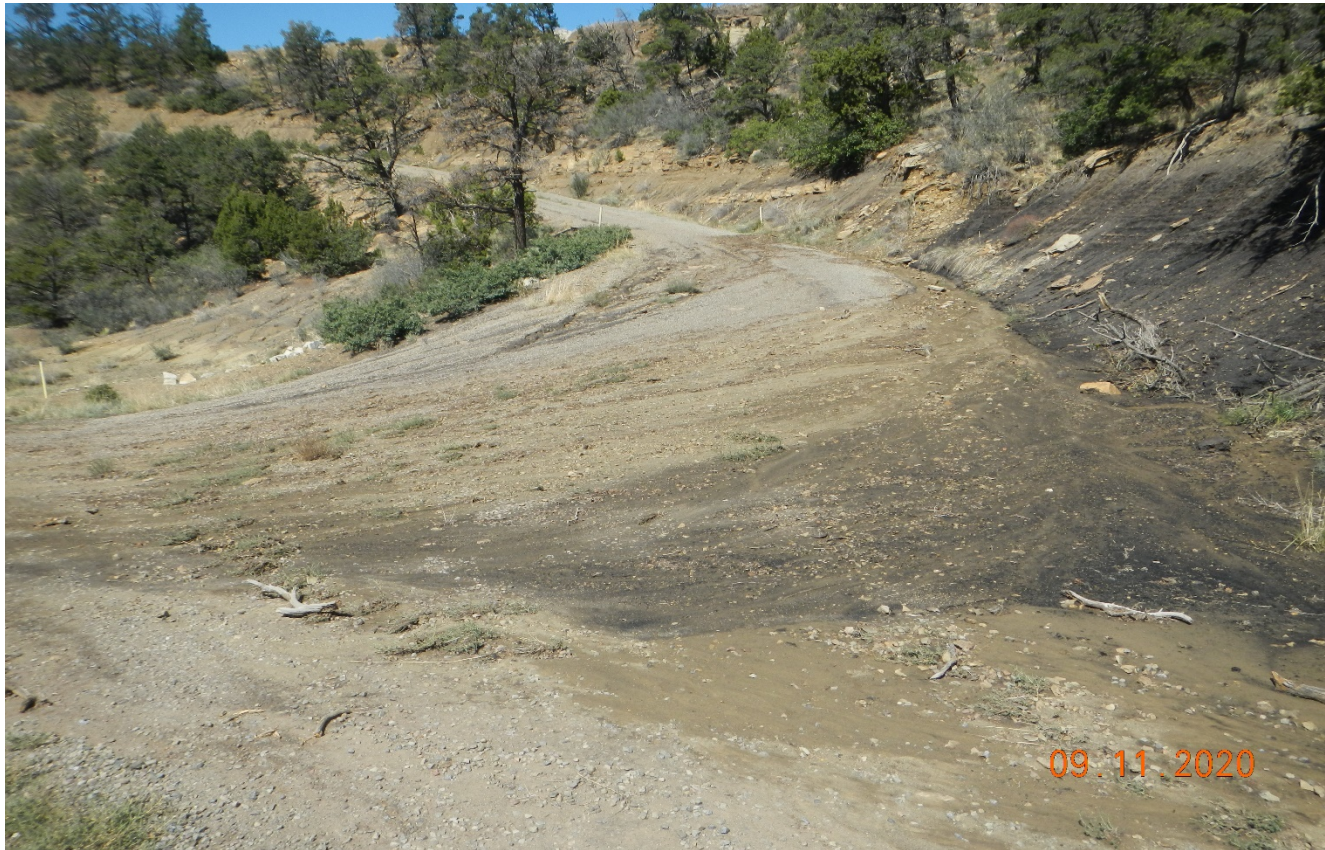
**Photo 1.** Facing northeast toward the access road. Stormwater is not flowing toward the culvert and is going across the road creating erosion shown in next photo.

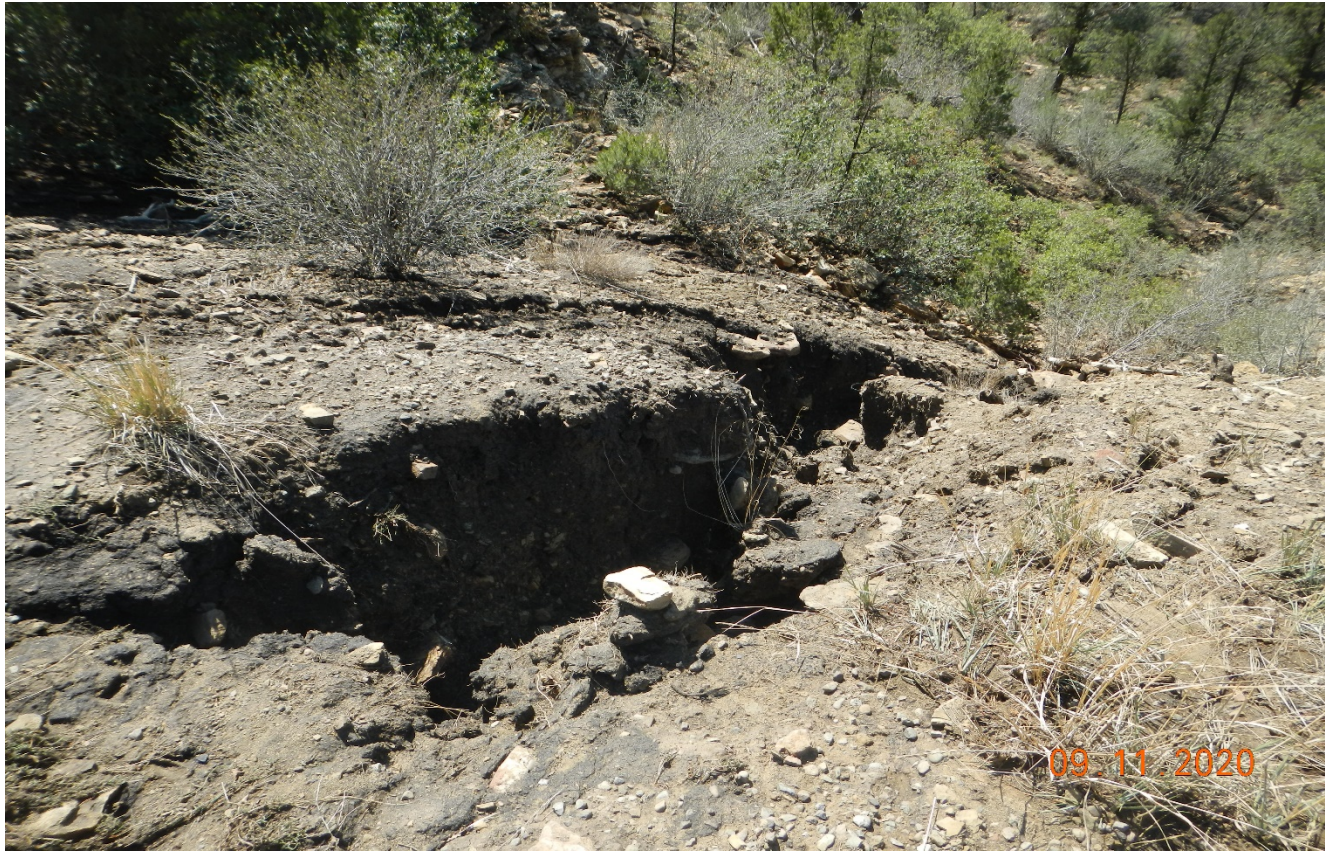
**Photo 2.** There is erosion occurring off the fill slope from stormwater flowing across the road shown in previous photo.

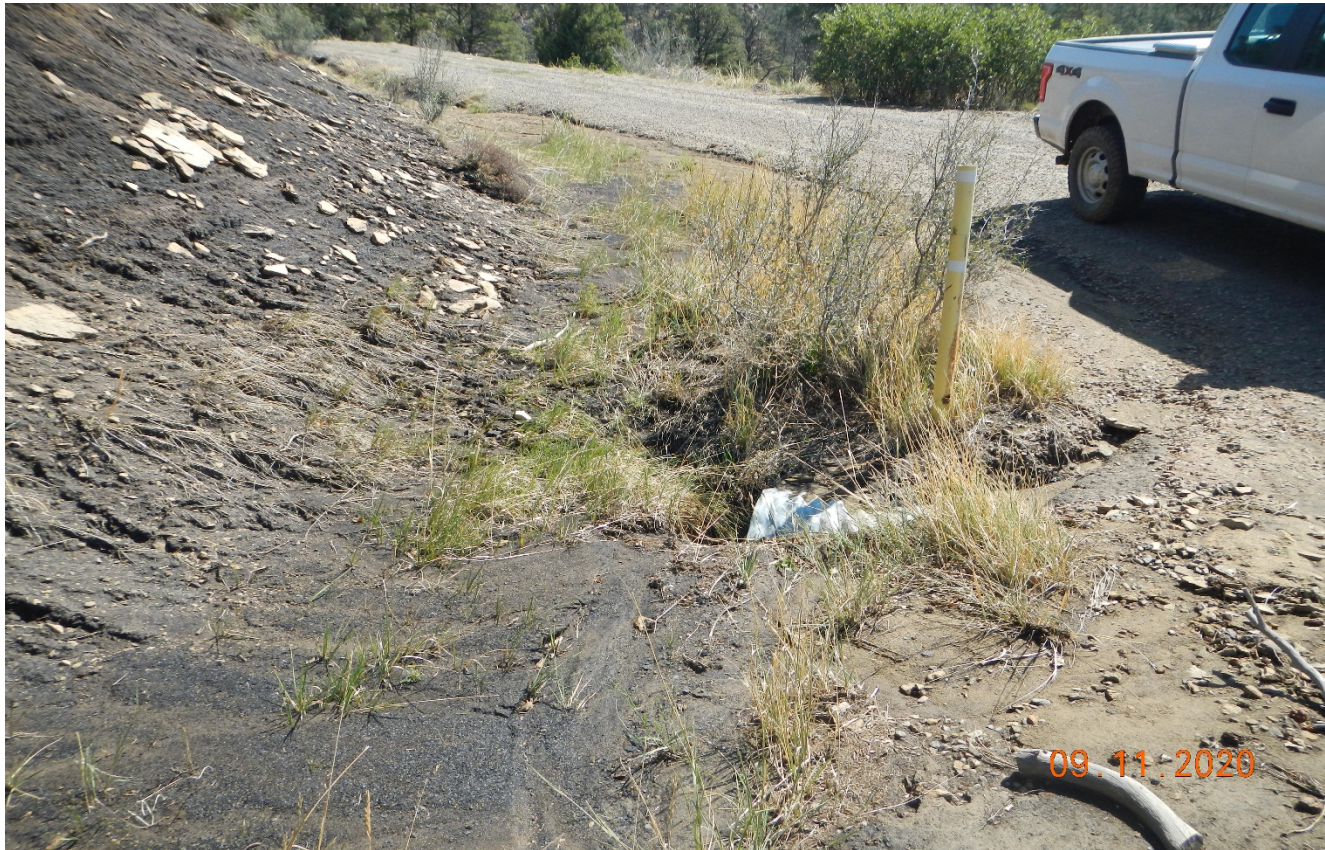
**Photo 3.** The culvert is filled in with sediment at beginning of the access road.

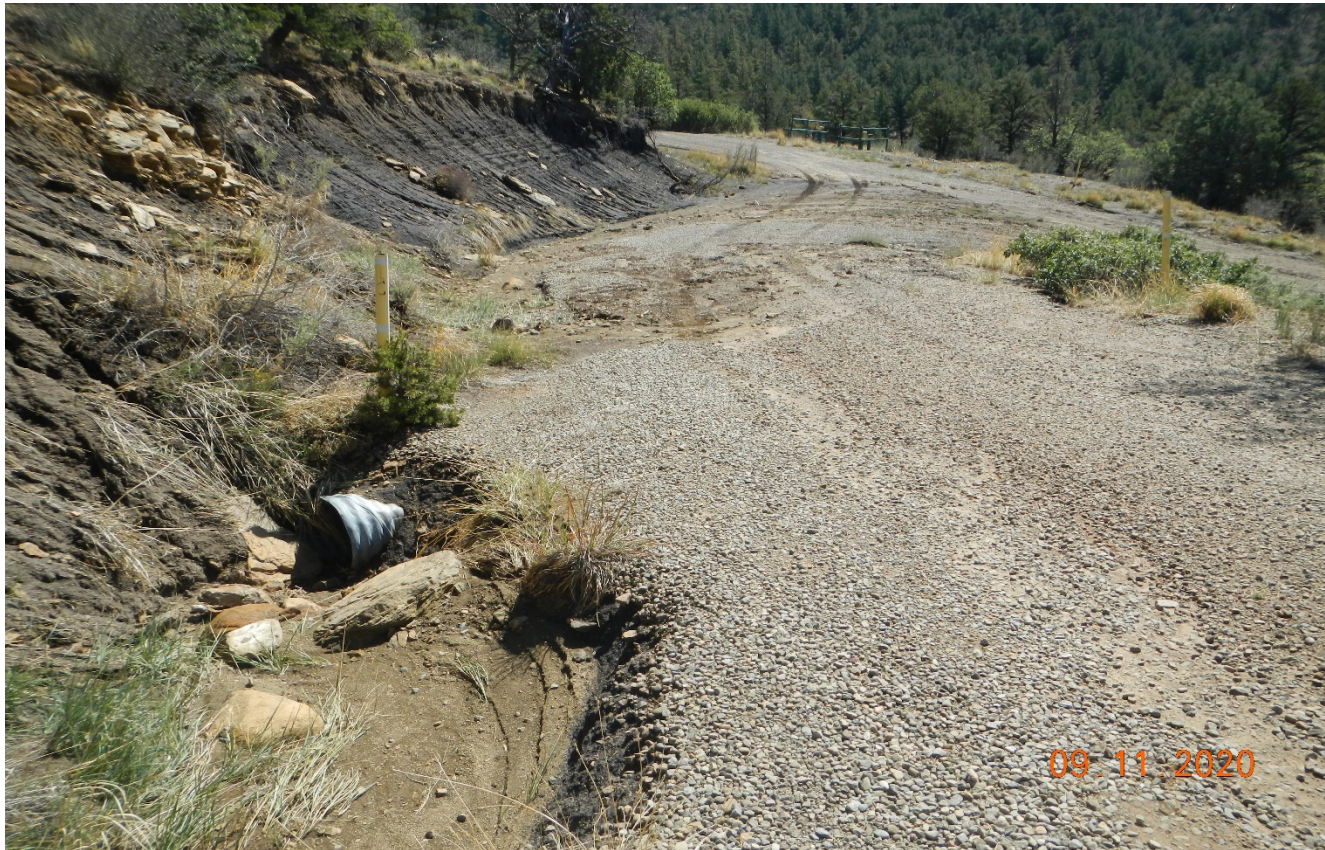
**Photo 4.** Facing back down toward the access road.

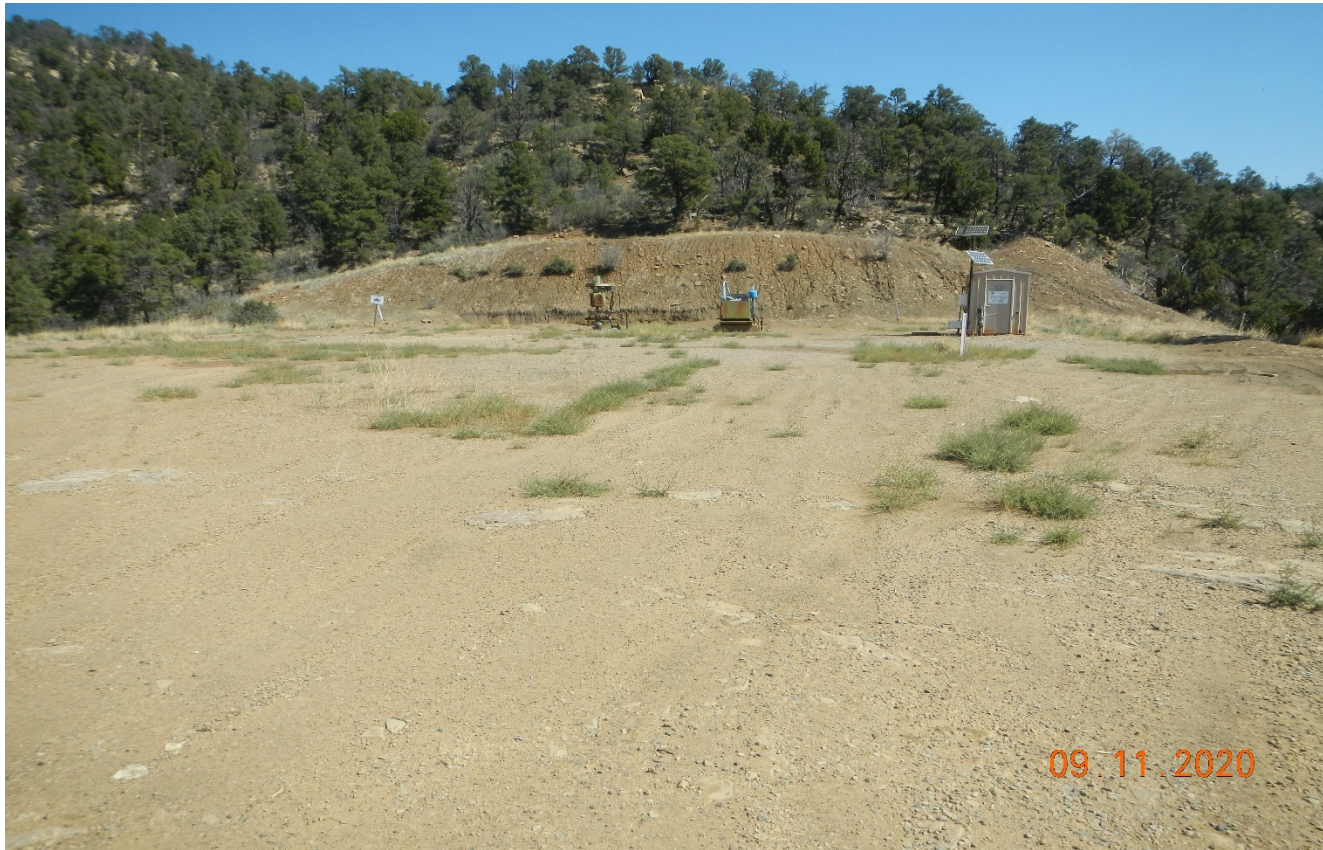
**Photo 5.** Facing northeast toward the location.
