Inspection Photos
Location Name: AC 18-4
Location ID: 308023

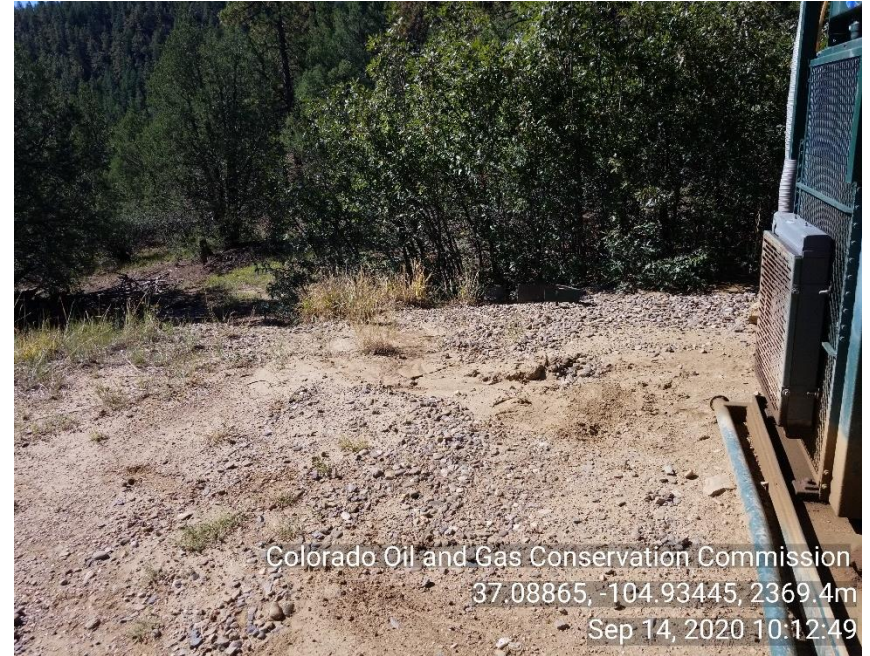
Photo 2 Stormwater running off location carrying sediment into drainage.

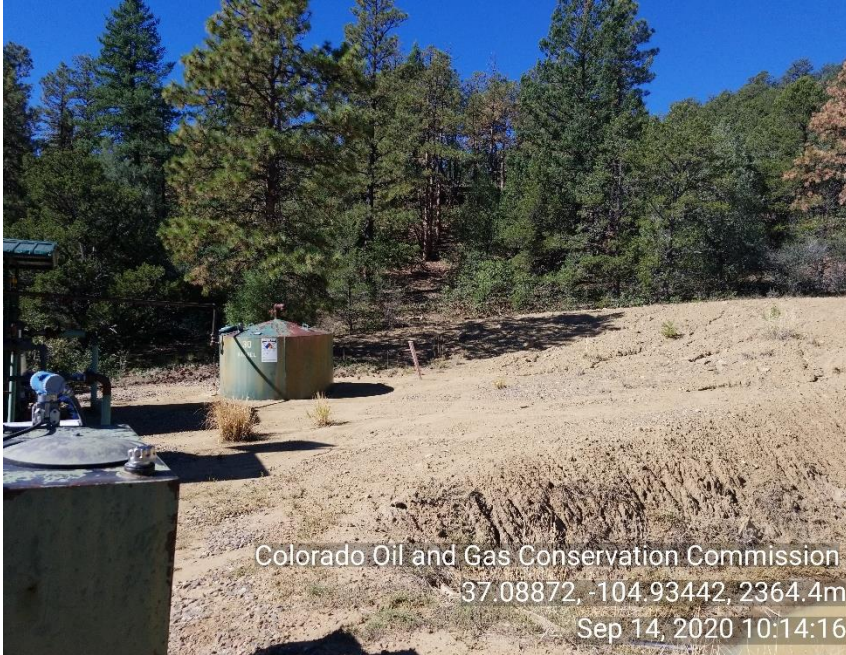
Photo 3 Drainage ditch on backside of location not in place to control run on stormwater to location issue in Photo 2

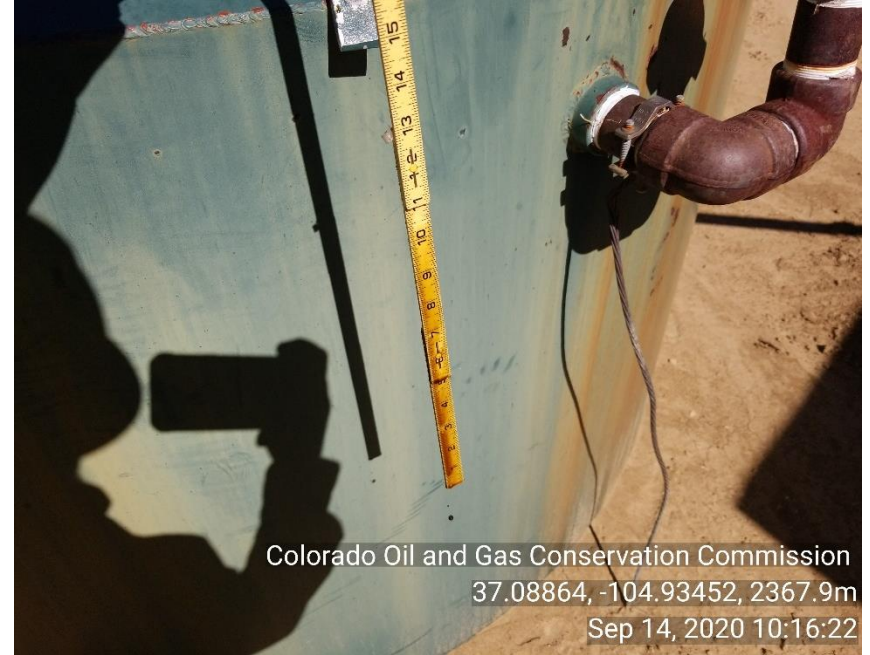
Photo 4 Approx 11 in of what appears to be non E&P waste in 30bbl produced water tank.

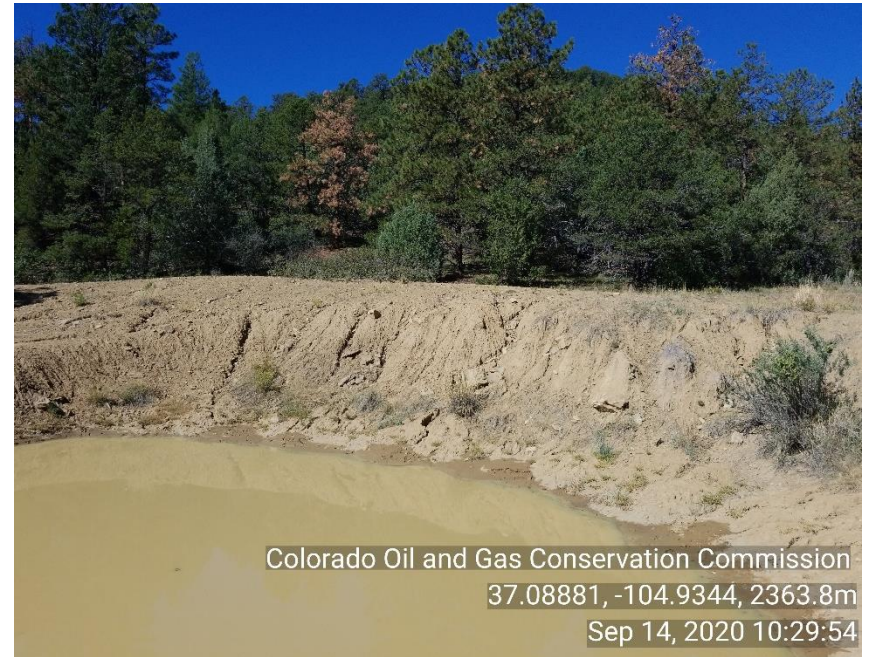
Photo 6 Stormwater running into production pit due to failed location BMP's.

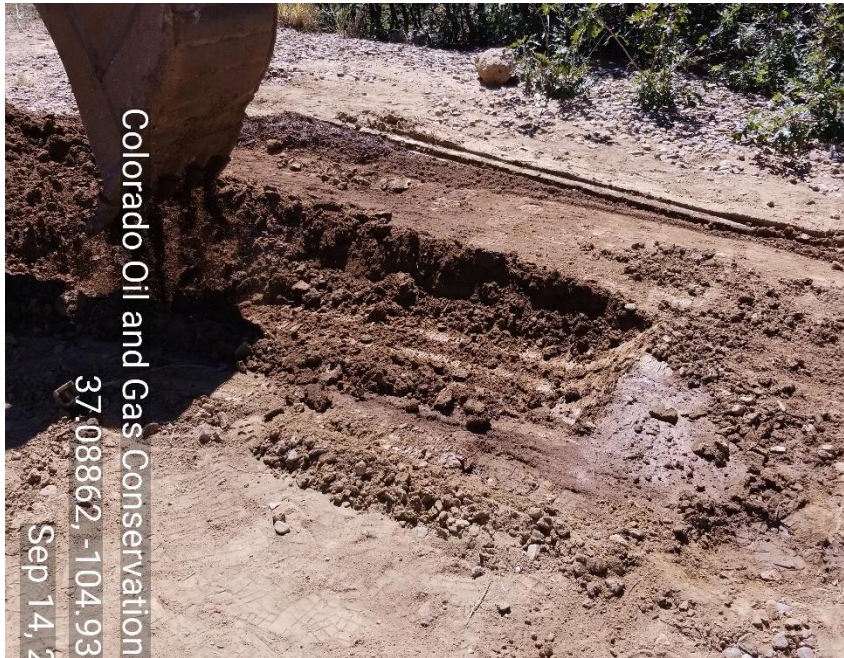
Photo 9 digging under liquid ring

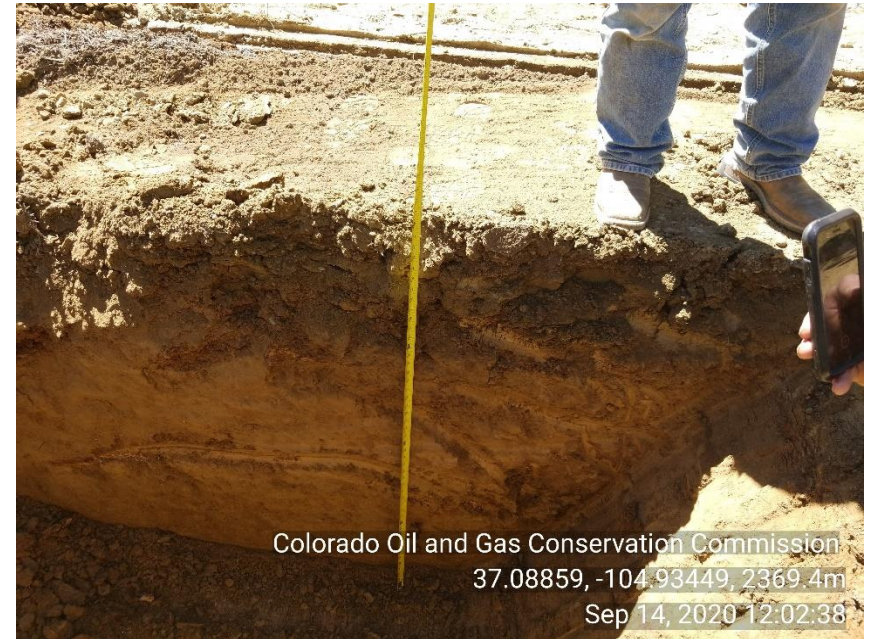
Photo 10 Dug down approx 4 ft did not observe contaminated soil.

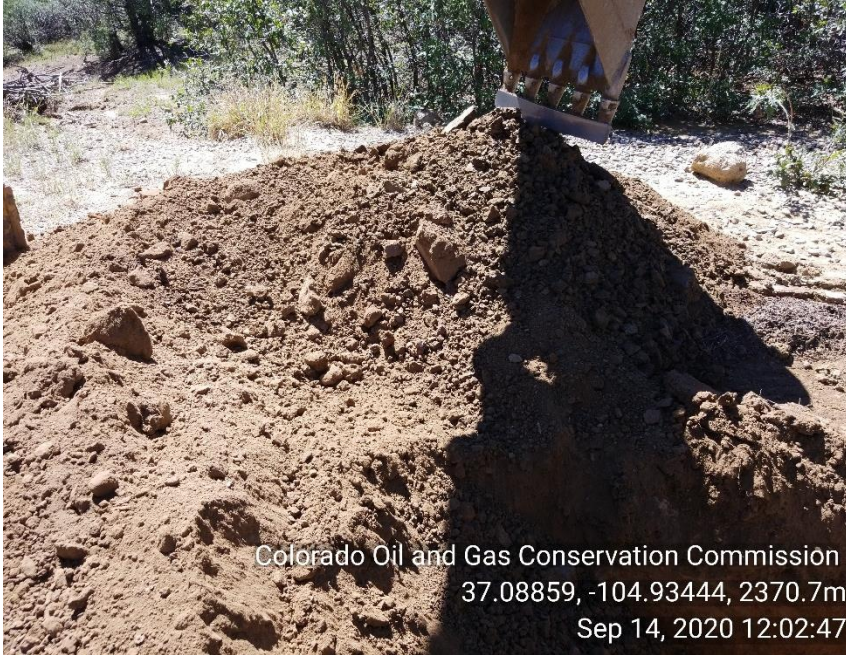
Photo11 material dug out of hole

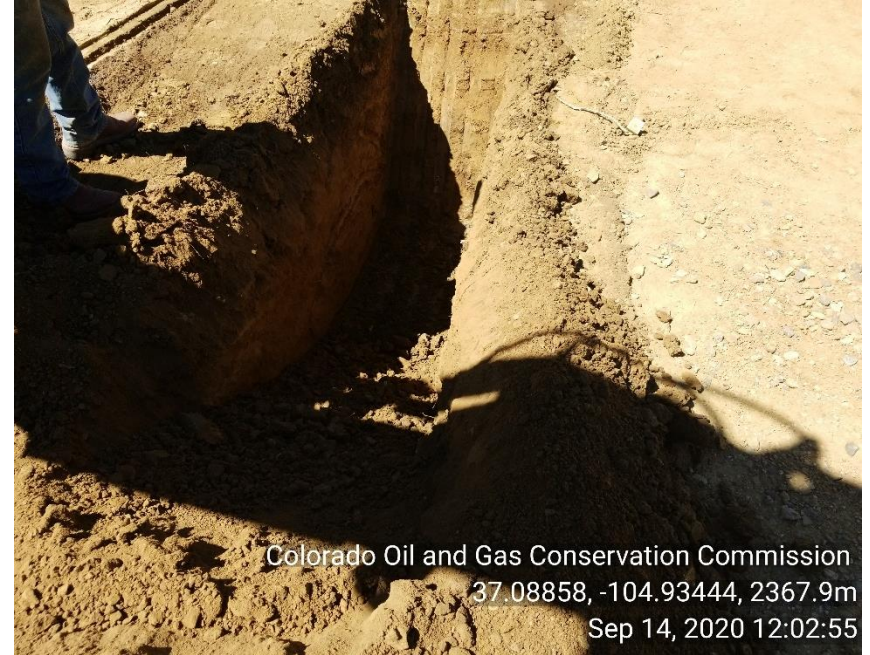
Photo 12 side view of trench dug under liquid ring.

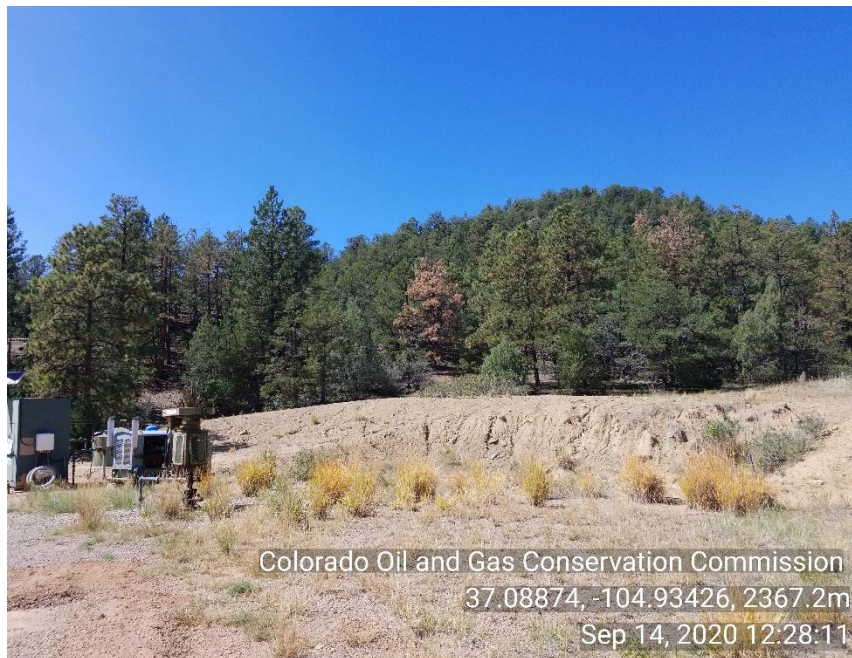
Photo 13 Weeds around equipment and on location.
